Attachment K. Remediation, Decommissioning, Restoration and Aftercare

**Greenstar Materials Recovery Facility
Millenium Business Park
Ballycoolin
Co. Dublin**

Waste Licence No, W0183-01

Closure & Decommissioning Plan

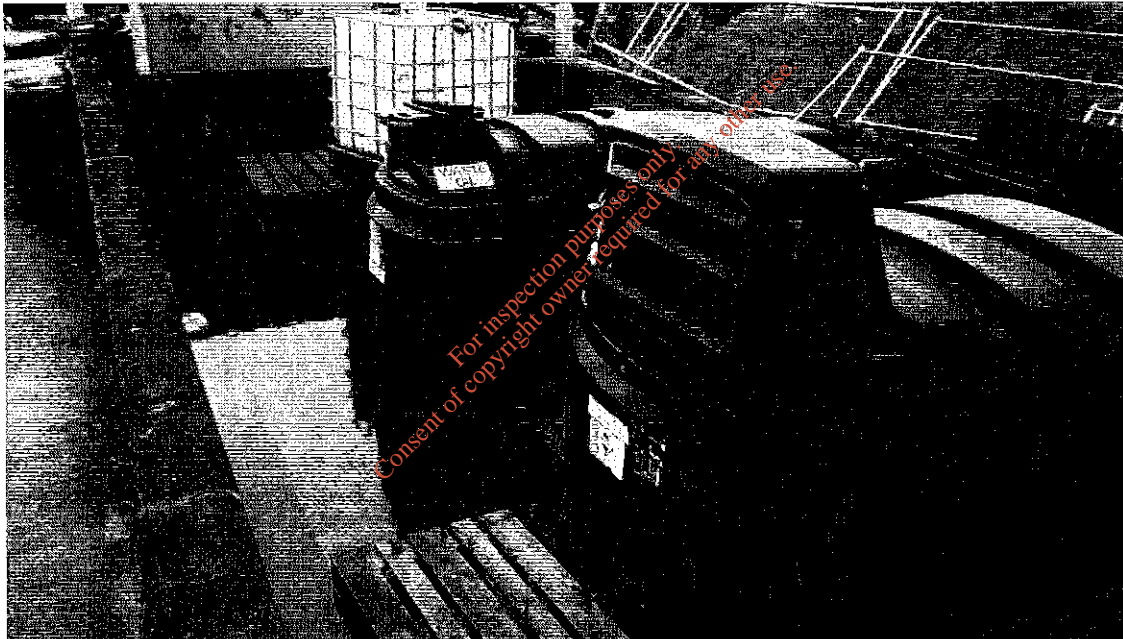
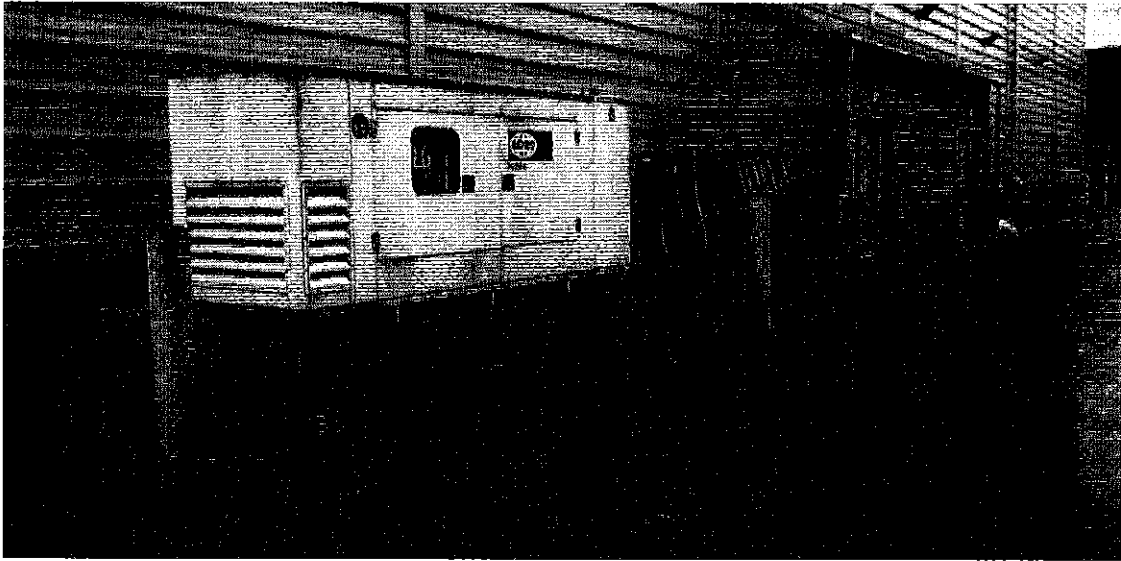
Photo 2 – Green Diesel and Waste Oil Tanks

The Millenium Park site contains 2 (No.) x 2,500 litre self-bunded plastic tanks containing marked (green) diesel as seen on Photos 2 and 3 below.

Upon decommissioning of the site, the diesel should be removed from these tanks. We suggest that the positive value of the diesel would outweigh the cost of its removal, so we do not attach a cost to this potential pollutant

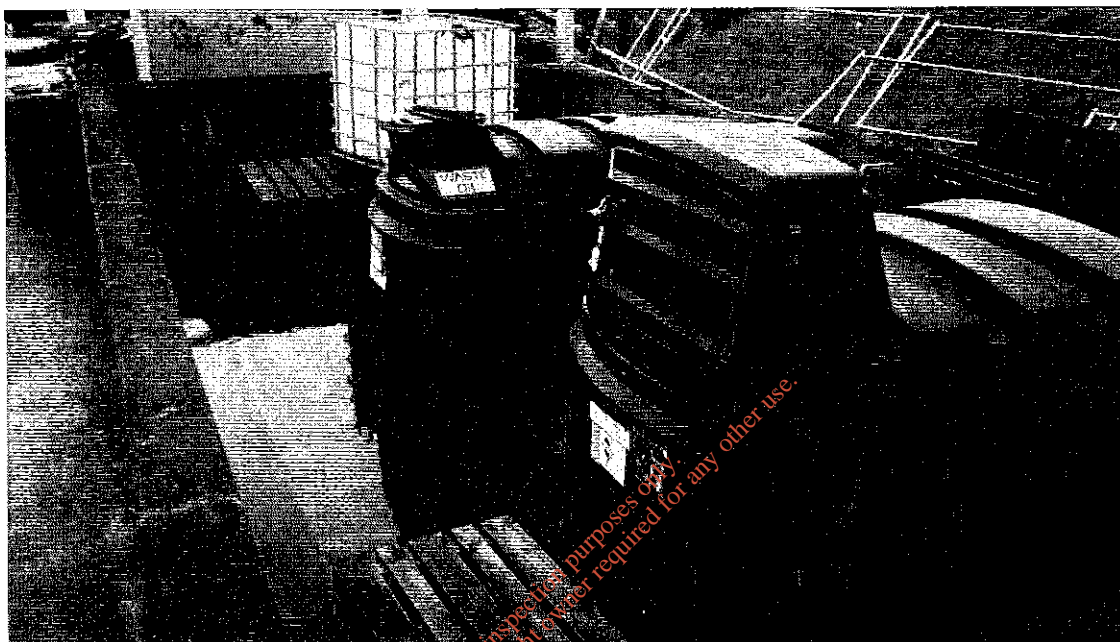
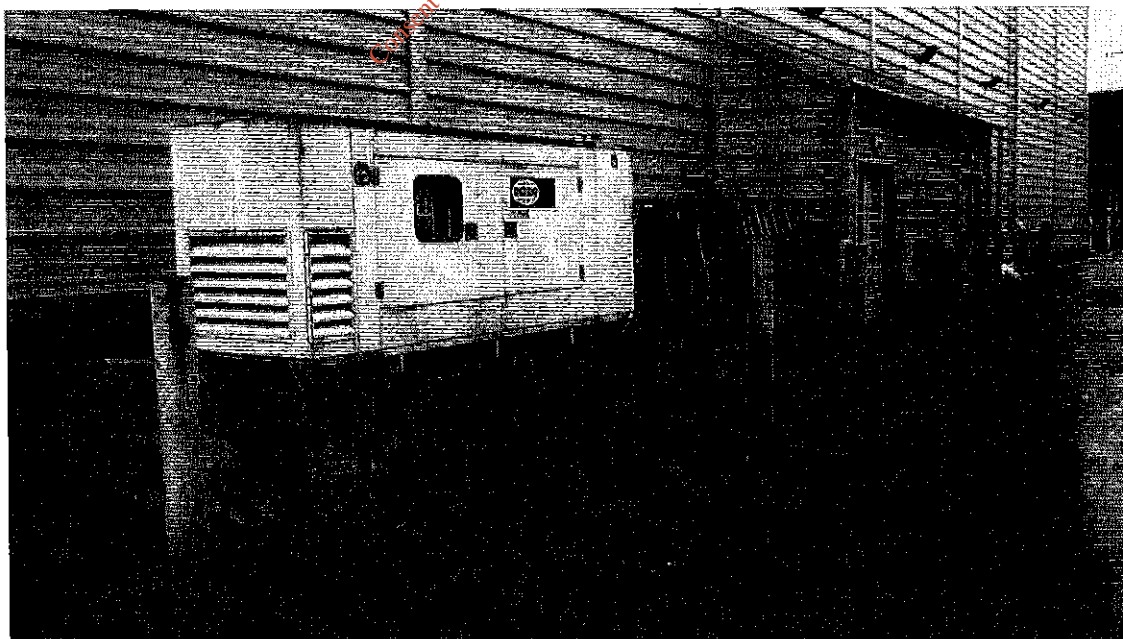
Photo 2 – Green Diesel and Waste Oil Tanks

The Millenium Park site contains 3 (No.) x 2,500 litre self-bunded plastic tanks containing hydrocarbons. A marked (green) diesel tank and a waste oil tank are contained in a large bunded area (capacity 75m³) at the eastern boundary of the site as shown in Photo 1 below and a second diesel tank used for a back-up generator is located adjacent to the generator as shown on Photo 2 below.

These tanks are potential sources of contamination that must be considered in this risk assessment. Minor spillages of hydrocarbon can usually be addressed by treatment with

absorbent material contained in spill-kits that are available on site. However, a major impact on one of these tanks from a vehicle such as a loading shovel could penetrate the tank and the bund, causing a spill that must be considered in the ELRA. The concrete bunds and crash barriers will be given full consideration in mitigation of this potential risk.

The diesel tanks at the site are all self-bunded and are all contained within concrete bunds with more than adequate capacity to contain the full volume of the tanks. The likely occurrence of a major rupture to any of the diesel tanks is considered 'low', as the tanks are well located and well protected from impact by a loading shovel or other site plant.

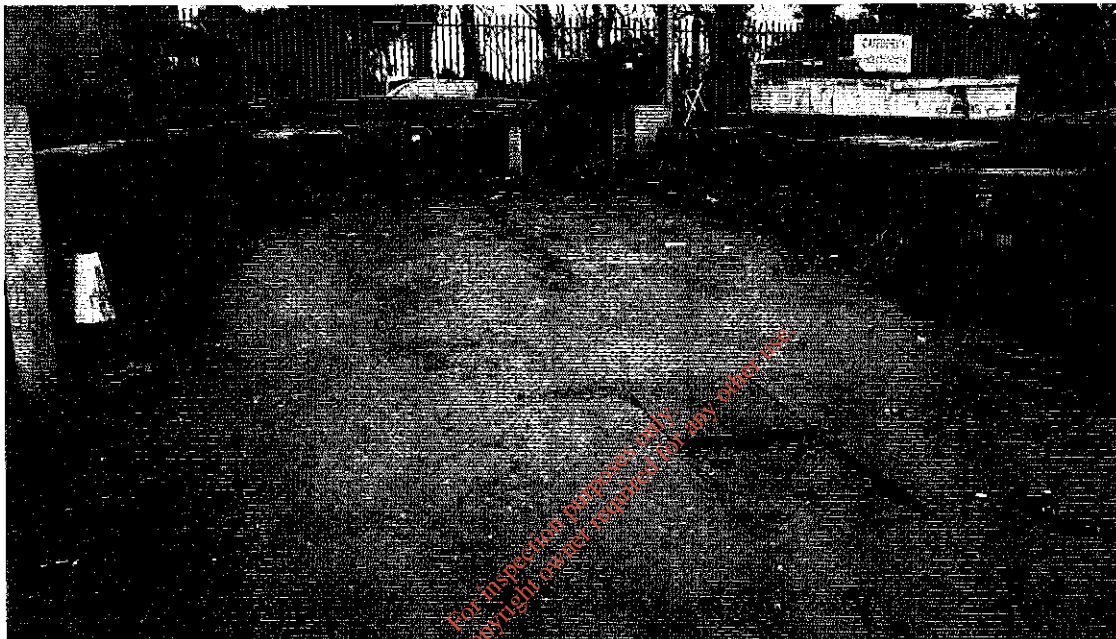
Photo 7 – Truck and Bin Wash Area

Drainage from the truck and bin wash area is directed to the foul water system via a silt trap and hydrocarbon interceptor.

Note: We have been informed that Lub Oil Tank in Photo 7 was empty and is stored in bunded area when full.
