Dawn Pork and Bacon Annual Environmental Report 2016

Licence Registration No. PO 175-02

Issued By: 51 New Moroney Date: 31st March 2017

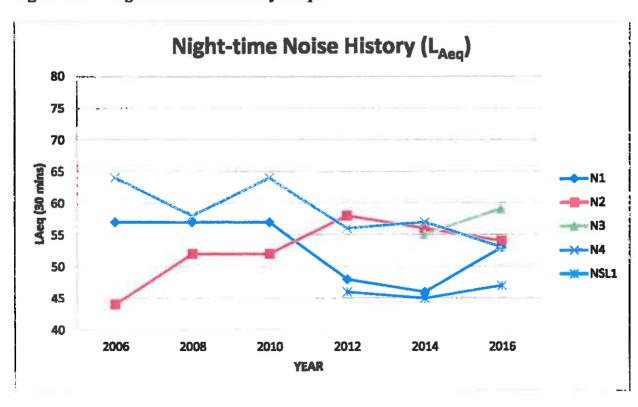
Figure 7.2: Night-time Noise History Graph

As can be seen in table 7.1 above, 2016 daytime noise levels (69 L_{Aeq}) are similar to those found in 2014 (68 L_{Aeq}) and indicate similar onsite traffic levels during both surveys. Night time noise levels were 4 dBA L_{Aeq} higher in 2016 than in 2014 due to the operation of the refrigerated trailer.
