## FIRE SAFETY COMPLIANCE REPORT

**PROJECT:** FIRE SAFETY COMPLIANCE ASSESSMENT OF  
2 WHITESTOWN ROAD,  
WHITESTOWN INDUSTRIAL ESTATE,  
TALLAGHT,  
DUBLIN 24.

**CLIENT:** HARP INTERNATIONAL

**JOB No:** 3599F

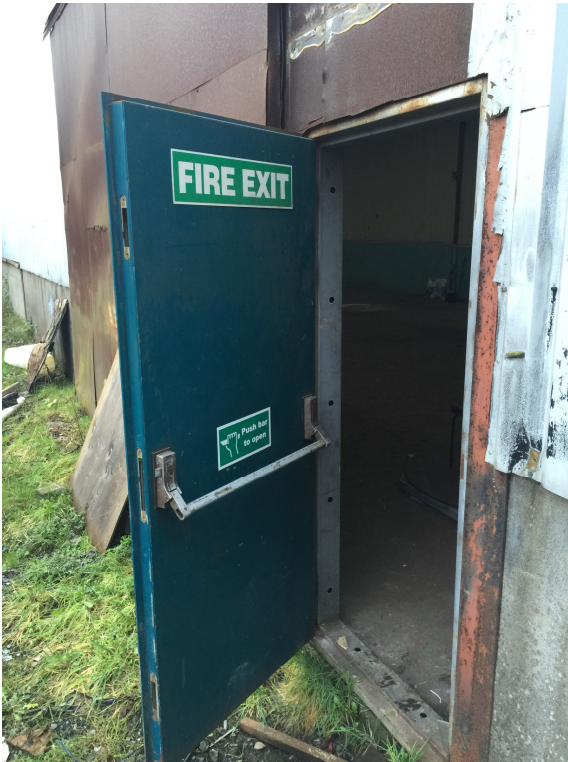
All exit capacities from individual rooms and floors has sufficient capacity. However, the rear fire exit, to which the persons at Mezzanine level or the alternative route used by the remainder of persons within the building will use the exit as an alternative, does not have a safe route once persons have exited the building. (Fig. 3 & 4)  
The access door between the protected hallway and the main hall the doorway has a large channel in the floor. (Fig. 5)

The largest issue presenting itself is the escape route from the rear fire exit to the external. The internal escape route is acceptable, however once the occupants escape from the building there is no route to a place of safety.

Figure 3: Rear Fire Exit

A boundary wall or fence should be established to provide a route for persons to get off the site and away from the building.  
The channel at the door way should be filled in to create a level floor.

Where there is a dead end, all travel distance limits are within the limits. Where there is no dead end there is an alternative exit, these limits are also satisfied.  
All final exits must be accessible at all times and free from blockages.  
All exits from rooms must be accessible.  
The route externally from the rear fire exit should be provided to ensure persons can get to a place of safety away from the building.

***This has now been corrected.***

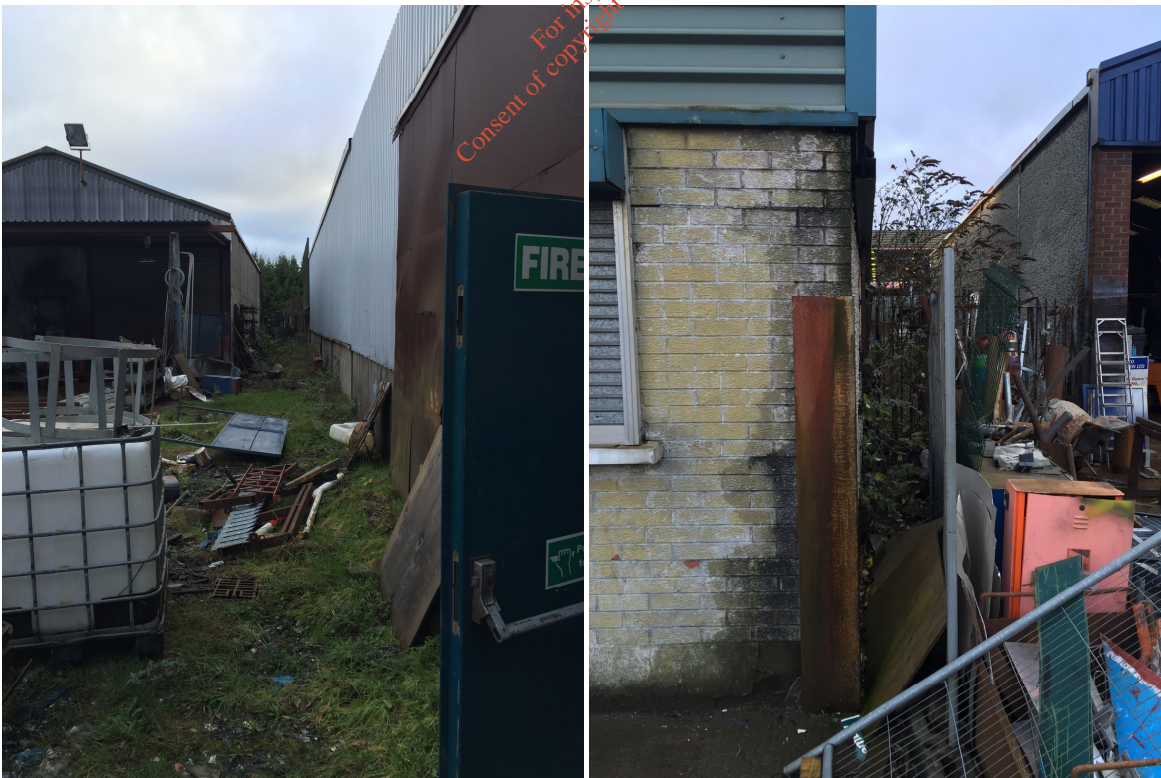
Figure 4: View along boundary line. (From Rear Exit and from Front Yard)

The locked gate must be openable from the rear yard and not blocked by rubbish or overgrowth.

***The above gate and fencing had been tidied up and is now openable. (02.03.16)***

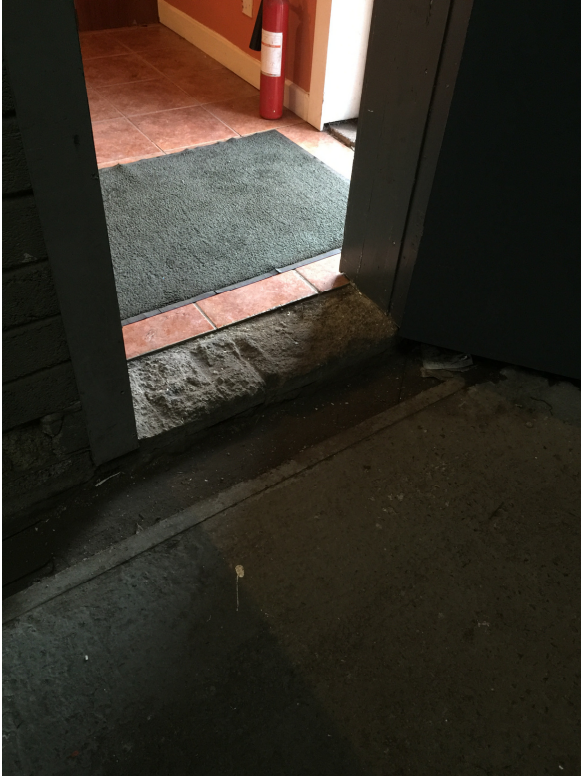
**Figure 5: Channel through escape route**

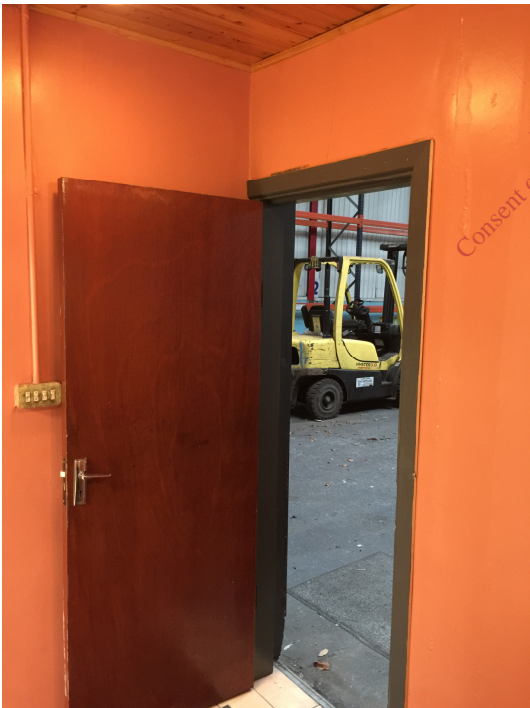
Both doors which provide access to the office block from the main floor space did not appear to be fire doors and there was no evidence of intumescent strips. (Fig. 6)

**Figure 6: Door from kitchenette to main hall**

- Replace all doors mentioned above to the FD30S standard in accordance with Appendix B – Fire Doors of TGD B.
- The main entrance should be a sterile area and be kept free from rubbish and any other potentially flammable items.
- The mezzanine should be fitted with a railing to prevent persons from falling off the edge, if persons are to have access to it. If access is required for forklifts to store materials, gates should be installed in the railings.

***The Fire Doors have now been upgraded to an FD30S standard. (28.04.16)***

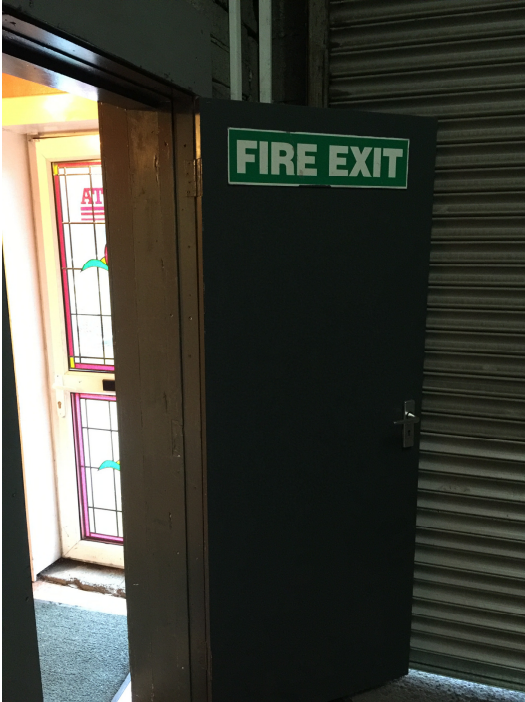
A fire door should be fitted between the office and the entrance lobby to protect the escape route of persons exiting from the main hall space. (Fig. 7)

**Figure 7: Door from Main hall to Main Entrance**

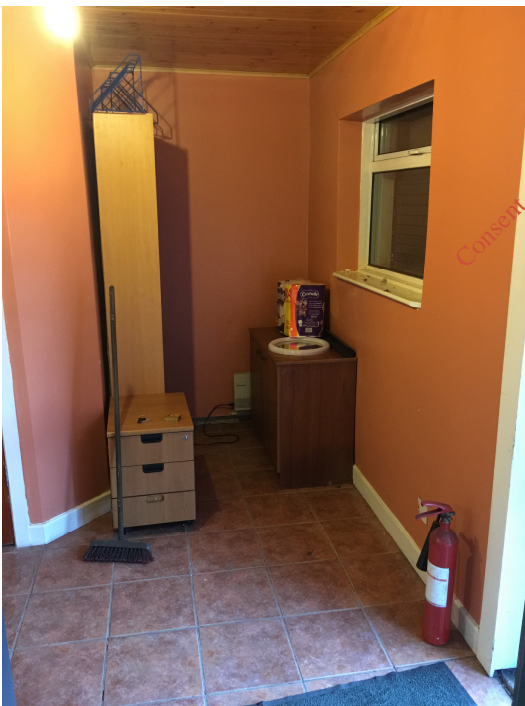
There was a small gathering of items and a bookcase in the main entrance. (Fig. 8)

**Figure 8: Storage in protected entrance**

***The main entrance is relatively free from obstructions. The bookcase remains in place. (22.04.16)***

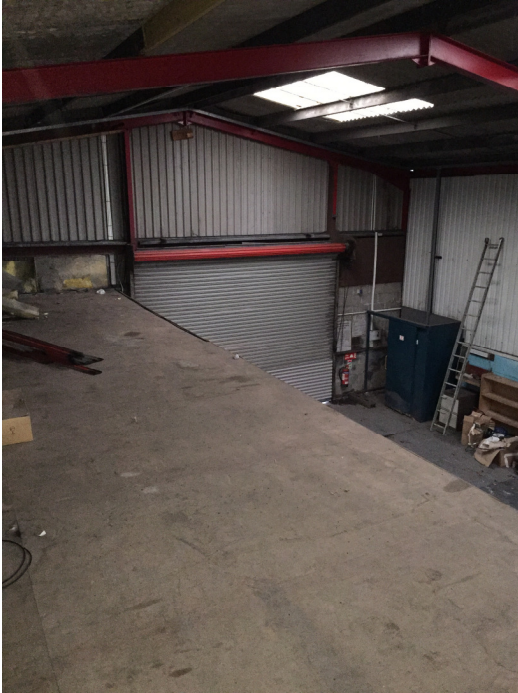
The mezzanine level above the office space did not have any railings to protect persons from falling off the edge. (Fig. 9)

**Figure 9: View from front mezzanine**

***The mezzanine has been decommissioned and will not be used by the company. The staircases are closed off and signs have been erected. (22.04.16)***

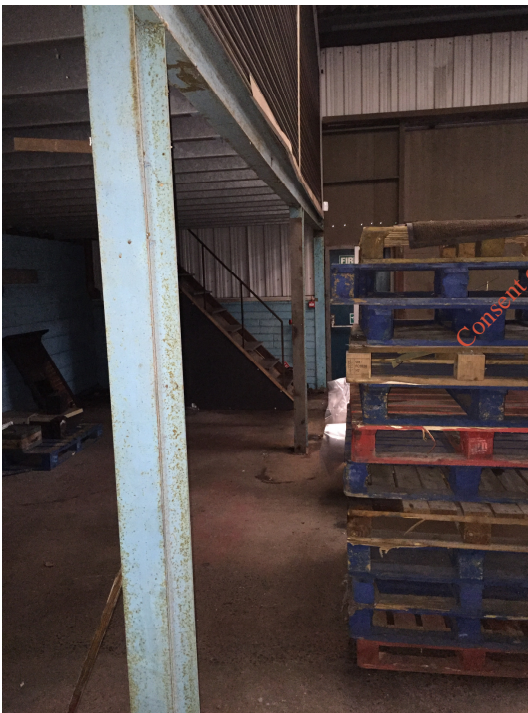
Wayfinding signage has been provided, but not in accordance with BS 5499 Part 3 1990. Some changes in direction on escape corridors have not been afforded wayfinding signage. (Fig. 10)  
There was no indication of emergency lighting anywhere within or external to the building. (Fig. 11)

**Figure 10: Minimal wayfinding signage**

- Wayfinding signage to be provided within the school, to be in accordance with BS 5499 Part 3 1990 and Safety, Health and Welfare at Work Act 2010.
- Emergency lighting should be provided in accordance with I.S. 3217: 2013.

**Update:**  
***Emergency Lighting & Signs have been provided. (22.04.16)***

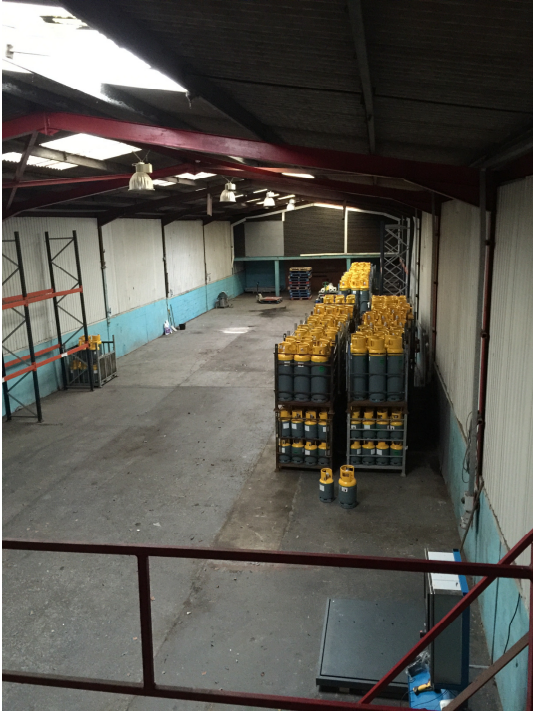
**Figure 11: No Emergency Lighting**

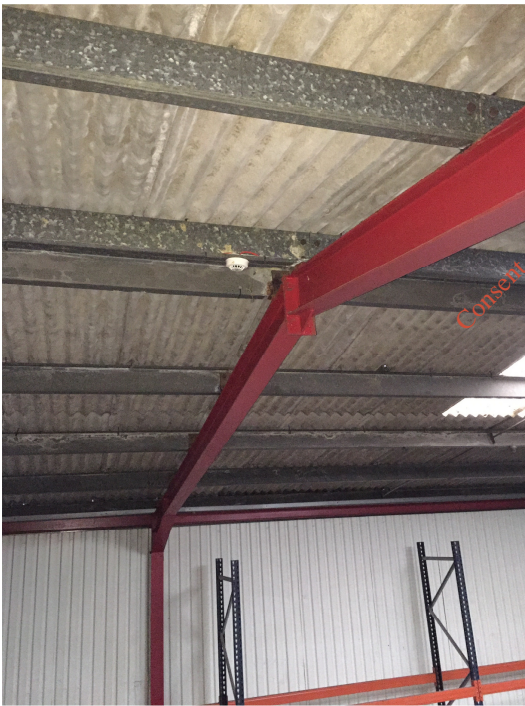
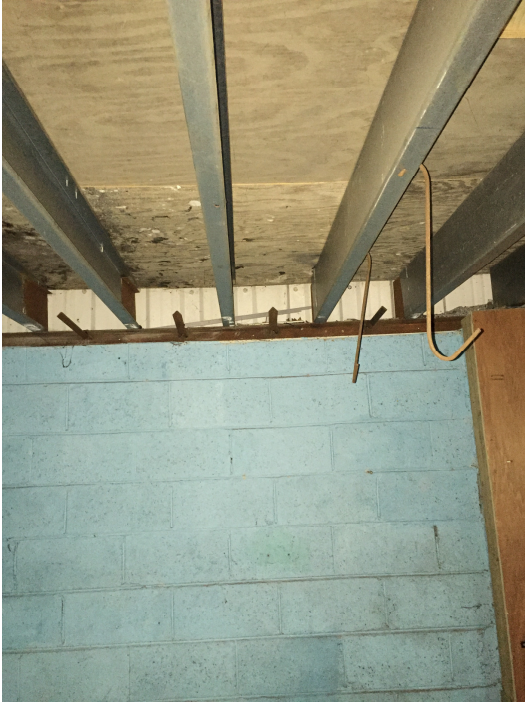
There is an insufficient level of smoke detection within the building. The existing system would not meet the minimum requirements of I.S. 3218: 2013. (Fig. 12 & 13)

**Figure 12: Fire Detection and Alarm System**

**Figure 13: No Fire Detection and Alarm System**

- A fire detection and alarm system designed in accordance with I.S. 3218: 2013 should be installed, to cover all areas of the building.

**Update:**  
***The Fire Detection and alarm systems has been upgraded. (22.04.16)***

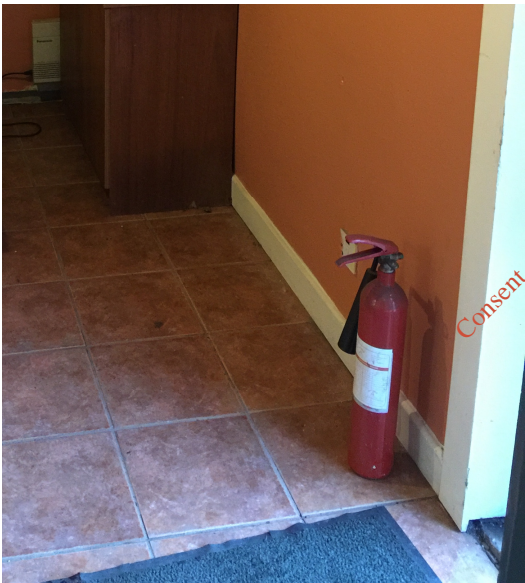
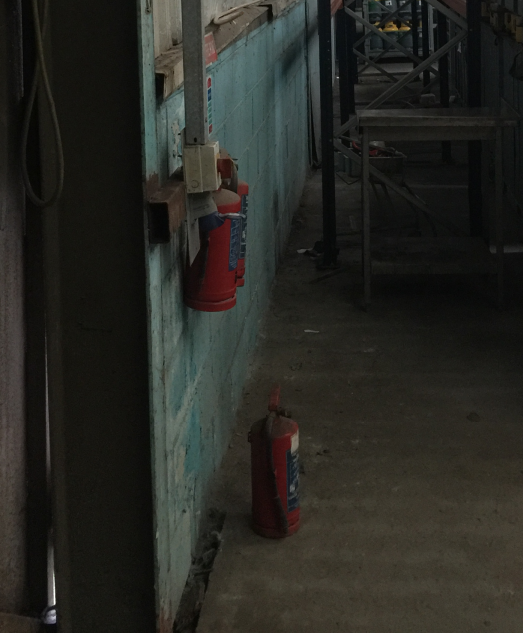
There are some fire extinguishers around the building, however, none of these extinguishers appeared to have been maintained or serviced in quite some time. (Fig. 14 & 15)

**Figure 14: Fire Extinguisher**

**Figure 15: Fire Extinguishers**

- Fire Extinguishers should be provided in accordance with I.S. 291:2015 and serviced.

**Update:**  
***The Fire extinguishers have been replaced. (22.04.16)***

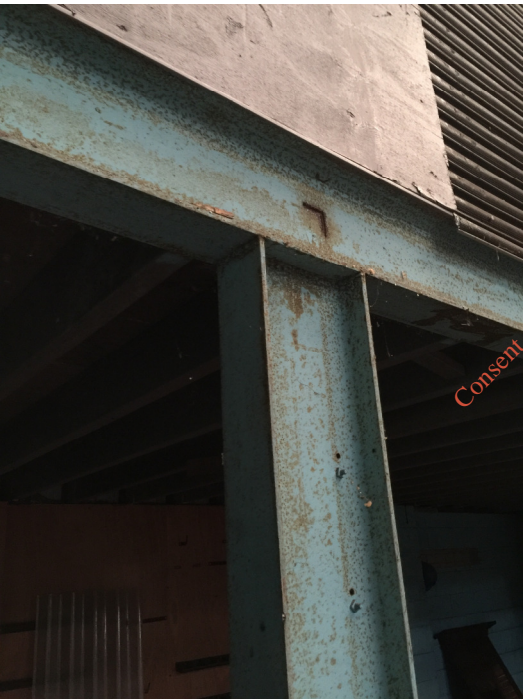
The mezzanine is supported with a steel structure (Columns and Beams), none of these columns or beams appear to have fire resisting materials applied to them. (Fig. 16)

The rear mezzanine level is supported by non fire rated steel. TGD B recommends that structure supporting a mezzanine floor be fire resisting for at least 30 minutes.

**Figure 16: Column and Beam supporting Mezzanine**

- The structure which supports the mezzanine is required to be 30 minutes fire resisting. The structure should be fitted/ coated with a fire resisting materials.

**Update:**  
***Not applicable as the mezzanine has been decommissioned from use. (22.04.16)***
