**SHORE ROAD HISTORIC LANDFILL,
CLIFDEN, CO. GALWAY**

**APPLICATION TO EPA
FOR
CERTIFICATE OF AUTHORISATION**

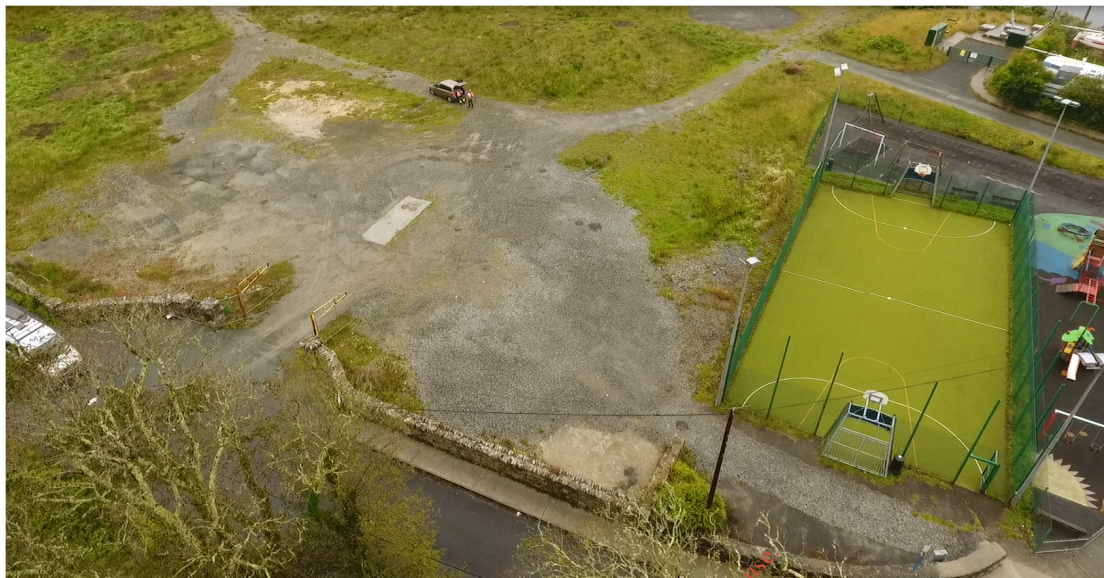
Plate 2. Location of site where the former handball alley was located. The broken masonry from the handball alley was used as infill in this area.

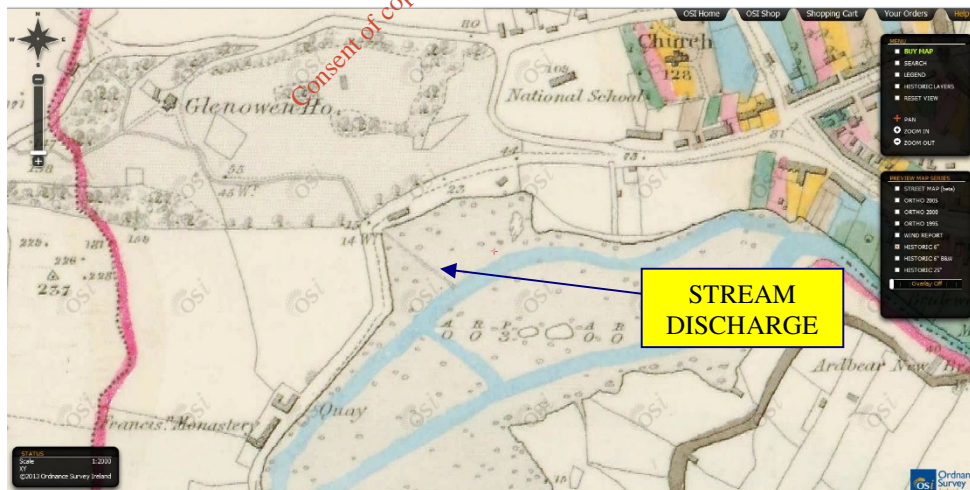
Plate 11. Historical 6-inch Ordnance Survey mapping showing location of surface water body passing through site

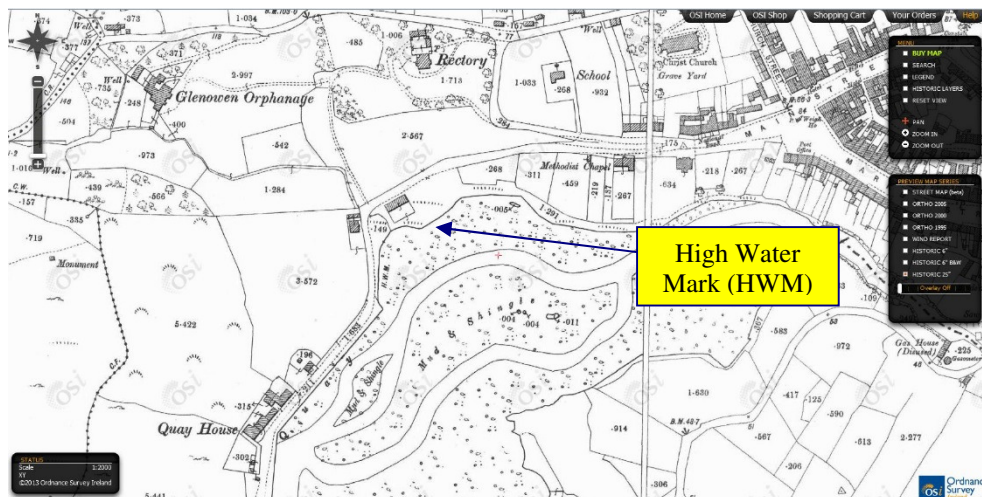
Plate 12. Historical 25-inch Ordnance Survey mapping showing location of new high water mark (HWM) (note position of former now demolished handball alley)

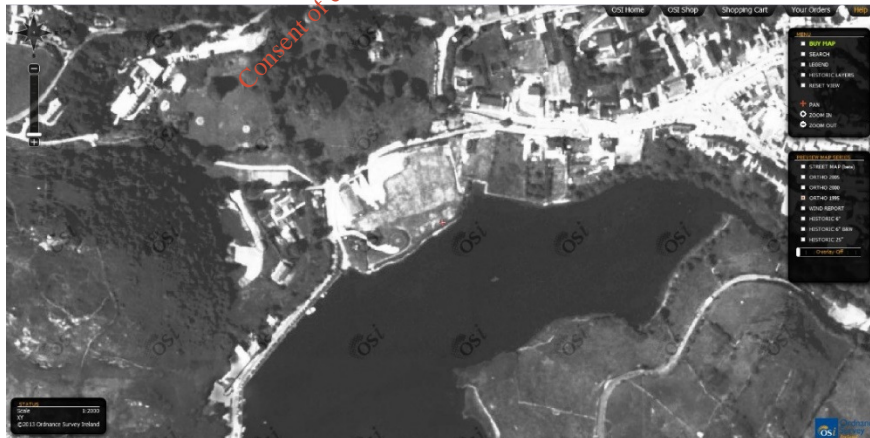
Plate 13. Historical 25-inch Ordnance Survey mapping showing final boundaries of site and Quay Wall

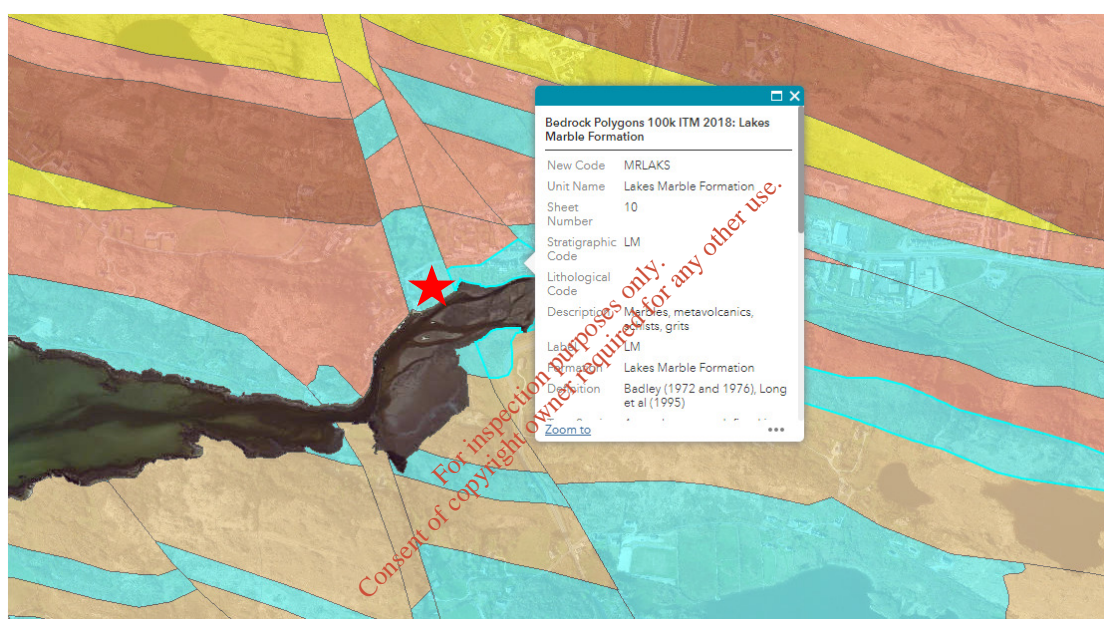
Plate 17. Regional geology mapping showing Lakes Marble Formation underlying under historic landfill site (blue polygon) with Streamstown Schist Formation (pink polygon) to the north.

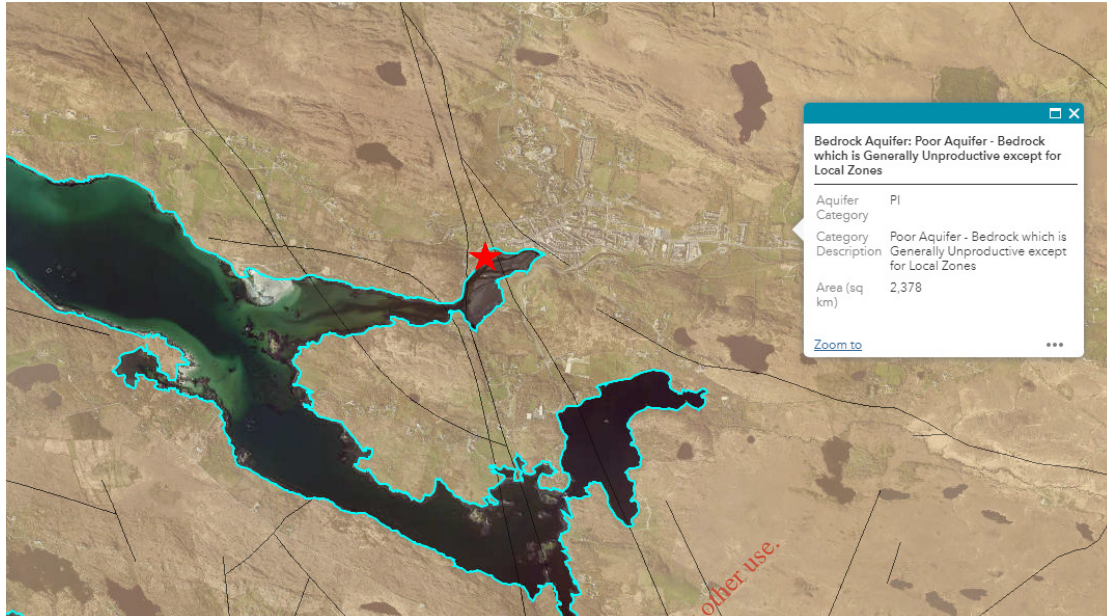
Plate 18. GSI Mapping showing Poor Aquifer (PI) in Clifden Area

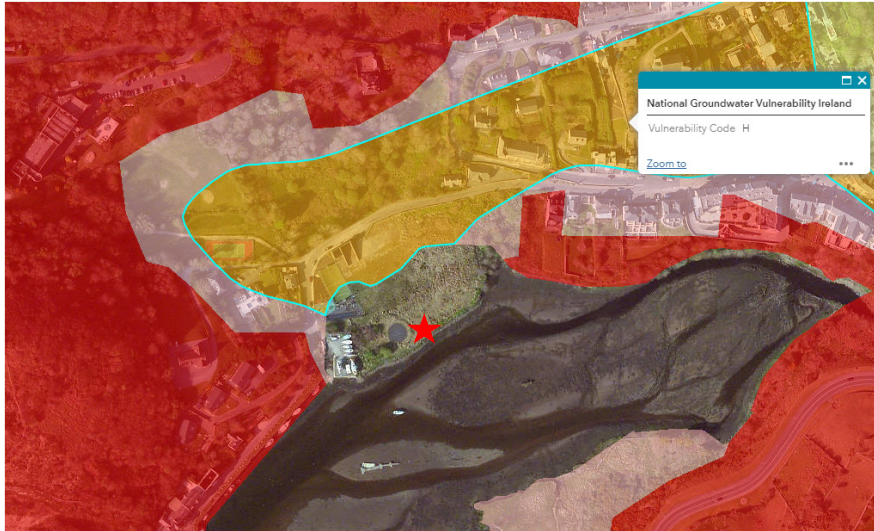
Plate 19. GSI Mapping showing Aquifer Vulnerability in the Clifden Area (note site is most likely ‘High Vulnerability’ given depth of overburden on site and mapping to north)

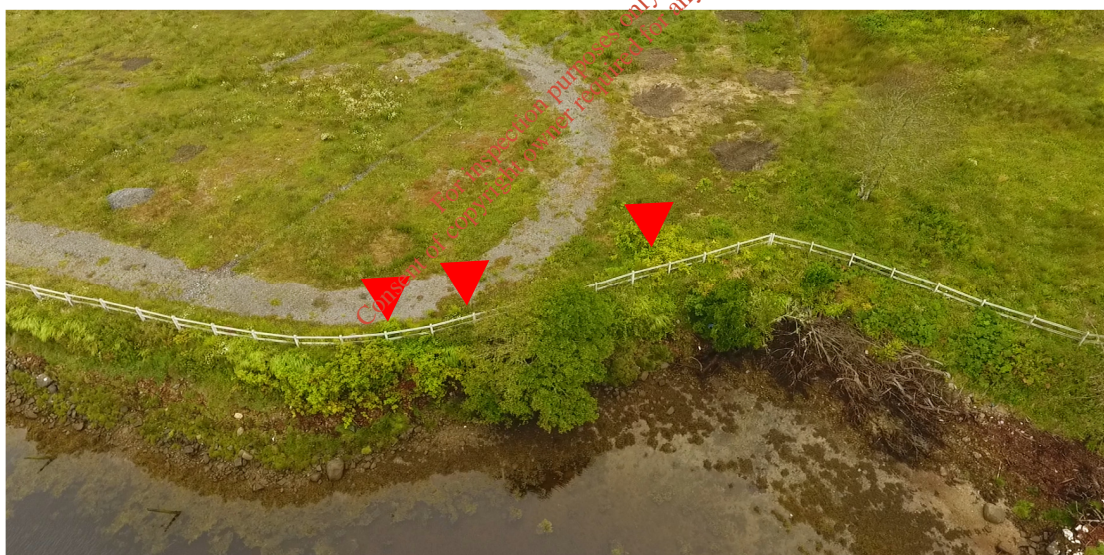
Plate 21. Aerial photograph taken at 30m elevation to the south of the site facing northwards towards south-eastern corner showing stands of Japanese Knotweed near boundary fence (see red markers). Note position of backfilled trialpits excavated in new C&D Waste Area approximately 15m away to the north.
