RE: Integrated Pollution Prevention Control License Application

Reference No: PO889-01

Applicant: Lisavaird Piggeries Limited

Location: Kippagh, Dunmanway, Co Cork

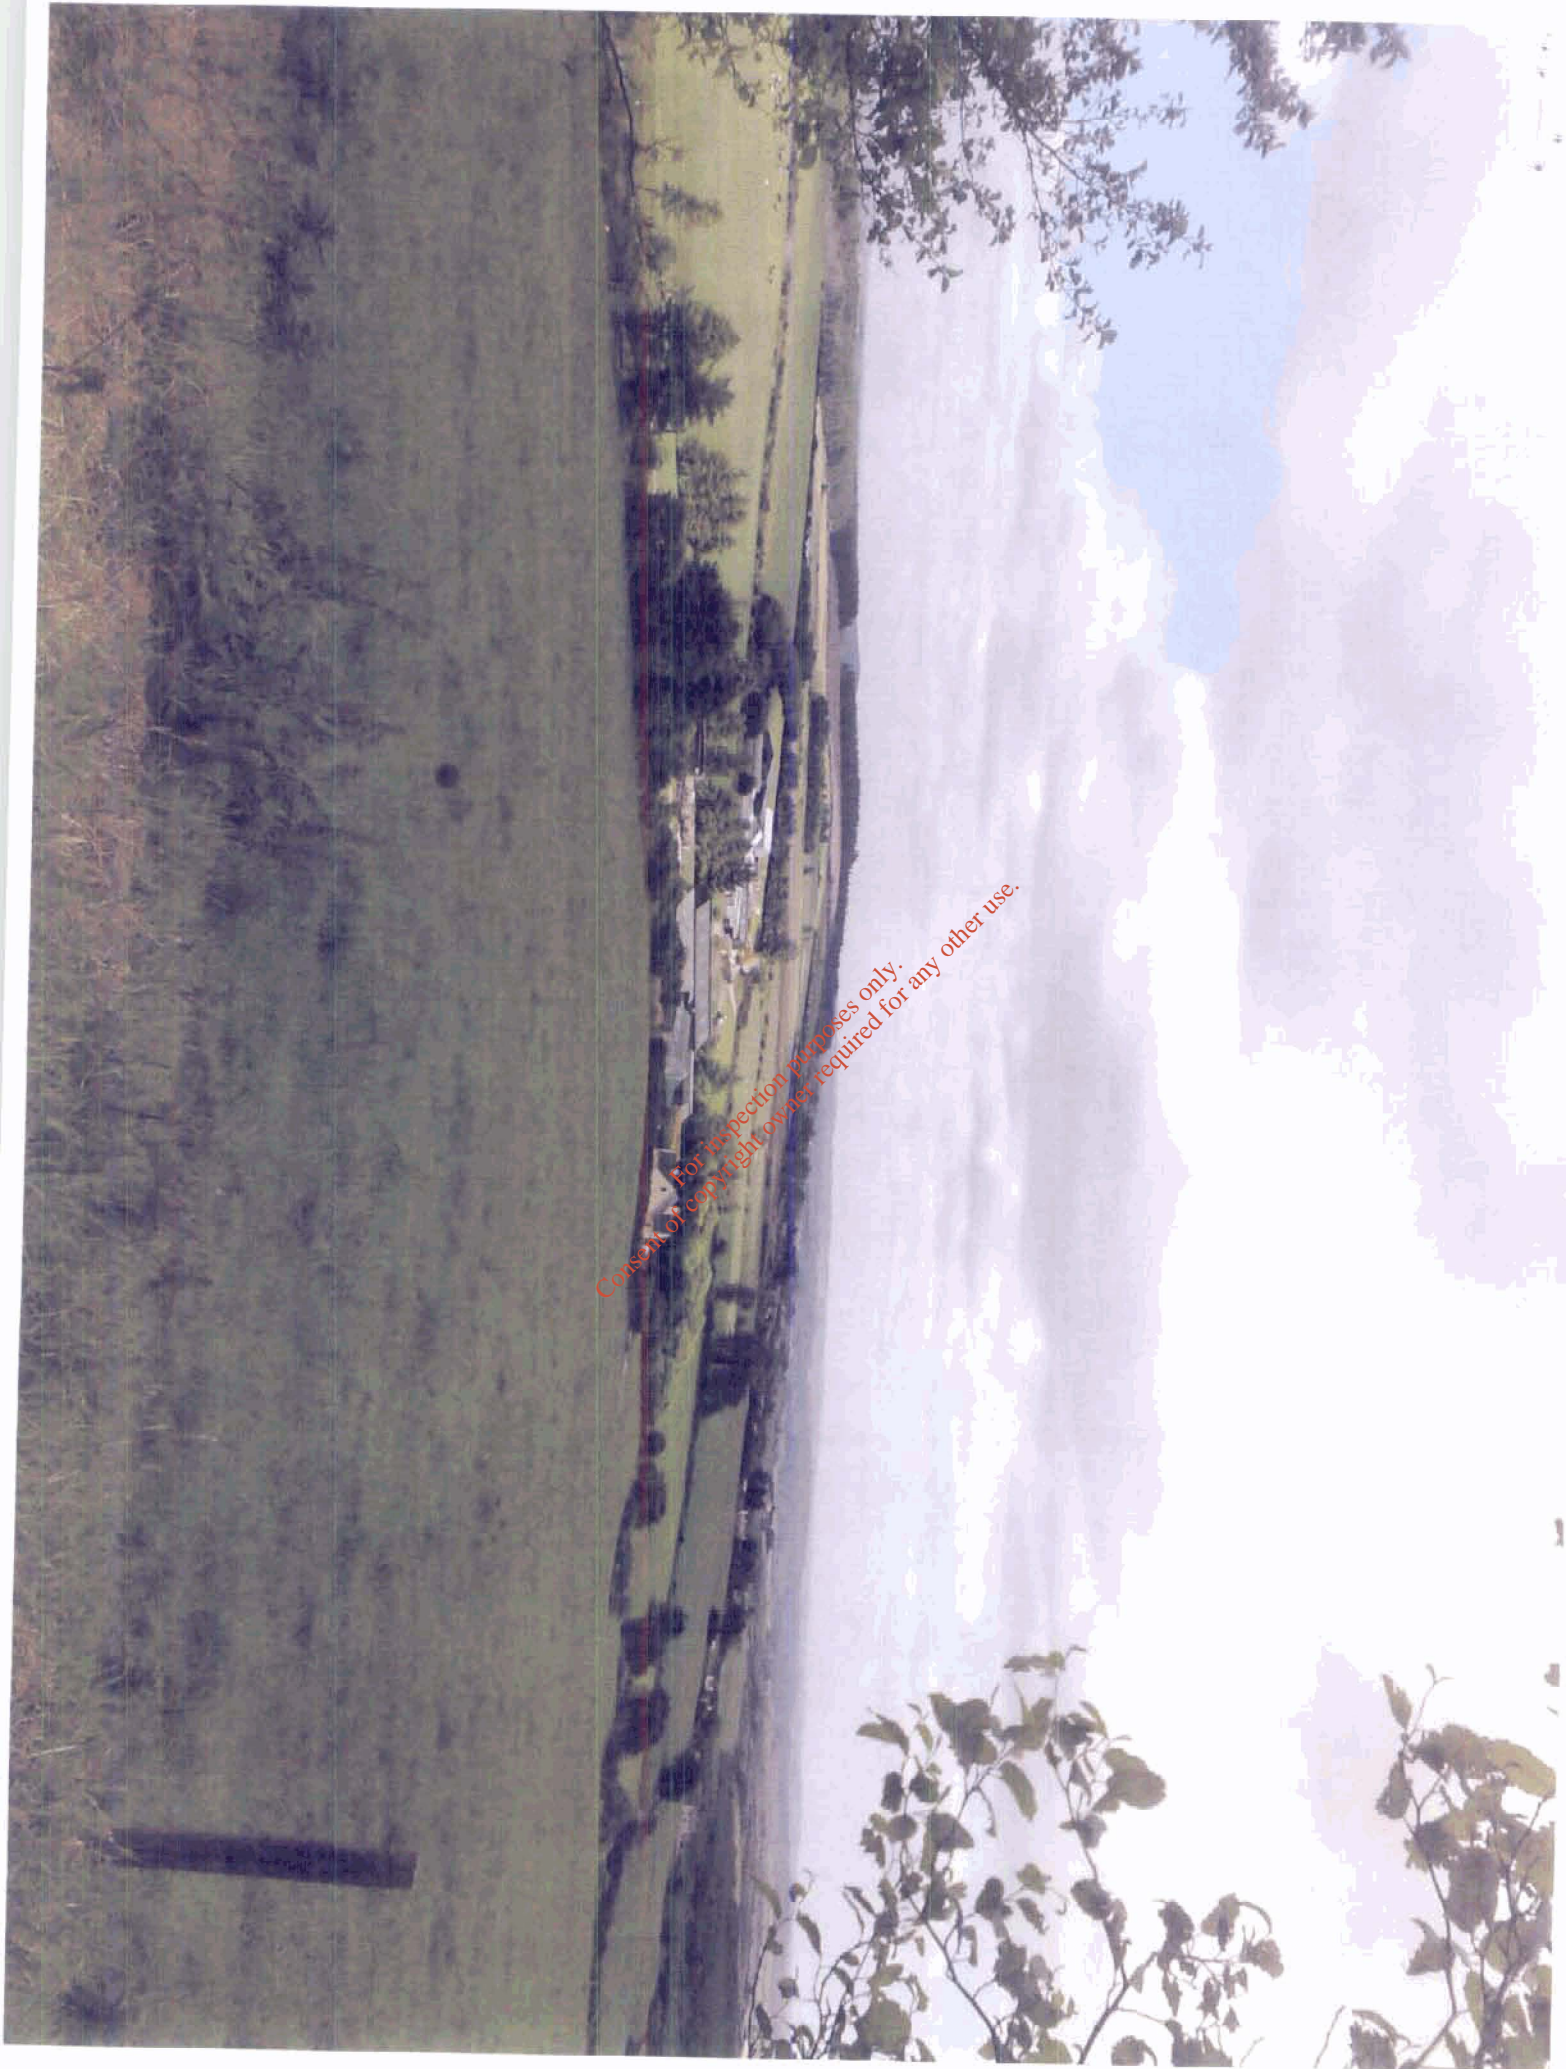
There are few dwellings nearby - the nearest dwelling is located downgradient of the piggery - a distance of 0.3 - 0.4km (by road - less as the crow flies) from the wall of the unit (see photos A + B attached). The distance between the dwelling and piggery may be less than the 400m distance recommended in the Batneec Guidance for the Pig Production Sector. Staff at the plant confirmed that the dwelling is occupied. The installation is upgradient from the Argideen river which is the source of drinking water supply to Clonakilty town. Curraghlicky lake is located 7.3km (by road) downgradient from the piggery from which drinking water is extracted to supply the needs of the nearby town of Drinagh. However the slope of the land on which the unit is located is away from this lake and towards the river.

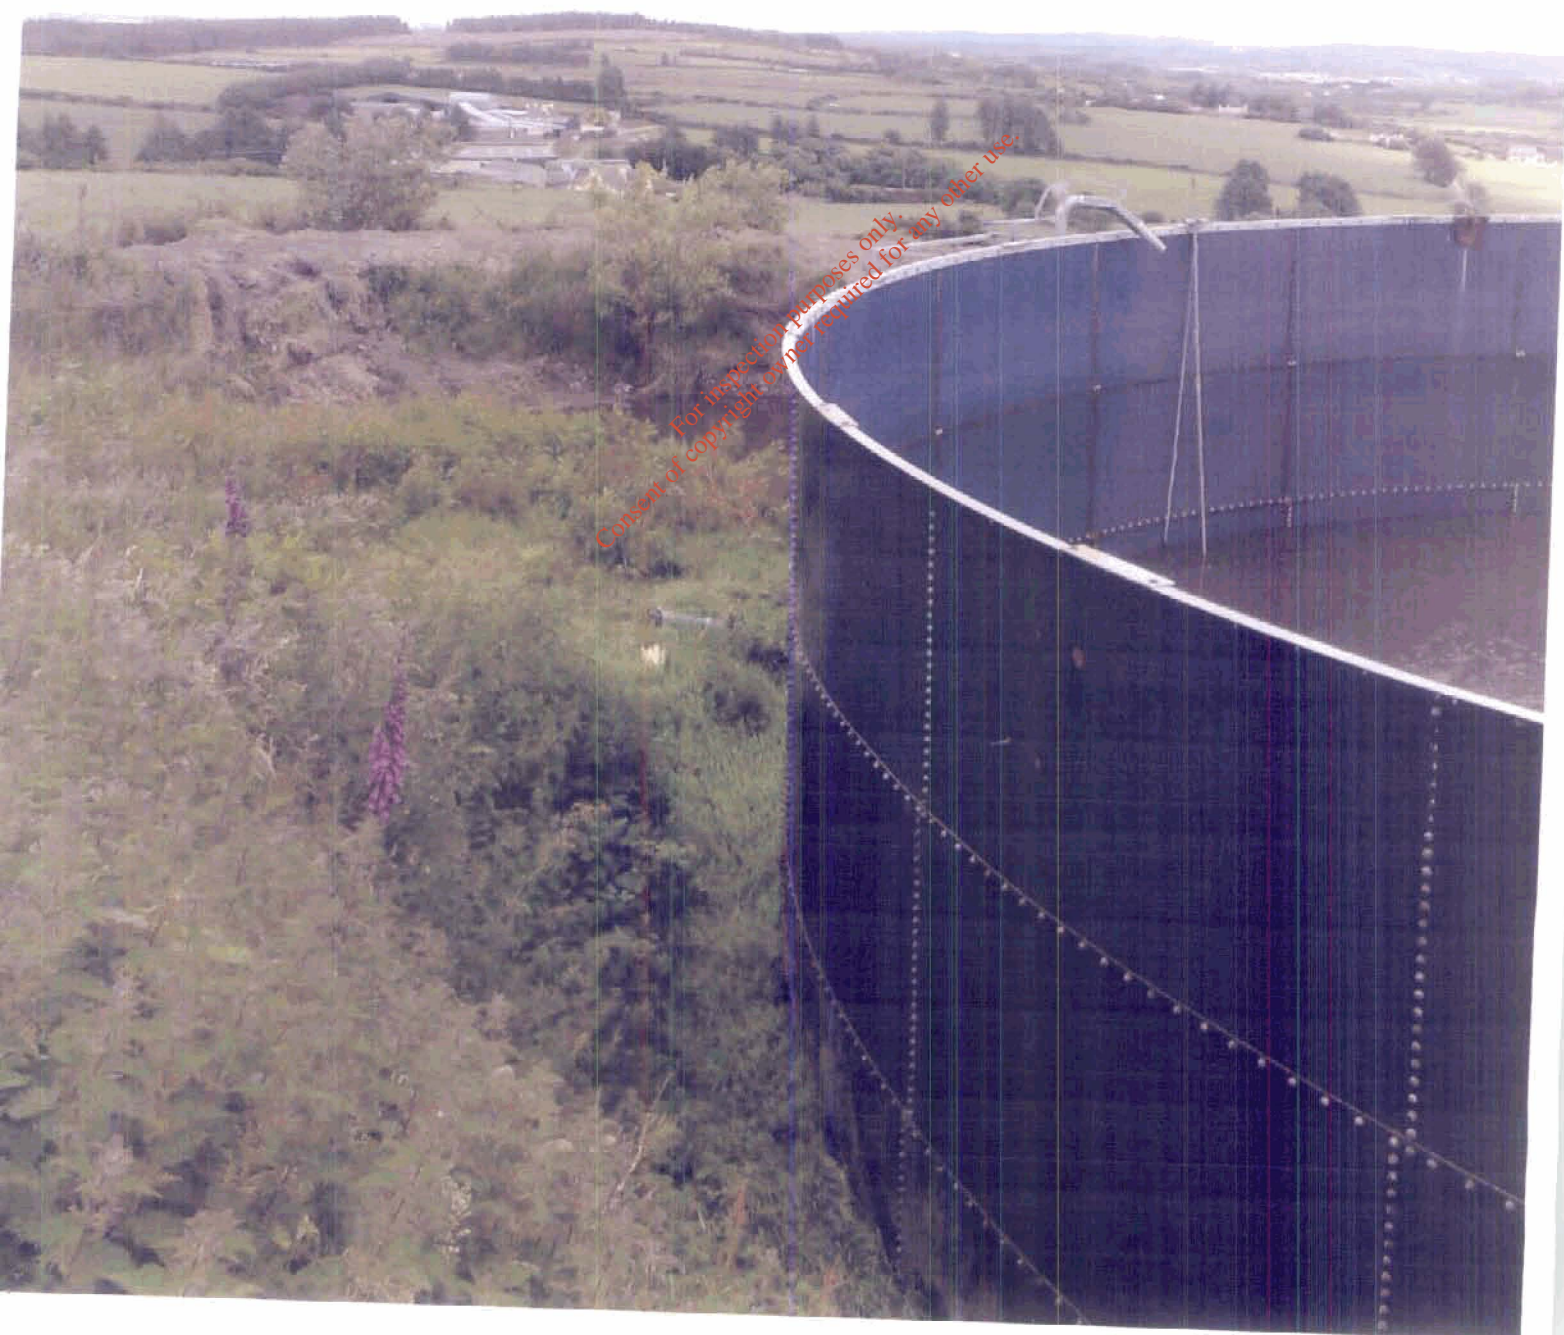
A	Nearest Dwelling
B	Proximity of tank to nearest dwelling
C	Earth Containment Bank around Tank
D	View of containment area on other side of tank
E	Tank for excess storage
F	Water Containment around tank
G	Crust on Slurry Tank
H + O	Open shed & area outside fencing
I	Open Skip
J	Entrails & carcasses in skip
K	Flies on carcasses in skip
L	Pigs & entrails 19 06 2009
M	Flies on Entrails in liquid
N	
O	
P

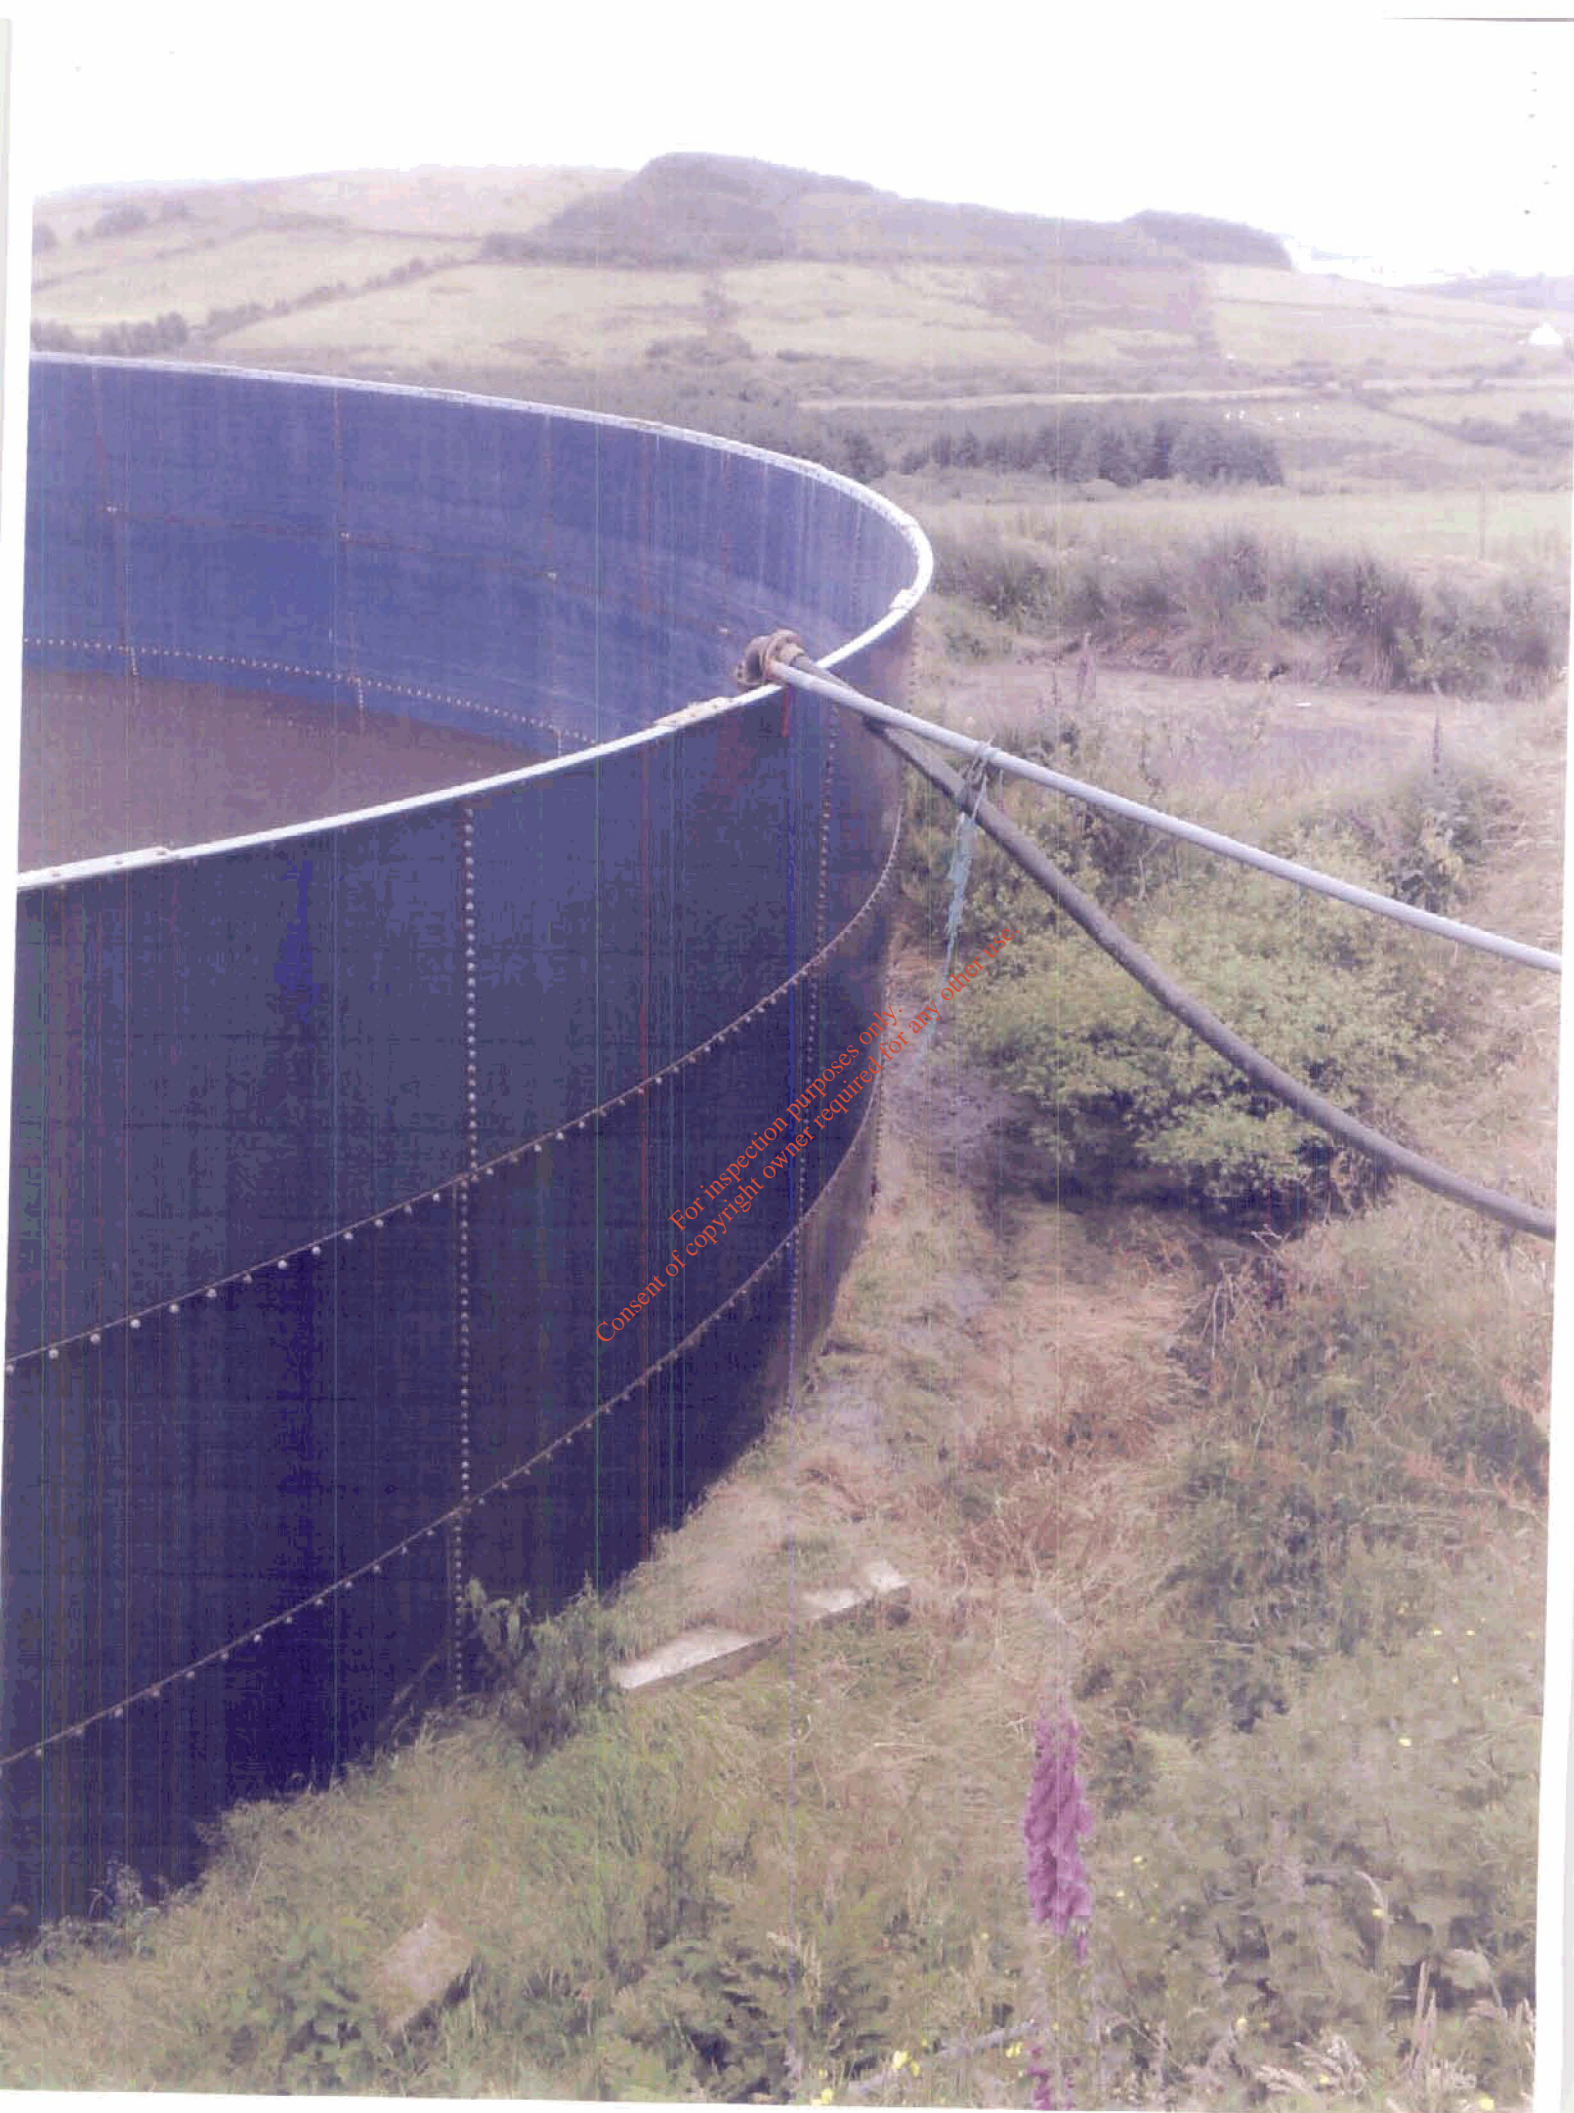
C

The third slurry tank (used in wintertime for excess storage) located outside the wall is surrounded by an earth bank (see photo C) which acts as a containment barrier in which some water was lodged. (see photos D + E + F attached).

One slurry tank is located inside the walled area. Two other slurry tanks are located outside the wall. One is surrounded by a fence. The circular tank is surrounded by an earth bank which is 8 ft deep. The application states there have been no accidental spillages onsite since the 1960's.
