Appendix D

RMP Sites within the surrounding area
Stray finds within the surrounding area
Legislative framework protection the archeological resource
Impact assessment and the cultural heritage resource
Mitigation measures and the cultural heritage resource

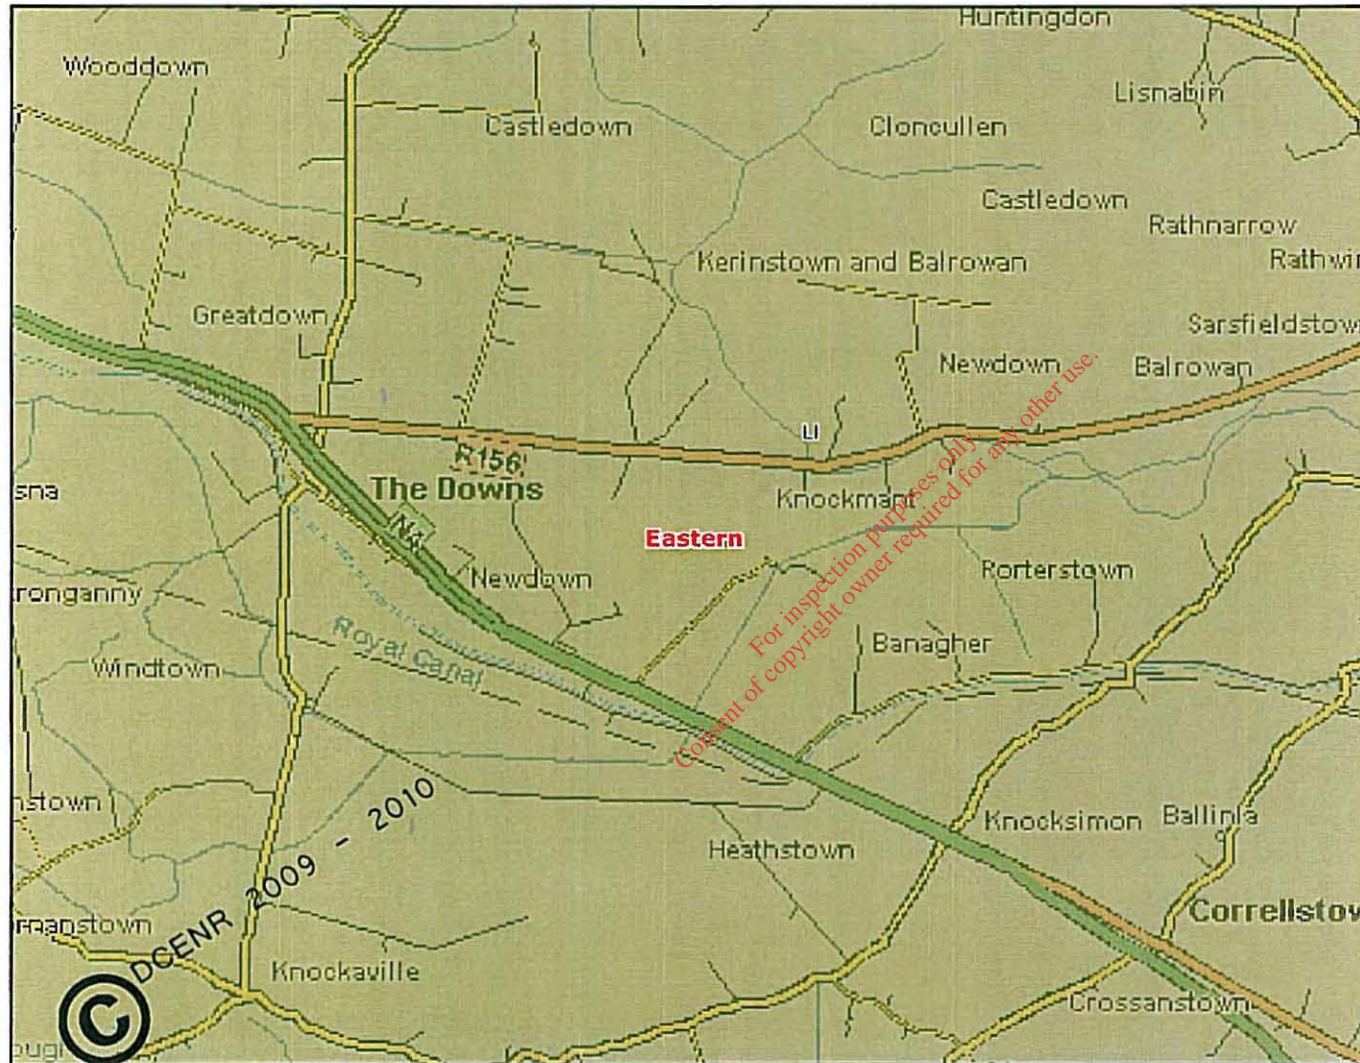
111_001_National Draft Bedrock Aquifer Map (LI)

- Legend**
- National Draft Bedrock Aquifer Map
- Rf - Regionally Important Aquifer - Fissured bedrock
 - Rk - Regionally Important Aquifer - Karstified
 - Rkd - Regionally Important Aquifer - Karstified (diffuse)
 - Rkc - Regionally Important Aquifer - Karstified (conduit)
 - Lm - Locally Important Aquifer - Bedrock which is Generally Moderately Productive
 - Lk - Locally Important Aquifer - Karstified
 - Ll - Locally Important Aquifer - Bedrock which is Moderately Productive only in Local Zones
 - Pl - Poor Aquifer - Bedrock which is Generally Unproductive except for Local Zones
 - Pu - Poor Aquifer - Bedrock which is Generally Unproductive
 - Unclassified
 - RBD Boundaries

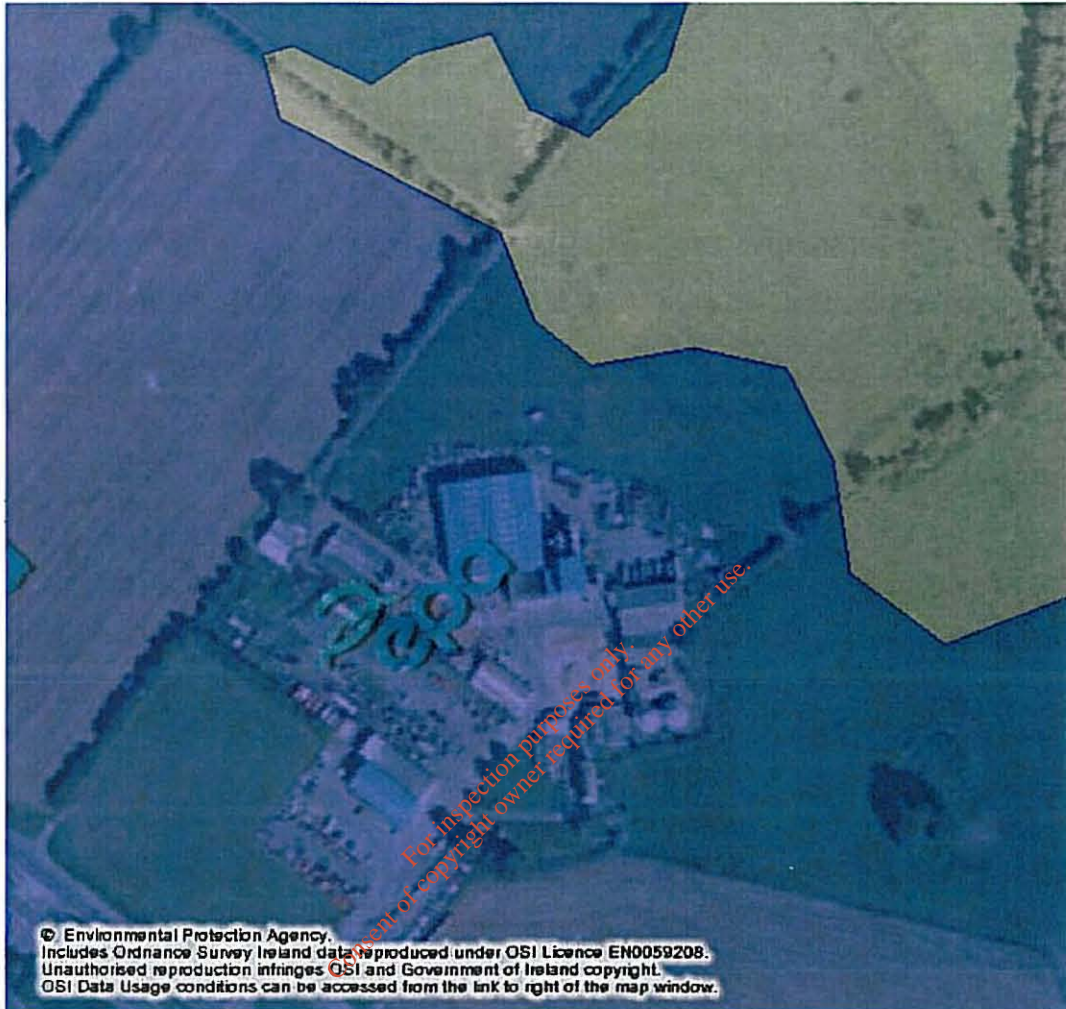
SOILS MAP

- BminDW - Grey Brown Podzolics
Brown Earths, Basic**

- Cut - Raised Bog
cutaway/cutover**
