## **Appendix A7.4 2016 VOC Emission Survey**

**KLRP-VOC/SURFACE EMISSIONS/2016/1 SURFACE EMISSIONS SURVEY AT  
KERDIFFSTOWN, NAAS, CO. KILDARE**

**PERFORMED BY ODOUR MONITORING IRELAND ON BEHALF OF JACOBS**

Document No. 2016351(ver.1)  
Visit No: 01  
Year: 2016

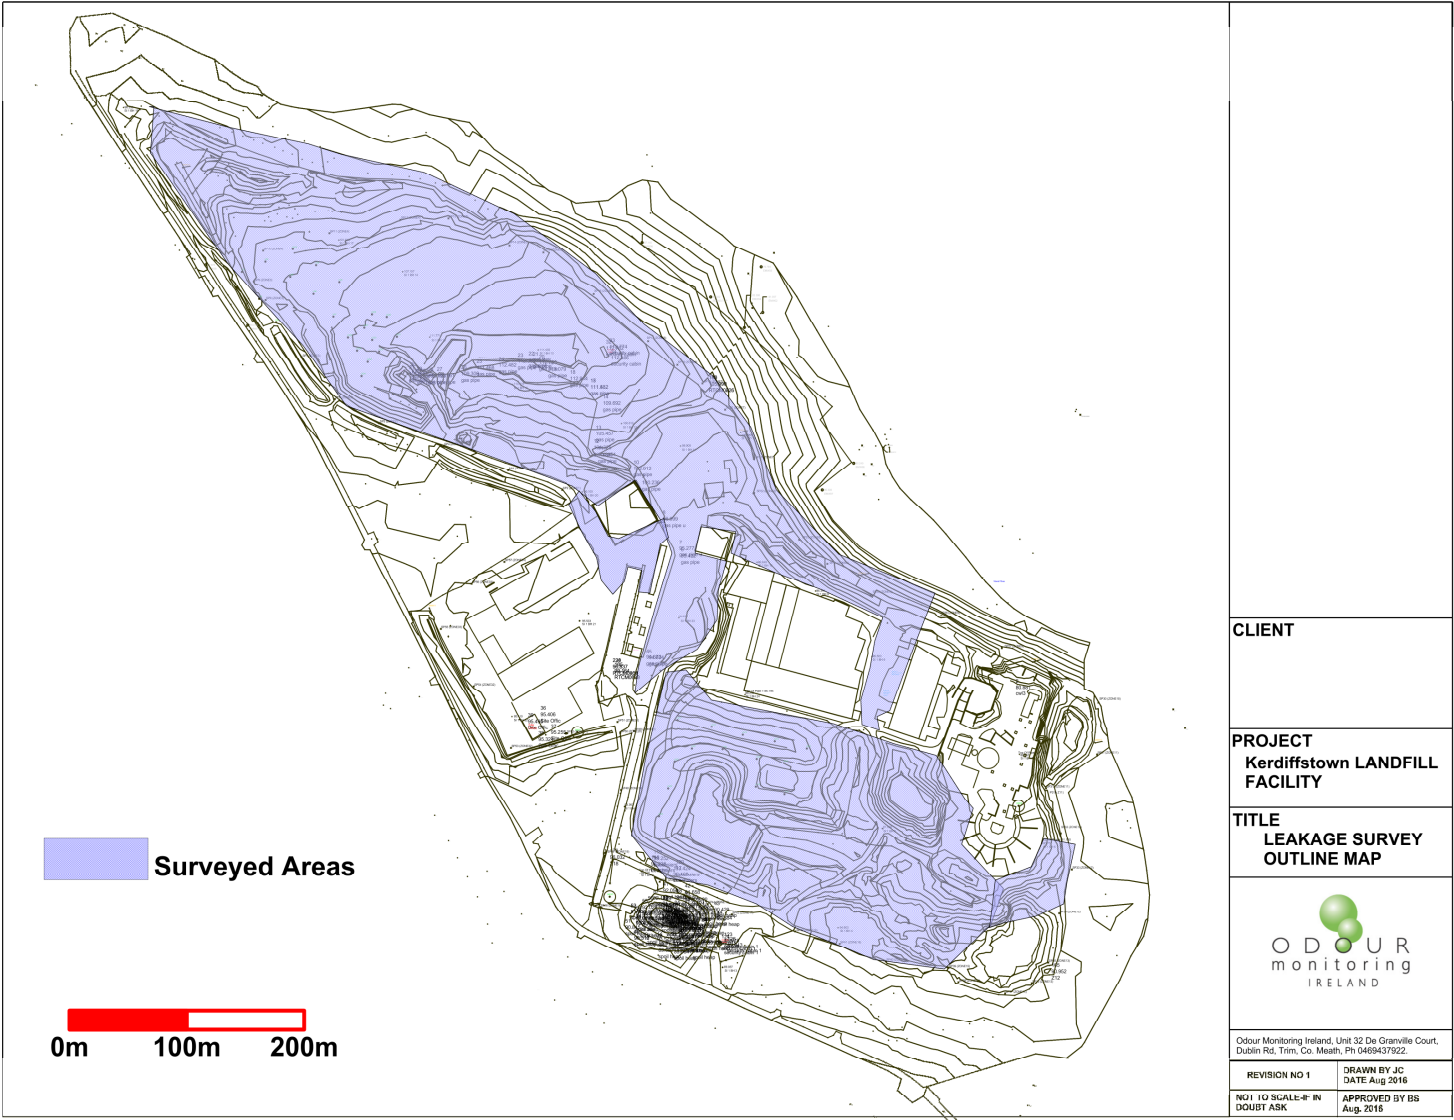
The current collection system consists of vertical wells, there are gravity condensate removal devices on the landfill gas abstraction system within the facility. Vertical facility gas abstraction is employed in the facility. There are two operational installed facility gas enclosed flares (500 m<sup>3</sup>/hr & 250 m<sup>3</sup>/hr) capacity enclosed flares. At the time of the survey one flare was in operation.

**Figure 6.1.** Cell capping outline & LFG infrastructure on the facility.

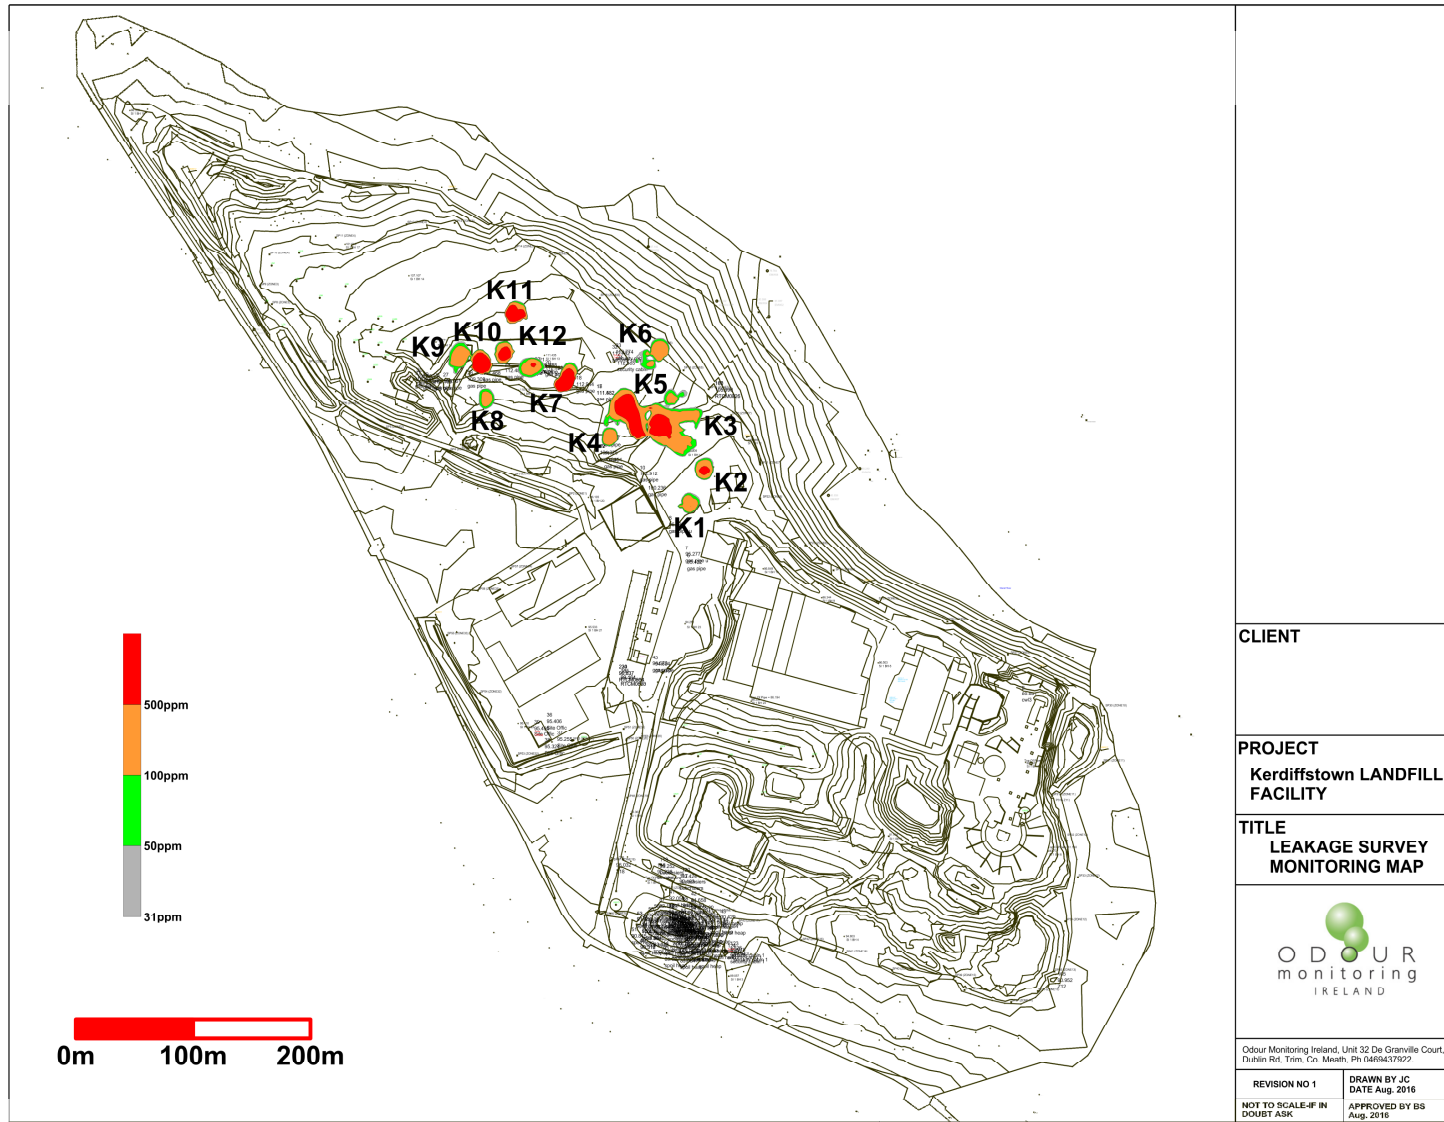
*Figure 6.2 and Table 3.1* illustrates the results obtained for the capping surface emissions survey. A total of twelve individual surface emissions zones were identified. Each surface emissions zone is discussed separately in this manner in order to allow for the development of remediation strategies to mitigate the individual surface emissions areas.

Twelve sources of facility gas surface emissions were identified (*see Figures 6.2 and Table 3.1*) within the facility.

Currently none of the facility area is permanently capped. Therefore the surface emission criterion averaged over the capped area does not apply. There were three surface emissions zones greater than or equal to 500 ppm around identified features. There were nine surface emissions zones greater than or equal to 100 ppm instantaneous reading on open surfaces within the facility footprint.

**Figure 6.2.** Facility gas surface emissions monitoring within the facility (colour scale area indicating TVOC gas colour scale).

**Table 3.1.** Capping VOC surface emission locations results with source identities correlating with *Figure 6.2 (see Appendix I)*.

Location ID	Easting (m)	Northing (m)	Max VOC conc. (ppm)	Identification and Mitigation	Recommended trigger levels
K1	291395	222205	557	Discrete Feature: Intermediate Cap, Vertical Well G35. Investigate and remediate the cause of the surface emissions.	<500ppm
K2	291407	222233	594	Discrete Feature: Intermediate Cap, Vertical Well G31. Investigate and remediate the cause of the surface emissions.	<500ppm
K3	291374	222272	3,847	Discrete Location: Intermediate Cap, Surface area. Investigate and remediate the cause of the surface emissions.	<100ppm
K4	291326	222261	387	Discrete Location: Intermediate Cap, Surface area. Investigate and remediate the cause of the surface emissions.	<100ppm
K5	291380	222296	184	Discrete Location: Intermediate Cap, Surface area. Investigate and remediate the cause of the surface emissions.	<100ppm
K6	291369	222337	398	Discrete Location: Intermediate Cap, Surface area. Investigate and remediate the cause of the surface emissions.	<100ppm

K7	291291	222310	6,947	Discrete Feature: Intermediate Cap, Vertical Well. Investigate and remediate the cause of the surface emissions.	<500ppm
K8	291220	222295	154	Discrete Location: Intermediate Cap, Surface area. Investigate and remediate the cause of the surface emissions.	<100ppm
K9	291215	222327	384	Discrete Location: Intermediate Cap, Surface area. Investigate and remediate the cause of the surface emissions.	<100ppm
K10	291238	222333	3,954	Discrete Location: Intermediate Cap, Surface areas. Investigate and remediate the cause of the surface emissions.	<100ppm
K11	291246	222369	4,178	Discrete Location: Intermediate Cap, Surface area. Investigate and remediate the cause of the surface emissions.	<100ppm
K12	291263	222324	3,749	Discrete Location: Intermediate Cap, Surface areas. Investigate and remediate the cause of the surface emissions.	<100ppm

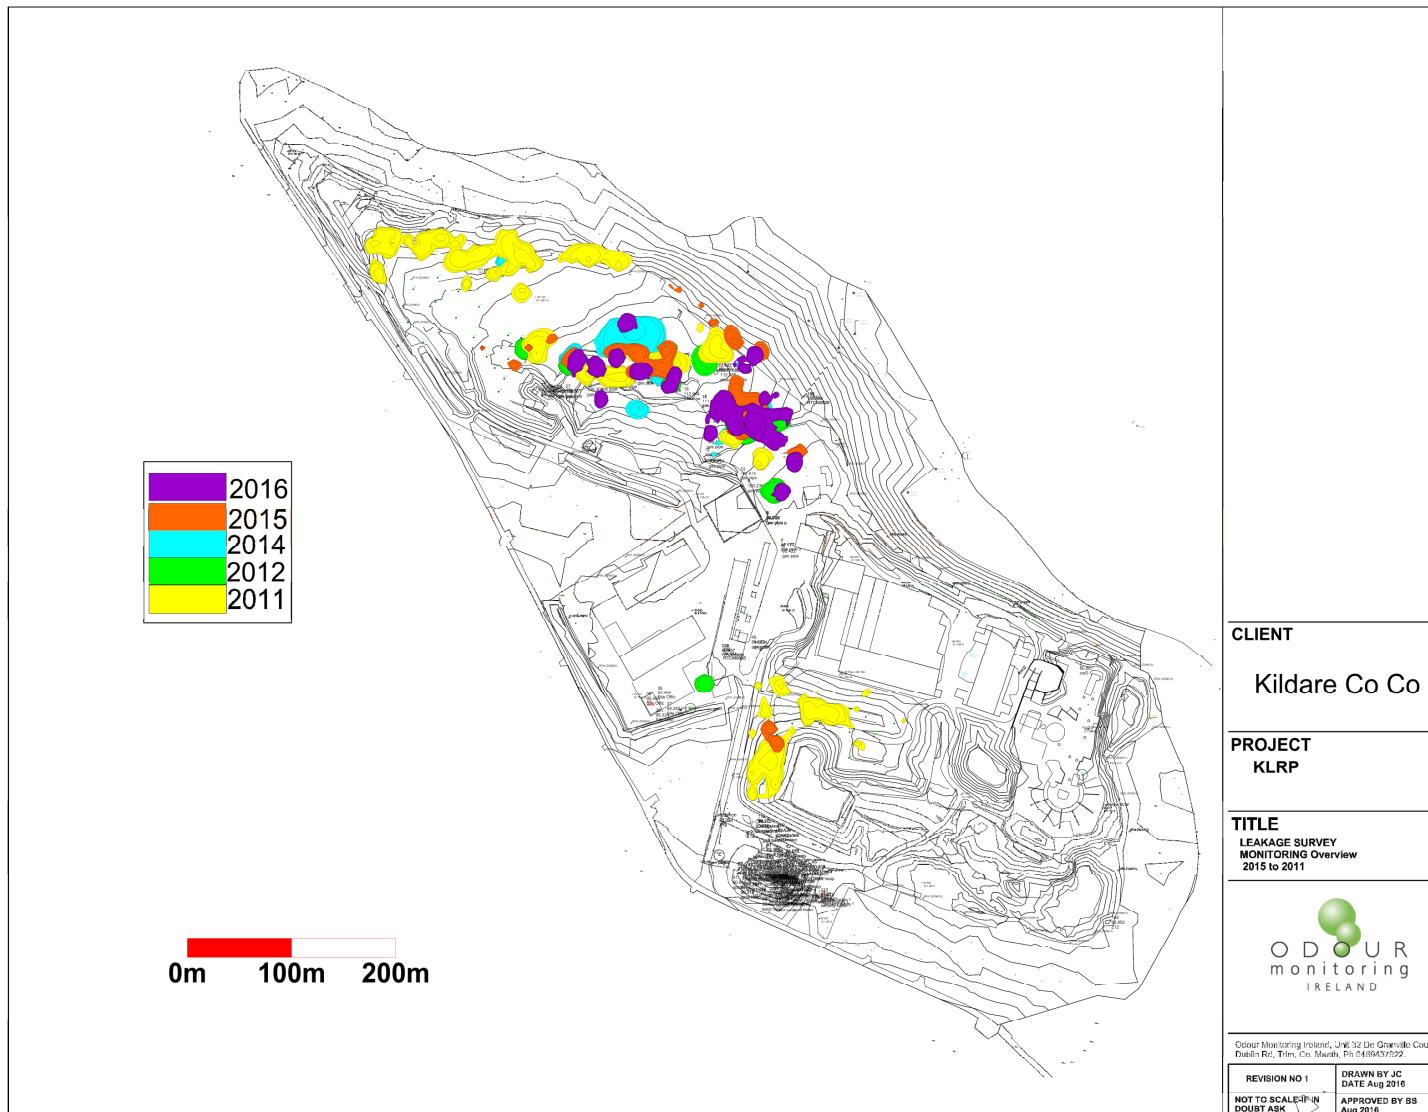
## 8. Appendix III Surface emissions mapping from 2011 to 2016.

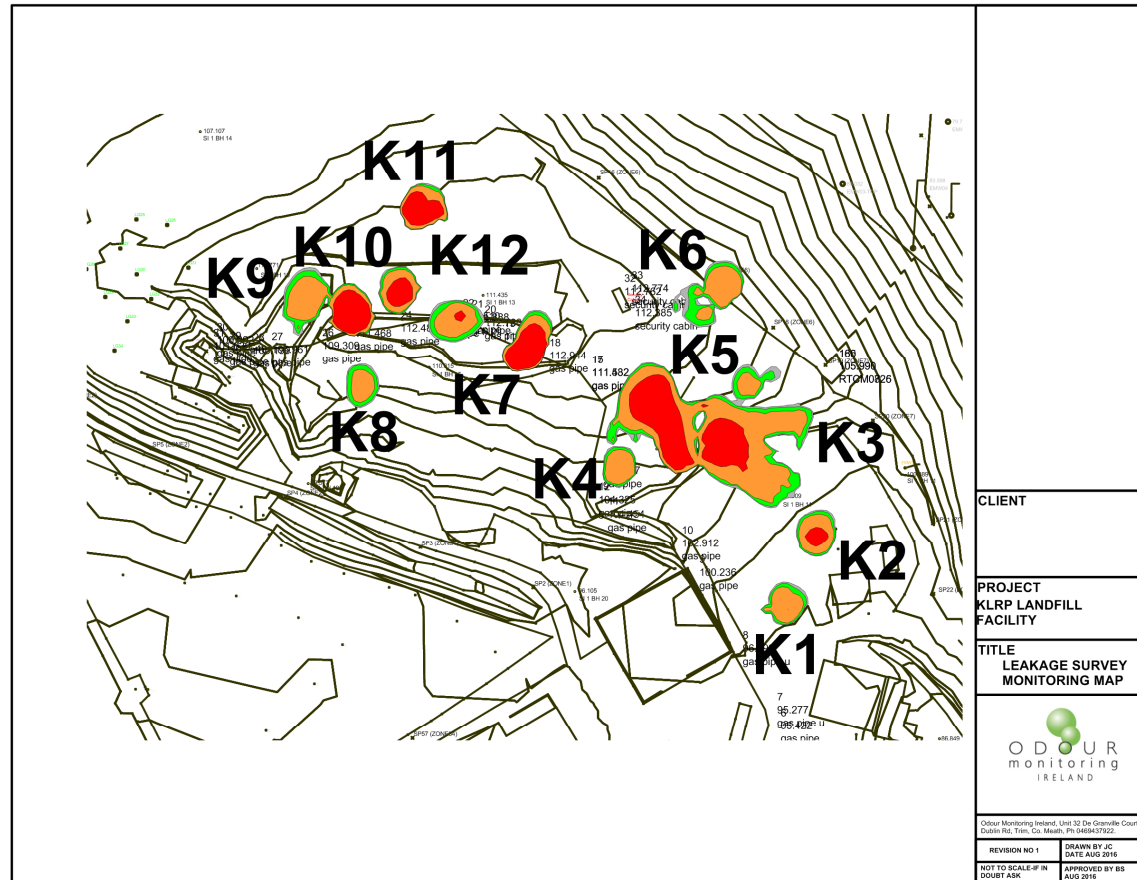
## Surface emissions mapping from Northern part of the facility 26/08/2016
