**Subject:** FW: Clashford Facility - Reg. No W0265-01  
**Attachments:** JSPE 173\_L25.pdf; JSPE 173\_L27\_15\_11\_17.pdf; P1317-1\_0020\_Clashford RF Water SamplingReport\_20171023.pdf; JSPE\_173\_L23.pdf

**RE: Clashford Recovery Facility Ltd – Restoration of quarry at Naul, Co. Meath.**

**Re: Environmental Order No. A02789/2017 (Section 55 Notice (WMA Act, 1996, as amended) - Clashford Recovery Facility, Naul, Co. Meath.**

**Re: Seasonal Water Quality Monitoring at Clashford Waste Recovery Facility, The Naul, Co. Meath**

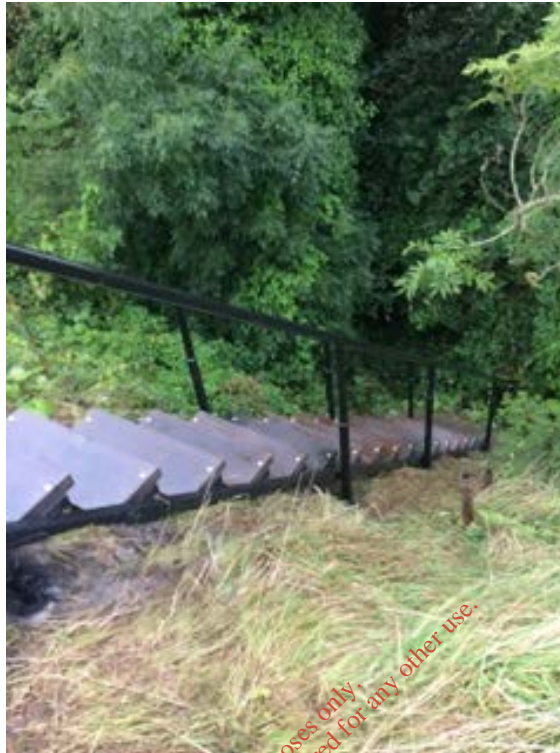
**Photograph 1: Installation of steps and handrails to form access to the monitoring point**

With reference to Section 55 notice issued, I attach Water Sampling Report for the recently installed well GW5 'P1317-1\_0020' which does not highlight pollution. I also attach conformation of steps to access attenuation pond 'JSPE 173 L23'

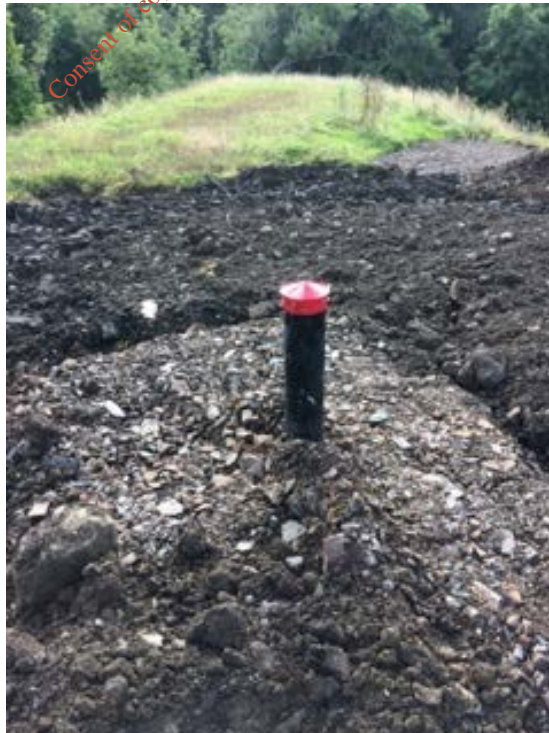
**Photograph 2: Groundwater Monitoring Well Installation, The Naul, Clashford, Co. Meath.**

A new groundwater monitoring well was installed at the site on 04<sup>th</sup> August 2017. The drilling works were completed by O'Rourke well drilling from Wexford. The drilling was completed using a truck mounted 2011 Drilltech T25KW drilling rig.
