Re: North Cork Co-op Creameries - EPA application

Registration No: P1051-01

ASSESSMENT OF BIOLOGICAL WATER QUALITY IN THE RIVER ALLOW, DOWNSTREAM OF KANTURK, COUNTY CORK

Appendix B - Photographic record of the current levels of discharge to the river at various locations

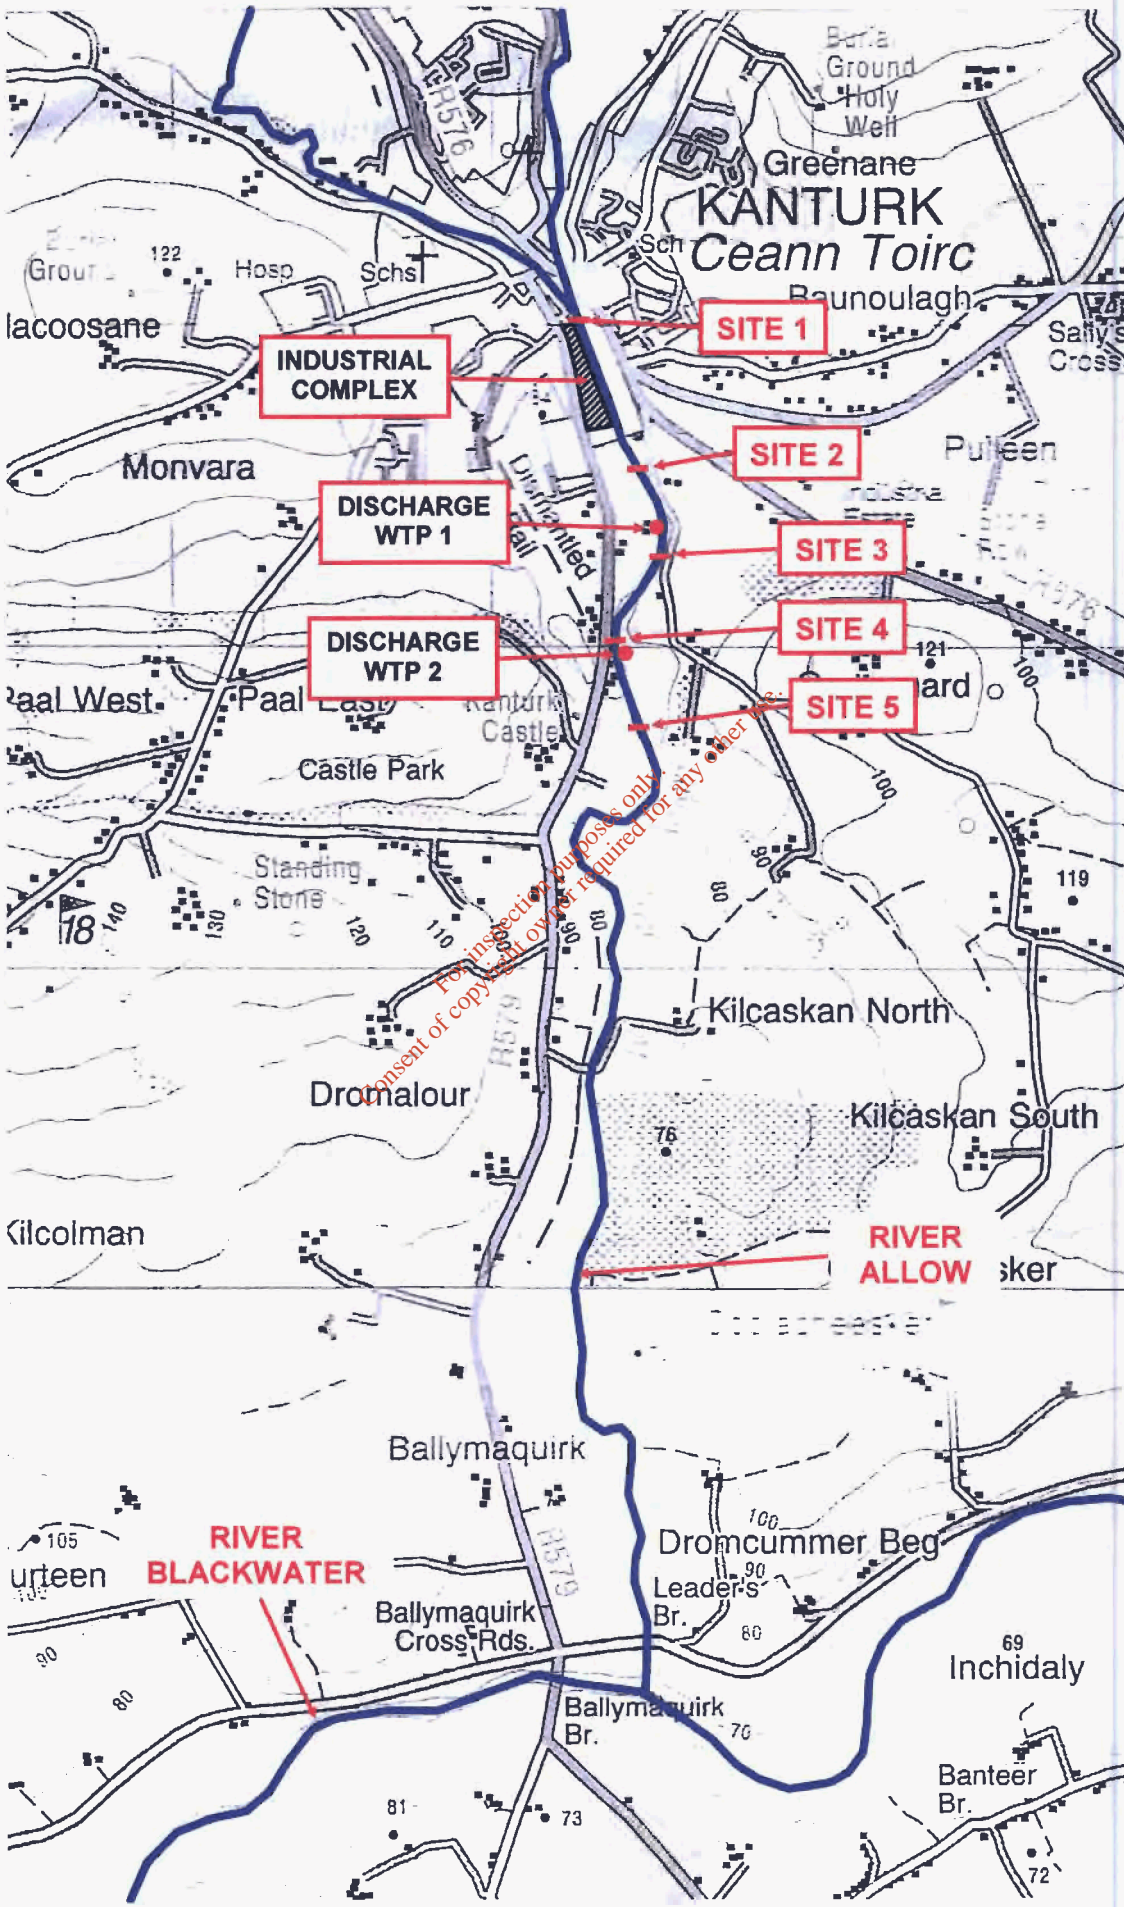
MAP 1 LOCATION OF BIOLOGICAL WATER QUALITY ASSESSMENT SITES

Sampling Sites: Five sites were selected for biological water quality assessment at the following locations(See Map 1):

Site Number	Location	GRID REFERENCE (GPS)
1	Immediately upstream of the main industrial complex	R 38287 03006
2	Downstream of the main industrial complex	R 38465 02559
3	c.100 m downstream of WTP1.	R 38516 02291

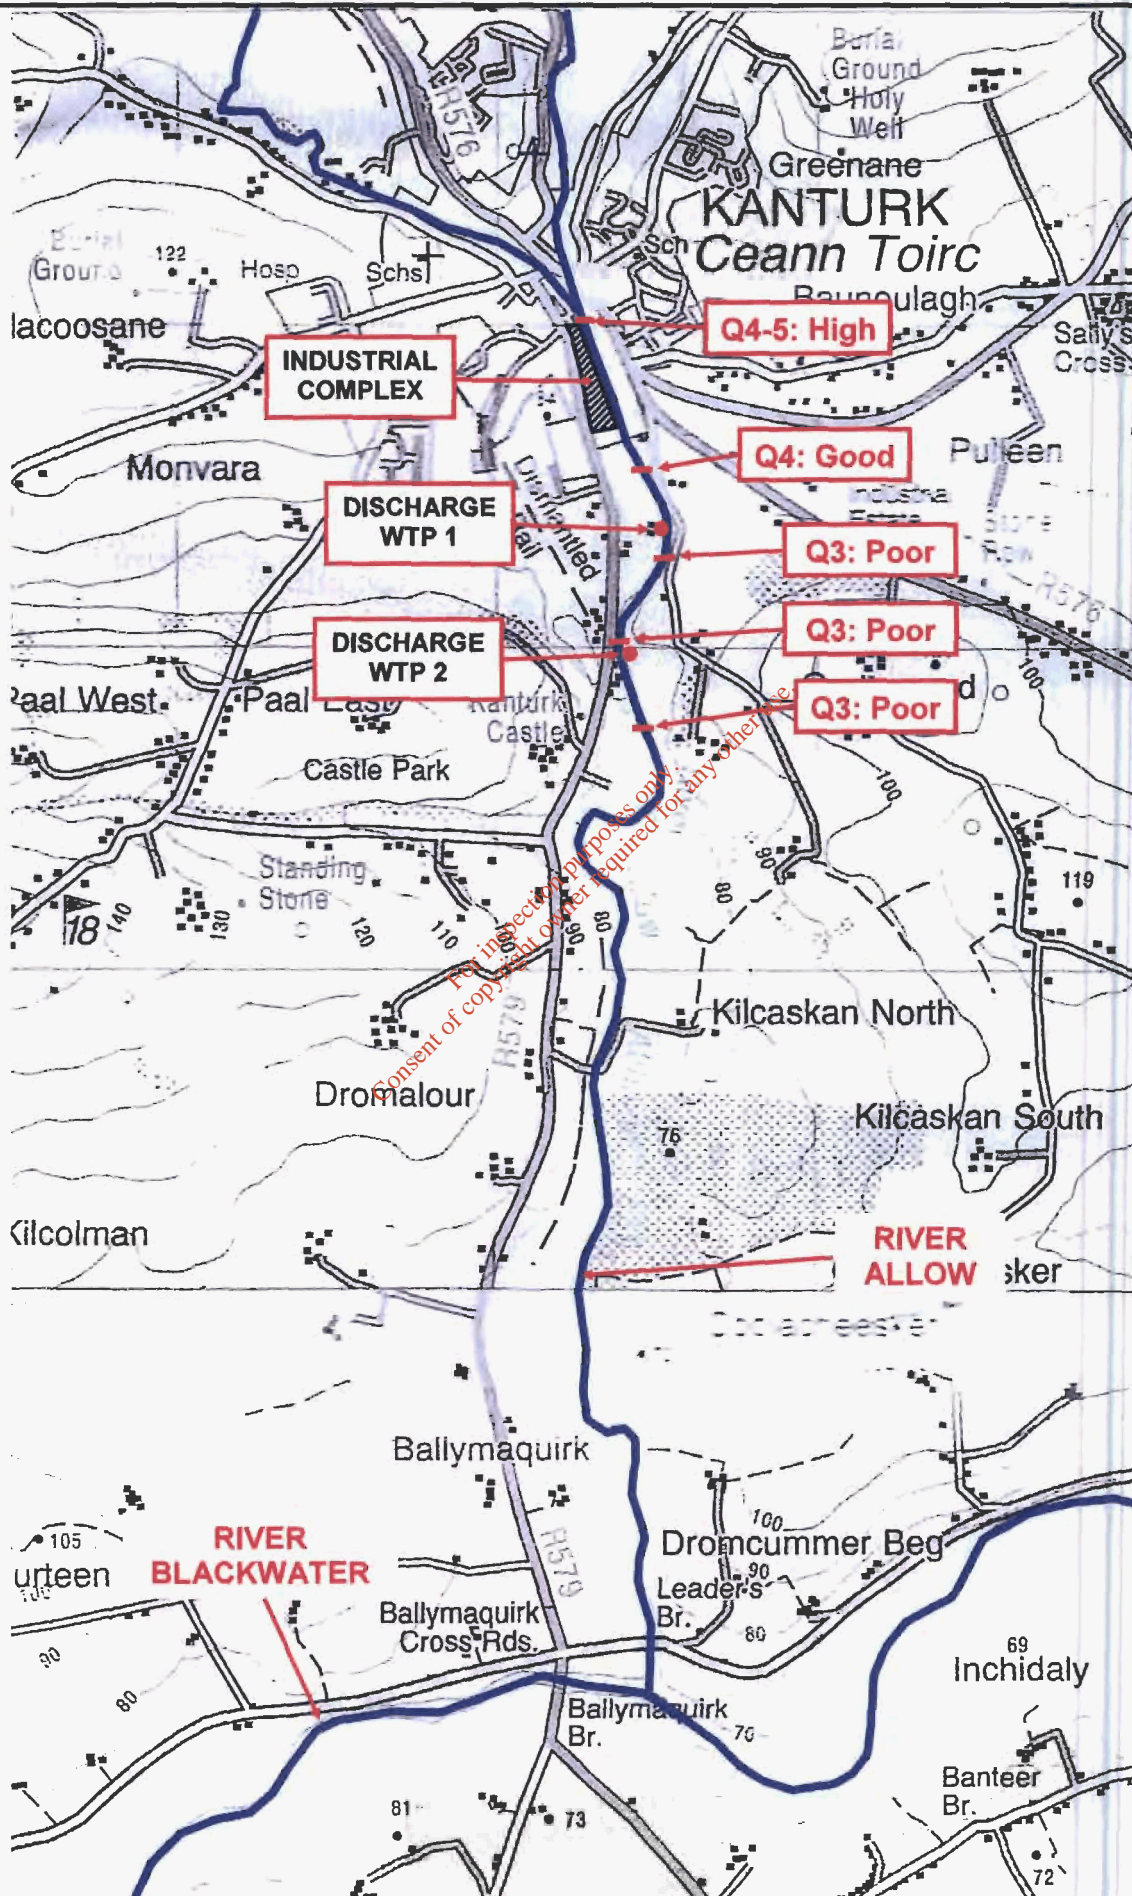
MAP 2 Q-RATINGS AND WATER FRAMEWORK DIRECTIVE ECOLOGICAL QUALITY RATING AT BIOLOGICAL WATER QUALITY ASSESSMENT SITES

Biological water quality ratings are shown on Map 2.

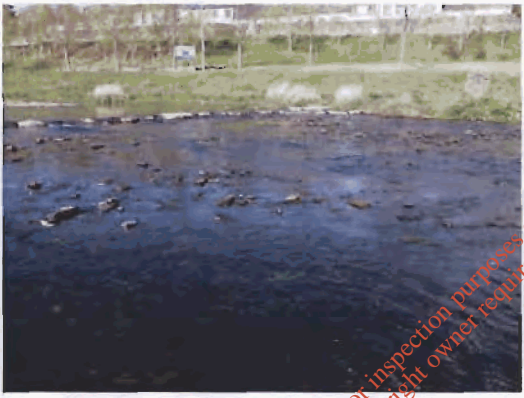
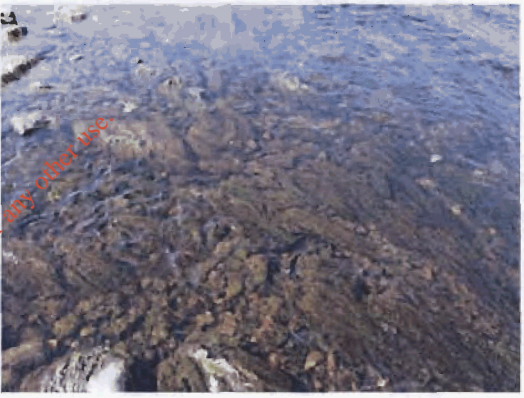
SITE A

Location	Immediately upstream of main industrial complex
Grid Reference	R 38287 03006
Description	"Sewage Fungus" absent.

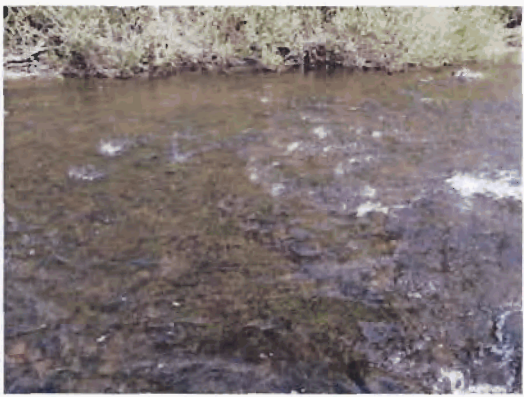
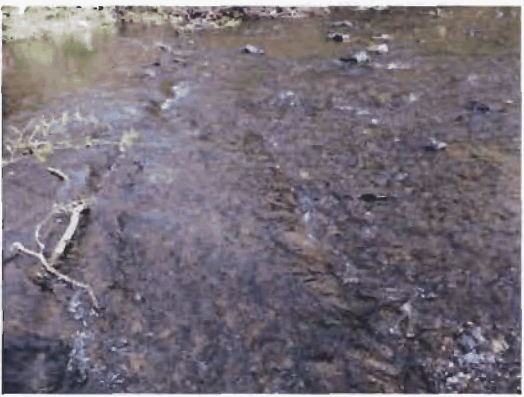
SITE B

Location	Immediately downstream of main industrial complex
Grid Reference	R 38465 02559
Description	"Sewage Fungus" absent

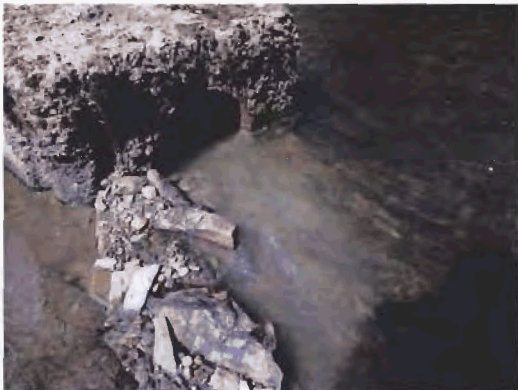
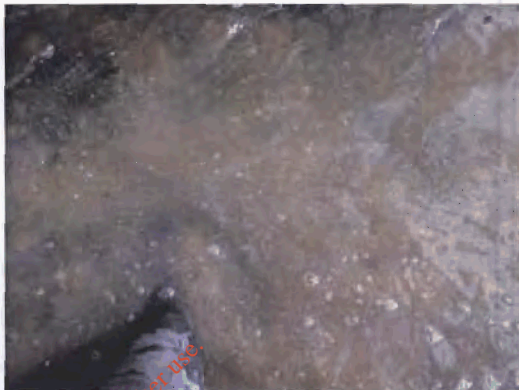
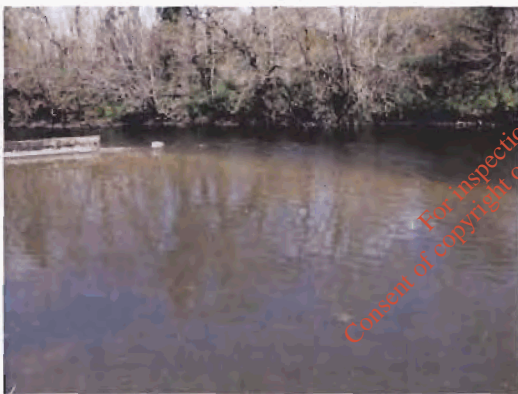
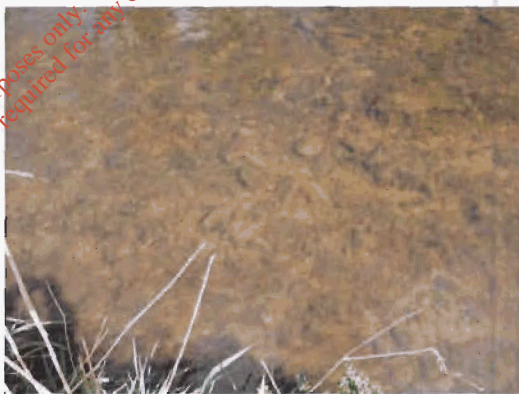
SITE C

Location	At and immediately downstream of effluent discharge WTP1
Grid Reference	R 38539 02353
Description	Turbid effluent discharge generating turbid plume in river.

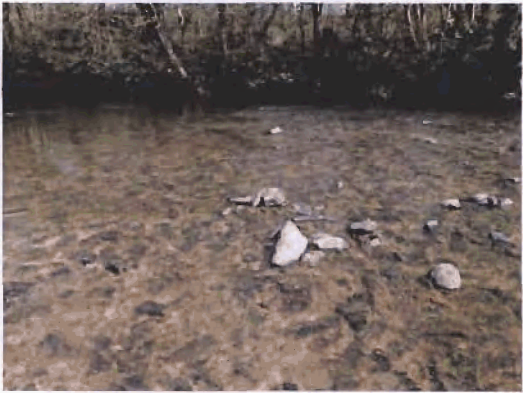
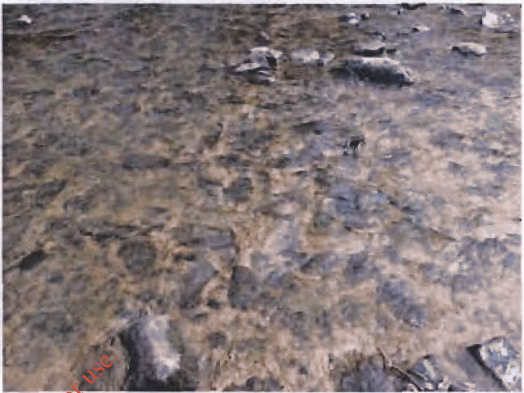
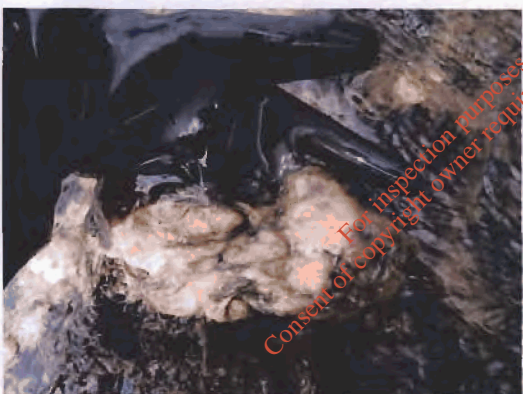
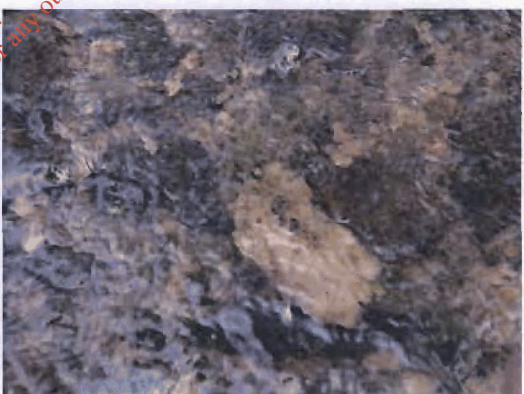
SITE D

Location	c.100m downstream of effluent discharge WTP1
Grid Reference	R 38516 02291
Description	Dense channel-wide growth of "Sewage Fungus"

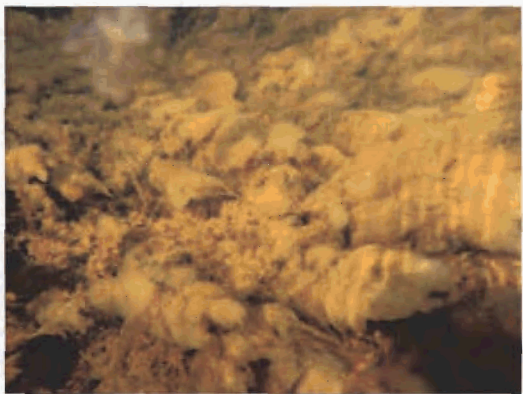
SITE E

Location	c.450m downstream of effluent discharge WTP1
Grid Reference	R 38383 02003
Description	Continuing dense channel-wide growths of "Sewage Fungus"

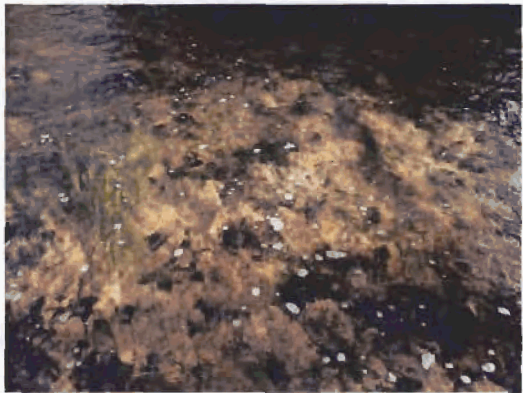
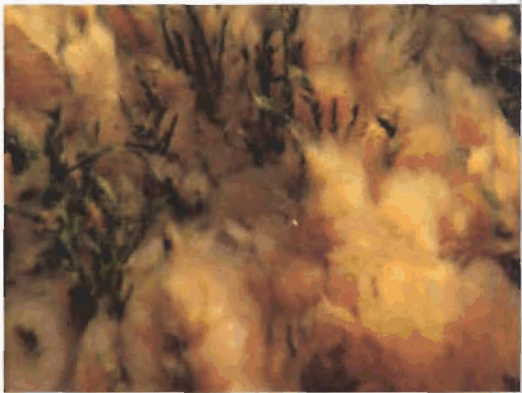
SITE F

Location	c.700m downstream of effluent discharge WTP1
Grid Reference	R 38470 01727
Description	Continuing dense channel-wide growths of "Sewage Fungus"

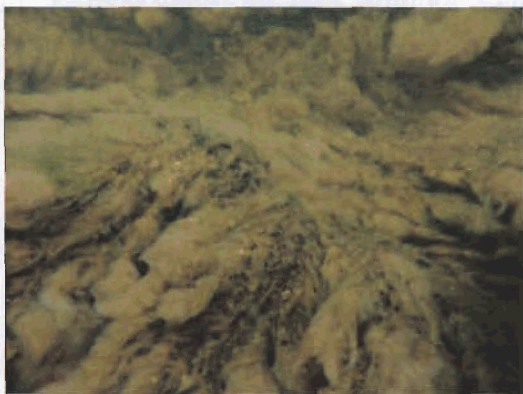
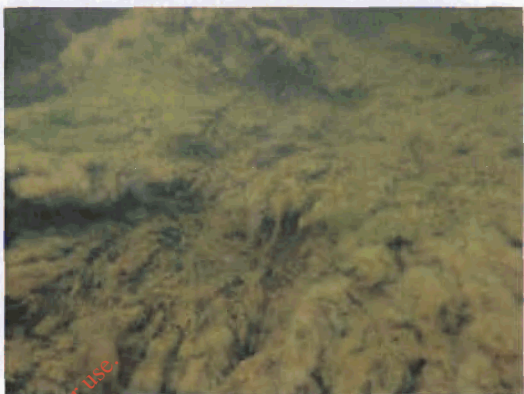
SITE G

Location	c.1.7m downstream of effluent discharge WTP1
Grid Reference	R 38303 00695
Description	Continuing dense channel-wide growths of "Sewage Fungus"

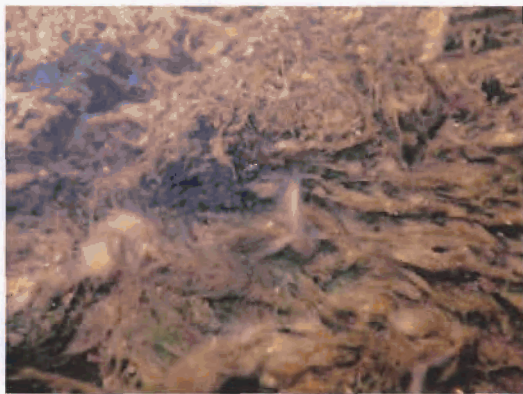
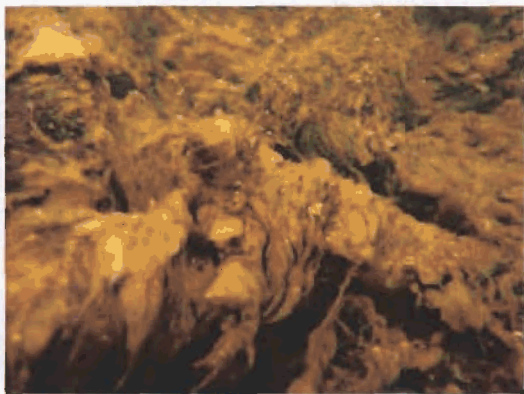
SITE H

Location	c.4km downstream of effluent discharge WTP1. Just upstream of Leader's Bridge and confluence with River Blackwater
Grid Reference	R 38480 98945
Description	Continuing channel-wide growths of "Sewage Fungus"

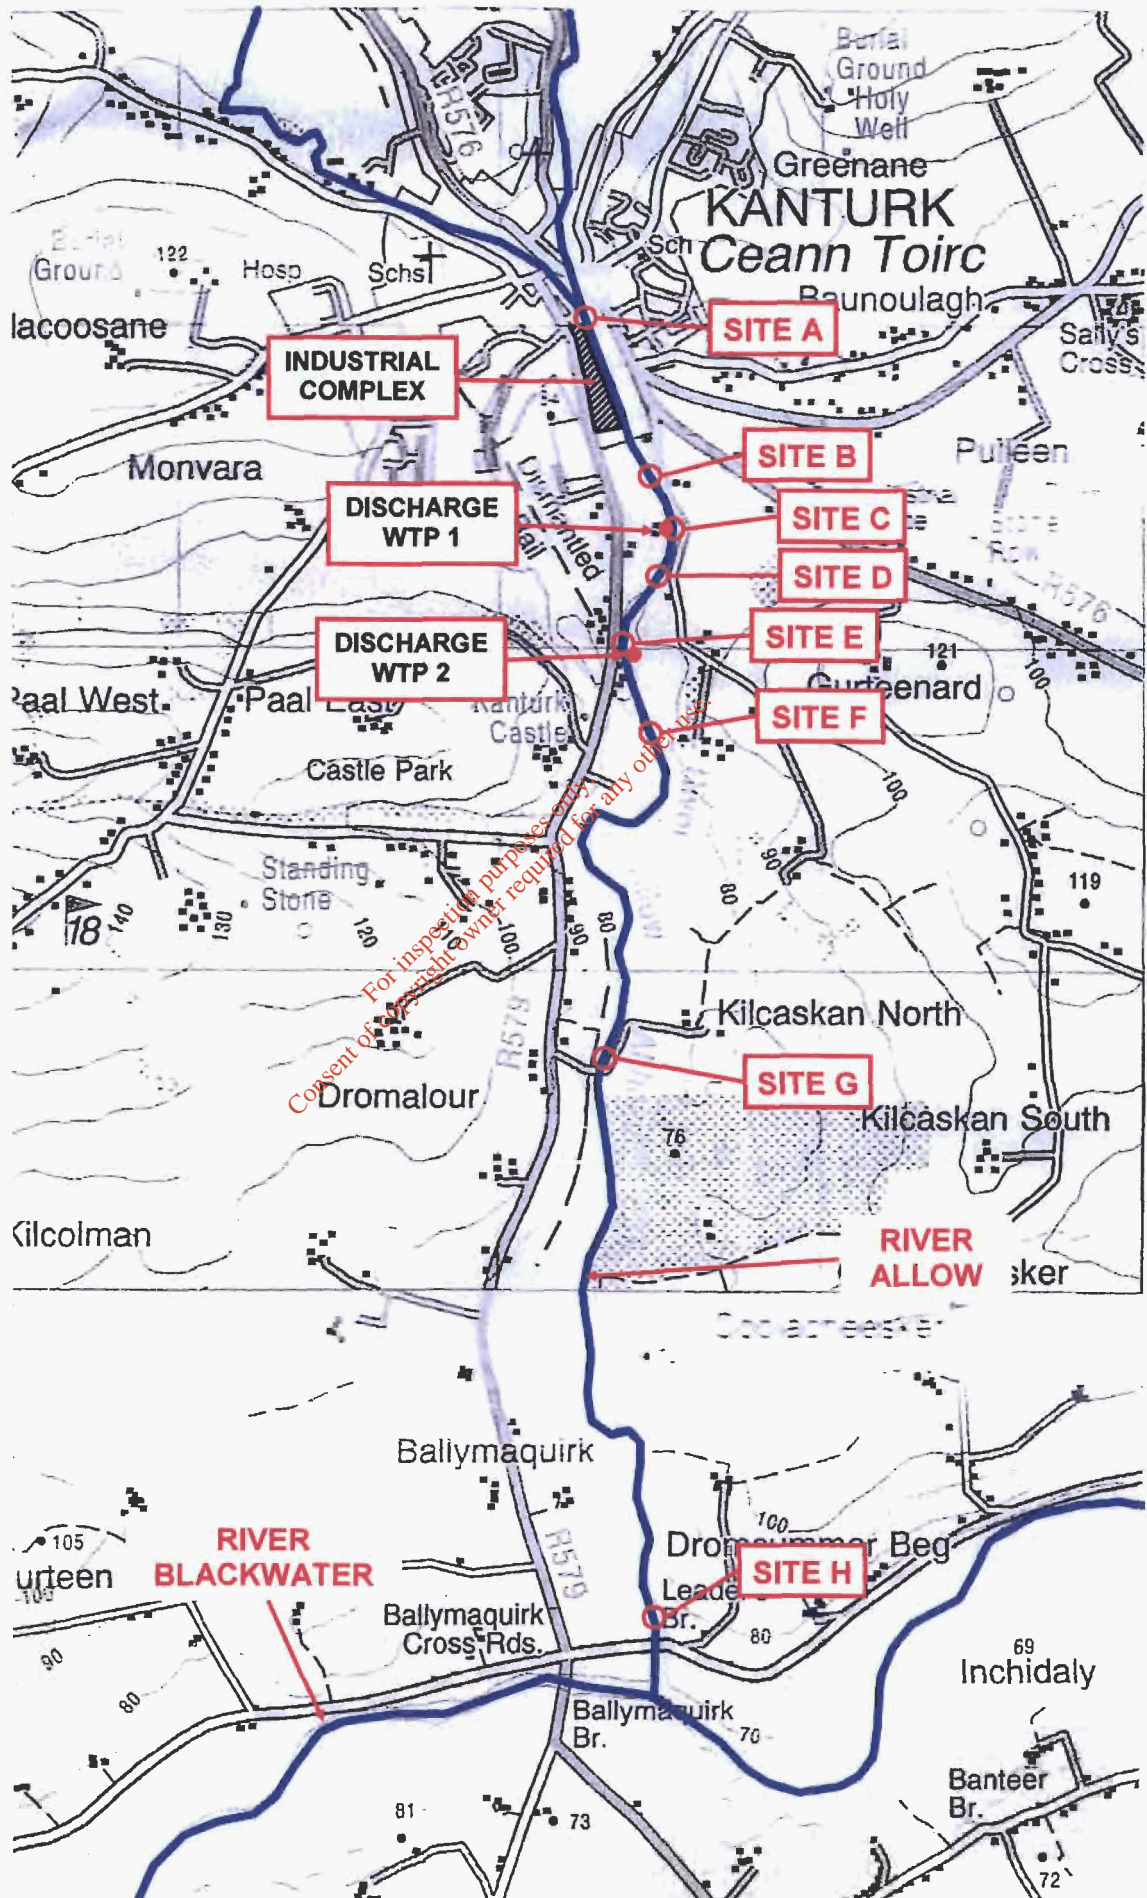
MAP 3 'SEWAGE FUNGUS' SURVEY LOCATIONS

Locations where 'sewage fungus' assessment was carried out are shown on Map 3.

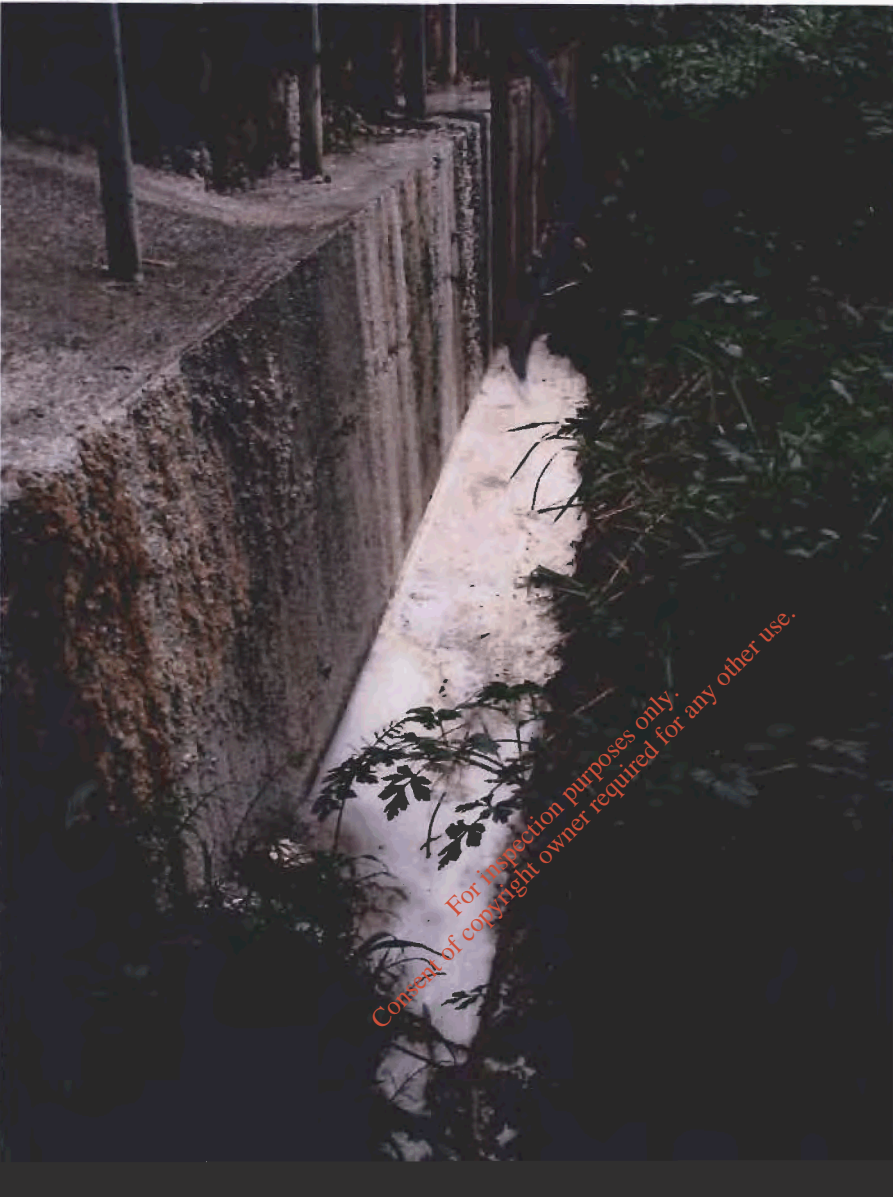
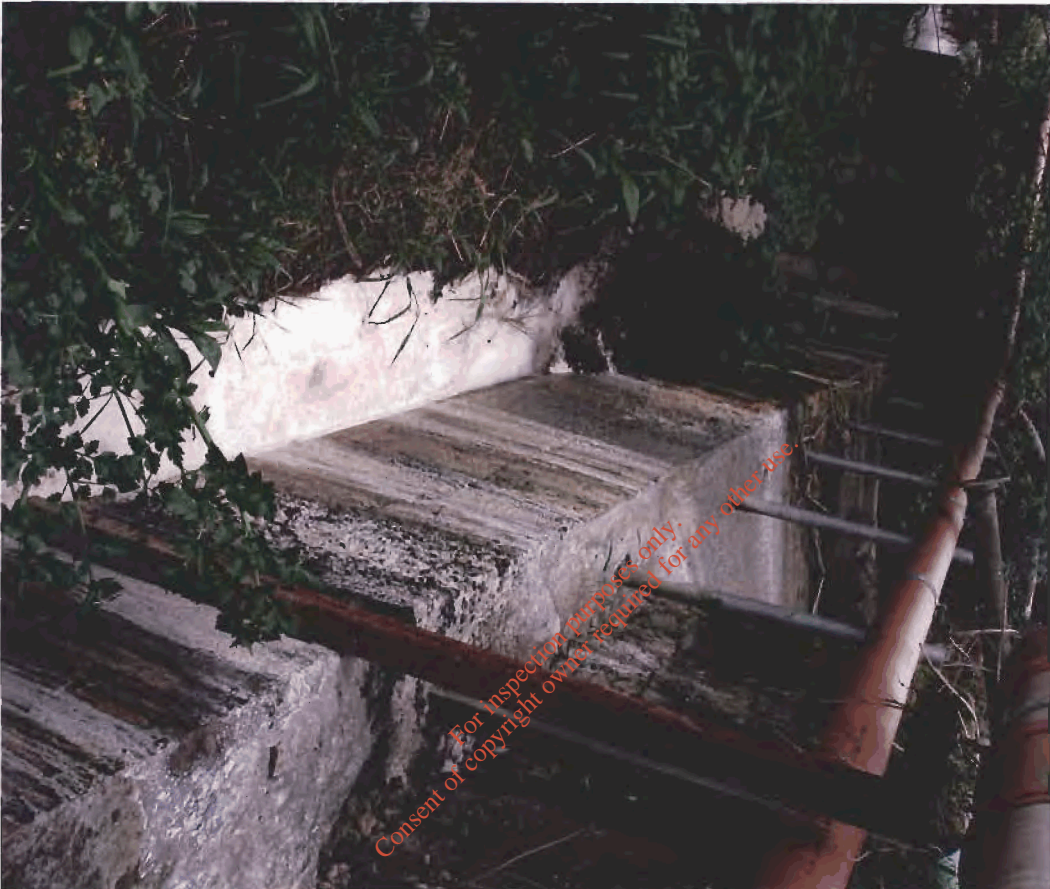
Discharge of milk at the Creamery Milk Intake Plant

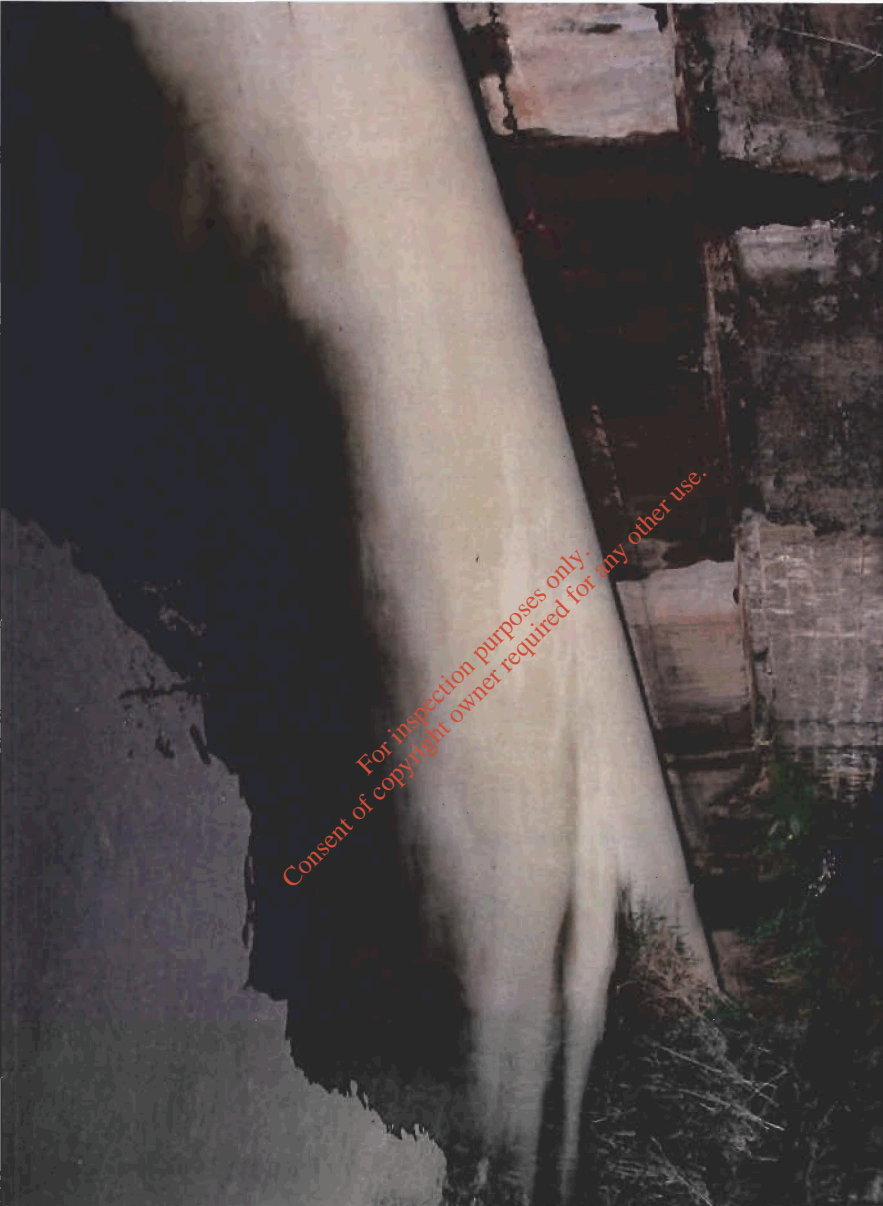
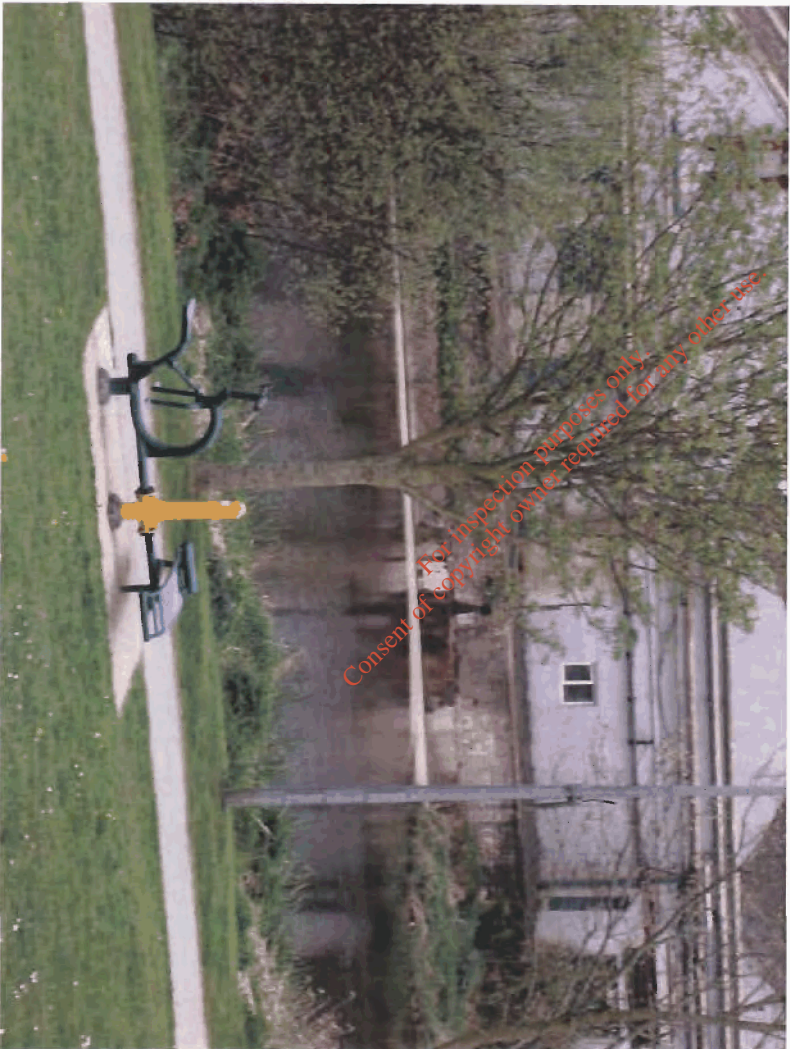
Spillage of milk from Milk Intake Plant into Allow
River

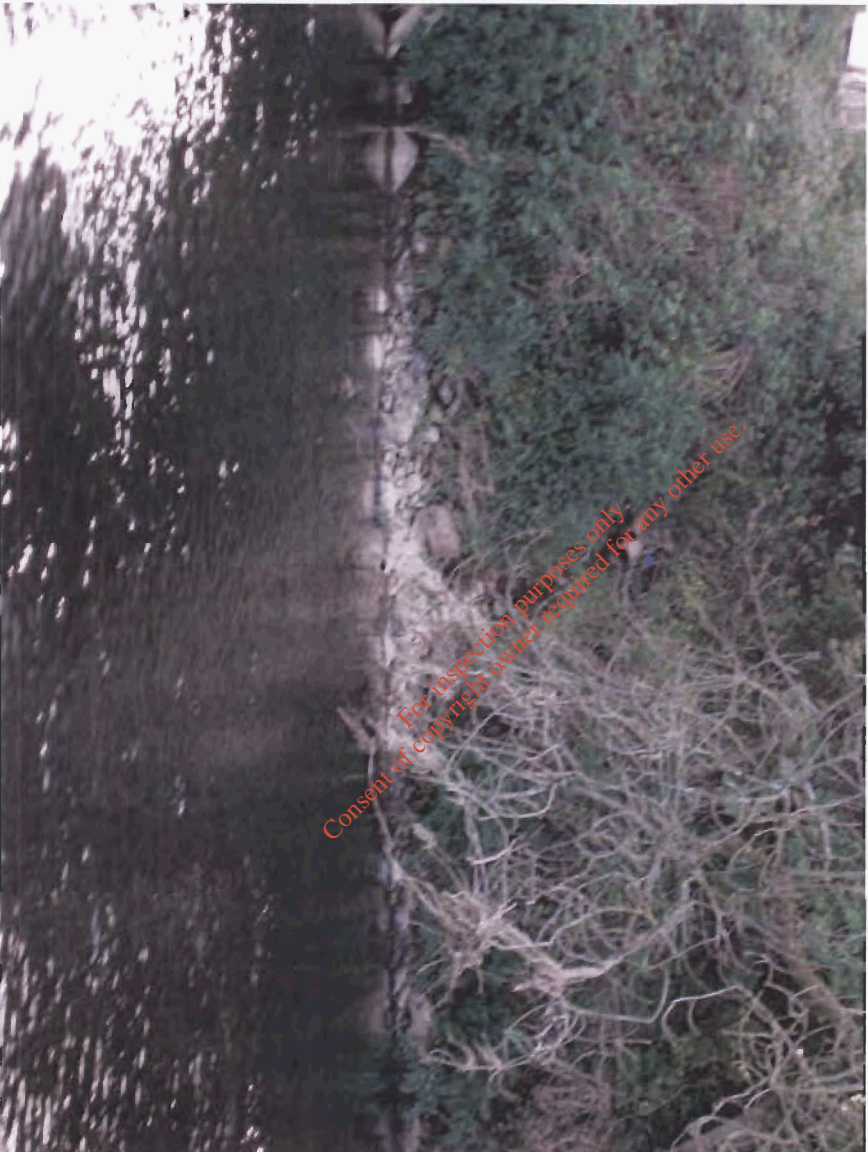
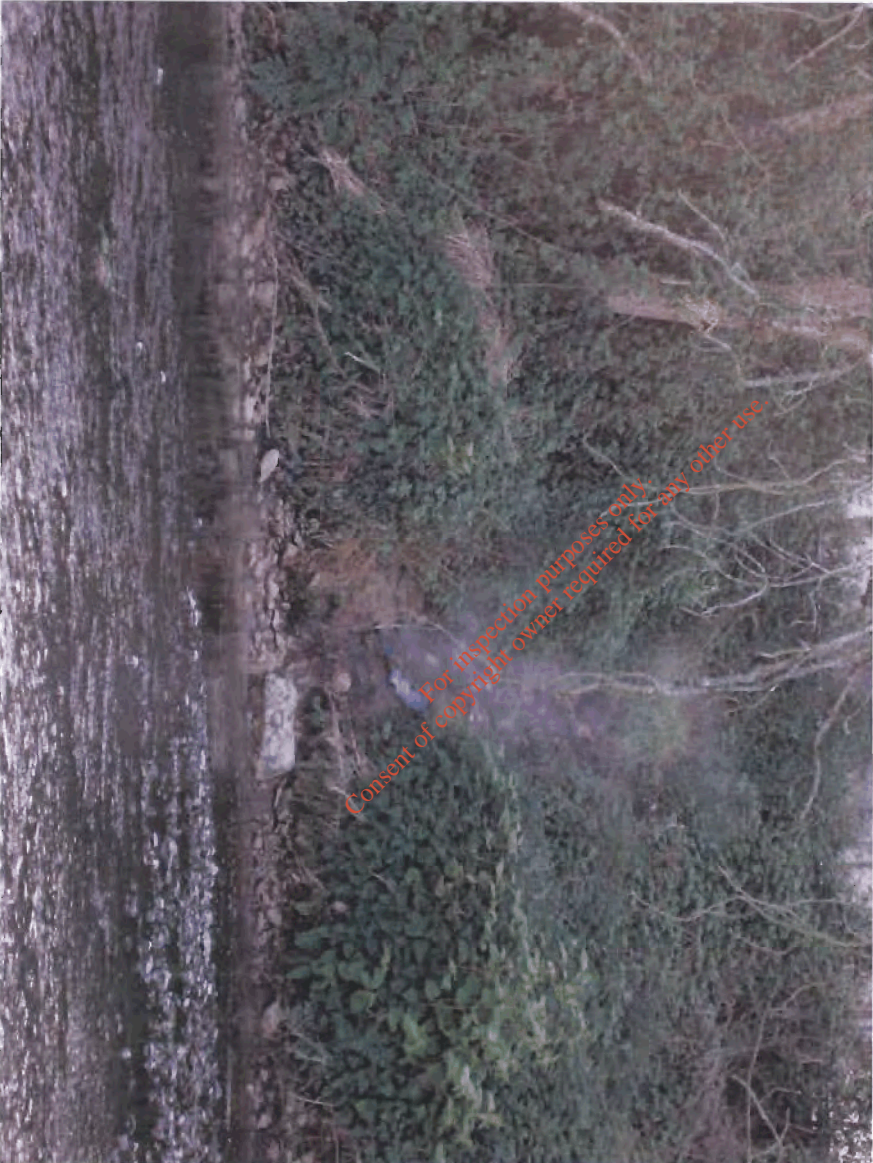
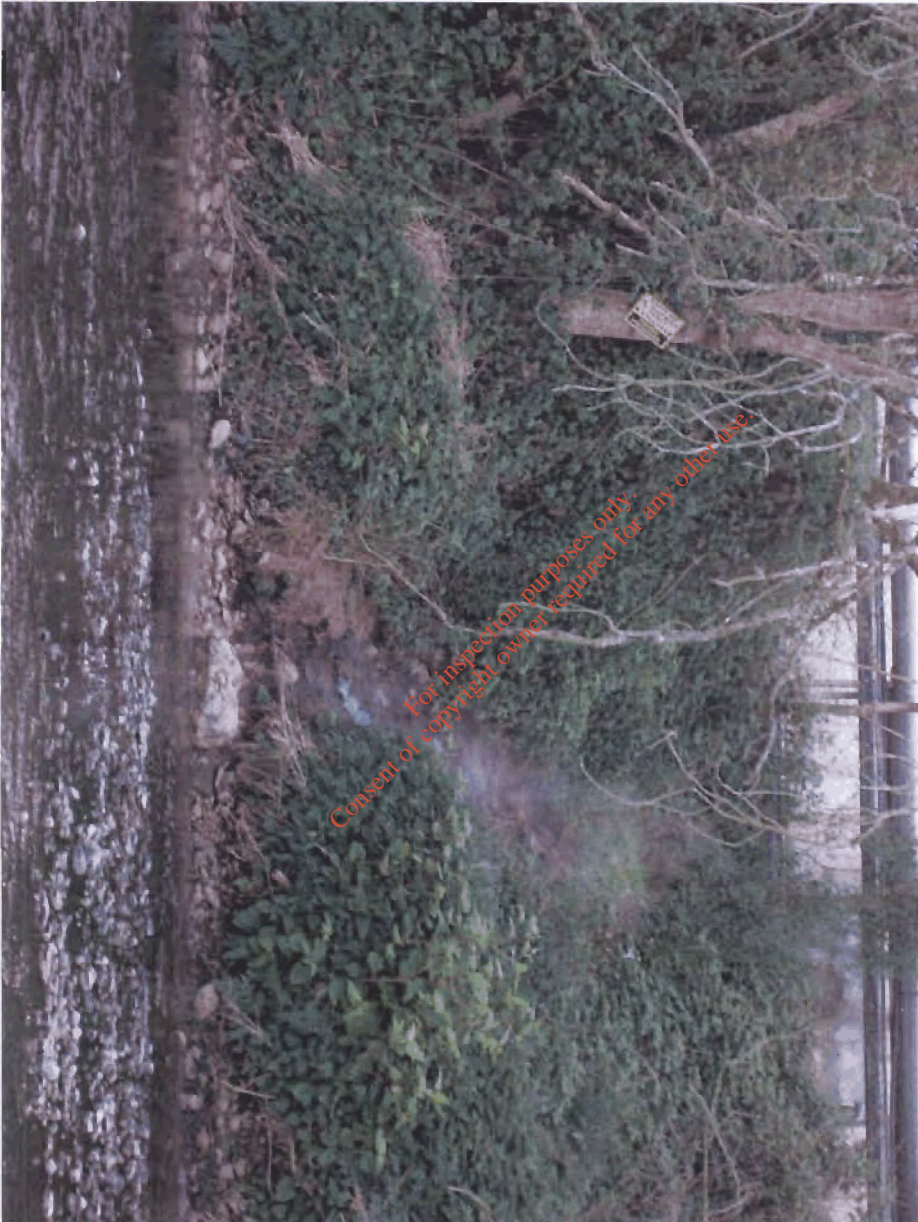
Pipe from North Cork Co-Op opposite County Council Bring
Centre releasing steam and liquid into river and burning
vegetation.

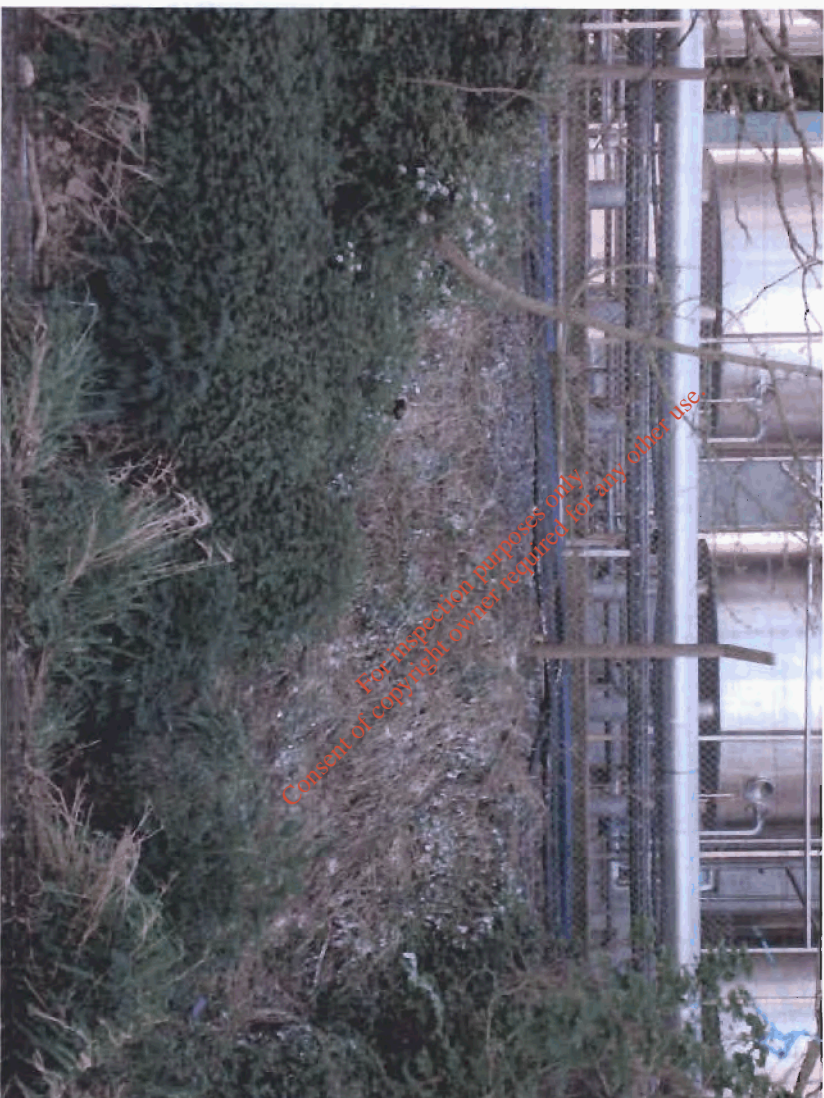
Overflow from Creamery yard flowing down bankside into Allow
River. Discharge burning all vegetation in its path.

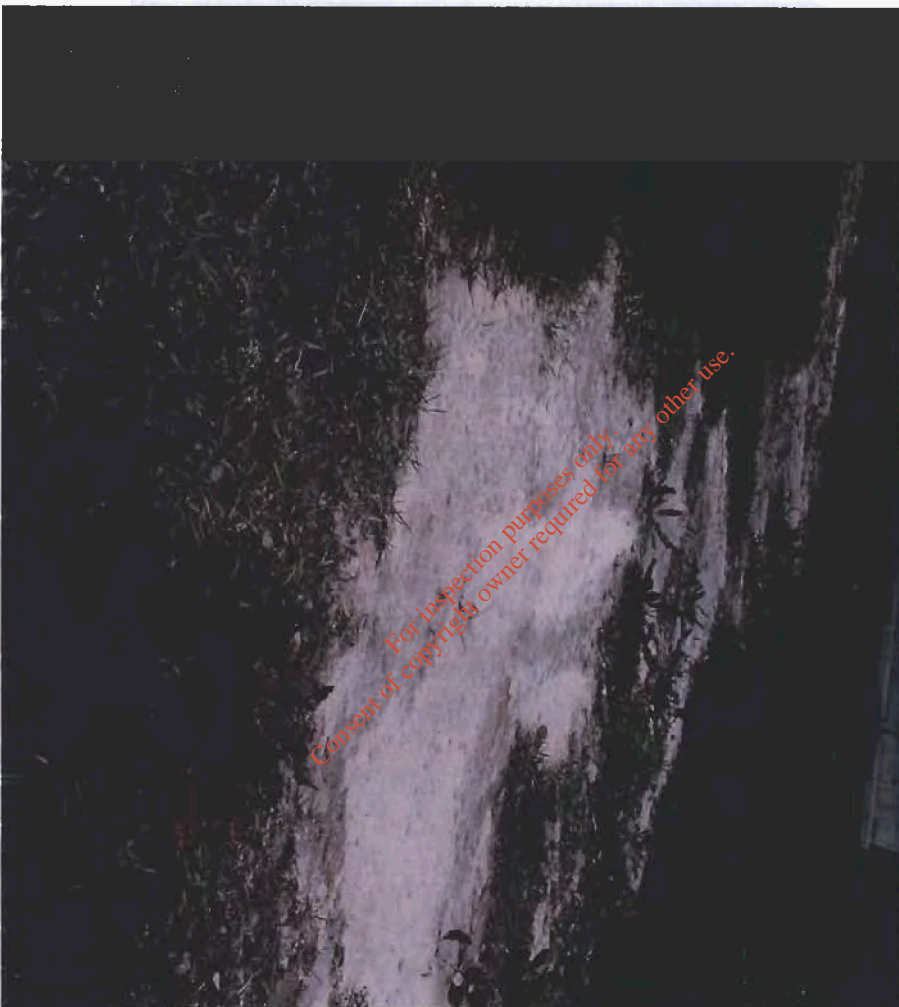
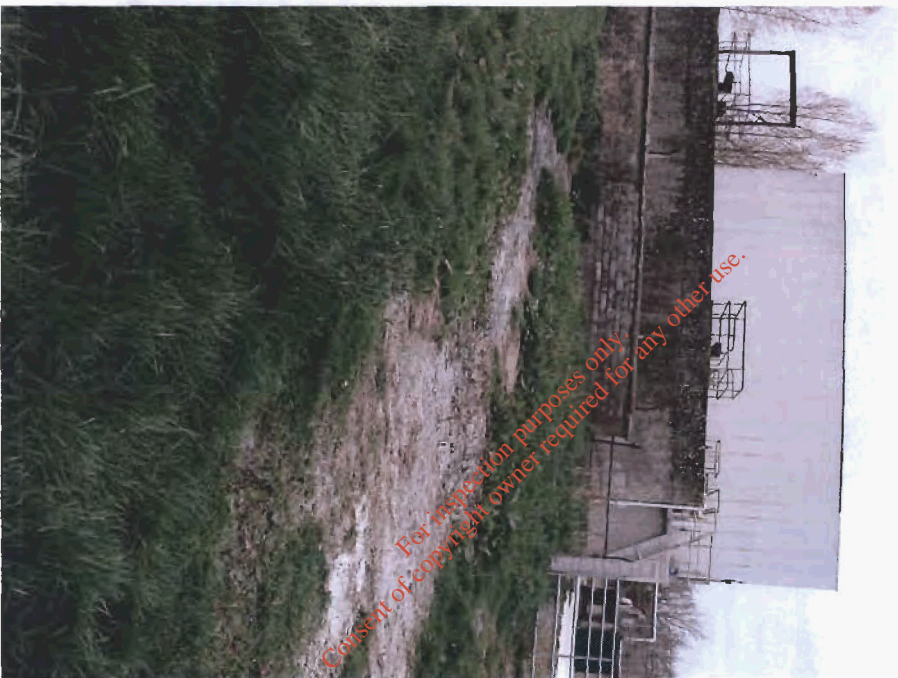
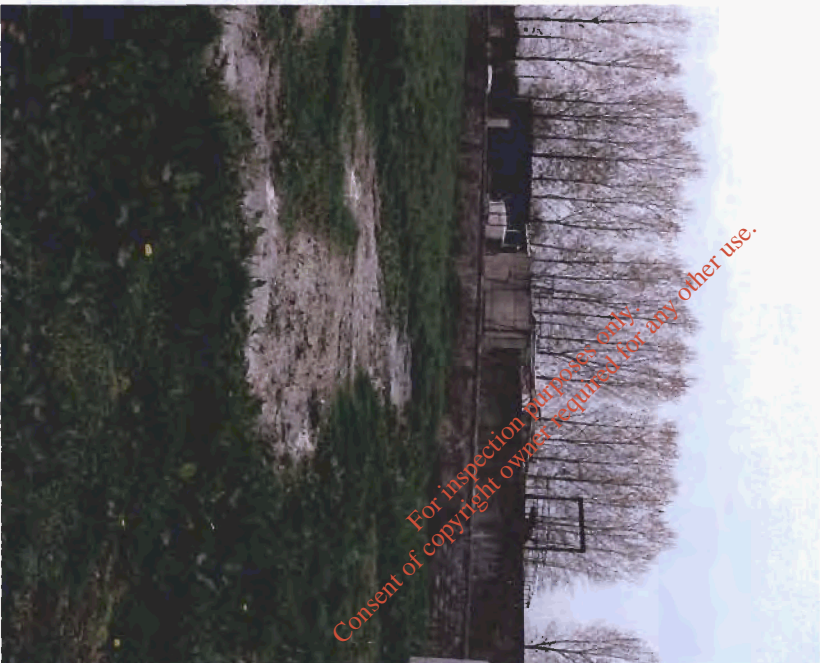
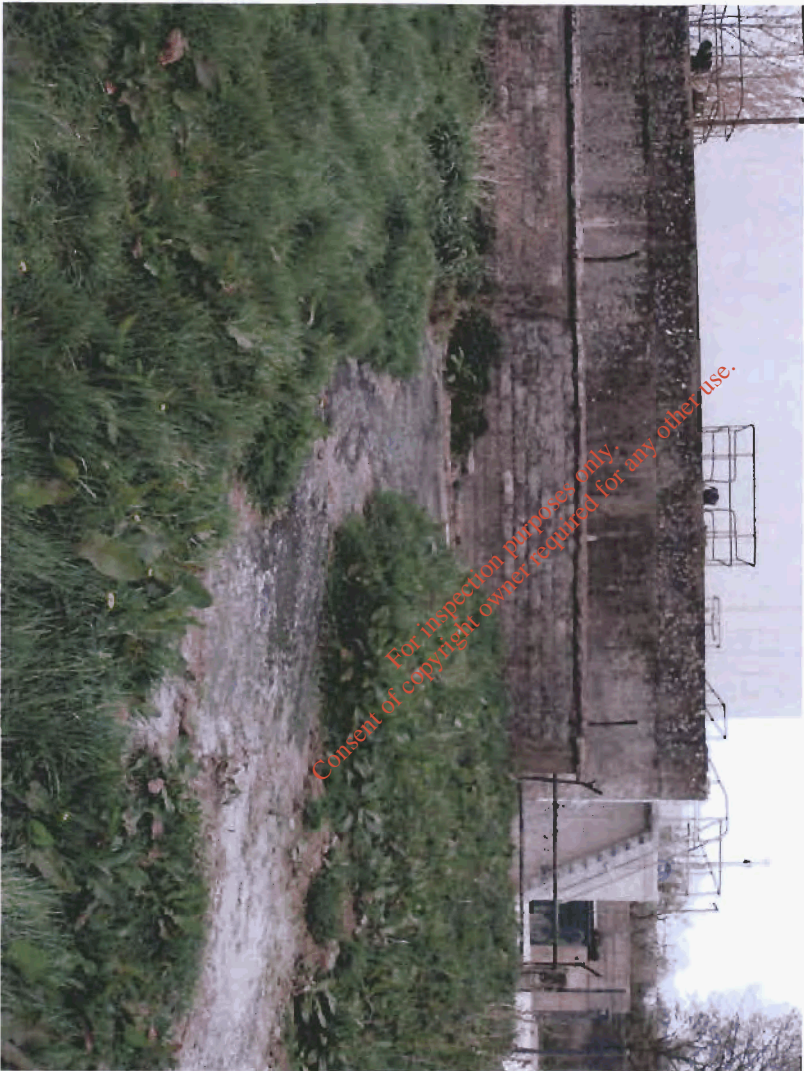
Discharge run-off from overflowing tanks in North Cork Co-Op waste treatment plant, Bluepool Road. Discharge is in the southern field and flows eventually into Allow River.

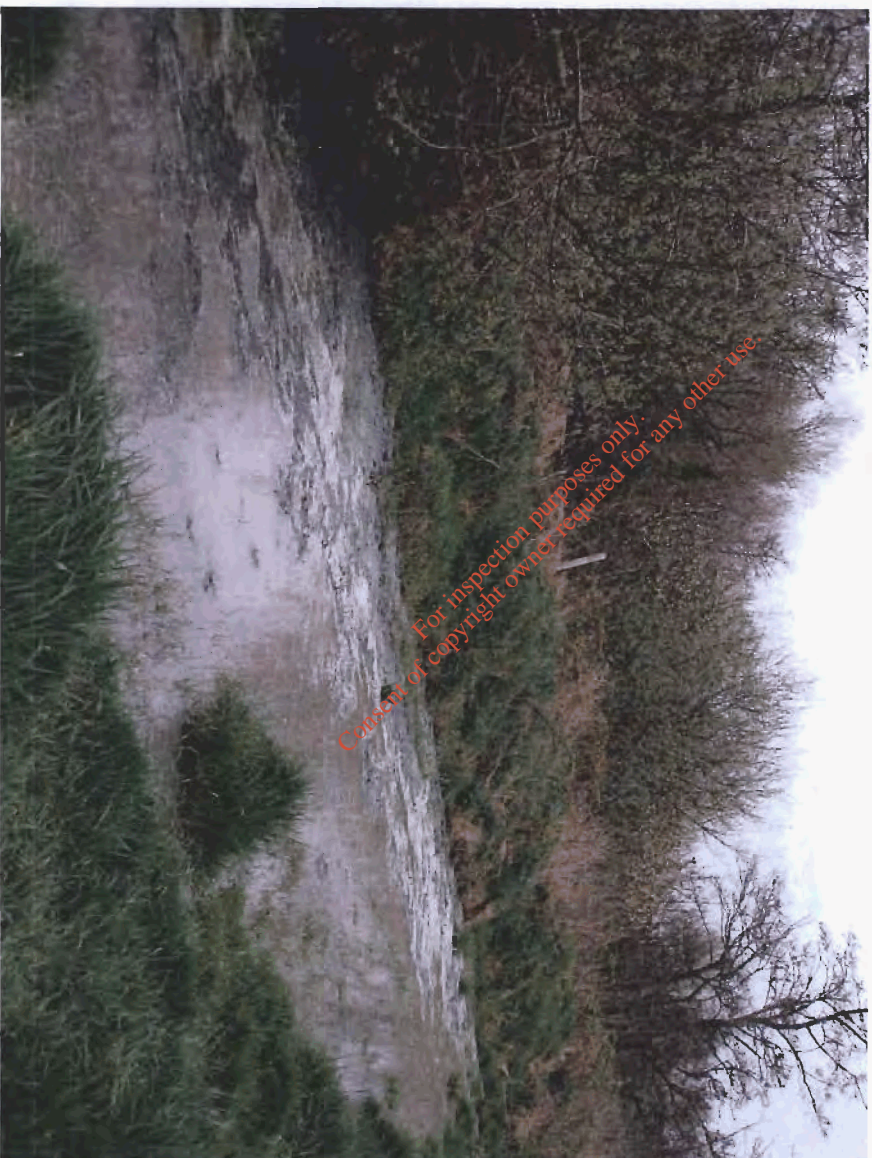
Discharge running from North Cork Co-Op Waste Plant in the field at southern side of Plant. (Allow River at the other side of the fence). Discharge goes through the fence and into the Allow River.
