Re: North Cork Co-op Creameries - EPA application

Registration No: P1051-01

ASSESSMENT OF BIOLOGICAL WATER QUALITY IN THE RIVER ALLOW, DOWNSTREAM OF KANTURK, COUNTY CORK

Appendix B - Photographic record of the current levels of discharge to the river at various locations

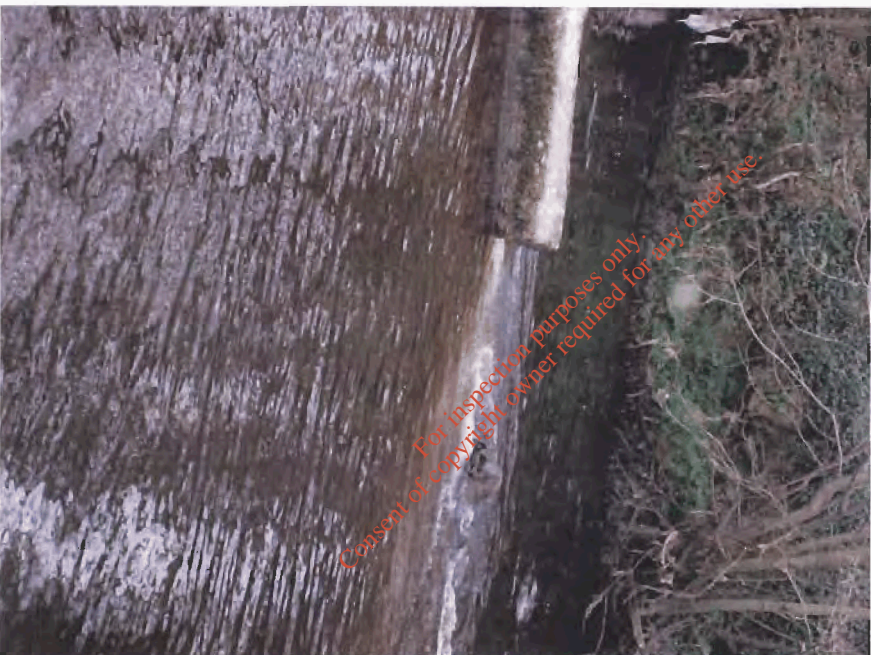
Pipe running from North Cork Co-Op waste treatment Plant into Allow River.
Brown discharge being released.

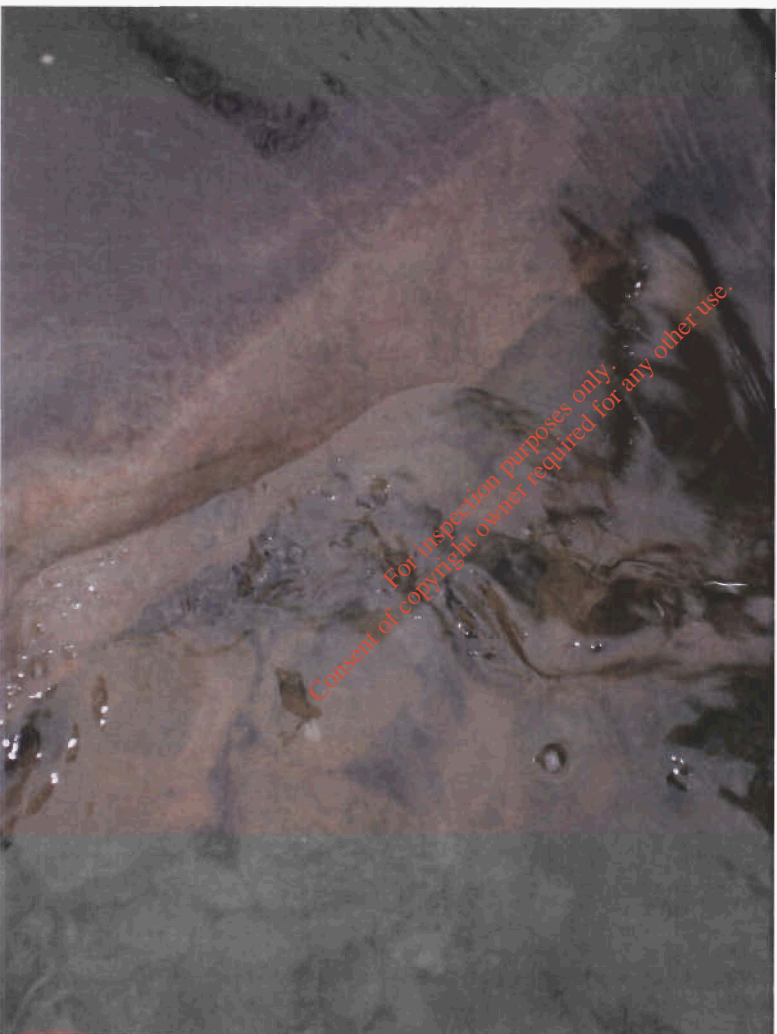
Discharge from the pipe at waste plant into River
Allow.

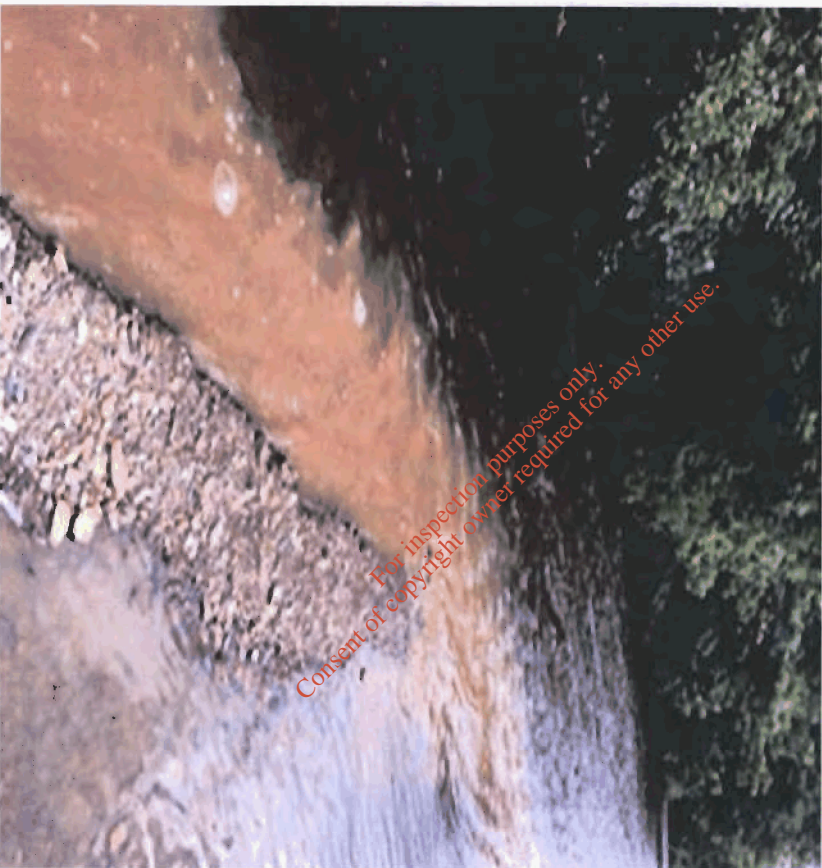
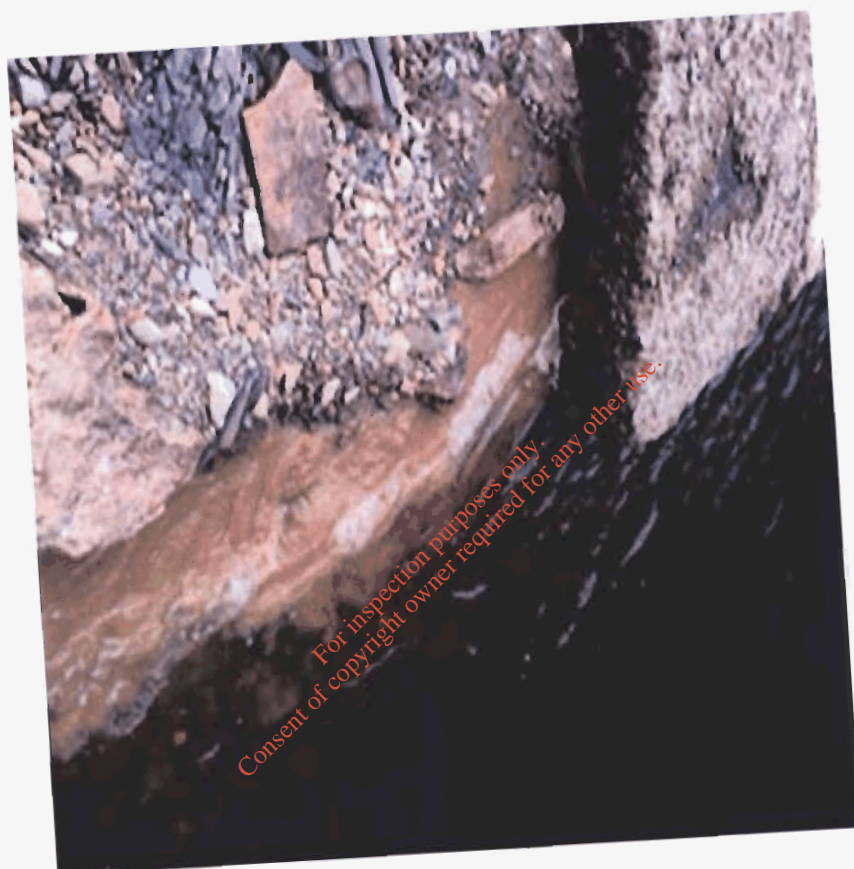
Discharge from pipe at North Cork Co-Op wastewater plant into River Allow

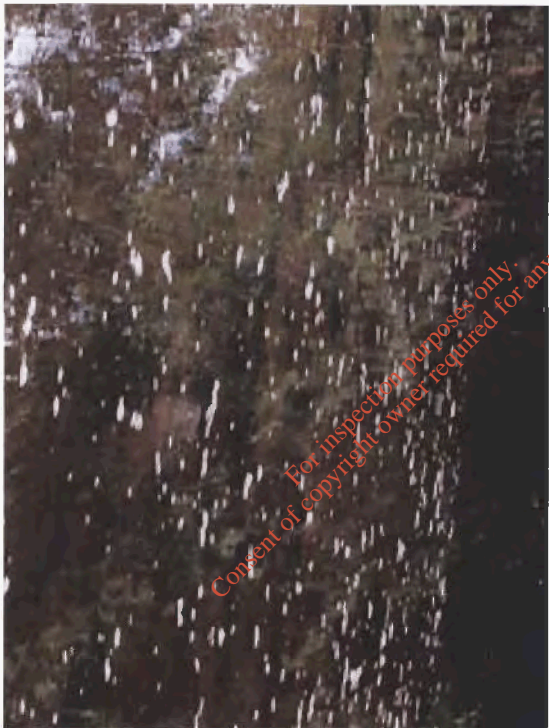
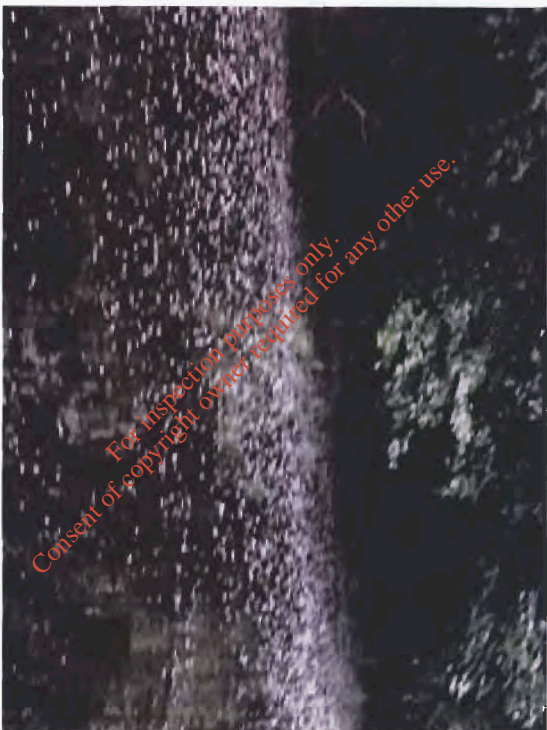
River Allow at the North Cork Co-Op waste water plant with white foam floating on surface of the river.

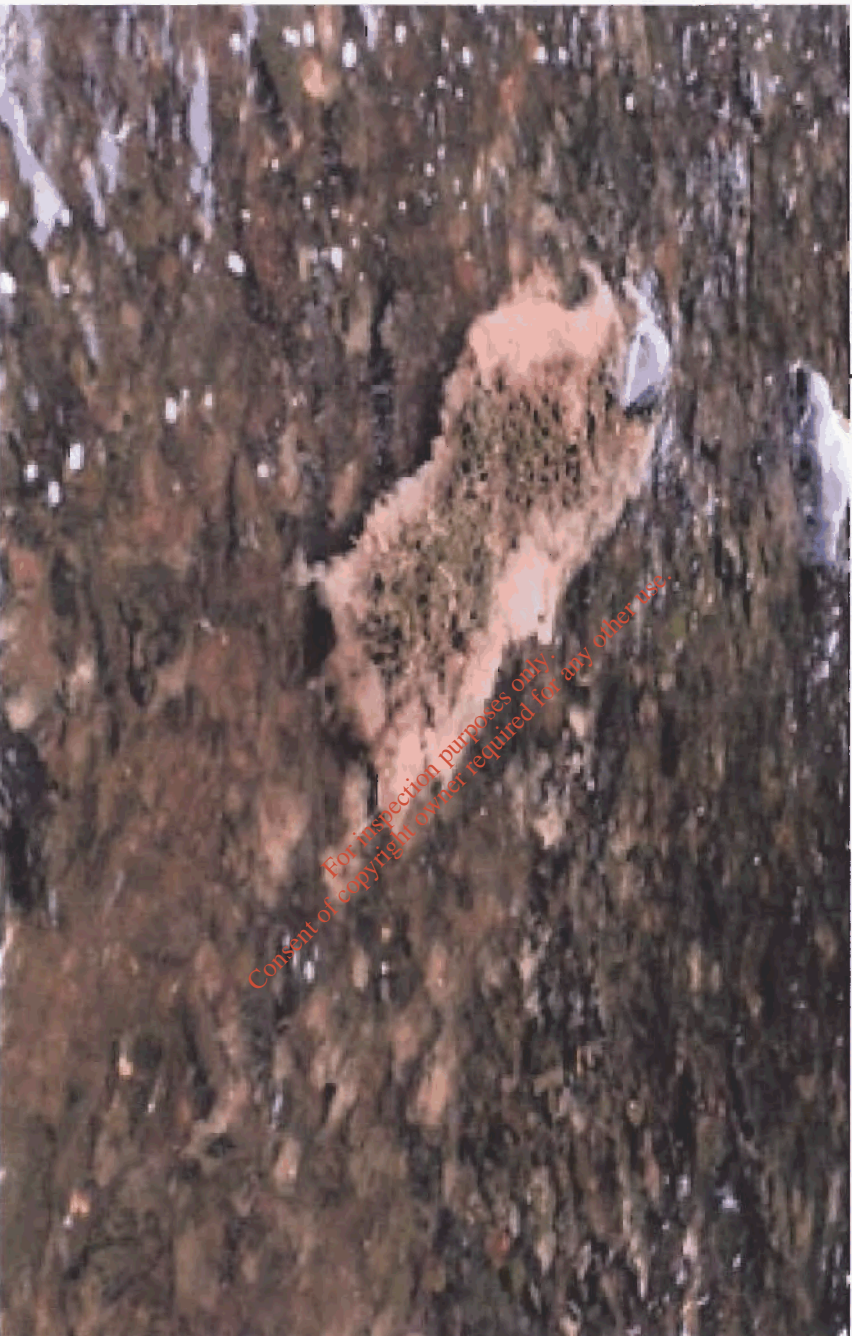
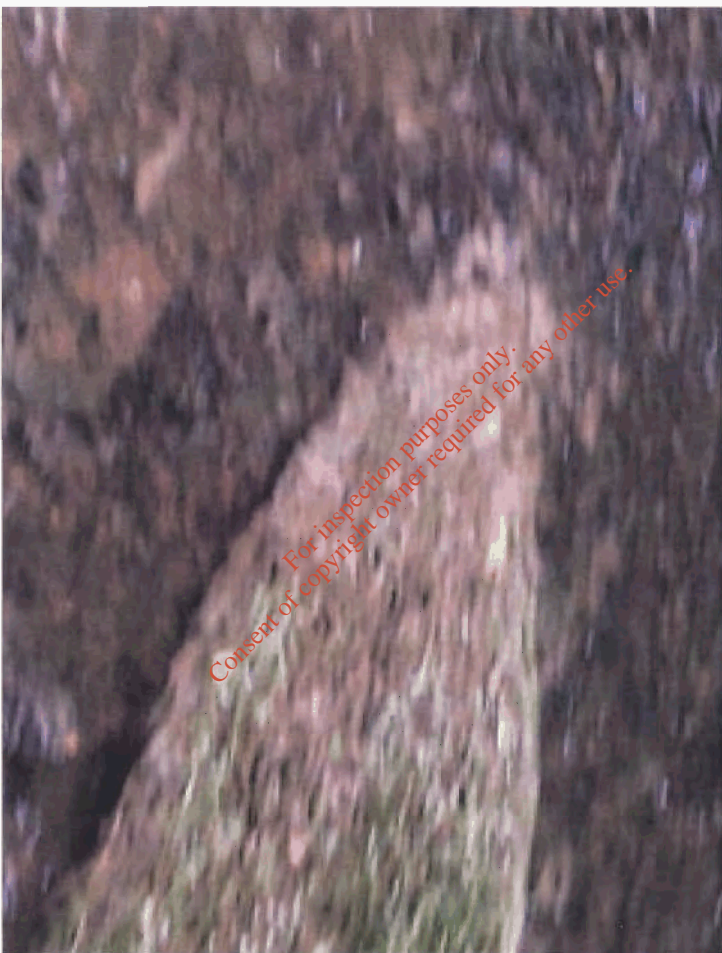
Ranunculus weed covered in discharge from North Cork
water waste plant in river Allow.

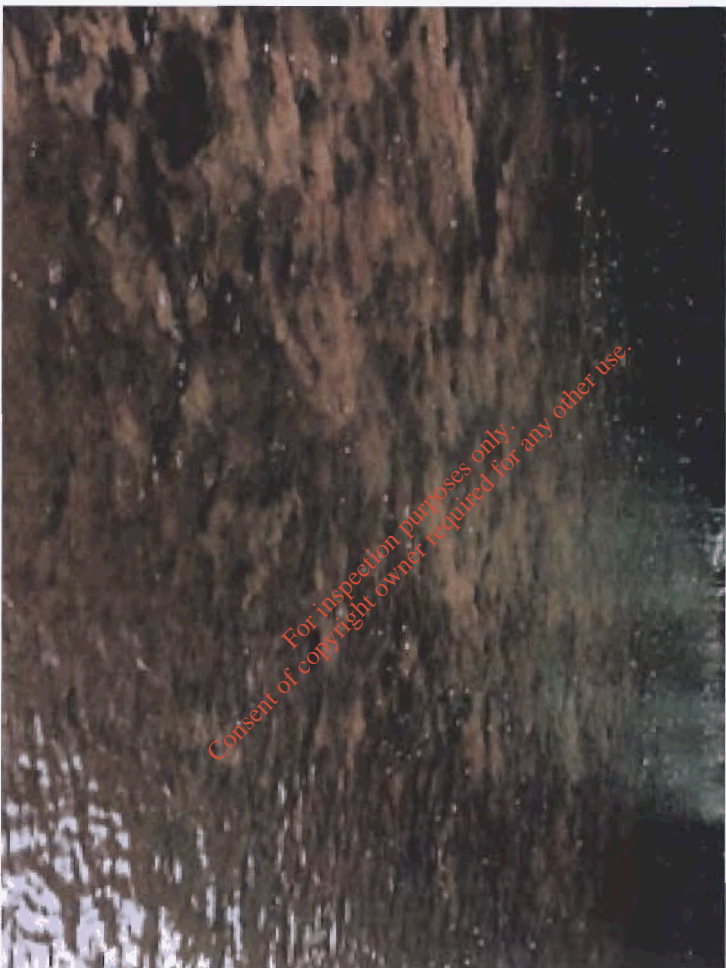
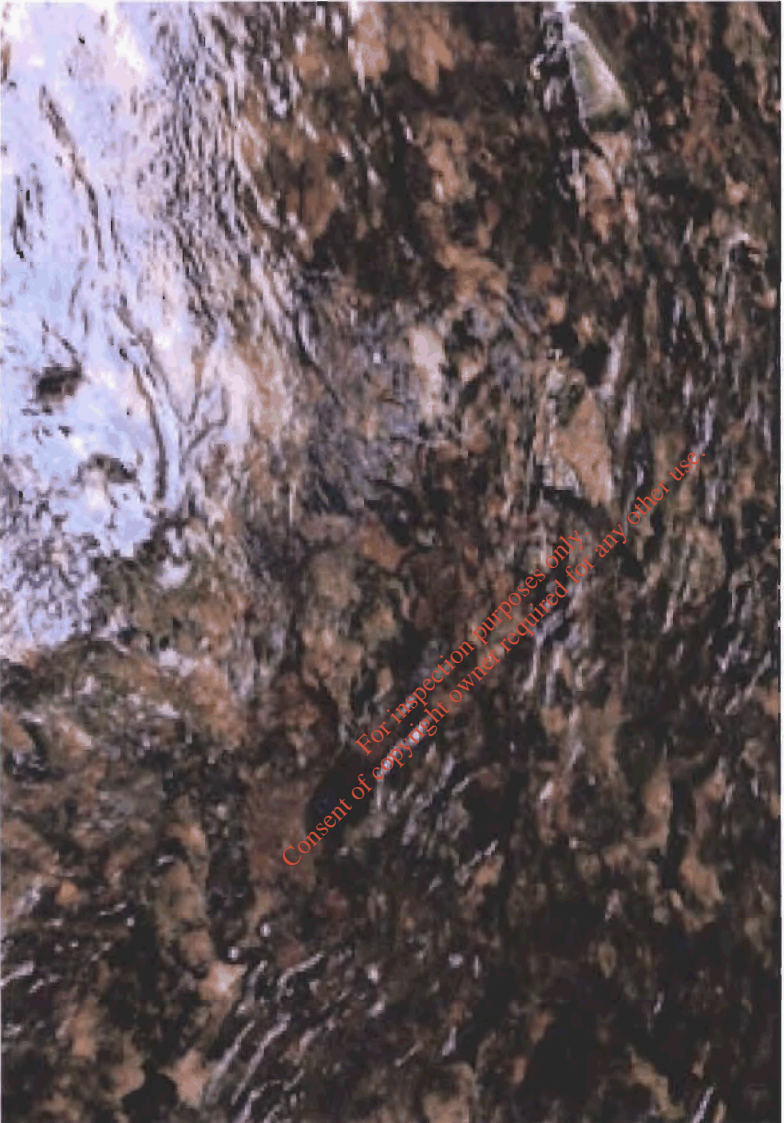
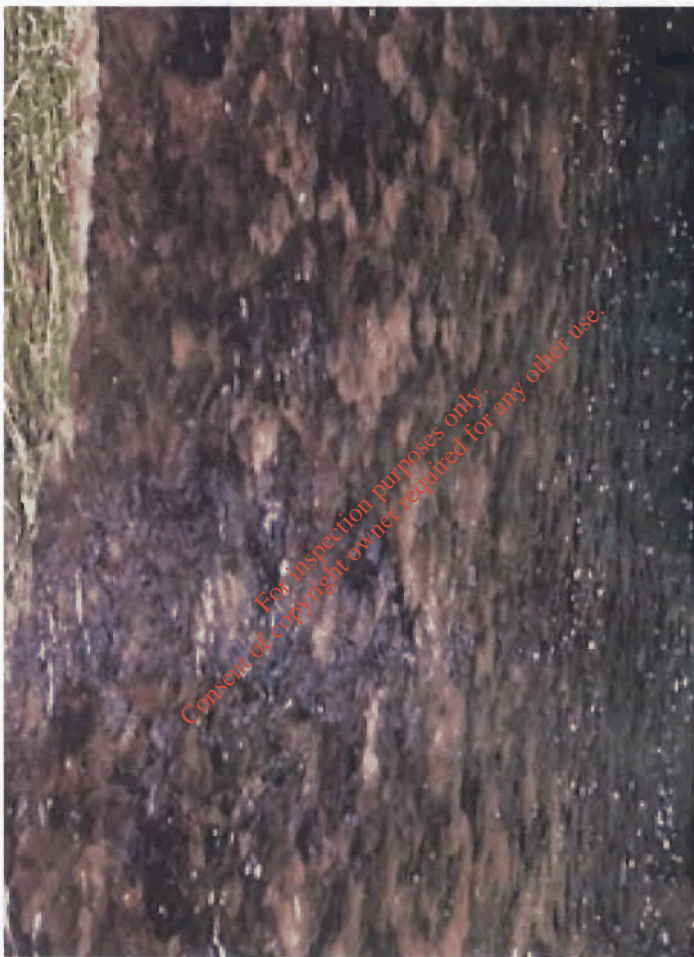
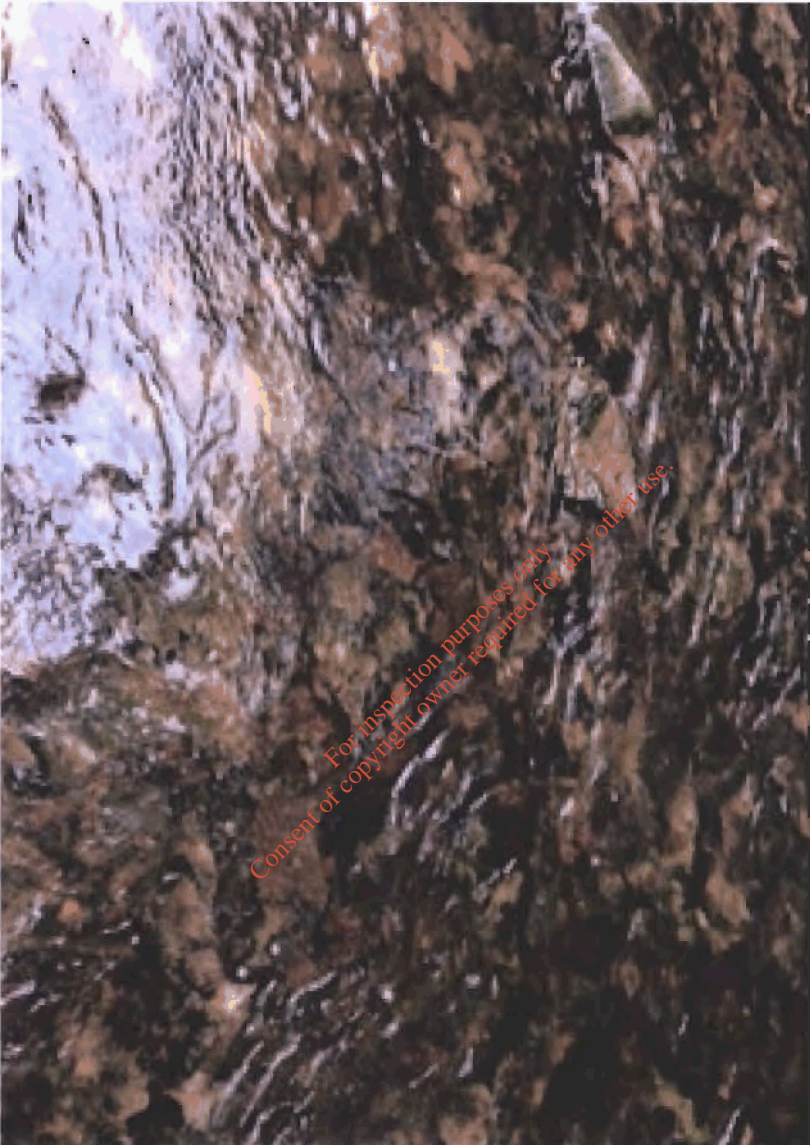
Bed of Allow River covered in discharge from North
Co-Op waste water plant.

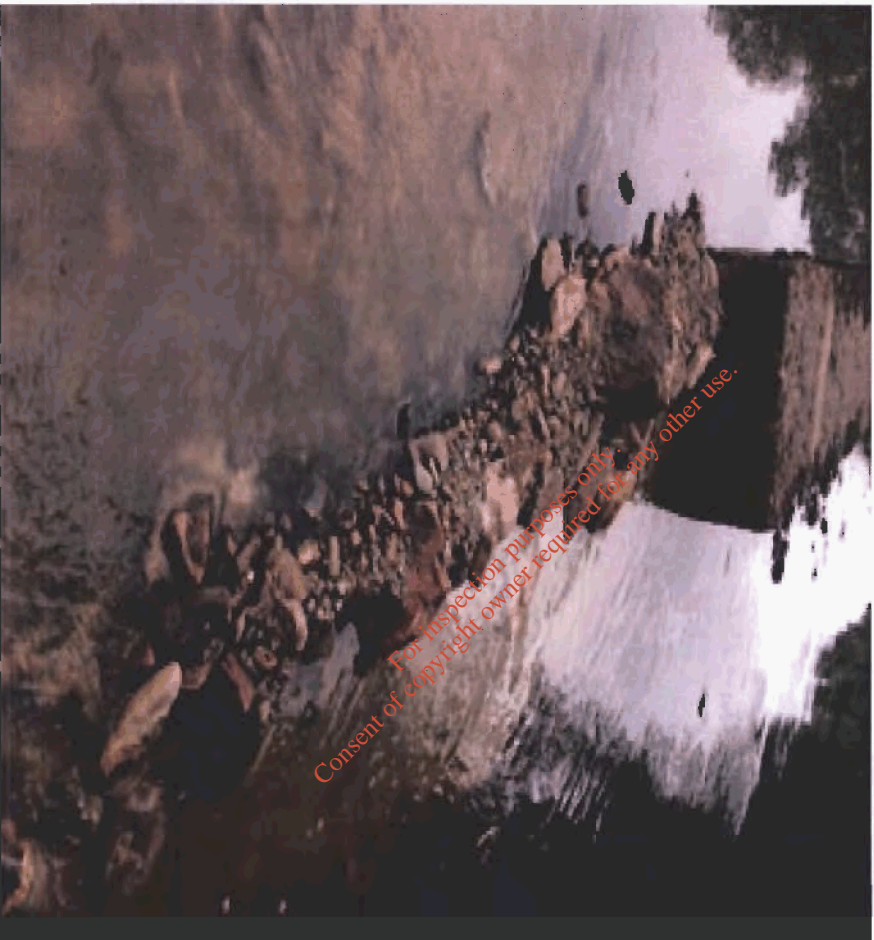
Pipe at North Cork Co-Op waste water plant discharging into River Allow.

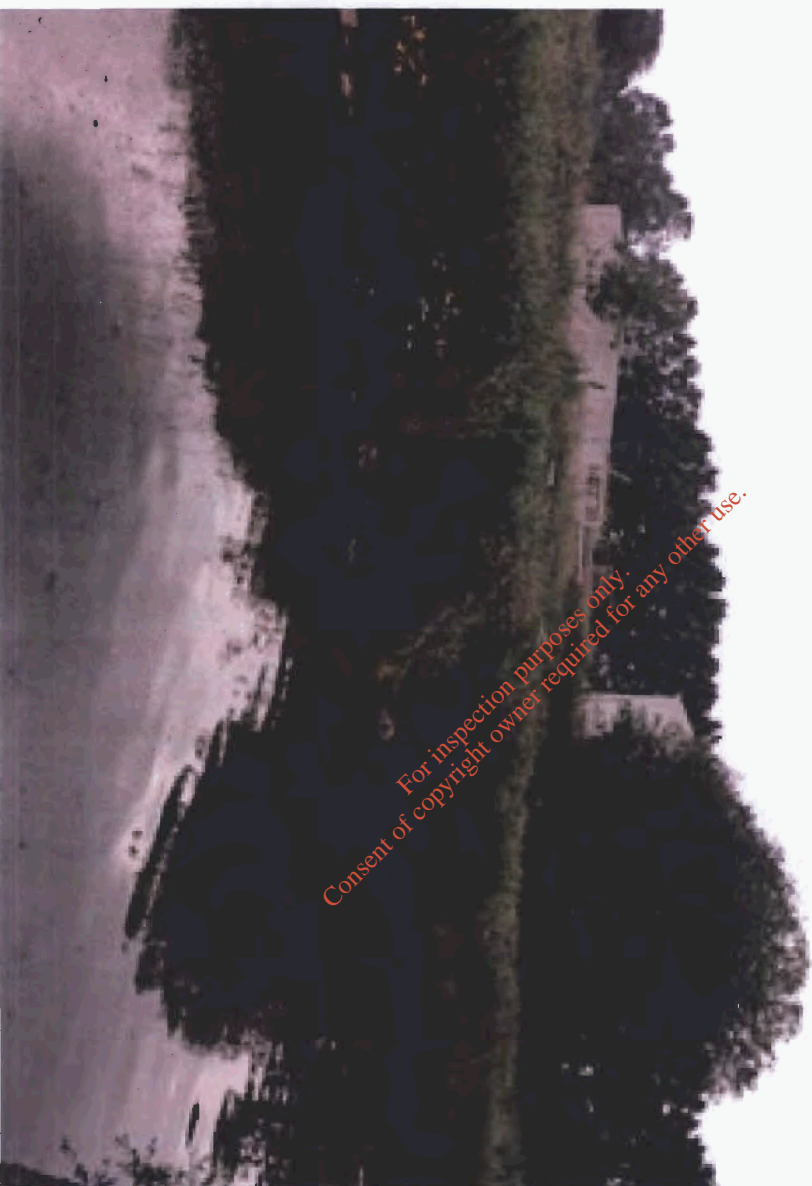
Pool on River Allow downstream of North Cork Co-Op waste water plant with discharge clearly seen on surface and on bed of the river.
