## Final Independent Closure Audit Report

Cappoquin Poultry,  
Lefanta,  
Cappoquin,  
Co. Waterford.

IPPC Licence No,  
P0834-02

Prepared By: Peter Pearson  
PP Environmental Consultants Ltd

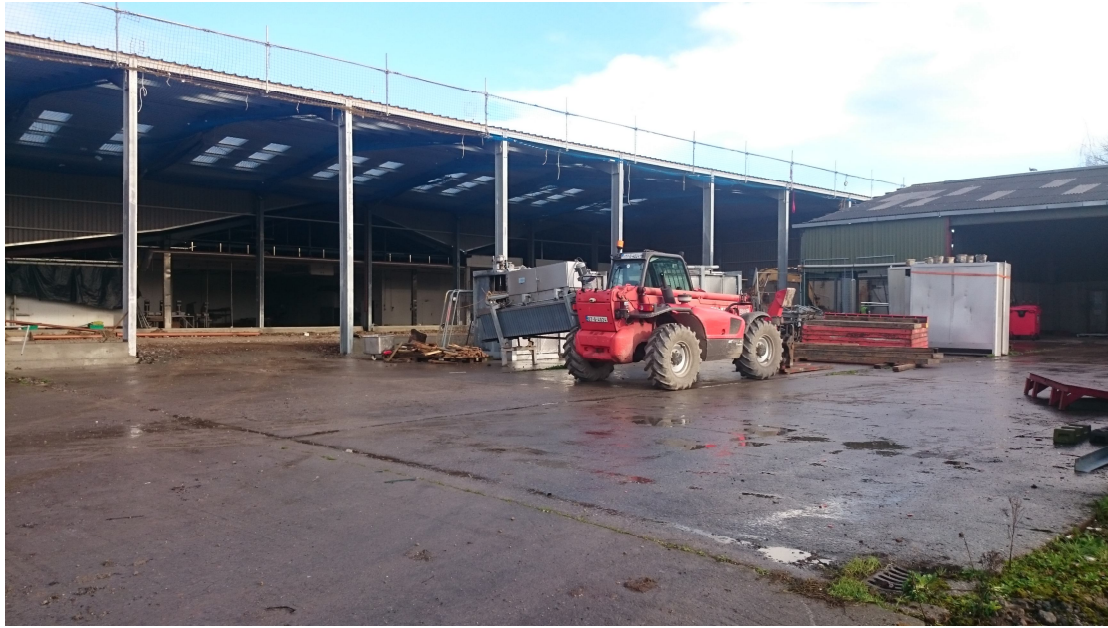
Photo 1 – New Pig Slaughtering Building

While the above regulatory matters were being approved, Sucrop Ltd made a decision to commence pig slaughtering at the facility sooner rather than later. As a result of this decision, work commenced in late 2016 on increasing the height of the slaughtering processing area to cater for pigs. A photo of the new building (currently under construction) is provided in Appendix 4.

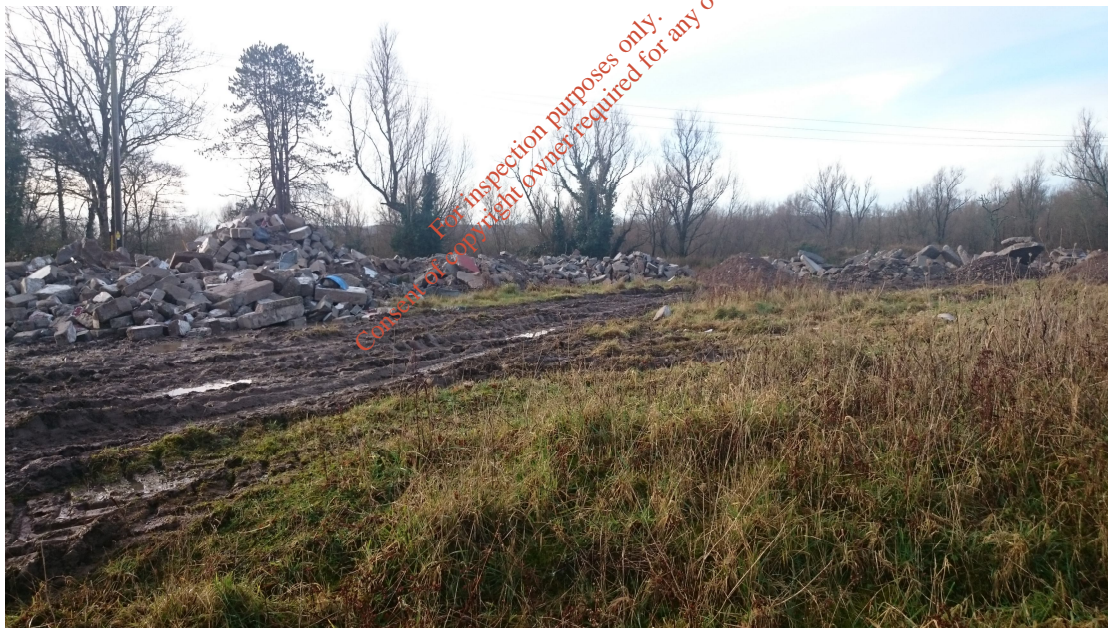
Photo 2 – Concrete Floor from previous slaughtering building  
(concrete is to be crushed and reused on-site for truck laydown areas).

A concrete floor from the previous chicken slaughtering building has been removed and is stored on-site. This concrete will be crushed at a future date and reused on-site for truck parking areas – see Photo in Appendix 4.

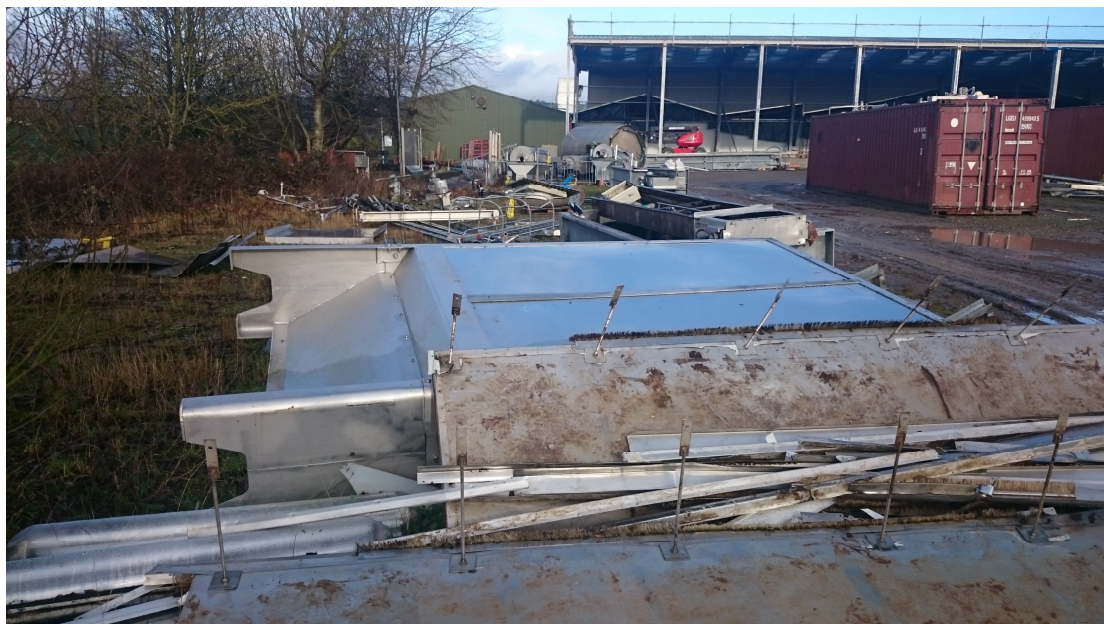
Photo 3 – Equipment remaining on-site to be reused in new Pig Slaughtering Facility

Appendix 2 includes a drawing (Drg. No. 1507-I-SF-005) showing the locations of the main equipment items remaining on-site. During the site visit on the 27<sup>th</sup> Jan 2017, other equipment currently stored outside was identified to the Agency as being suitable for reuse in the proposed new pig slaughtering facility and that this equipment will be moved back indoors following the completion of the new slaughtering hall.

This equipment is not of environmental concern. Appendix 4 contains photos showing the equipment currently stored outdoors at the Cappelquin site.

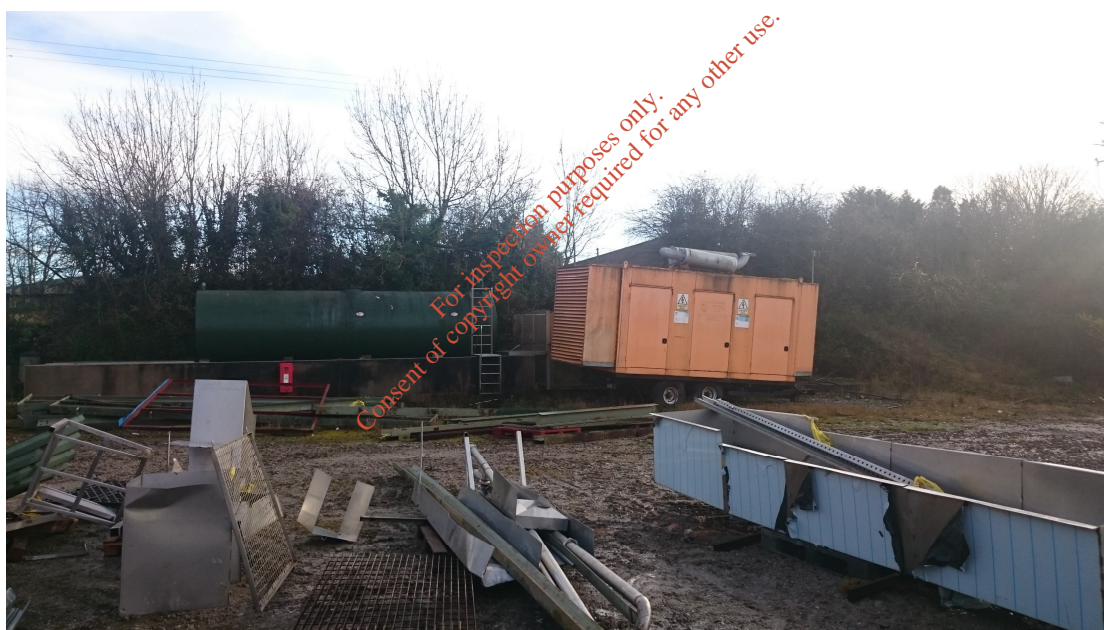
Photo 4 – Equipment Remaining on-site  
(Generator to be removed offsite once power is reconnected to site).  
(Oil tank bund (in the background) to be sealed prior to operations commencing on-site)

The first item is to line the oil tank bund with a sealant to ensure that it passes an integrity test.
