Project	Archaeological Appraisal
Archaeologist	Deirdre Murphy
Client	Goode Concrete Ltd, Naas Industrial Estate, Naas, County Kildare

Site Name	Goode Concrete Ltd, Carbury, County Kildare.
Townland	Kilglass
Planning Ref.	95/1236 and PL09.098683

NON-TECHNICAL SUMMARY

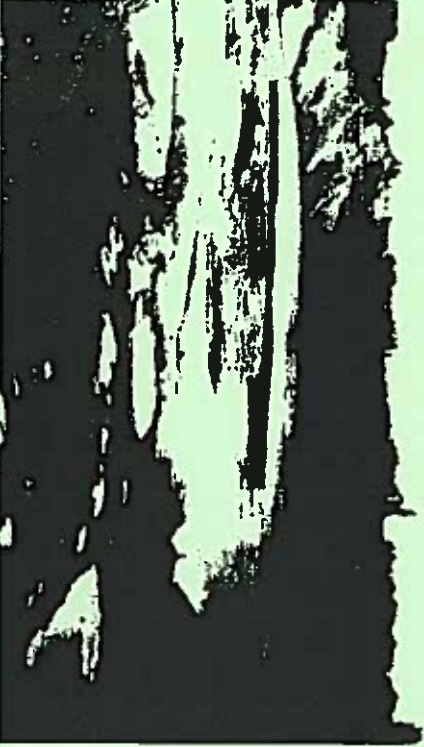
Page 1	1. Introduction	Page 1
Page 1	2. Methodology	Page 1
Page 2	3. Desk Based Survey	Page 2
Page 2	3.1 Archaeological and Historical Background	Page 2
Page 4	3.2 Record of Monuments and Places	Page 4
Page 6	3.3 Topographical Files National Museum	Page 6
Page 6	3.4 Cartographic Review	Page 6
Page 7	3.5 Aerial Photography	Page 7
Page 7	3.6 Field Survey	Page 7
Page 8	4. Conclusions	Page 8
Page 10	5. Bibliography	Page 10
	List of Figures	
	Figure 1: Site Location.	
	Figure 2: Map showing RMP sites	
	Figure 3: Outline plan showing quarry layout and green areas of site.	
	List of Plates	
	Plate 1: Roadway in south eastern area of site.	
	Plate 2: View of Area 1 from north.	
	Plate 3: View of Area 1 from south.	
	Plate 4: Block Plant.	
	Plate 5: Area to north of block plant, central part of site.	
	Plate 6: North East area of site.	
	Plate 7: Quarry face in north east area of site.	
	Plate 8: Detail of quarry face north east area of site.
