**ARCHAEOLOGICAL ASSESSMENT**

**Ballinderry, Carbury  
County Kildare.**

**Client: Goode Concrete Ltd, Killeen Road,  
Ballyfermot, County Dublin**

**Licence No. 02E1803  
Planning Ref. 02/1475  
NGR 26955, 23945**

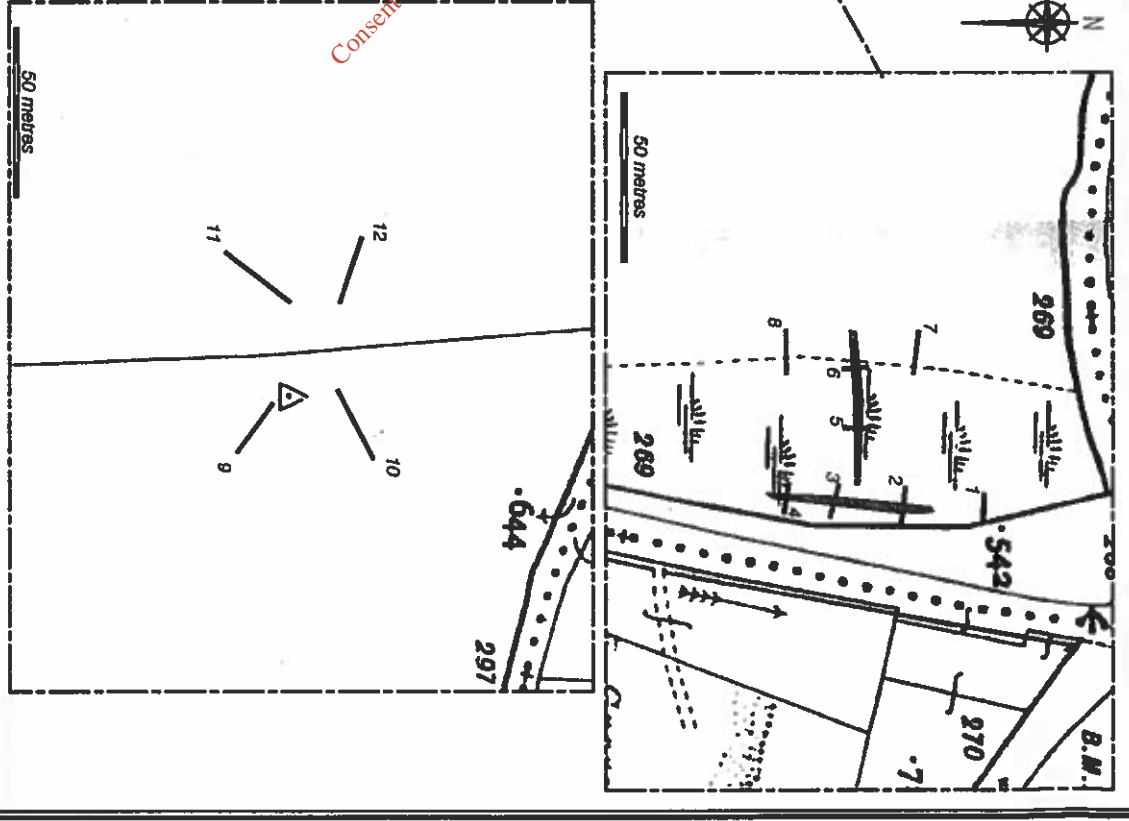
Figure 3: Detail of site showing location of test trenches

A total of twelve test trenches were excavated within the proposed development site (Figures 2-3). Four test trenches were excavated in the area of the low linear platform (Plate 1); two were excavated across the linear depression (Plate 2); two were excavated through the cultivation ridges on the eastern slope of the hill and four were excavated within a low hill between the boundaries of Field One and Field Two.

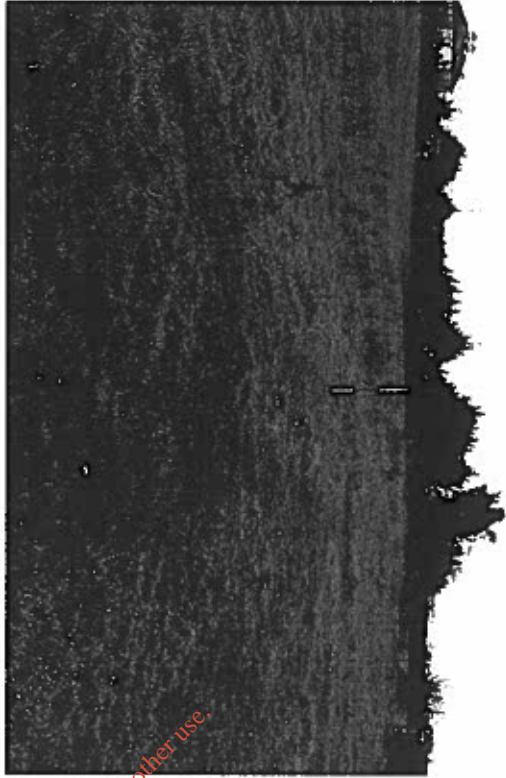
Plate 1: General view of low linear platform before testing to the north. (02\_05\_Ballinderry\_07)

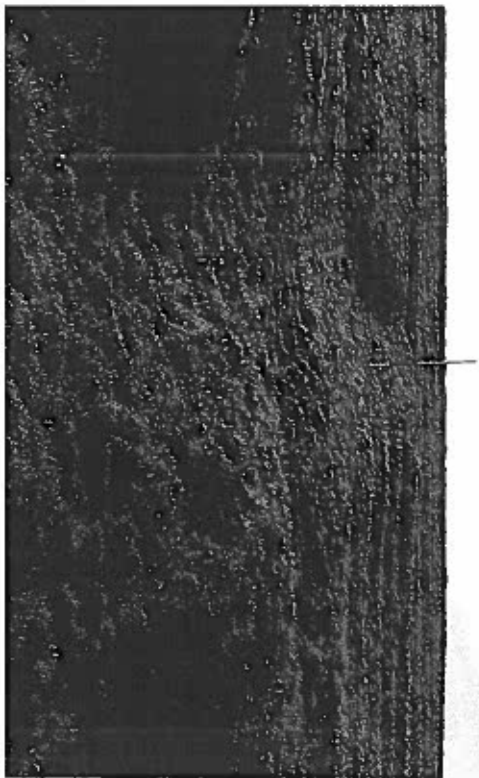
Plate 2: General view of linear depression and cultivation ridges on the eastern slope before testing. (02\_05\_Ballinderry\_26)

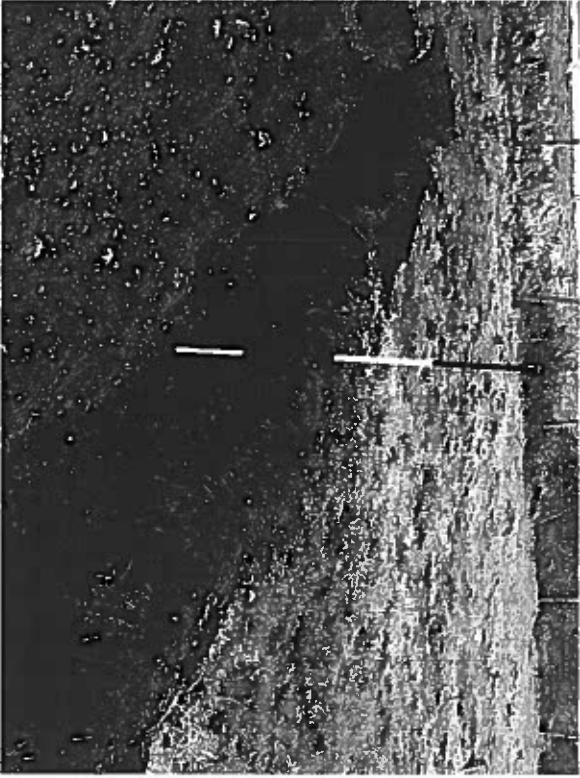
**Trench Two**  
Trench Two was excavated to the south of Trench One (Plate 3). It was orientated east-west and measured 10.0m in length, 1.0m in width and a minimum of 0.51m and a maximum of 1.19m in depth. The sod and topsoil (F200) measured 0.38m in thickness and lay above the dark-brown peaty clay (F201) which extended to a depth of 0.81m. The low linear platform (F203) measured 2.4m in width and 0.39m in thickness and was constructed from a compact dark-grey clay

Plate 3: General view of trench two following excavation to the southeast showing low linear platform F203 in section. (02\_05\_Ballinderry\_14)

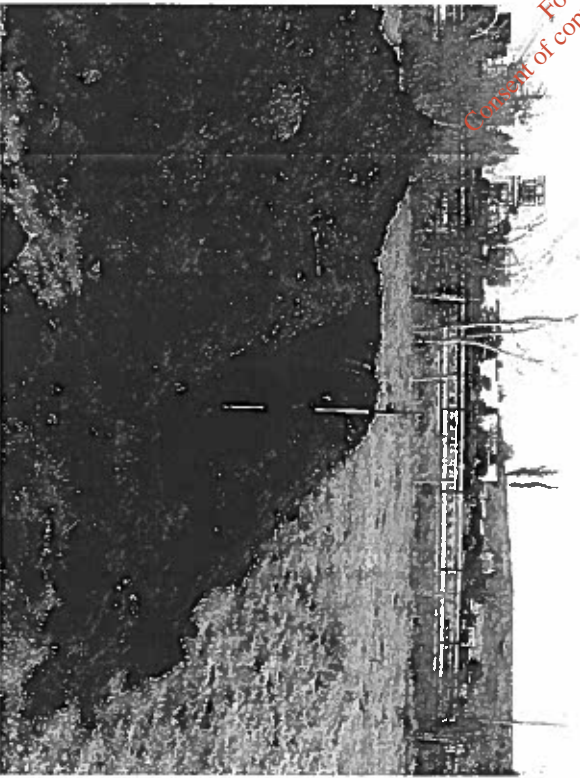
Trench Three was excavated to the south of Trench Two (Plate 4). It was orientated east-west and measured 9.3m in length, 1.0m in width and extended to a minimum of 0.82m and a maximum of 1.16m in depth. The sod and topsoil (F300) measured 0.38m in thickness and lay above the dark-brown peaty clay (F301) which extended to a depth of 0.74m and lay directly above a thin layer of black peat (F302). This layer measured a maximum of 0.19m in thickness and lay directly above the natural light-grey coarse sand and gravel (F303). The low linear platform (F304) was exposed below the sod and topsoil. It measured 2.84m in width and 0.51m in thickness and consisted of a compact light-mid-brown clay containing inclusions of coarse sand and frequent round pebble-sized stone. No archaeological features or deposits were exposed and no finds were

Plate 4: General view of trench three to the east. (02\_05\_Ballinderry\_18)

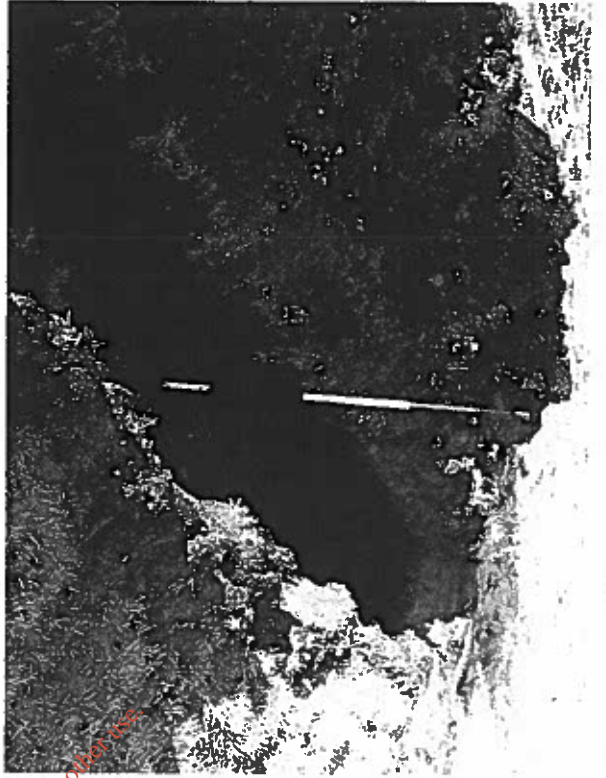
Trench Five was excavated at the eastern end of the linear depression (Plate 5). It was orientated north-south and measured 6.54m in length, 1.0m in width and extended to a depth of 1.2m. The sod and topsoil (F500) measured 0.22m in thickness and lay directly above the mid-grey sandy clay (F501) of a cultivation furrow exposed to the west and the compact dark-grey peaty clay (F502) fill of the linear depression/ditch (F505). This ditch was U-shaped in profile and measured 1.42m in width and 0.41m in depth and had been cut into the black peat (F503) below. This layer contained moderate inclusions of naturally-deposited wood and tree trunks and lay directly above

Plate 5: Trench five to the northwest showing ditch F505. (02\_05\_Ballinderry\_28)

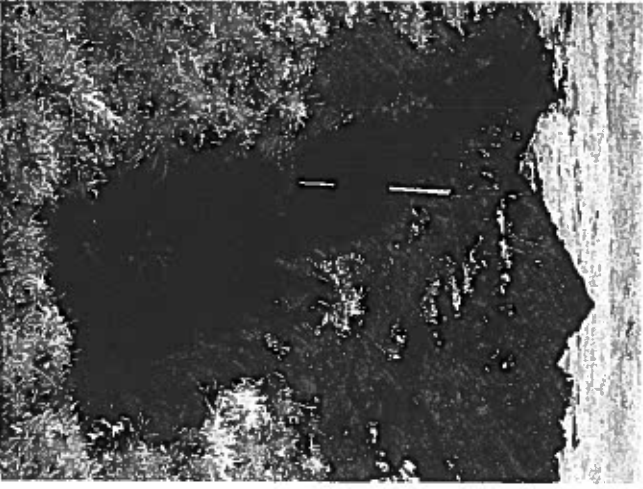
Trench Four was excavated to the south of Trench Three (Plate 7). It was orientated east-west and measured 10.0m in length, 1.0m in width and extended to a minimum of 1.0m and a maximum of 1.6m in depth. The sod and topsoil (F400) measured 0.38m in thickness and lay above the dark-brown-black peaty clay (F401). It extended to a depth of 1.26m and lay directly above the natural light-grey-cream marl (F402). No archaeological features or deposits were exposed and no finds

Plate 7: Trench four to the west showing natural clays F401 and F402. (02\_05\_Ballinderry\_22)

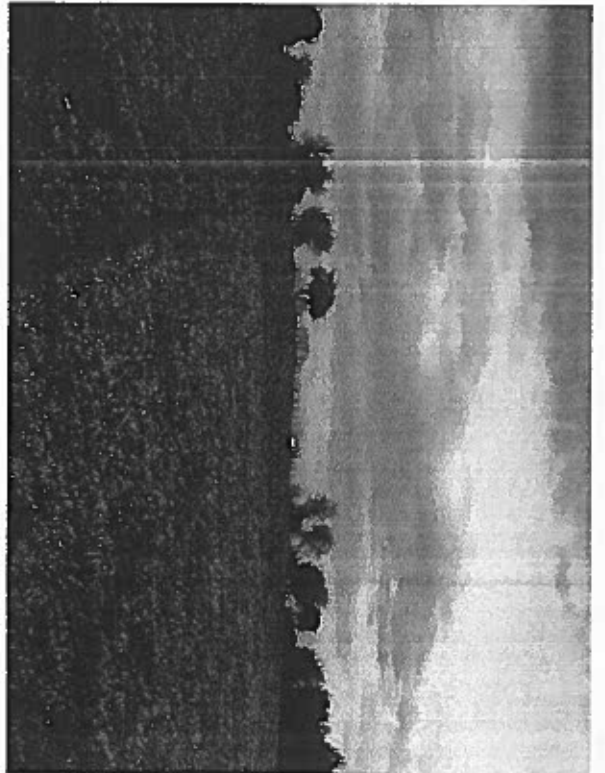
Plate 6: Low hill at boundary of fields one and two before testing to the west. (02\_05\_Ballinderry\_44)

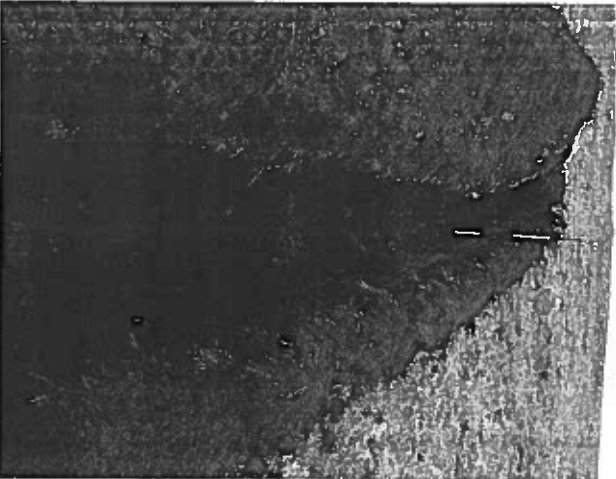
Trench Eight was excavated to the south of the linear depression/ditch (Plate 8). It was orientated east-west and measured 13.0m in length, 1.0m in width and extended to a minimum of 0.89m and a maximum of 1.15m in depth. The sod and topsoil (F800) measured 0.22m in thickness and lay above the dark-brown sandy ploughsoil (F801; Plate 9). It contained frequent inclusions of round pebble-sized stone and moderate inclusions of angular stone. It measured an average of 0.35m in thickness and lay directly above the natural light-brown sand (F802) which extended to a depth of 1.18m and lay above the natural mid-grey sand (F803). No archaeological deposits or features were exposed and no finds were recovered.

Plate 8: General view of trench eight following excavation to the west. (02\_05\_Ballinderry\_42)

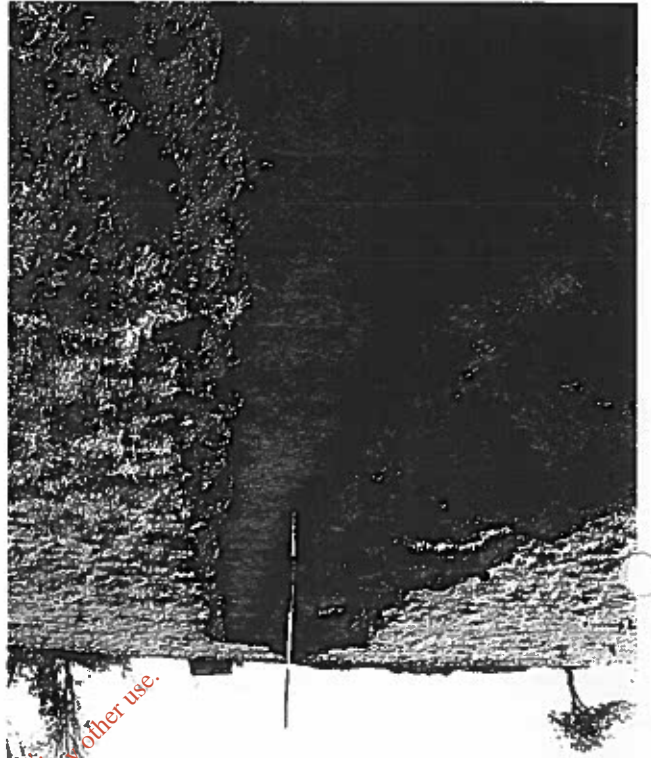
Trench Ten was excavated on a low hill in the centre of the proposed quarry at the boundaries of Field One and Field Two (Plate 11). It was orientated southwest-northeast and measured 20.0m in length, 1.0m in width and extended to a maximum depth of 0.34m. The sod and topsoil (F1000) measured 0.15m in thickness and lay directly above the compact natural light-brown sandy clay (F1001). No archaeological features or deposits were exposed and no finds were recovered.

Plate 11: Trench ten to the southwest showing sod and topsoil F1000 and natural sandy clay F1001. (02\_05\_Ballinderry\_50)

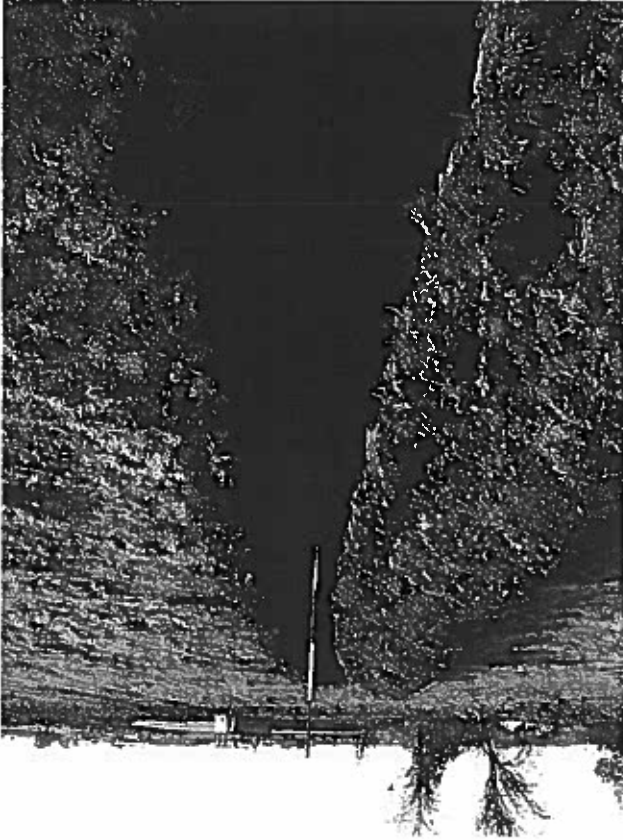
Plate 9: Section of trench eight showing ploughsoil F801 and natural sandy clay F802. (02\_05\_Ballinderry\_41)
