# 3. Land Surface Zoning for Groundwater Protection

**Assessment of Impact  
on Flora and Fauna  
by Proposed  
Development  
at Carranstown, Co. Meath**

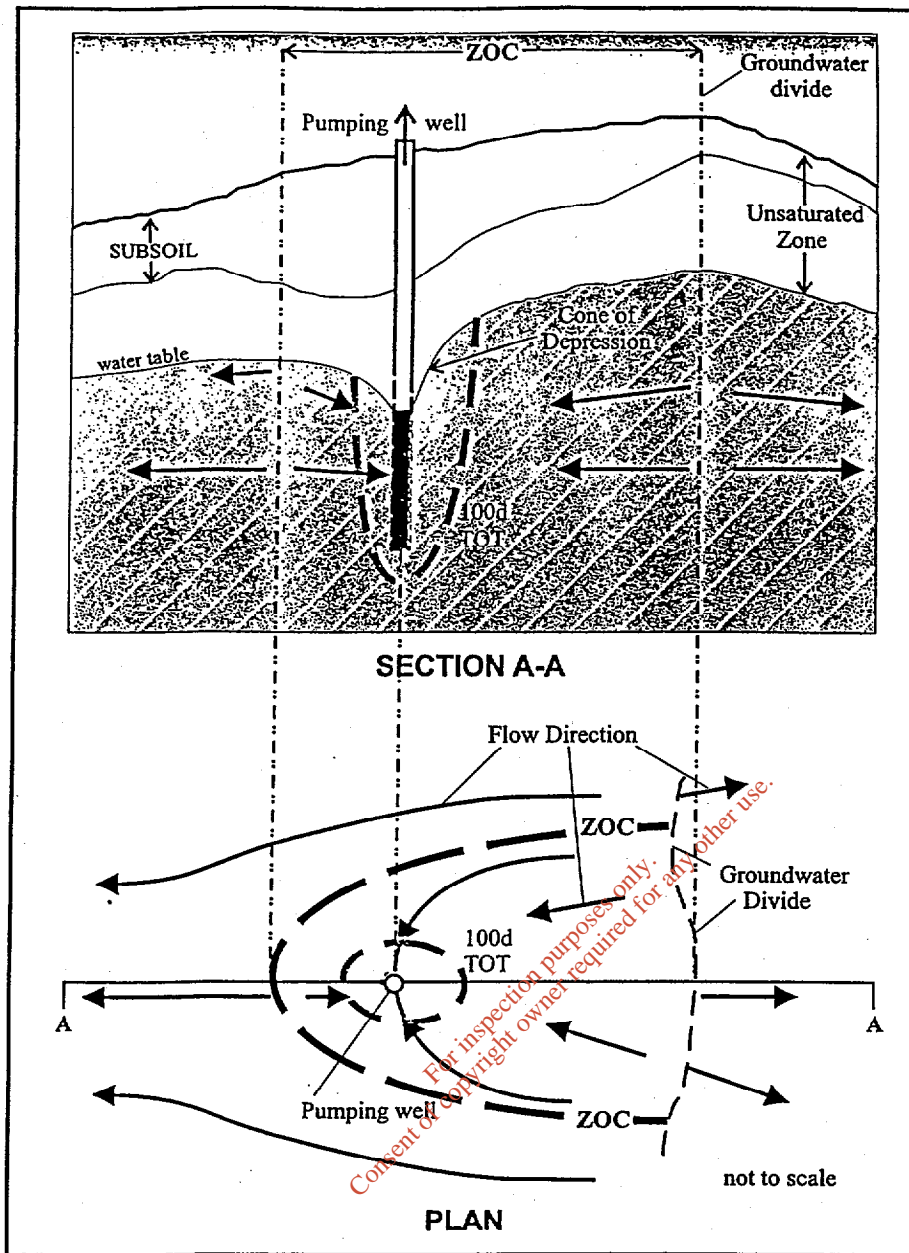
Figure 5. Conceptual Model of the Zone of Contribution (ZOC) at a Pumping Well (adapted from US EPA, 1987)

A conceptual model of the ZOC and the 100-day TOT boundary is given in Figure 5.

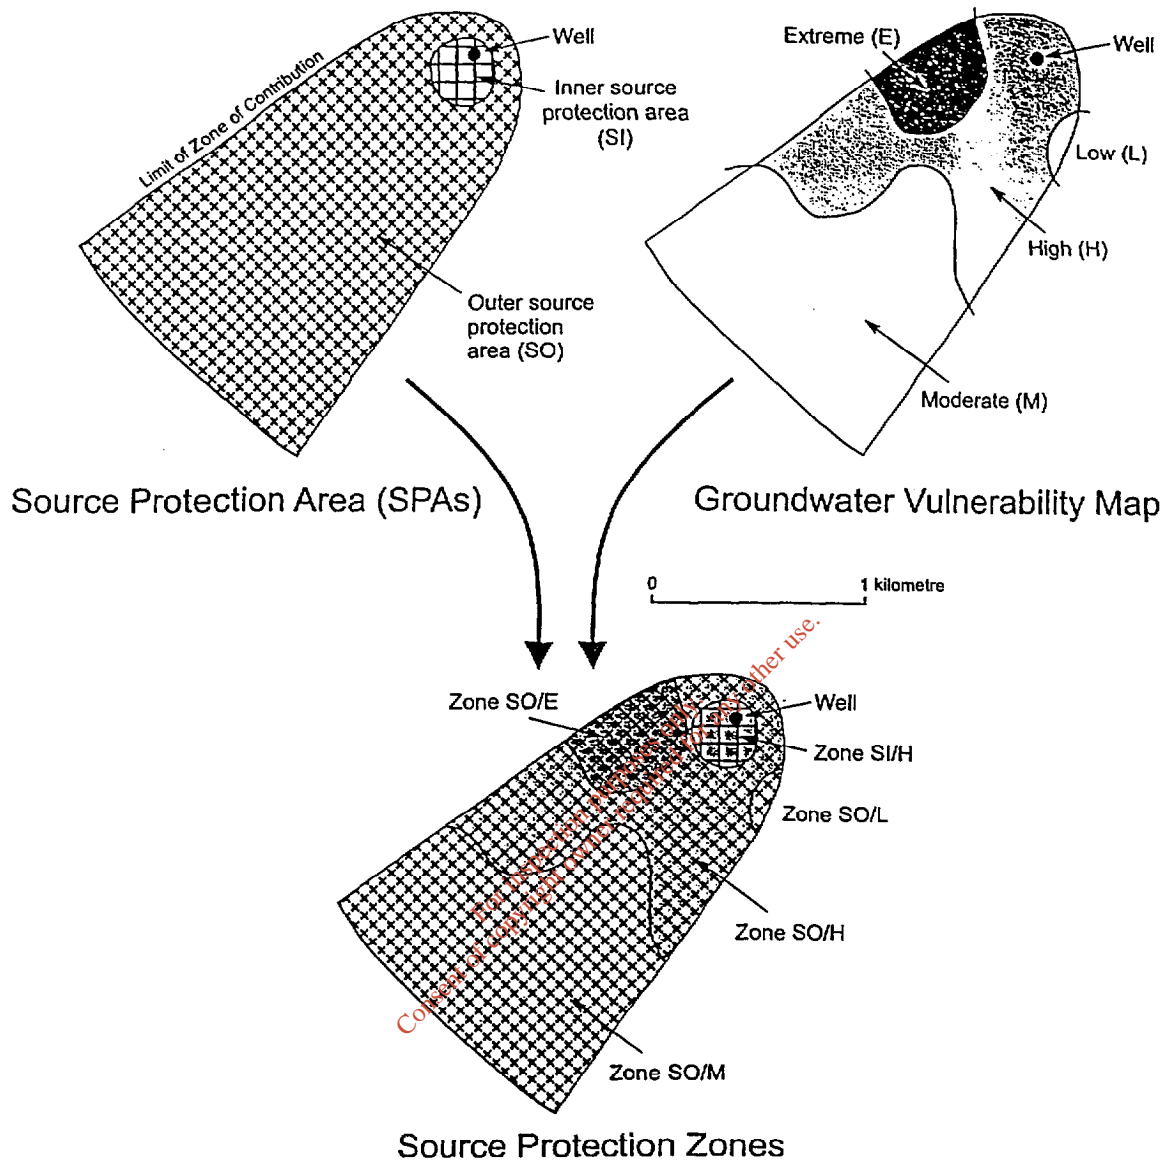
Figure 6. Delineation of source protection zones around a public supply well from the integration of the source protection area map and the vulnerability map.

All of the hydrogeological settings represented by the zones may not be present around each groundwater source. The integration of the SPAs and the vulnerability ratings is illustrated in Figure 6.

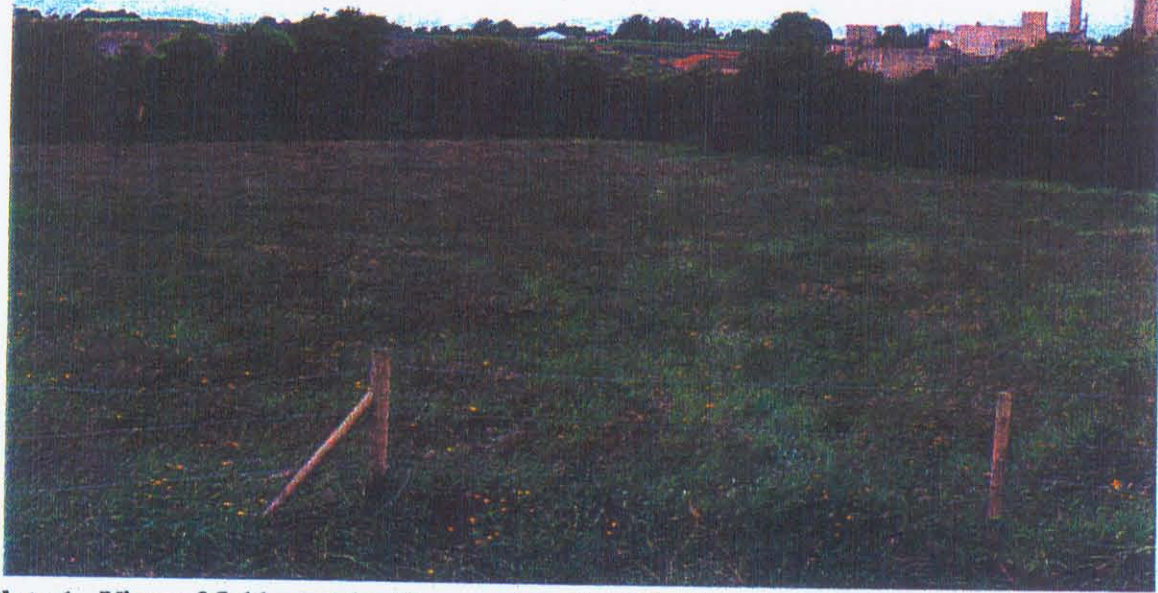
**Plate 1.** View of field no. 1 looking northwards. Meadow grassland is the dominant habitat at the site. The hedgerow on the right hand side marks the townland boundary. The cement works is visible in the photograph.

Meadow grassland is the principal habitat type at the site (see plates 1 and 4), occurring in all of the fields apart from part of field 1 and most of field 2 where grazed pasture occurs (see map). The sward is approximately 50 cm to 70 cm high. It is dominated by common agricultural grass species, including rye grass (*Lolium perenne*), creeping bent (*Agrostis stolonifera*), cock's foot (*Dactylis glomerata*) and Yorkshire fog (*Holcus lanatus*). Common perennial herb species include meadow buttercup (*Ranunculus acris*), creeping buttercup (*Ranunculus repens*), red clover (*Trifolium repens*), common mouse-ear (*Cerastium fontanum*), daisy (*Bellis perennis*), ribwort plantain (*Plantago lanceolata*) and speedwell (*Veronica serpyllifolia*). Thistles (*Cirsium vulgare* and *C. arvense*) and nettles (*Urtica dioica*) are frequent in parts, especially towards the field margins.

This hedgerow marks the townland boundary along the northern and north-eastern part of site (see plate 1). The hedgerow is mostly intact though has not been managed in the last few years. It is on average about 5-6 m high and there are no tall trees. It is accompanied by a wide ditch (c.2 m width in places) and in parts the ditch has been planted on both sides. At the time of survey the ditch was damp in places. Some typical shade species such as lords and ladies (*Arum maculatum*) and hart's-tongue fern (*Phyllitis scolopendrium*) were noted within the ditch. Of some ecological value.

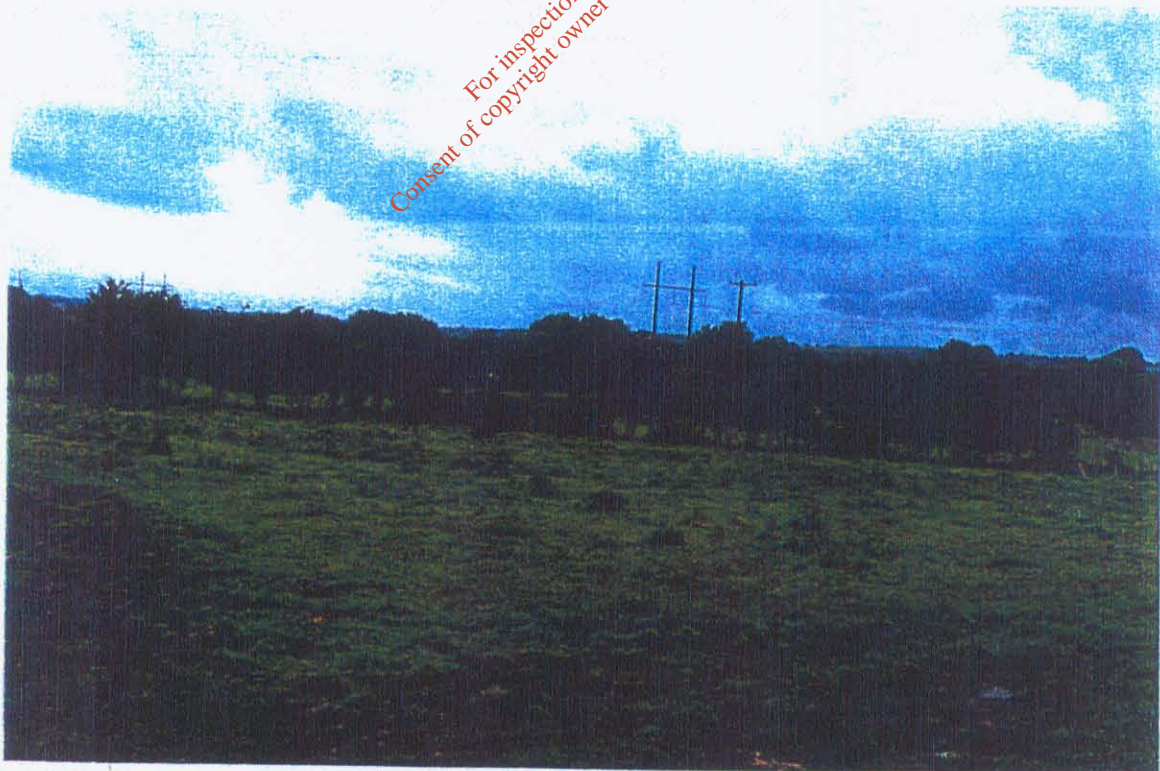
**Plate 2.** View from field no. 2 looking westwards. Pasture quality is poor. Many of the hedgerows on site, including the one in the photograph (H7), are not stock-proof and generally of poor quality as regards species and structural diversity.

This hedgerow is of very poor quality, comprising a line of hawthorns with little or no understorey (see plate 2). Cattle roam freely through it. Some of the hawthorns are quite old and have fallen or broken branches. Of negligible ecological value.

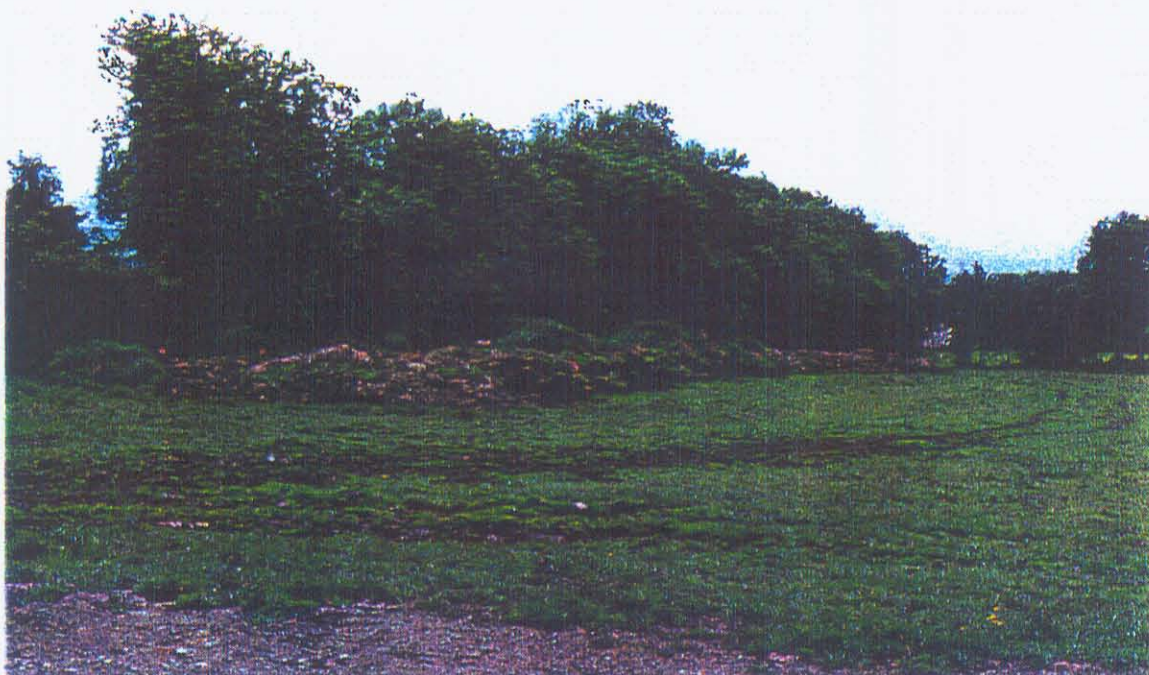
**Plate 3.** An ash treeline forms the boundary with the road in field no. 2. This is of some ecological value.

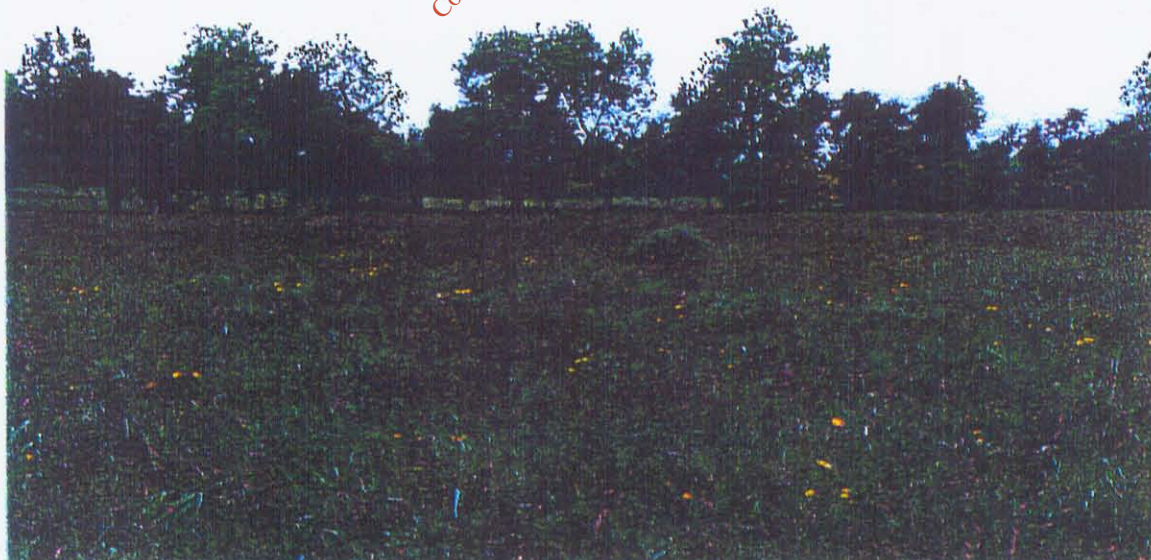
**Plate 4.** View of western hedgerow (H9) in field no. 4. This includes a line of tall ash trees. As with other hedgerows on site, it is not stock-proof.
