2 THE EXISTING ENVIRONMENT

This section focuses on the socio-economic aspects of a proposed Waste Recycling Park at a site in the townland of Newtown, Kilshane Cross, Dublin 15. Issues that will be addressed in this portion of the EIS include the existing environment, population and household statistics, settlement patterns, recreation and tourism, employment, health and safety and relevant planning issues. The principal concern in this respect is that human beings experience no significant negative impacts as a consequence of the construction and operation of this development.

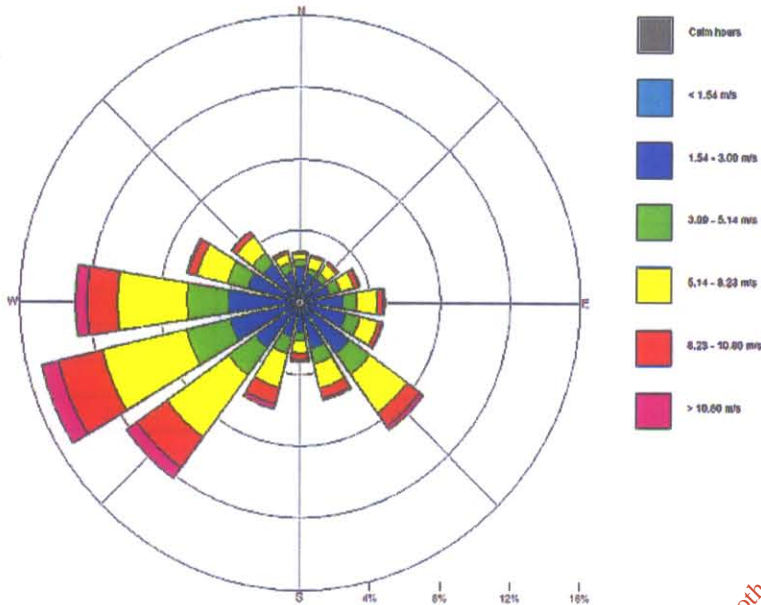
Figure 2.5.1 Windrose for Dublin airport meteorological station of six years meteorological data (1998 to 2003 inclusive)

Figure 2.5.1 shows wind rose for Dublin Airport, showing that the prevailing winds are from the southwest, with lesser wind flows from the south and west. Tables 2.5.4, 2.5.5, 2.5.6, 2.5.7 and 2.5.8 illustrates specific meteorological statistics for wind speed and direction at Dublin Airport over the six years and during different seasons.

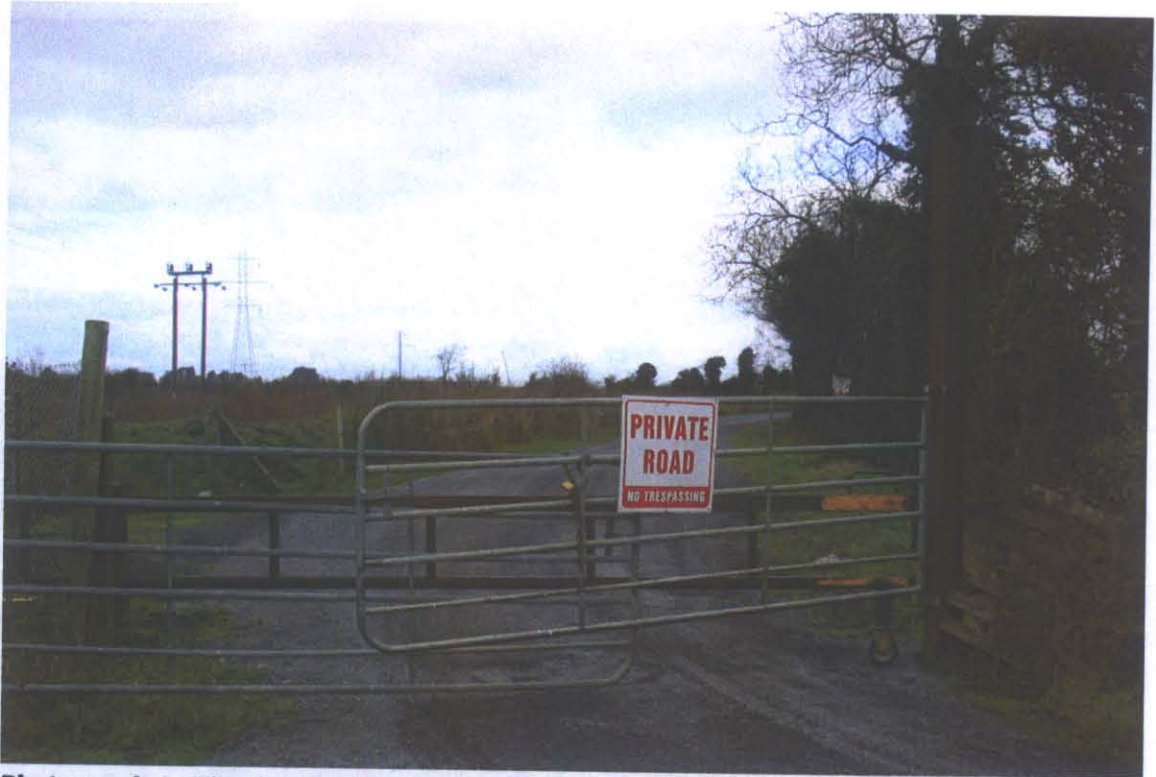
Photograph 1. The view from Johnstown track looking north-west towards the site. The remainder of this access track is private and leads to a small commercial building. Views of the taller buildings and structures of the Waste Recycling Park will be visible from here.

The cluster of houses by the south-eastern boundary are bordered by a concrete wall of approximately 1.8m to the north and west. Some of these properties have direct views into the site from ground and first floor windows (refer to Photograph 15). Further to the southeast along Johnstown lane the views to the site are screened by intervening dense hedgerows and intermittent trees (refer to Photographs 1

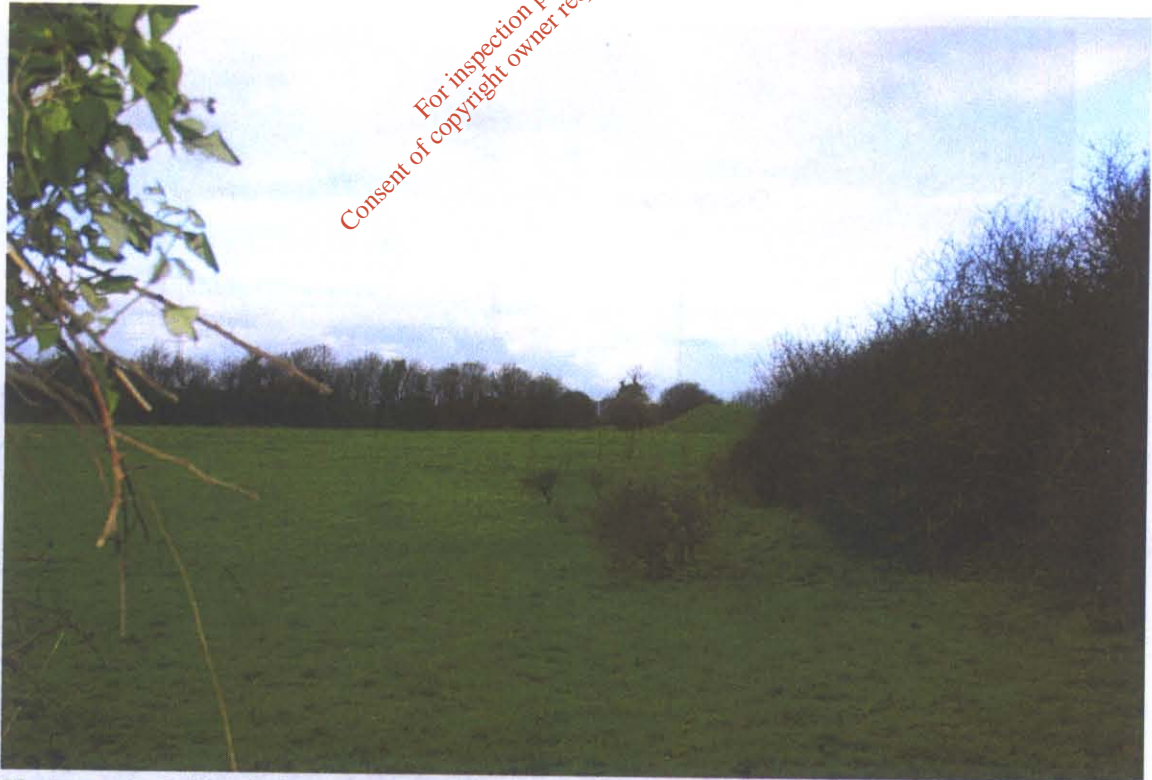
Photograph 2. View looking north through one of the few gaps in the dense hedgerow at eastern end of Johnstown track. Further dense intervening vegetation will screen the Waste Recycling Park, however the taller buildings and structures may be visible.

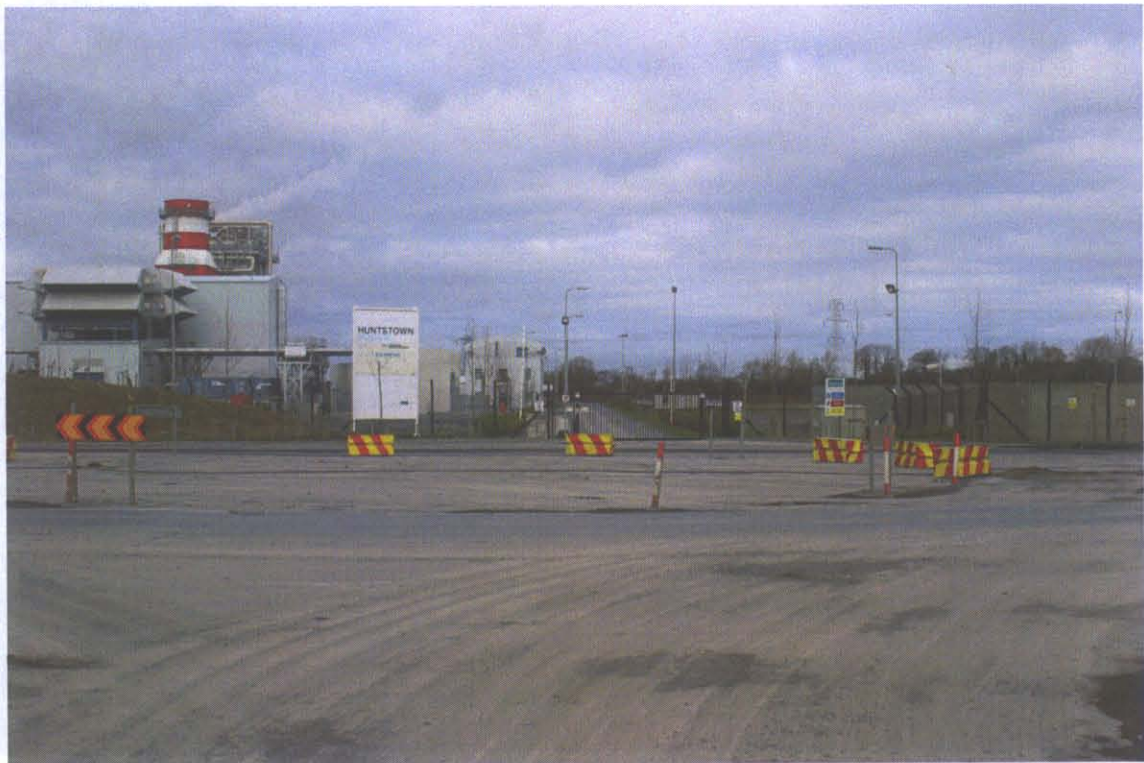
Photograph 3. The view from the quarry access road looking north is screened by the quarry and power plant.

Views of the site from the southwest are limited by the presence of the large industrial power plant (refer to Photograph 3) and quarry workings at Huntstown and intervening dense hedgerows and trees. Views to the site from the west are limited by quarry structures and by the large temporary ridges formed from the quarry spoil which in places are estimated up to 16m in height. (refer to Photograph 4). The view from the north will be obscured by the new N2, Kilshane road overbridge and intervening vegetation (refer to Photograph 6). The view to the site from the northwest will be limited by dense intervening vegetation (refer to Photograph 5). The principal views of the site are from the northeast (refer to Photograph 7) and east (refer to Photograph 8), however they are limited by intervening vegetation, topography and route of the new N2 road and associated earthworks. There will also be main views from the new N2 in opening year, especially from elevated sections.

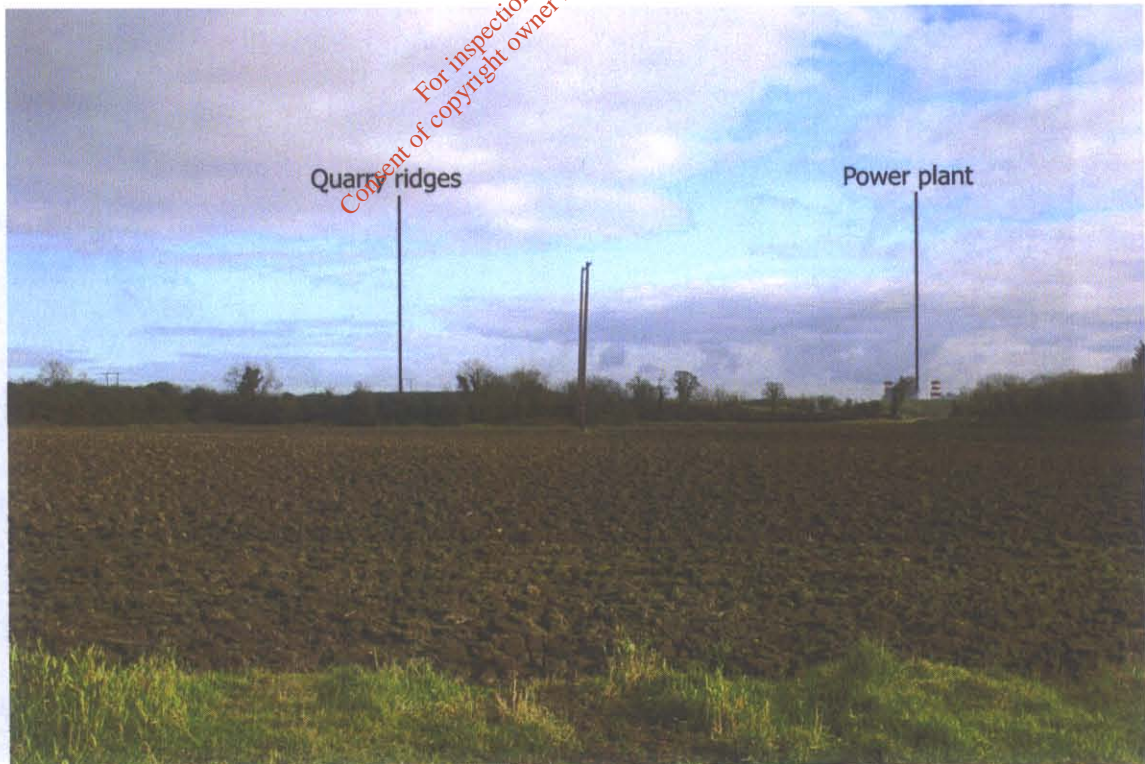
Photograph 4. View looking east from one of the few gaps in the hedgerow at eastern side of minor road that runs through Kilshane. The intermittent vegetation and temporary quarry embankments will limit views to the Recycling Park.

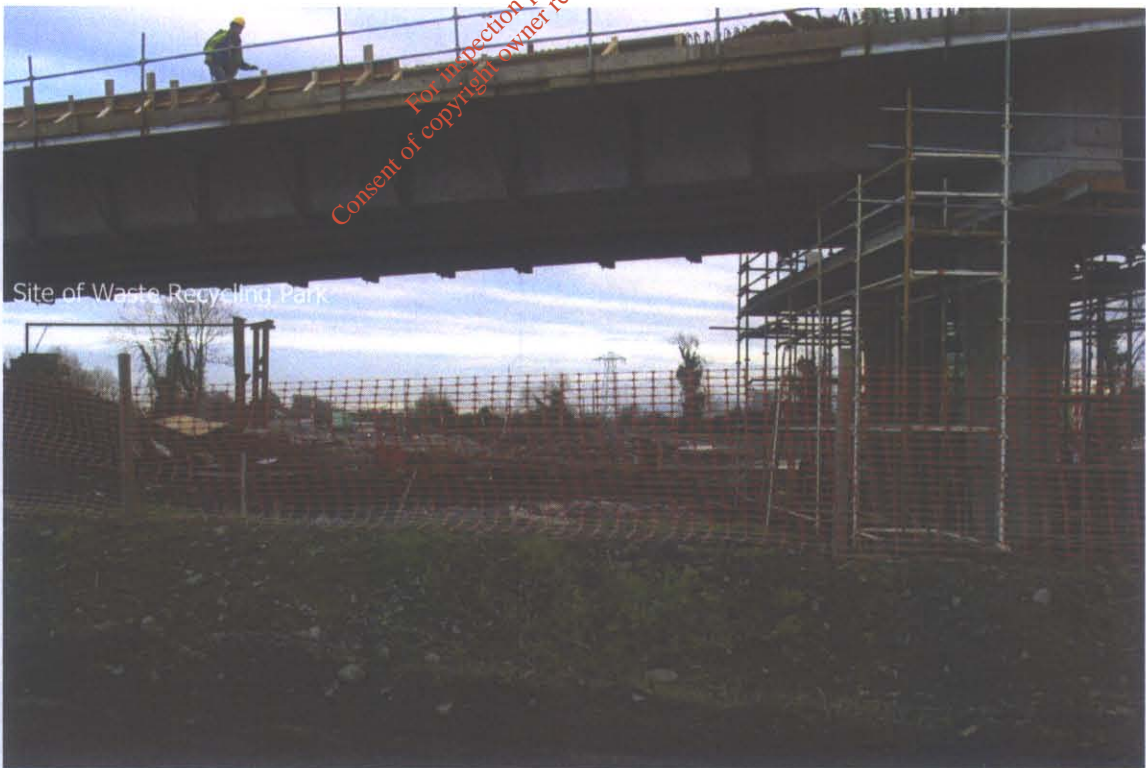
Photograph 6. View looking south from centerline of new N2 at site Kilshane road overbridge (under construction). The site is located in the middle left of this view. Intervening vegetation and approach earthworks of the new overbridge will screen the majority of the Waste Recycling Park from here.

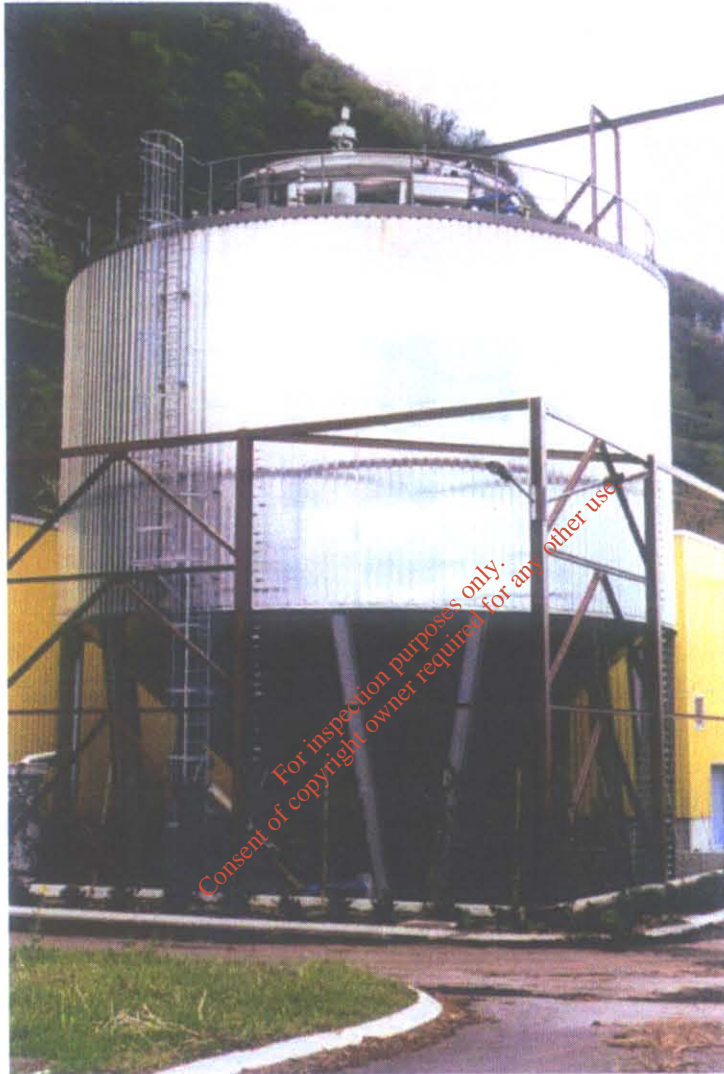
DRANCO PLANT VILLENEUVE (SWITZERLAND)

Location : Villeneuve, Switzerland
Capacity : 10.000 tons of biowaste per year
Digester volume : 940 m³
Start-up : February 1999
Realization time : January 1998 - February 1999
Client : SA Compost Chablais-Riviera

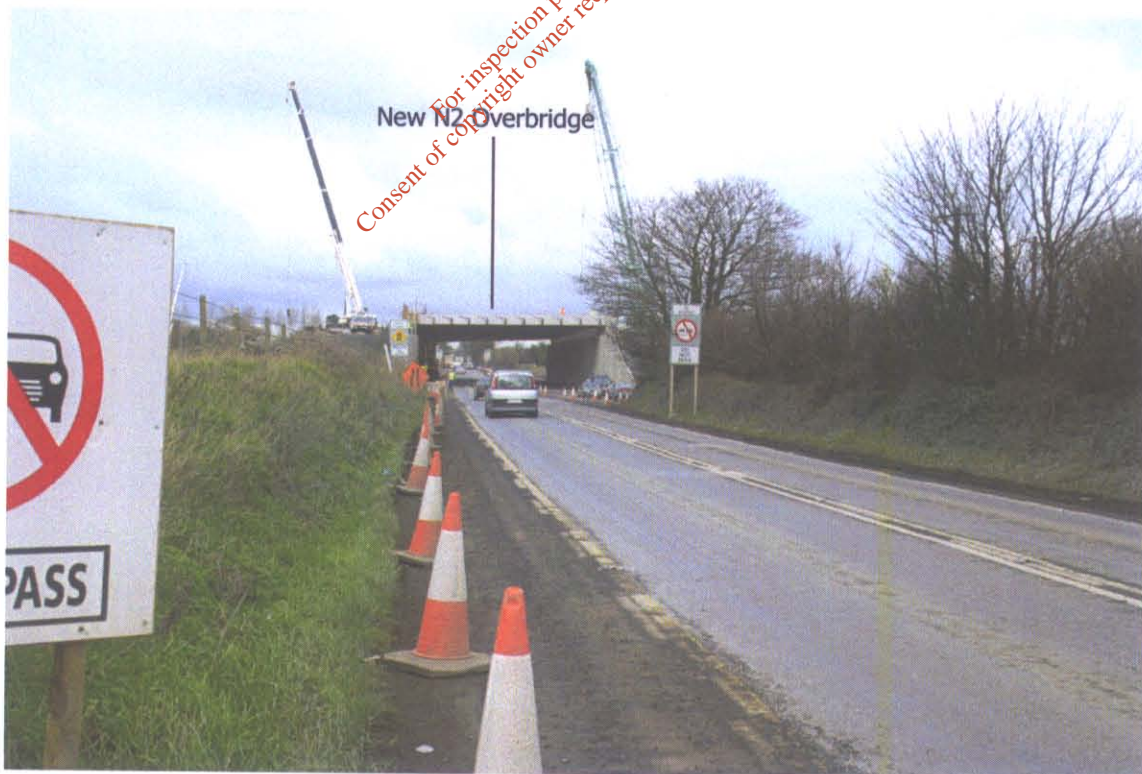
Photograph 14. View from N2 at proposed site entrance, looking to the north to the new N2 overbridge (under construction). The existing earth embankments will provide some screening of the site to road users.
