Preliminary Risk Assessment Report

**REPORT ON
PRELIMINARY RISK ASSESSMENT
SITE AT
WHITESTOWN LOWER, CO. WICKLOW.**

**Prepared By:
Environment & Resource Management Ltd.
No. 3 Tara Court,
Naas, Co. Kildare.**

March 2004

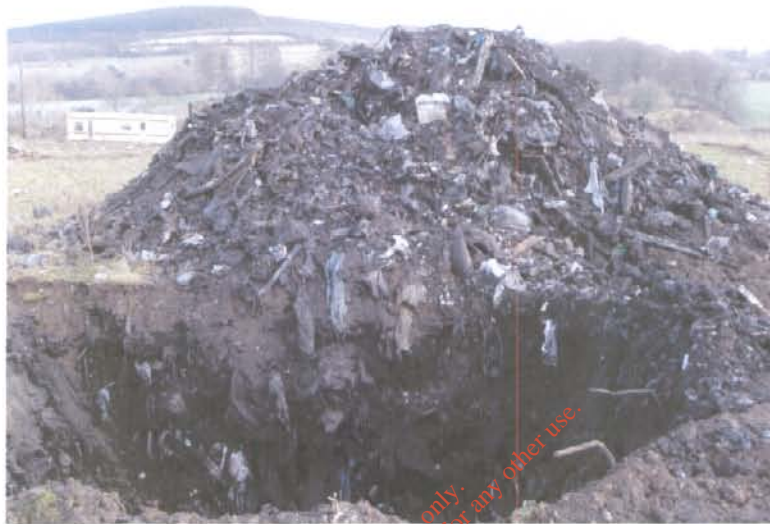
Fines within the waste body were moderately stained from interaction with the wastes. No leachate was noted at any of the trial pit locations within this zone. A mild to moderate decomposition odour was observed in many of the trial pits within this zone. Trial pits located towards the west of this zone determined the base of this waste body. Photoview 1 depicts wastes in Trial Pit 6, which is representative of this zone.

Photoview 1. Trial Pit 6 containing previously deposited wastes

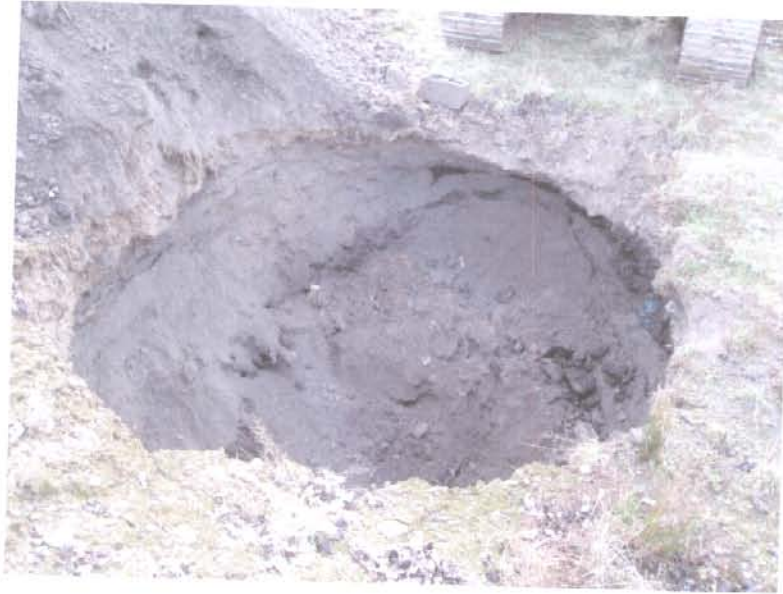
The zone had a very high percentage of soils/fines (commonly in excess of 90% or higher). The soils/fines were predominantly clean, with sparse waste intermixed. Where waste is present in this zone, the waste layer was identified in excess of 3.0m in thickness. Soils/fines within these waste layers are slightly stained by interaction with the waste body. Photoview 2 depicts wastes in Trial Pit 62, which is representative of Zone B. No leachate was identified in Zone B, and only mild to no odours were observed.

Photoview 2. Trial Pit 62 containing fines/soils

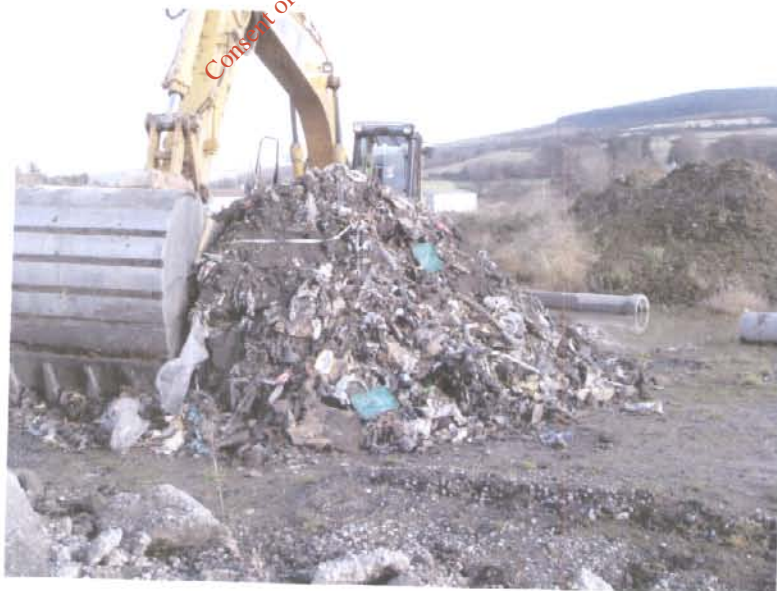
Waste in this zone appears to date back to 1998 (based on a newspaper and correspondence identified from 1998) and is the most decomposed. Some of the wastes in this zone appear to have been passed through a shredding process. The fines are heavily stained from interaction with the decomposing wastes within this zone. Leachate was identified within this zone, and moderate to strong decomposition odours were identified. Photoview 3 depicts wastes in Trial Pit 27, which is representative of Zone C.

Photoview 3: Trial Pit No. 27 containing previously deposited wastes

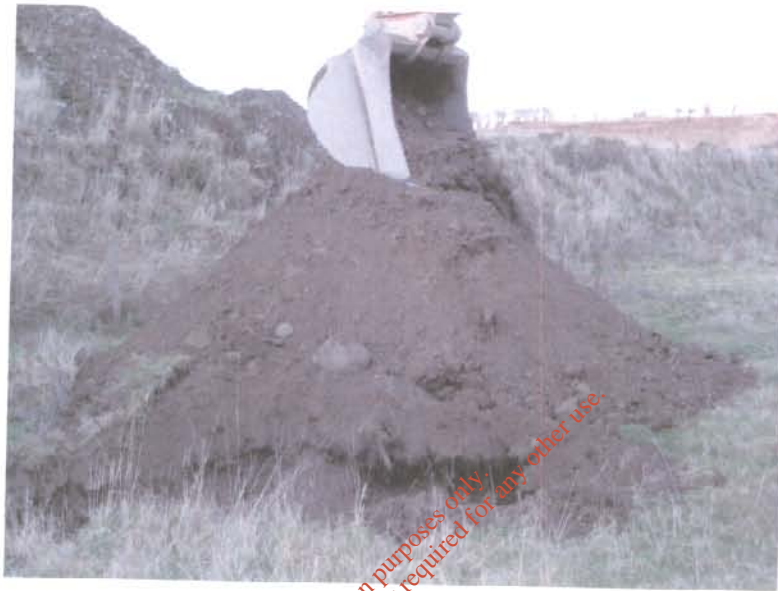
This zone does not contain any waste (i.e. materials identified in other zones on site). The lands appear to be natural ground, with some levelling with native overburden from the site likely to have been undertaken in the past. This zone was not considered during the estimation of waste imported waste quantities on the site. Photoview 4. depicts soils in Trial Pit 32, which is representative of the raised grassland pasture located south of existing site buildings.

Photoview 4. Trial Pit 32 containing clean soils (no imported wastes apparent)
