Fingal Landfill Project

Environmental Impact Statement

**Environmental Impact Statement
Architectural Heritage**

February 21st 2006

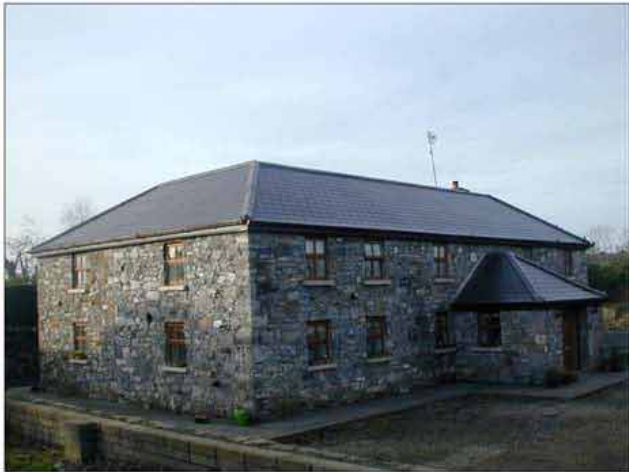
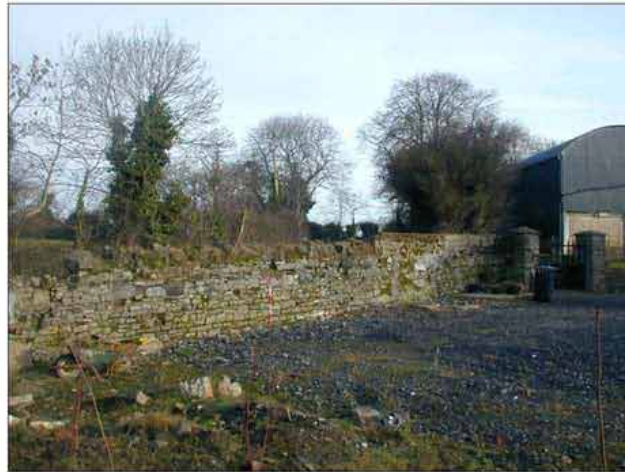
Townland	Nevitt	Present Use	Farmhouse and outbuildings
Inspection Date	February 2004	Original Use	Farmhouse and outbuildings
Status/Protection	None	Type	Farmhouse and outbuildings
Condition	Excellent	Significance/Interest	Social, technical
Photographic Details	Plates 1 & 2	Observation	The original farmhouse has been extended on two different occasions.

Description	Composition	A two-storey rubble stone farmhouse with a complex of associated farm buildings.
	Roof	Hipped at sides, covered with modern tiles and single stone stack on west side of the roof.
	Walls	Rubble limestone
	Windows	Square-headed openings with uPVC casement windows.
	Doors	A modern projecting porch of rubble stone with side windows and a uPVC door.
	Site	The front boundary wall of the site is composed of a mixture of rubble stone and clay. The scars of a structure are visible along the inner side of the wall. The entrance is flanked by square stone piers with a wrought-iron gate. The remains of another structure is evident along the southern boundary wall.
	Outbuildings	A number of modern outbuildings are located around the yard at the east side of the house.
History (See Figs. 2-4)	Two structures are marked on the site on Rocque's map of 1760, however none of these structures survives. Three later structures are shown on the 1 st edition OS map of 1837, of which only the remnants of one survive along the rear wall of the site. Part of the present farmhouse is indicated on the 1906 OS map along with three outbuildings which have been replaced by modern structures.

This property lies close to the proposed disposal area and is scheduled for removal. The property has undergone significant modifications involving the addition of a large extension to the original farmhouse and the construction of modern outbuildings. Remnants of early clay and stone outbuildings survive along the boundary walls of the property. The removal of these remnants, along with the modernised farmhouse, will result in a minor adverse impact.

Prior to removal it is recommended that a record of the property be compiled. This record should include an accurate and succinct written description of the property, the identification of the property on a map and a scaled photographic survey.

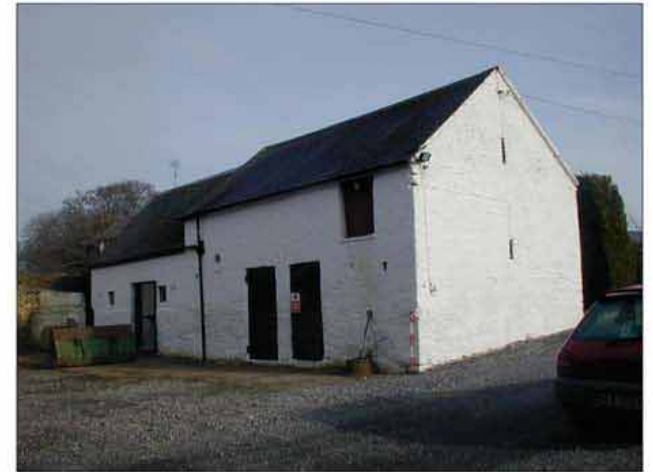
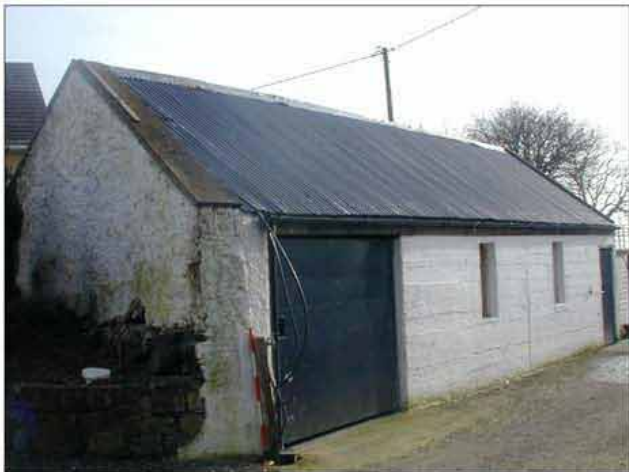
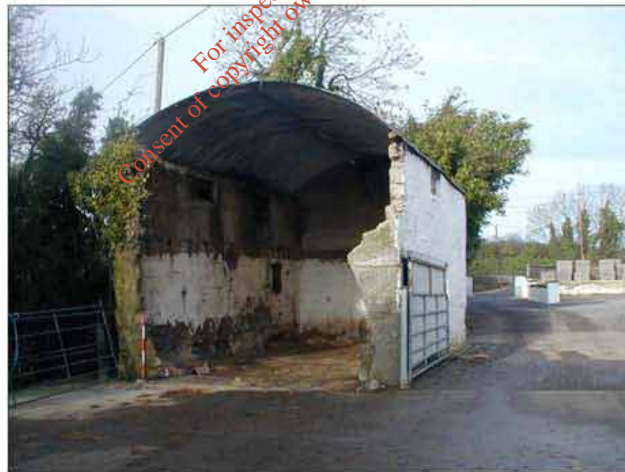
Townland	Nevitt	Present Use	Modern house and outbuildings
Inspection Date	February 2004	Original Use	Outbuildings
Status/Protection	None	Type	Residence & farm outbuildings
Condition	Fair to good	Significance/Interest	Social, technical
Photograph Details	Plates 3, 4 & 5	Observation	Site ground level has been reduced
Description	Composition	A complex of single and loft-storey clay and stone outbuildings with a modern house arranged around two yards. A number of modern sheds also form part of the site.	
	Roof	Covered with a mixture of corrugated concrete tiles & natural slate. Southern outbuilding has barrel-shaped corrugated roof. Site contains a number of early clay and stone structures. One outbuilding of modern construction has been built against an early gable wall.	
	Walls	Rubble stone and clay with a white-washed finish. Sections of some walls have been rebuilt with concrete blocks. The remnants of what appears to be a clay lean-to is attached to the east wall one of the outbuildings.

Windows	Small square or slit openings with unglazed panes.	
	Doors	Square-headed openings with replacement timber doors.	
	Site	The entrance to the property is marked by square pebble-dashed piers and wrought-iron gates.	
	Associated Features	A small stream running along the west side of the property is spanned by two culverts. Both are of

History (See Figs. 2-4)	<p>rubble stone construction and have cut-stone blocks forming the arches.</p> <p>One structure is marked on Rocque's 1760 map but no longer survives. Three structures aligned in a row on the northeast side of a yard are indicated on the 1837 OS map and also on the 1870 and 1906 OS editions. The middle of these structures has been removed. By the time the 1936-37 OS map was surveyed a number of structures had been constructed along the opposite southwest side the yard and a detached structure is also shown in a second yard to the south.</p>
--------------------------------	--

Property ID 2 lies close to the proposed disposal area and is scheduled for removal. The property is composed of farm buildings and a modern dwelling. The significance of the property lies in the technical use of clay in their construction. The removal of these structures will result in a significant adverse impact.

Prior to removal it is recommended that a record of the property be compiled. This record should include an accurate and succinct written description of the property, the identification of the property on a map, a scaled photographic survey particularly of architectural and constructional details and sketch floor plans and sections drawn on squared paper providing an indication of recognizable scale.

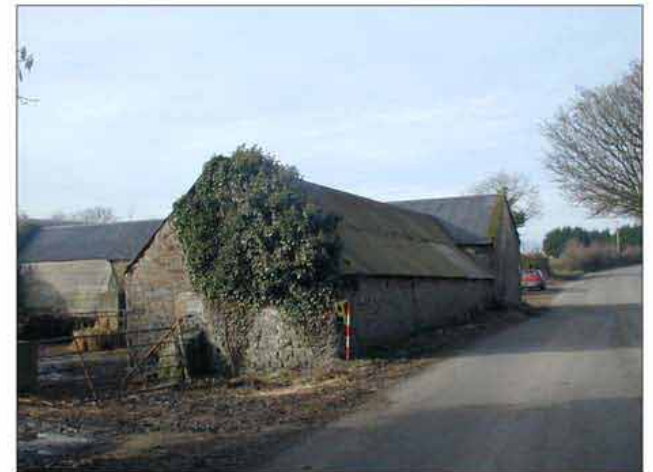
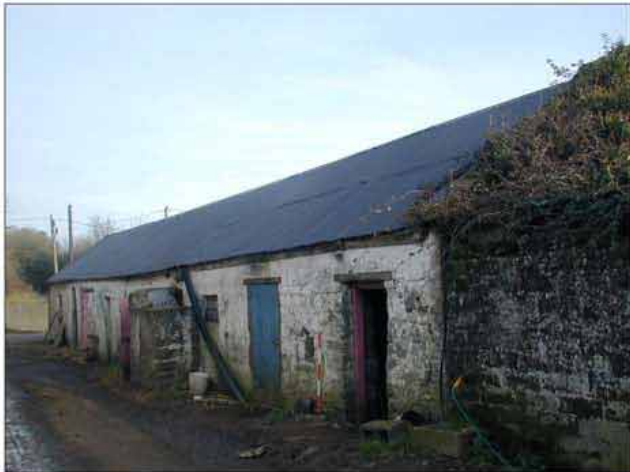
Townland	Nevitt	Present Use	Outbuildings
Inspection Date	February 2004	Original Use	Dwelling and outbuildings
Status/Protection	None	Type	Farm outbuildings
Condition	Fair to poor	Significance/Interest	Social, technical
Photograph Details	Plates 6 & 7	Observation	Outbuildings have been repaired over time
Description	Composition	A complex of single-storey clay and rubble stone farm buildings. One structure has a gable fronting on the roadside and a replacement corrugated iron roof. West elevation is partially white-washed and has a number of square-headed openings. A later segmental headed opening with a glazed fanlight has been inserted. Remnants of clay walls are visible on the rear elevation. A rubble stone outbuilding abuts the east side and has a blank elevation fronting onto the road-side. A detached stone outbuilding is set back from the road and has a replacement corrugated roof.	
	Roof	Pitched and covered with corrugated iron sheets

Walls	Mixture of clay, stone and concrete blocks, partially rendered and painted.	
	Windows	Square-headed opes, no windows	
	Doors	1 Segmental headed ope with remnants of over-light. Remainder of opes have timber planked doors.	
	Site	No formal boundary to the site, located directly off side of road	
History (See Figs. 2-4)	Three structures are marked on the site on Rocque's map of 1760 however, none of these structures survives. A number of structures are shown on the site on the 1837 OS map, two of which correspond to the existing outbuildings. An additional structure is located at the rear of the site on the 1870 OS map. The 1906 OS map indicates that the original building flanking the roadside was removed and replaced in the early 20 th century by the present structure. Additional outbuildings are shown on the 1936-37 OS map some of which no longer survive.

Property ID 3 lies within the proposed disposal area and is scheduled for removal. It is composed of a number of structures forming a farmyard. Alterations have been carried out to openings of a number of the structures and a modern addition has been constructed at rear of one of the farm buildings. Parts of the property are also in a poor condition and repairs have been carried out using concrete blocks. Despite these factors, the significance of the property lies in the survival of clay within parts of the wall structure. The removal of these structures

will result in a significant adverse impact. It should be noted that a farmyard of good quality, ID 13, situated in the northwest corner of the study area will be unaffected by the proposed landfill and is a better example of this type of property.

Prior to removal it is recommended that a record of the property be compiled. This record should include an accurate and succinct written description of the property, the identification of the property on a map, a scaled photographic survey particularly of architectural and constructional details and sketch floor plans and sections drawn on squared paper providing an indication of recognizable scale.

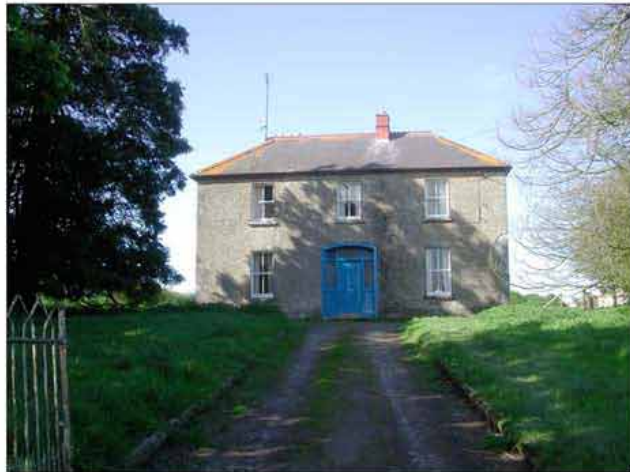
Plate 8 ID 4

Status/Protection	None	Type	Dwelling
Condition	Fair to poor	Significance/Interest	Architectural
Photograph Details	Plate 8	Observation	Retains original external features
Description	Composition	A two-storey three bay house of circa early twentieth century date.	
	Roof	A single hipped pitch with natural slate and decorative terracotta ridge tiles. Two red brick stacks are positioned on the roof.	
	Walls	Pebble dashed and unpainted.	
	Windows	Small square openings with two-over-two pane timber sashes.	
	Doors	A slight segmental-shaped opening with a timber panelled door flanked by side-lights and an over-light.	
	Site	The entrance to the property is marked by a stretch of curved rendered walling with square piers and a wrought-iron gate. A lawn is positioned to the front and rear of the house.	
History	The house is first shown on the 1906 OS map

Property ID 4 lies within the proposed disposal area and is scheduled for removal. It is a dwelling of early-twentieth century date with a recessed entrance and cast-iron gates. The building retains its original external features and is a well proportioned structure. The removal of these structures will result in a significant adverse impact.

Prior to removal it is recommended that a record of the property be compiled. This record should include an accurate and succinct written description of the property, the identification of the property on a map, a scaled photographic survey particularly of architectural and constructional details and sketch floor plans and sections drawn on squared paper providing an indication of recognizable scale.

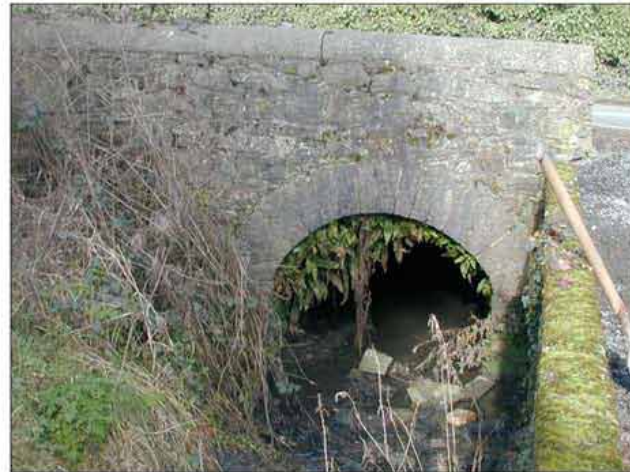
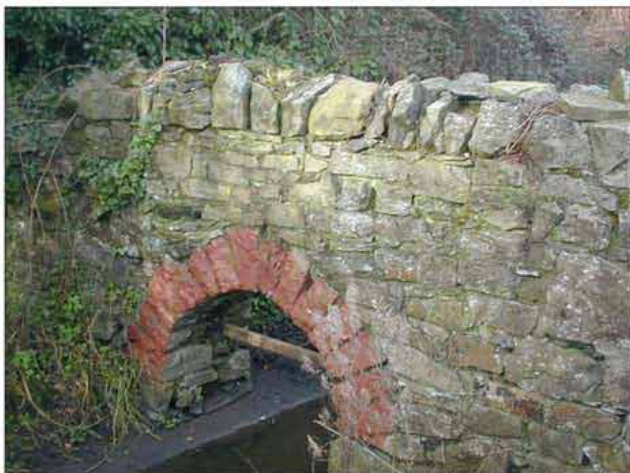
Townland	Nevitt	Present Use	Bridge
Inspection Date	February 2004	Original Use	Bridge
Status/Protection	None	Type	Bridge
Condition	Good	Significance/Interest	Technical
Photograph Details	Plates 9 & 10	Observation	None
Description	Composition	A stone bridge spans a small stream located adjacent to west side of property ID No 2. It is constructed of rubble and cut stone. The wall of the bridge rises to less than .8m in height and is topped by rounded capping stones. The single arch is framed by cut stone voussoirs.	
	Associated features	A rubble stone wall with a single arch spans the stream a short distance south of the bridge. This wall is of rougher construction and has a series of vertical capping stones.	
History (See Fig. 3)	Roadside bridge marked on 1837 OS map. Associated feature is of later construction.

ID 5, a small bridge, lies close to the proposed disposal area and is scheduled for removal. It is a well built structure of probable mid-nineteenth century date. The removal of this bridge will result in a moderate adverse impact.

Prior to removal it is recommended that a record of the bridge be compiled. This record should include an accurate and succinct written description of the structure, the identification of the structure on a map and a scaled photographic survey.

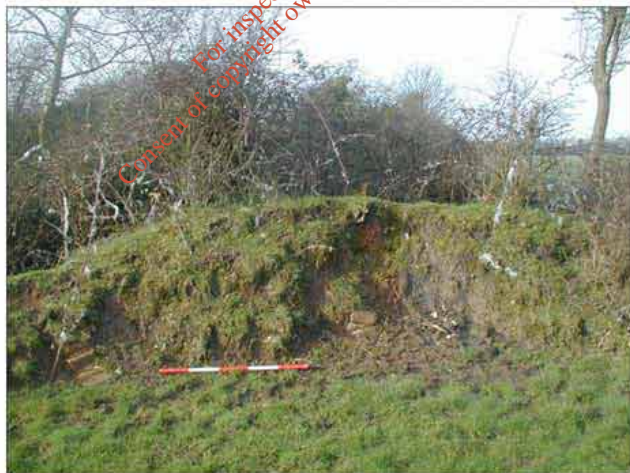
Plate 11 ID 6

Townland	Nevitt	Present Use	Dis-used limekiln
Inspection Date	February 2004	Original Use	Limekiln
Status/Protection	None	Type	Limekiln
Condition	Poor	Significance/Interest	Technical
Photograph Details	Plate 11	Observation	The remnants are located opposite the entrance of an old farmstead that is marked on the 1 st edition mapping.
Description	Composition	A mound composed of a pile of red brick and cut stone positioned along a field boundary. The remnants are located at the end of a sunken laneway, which would have acted as access to the limekiln.

ID 6, a disused limekiln, lies within the proposed disposal area and is scheduled for removal. The limekiln is in a poor state of repair. It is therefore considered that its removal will result in a minor adverse impact.

Prior to removal it is recommended that a record of the structure be compiled. This record should include an accurate and succinct written description of the structure, the identification of the structure on a map and a scaled photographic survey.

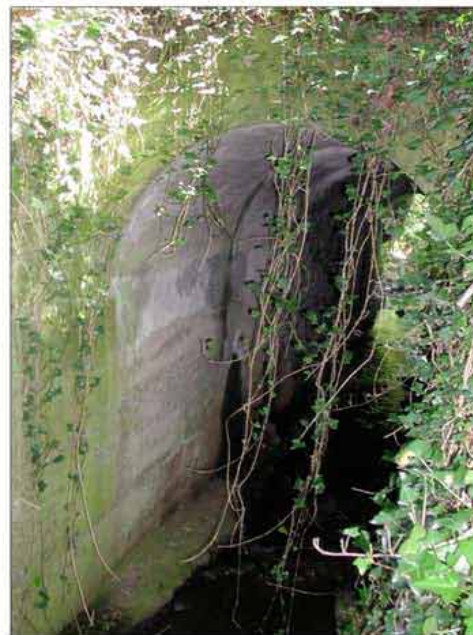
Plate 12 ID 12

Townland	Walshestown	Present Use	Bridge
Inspection Date	February 2004	Original Use	Bridge
Status/Protection	None	Type	Bridge
Condition	Good	Significance/Interest	Technical
Photograph Details	Plate 12	Observation	None
Description	Composition	A rubble stone bridge spanning a stream. It is very overgrown along the roadside. The rear side of the bridge is cement rendered. The tall single arch also has cement rendered reveals.	
History (See Figs. 3)	The bridge is marked on the 1837 OS map

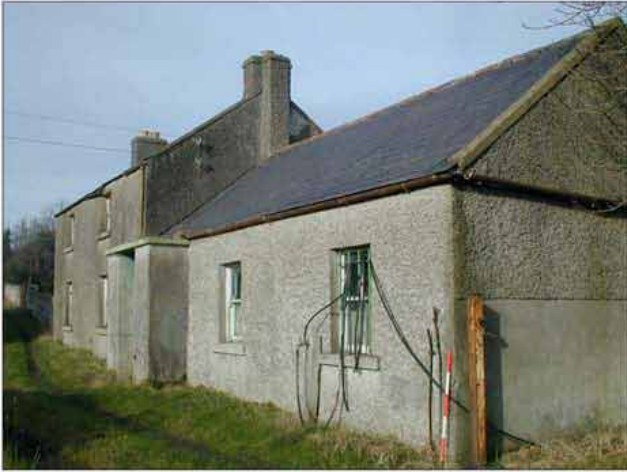
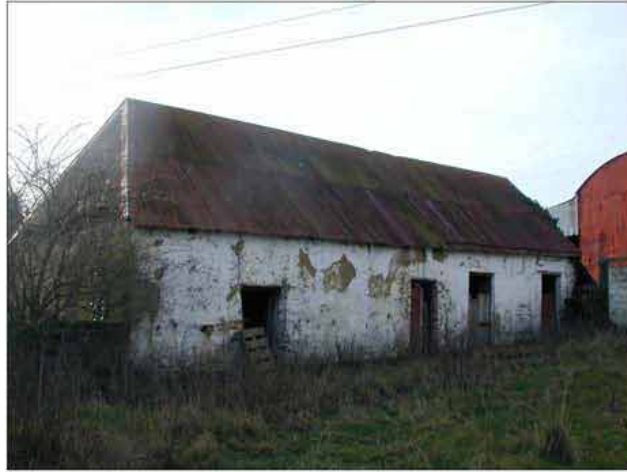
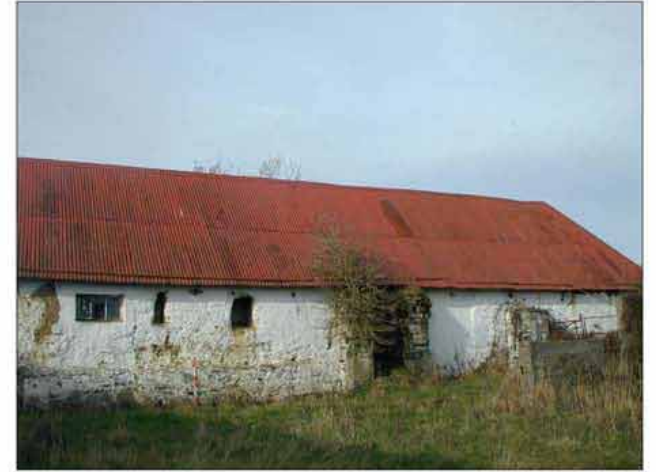
Townland	Walshestown	Present Use	Abandoned dwelling and outbuildings
Inspection Date	February 2004	Original Use	Dwelling and outbuilding
Designation	None	Type	Dwelling and farm outbuildings
Condition	Good	Significance/Interest	Social, technical
Photograph Details	Plates 13, 14 & 15	Observation	An example of good quality farmyard.
Description	Composition	A one/two storey farmhouse with a complex of clay and stone outbuildings arranged around a yard.	
	Roof	Single pitches with natural slate. Two small pebble dash stacks on western roof.	
	Walls	Unpainted pebble dashed	
	Windows	Square-headed openings with timber sashes.	
	Doors	A projecting porch with a timber panelled door.	
	Site	The entrance to the property is marked by square stone piers and a wrought-iron gate. A lane leads down to the building complex.	
	Outbuildings	A range of white-washed stone and clay outbuildings surrounds two sides of a yard. Rubble stone foundation approx. 80cm high with the remaining elevations constructed of clay. Roofs are steeply pitched corrugated iron. L-plan

<p>Associated Features</p> <p>History (See Figs. 3-4)</p>	<p>structure along the west side of the yard functioned as the original farmhouse -stone projecting porch with a short flight of steps leading up to it. Various sized window openings. Outbuilding along the south side of the yard has a number of door openings fronting onto the yard. A cast-iron pump, surrounded by briars, is positioned at the north side of the yard opposite the house.</p> <p>The property is indicated on the 1837 OS map and corresponds to the existing outbuildings. A rectilinear garden area is located in the northwest corner of the property and two square-plan plots of ground with tree-lined boundaries flank the east and west sides of the buildings. A number of alterations had occurred to the property by the time the revised edition OS map was surveyed. The existing house appears to have been modified by this time and additional structures including the large corrugated shed in the west side of the site were constructed.</p>

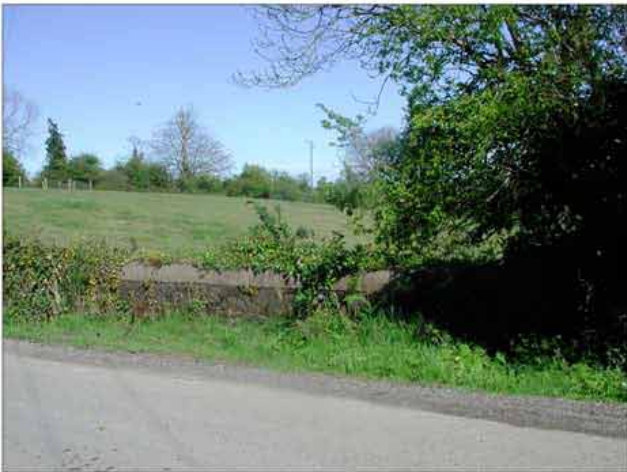
Plate 16 ID 14

Townland	Walshestown	Present Use	Bridge
Inspection Date	February 2004	Original Use	Bridge
Status/Protection	None	Type	Bridge
Condition	Good	Significance/Interest	Technical
Photograph Details	Plate 16	Observation	None
Description	Composition	A rubble stone bridge spanning a stream The walls of the bridge rise to approx .6m in height and is topped by rounded capping stones with a cement finish. The single arch has been repaired with cement. The rear sides of the bridge are partially obscured by vegetation.	
History (See Figs. 3)		The bridge is indicated on the 1837 OS map. A corn mill is indicated adjacent to the bridge on the west side of the road.

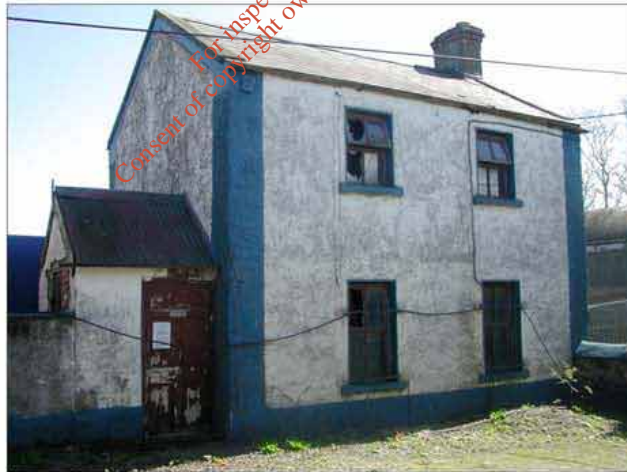
Plate 17 ID 15

Townland	Tooman	Present Use	Dis-used dwelling
Inspection Date	February 2004	Original Use	Dwelling
Status/Protection	None	Type	Dwelling
Condition	Fair	Significance/Interest	Architectural
Photograph Details	Plate 17	Observation	None
Description	Composition	A two-storey, two bay structure of early twentieth century date.	
	Roof	Single-pitch with natural slate and a yellow brick stack at the south gable. Timber eaves.	
	Walls	Painted pebble dashed	
	Windows	Square-headed openings with two-over-two paned sashes. Curved metal bars are positioned in front of the ground floor front windows.	
	Doors	A porch extends from the north side elevation.	
	Site	The building fronts directly onto the roadside.	
	Associated Features	None	
History (See Fig. 4)		The house is first shown on the revised edition OS map of 1936-7.

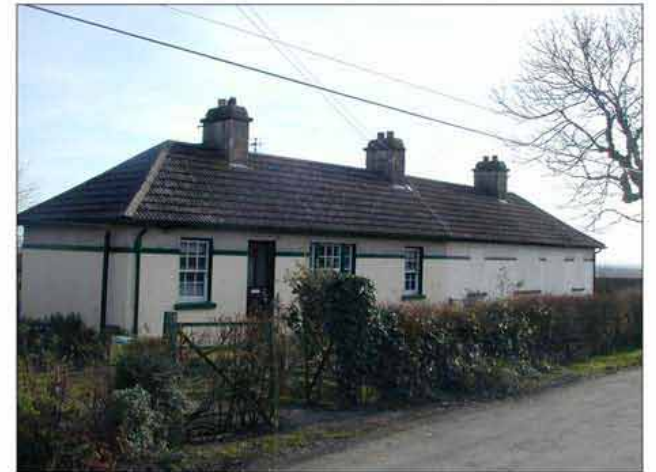
Plate 18 ID 16

Townland	Tooman	Present Use	Dwellings
Inspection Date	February 2004	Original Use	Dwellings
Status/Protection	None	Type	Dwellings
Condition	Good	Significance/Interest	Architectural, social
Photograph Details	Plate 18	Observation	The southern house is not occupied and the openings are blocked up.
Description	Composition	A pair of single-storey local authority houses of circa 1920 date.	
	Roof	Single-pitched hipped roofs with corrugated concrete tiles. Three rendered stacks are positioned on the ridge, one of which is shared by both.	
	Walls	Painted rendered and pebble dash.	
	Windows	Square-headed windows with painted cills and six-over-six paned sashes.	
	Doors	A square-headed door opening with timber and glazed door.	
	Site	A small garden is located in front of the houses and is bounded by a hedge.	
	Outbuildings	A small modern shed	
History (See Fig.4)		Both structures are indicated on the revised edition OS map of 1936-37.

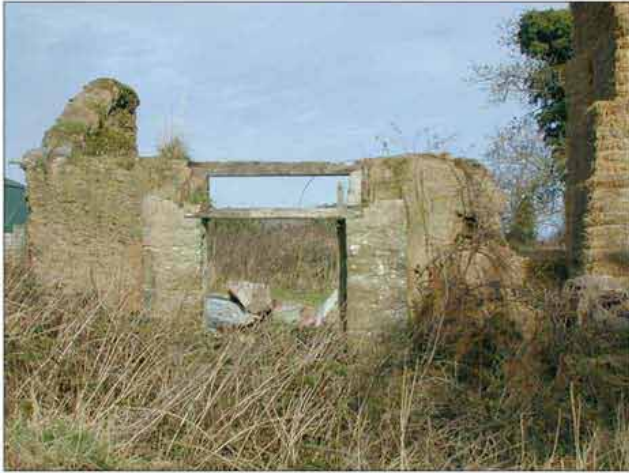
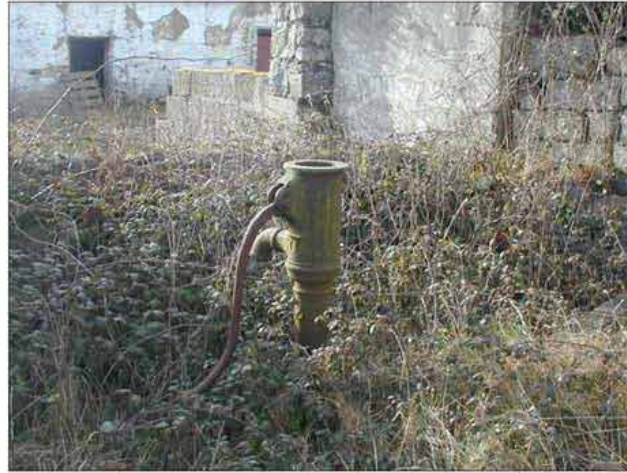
Townland	Knightstown	Present Use	Ruined dwelling
Inspection Date	February 2004	Original Use	Dwelling
Status/Protection	None	Type	Dwelling (ruinous)
Condition	Poor	Significance/Interest	Social, technical
Photograph Details	Plates 19 & 20	Observation	The dwelling is in a poor state of repair with only parts of two walls surviving.
Description	Composition	A ruined clay dwelling of probable early-nineteenth century date.	
	Roof	Not surviving.	
	Walls	Clay walls	
	Windows	Square-headed openings	
	Doors	The door opening on the south elevation has a rubble stone projecting porch and a timber over-light.	
	Site	The structure is located in the corner of a field and is accessed via a laneway. A scattering of overgrown rubble stone is positioned close by which appears to be associated with the ruined dwelling. A large modern corrugated shed is positioned across the lane from the ruin.	
	Associated Features	A cast-iron pump rests on a concrete plinth positioned above a well.

Three structures are shown arranged around a central yard on the 1837 OS map. A straight laneway, corresponding to the existing laneway, leads up to the property. Two additional structures were built on the property by the time the revised edition OS map of 1936-37 was surveyed.
