Soil, Geology and Hydrogeology of the Development Site [TES 2003]

SOIL, GEOLOGY AND HYDROGEOLOGY OF THE DEVELOPMENT SITE

SOIL, GEOLOGY & HYDROGEOLOGY

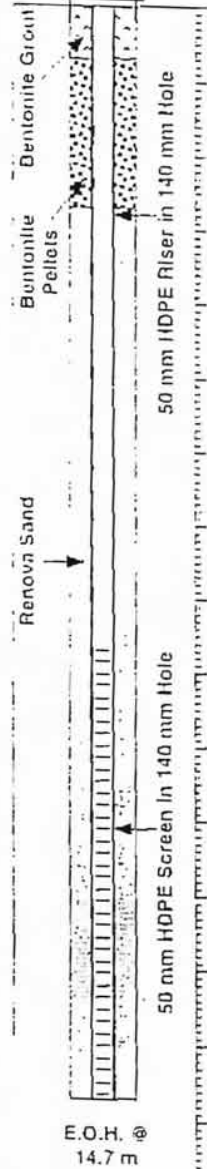
Construction Details

1.3 - 14.7 m Red Conglomerate
 Bedrock

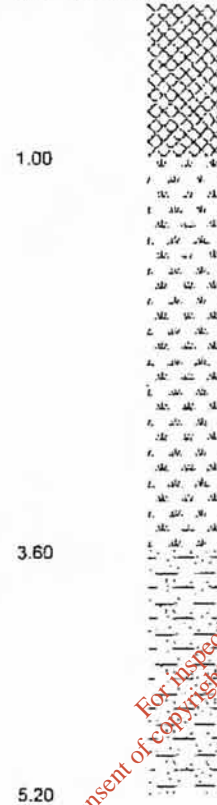
Aggregate/fill - limestone boulders and gravel

PEAT

Loose to medium dense, reddish brown Clayey SAND, with sub-rounded to sub-angular, medium grained gravel
