Project: 3684 –Integrated Waste Management Facility

Title: Environmental Impact Statement

Integrated Waste Management Facility

ENVIRONMENTAL IMPACT STATEMENT

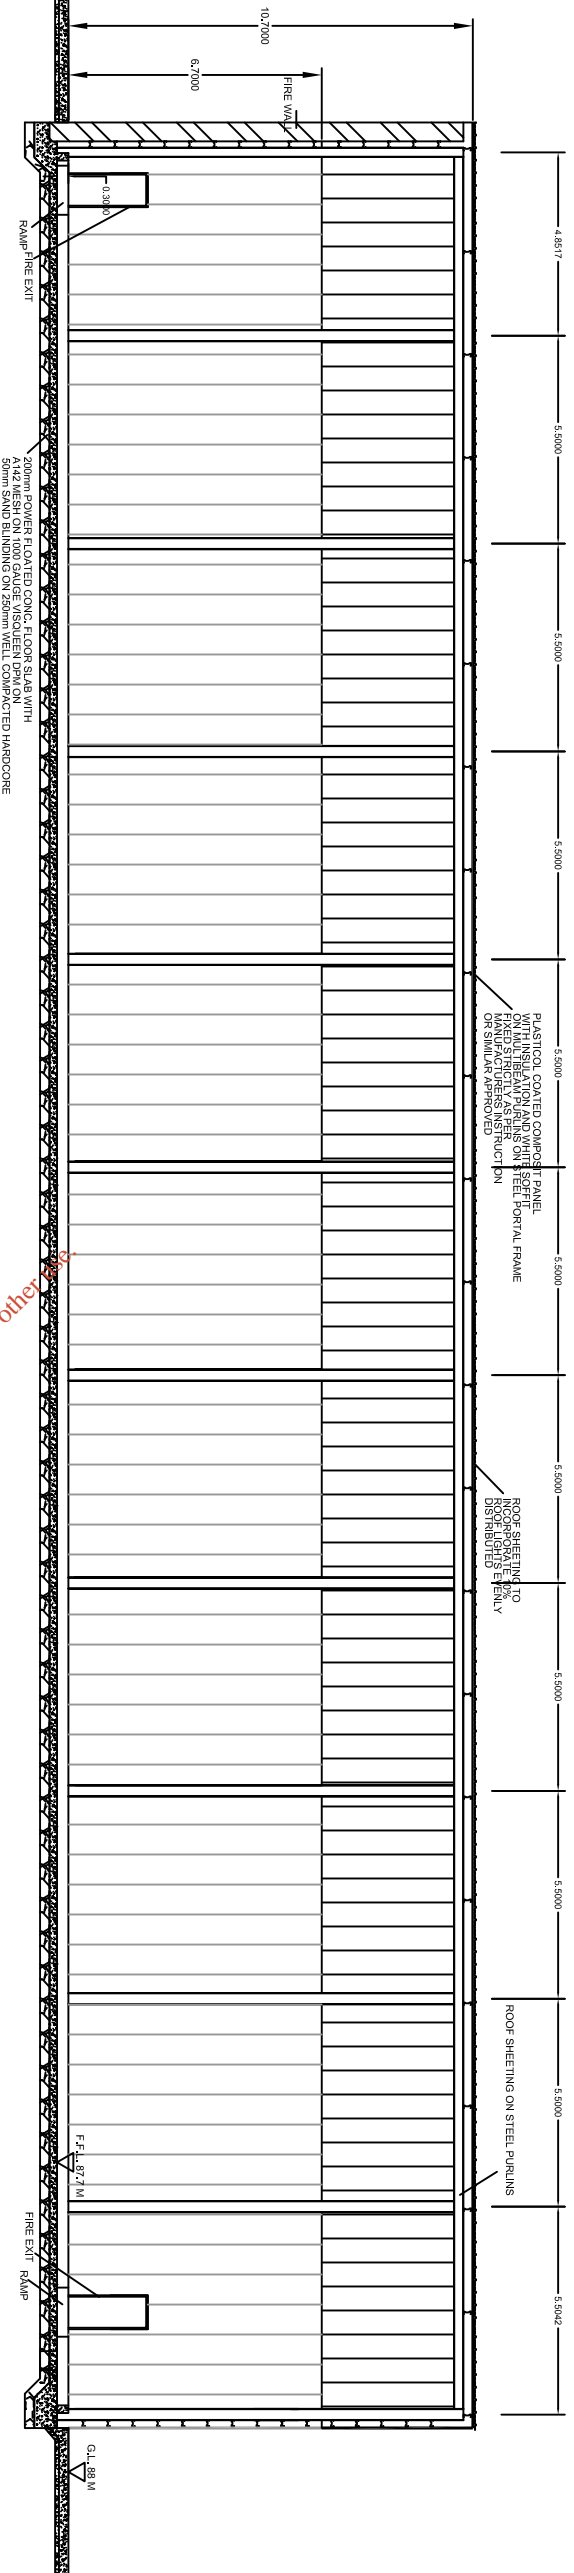
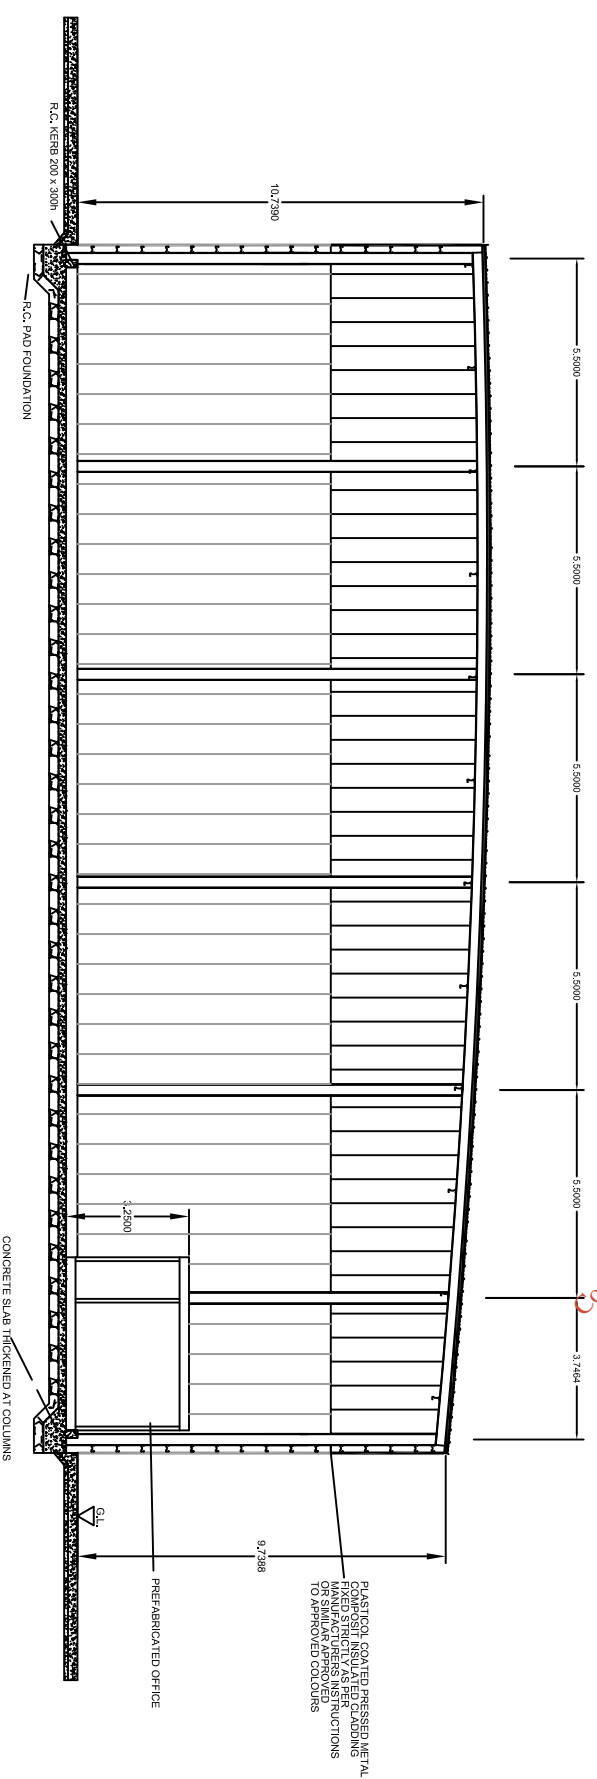
Drawing No.: **3684-01-207** Issue: **A**

The construction details for the Drum Recovery Centre are illustrated on Drawing No. 3684/01/207. The building is independently bunded from the rest of the site with the foul water collected in a sump. The internal floors have 1/60 gradients and drain into internal collection drains which direct any foul water to a collection sump located in the building. It should be noted however that only foul water due to the washing of the floor is generated in this building. This water is directed into the foul water sewer. A cut-off valve is provided at the outlet from the sump to the sewer, which can be either remotely or manually activated in the event of any accidental spillages in the building, thereby preventing any discharge above emission limit values.

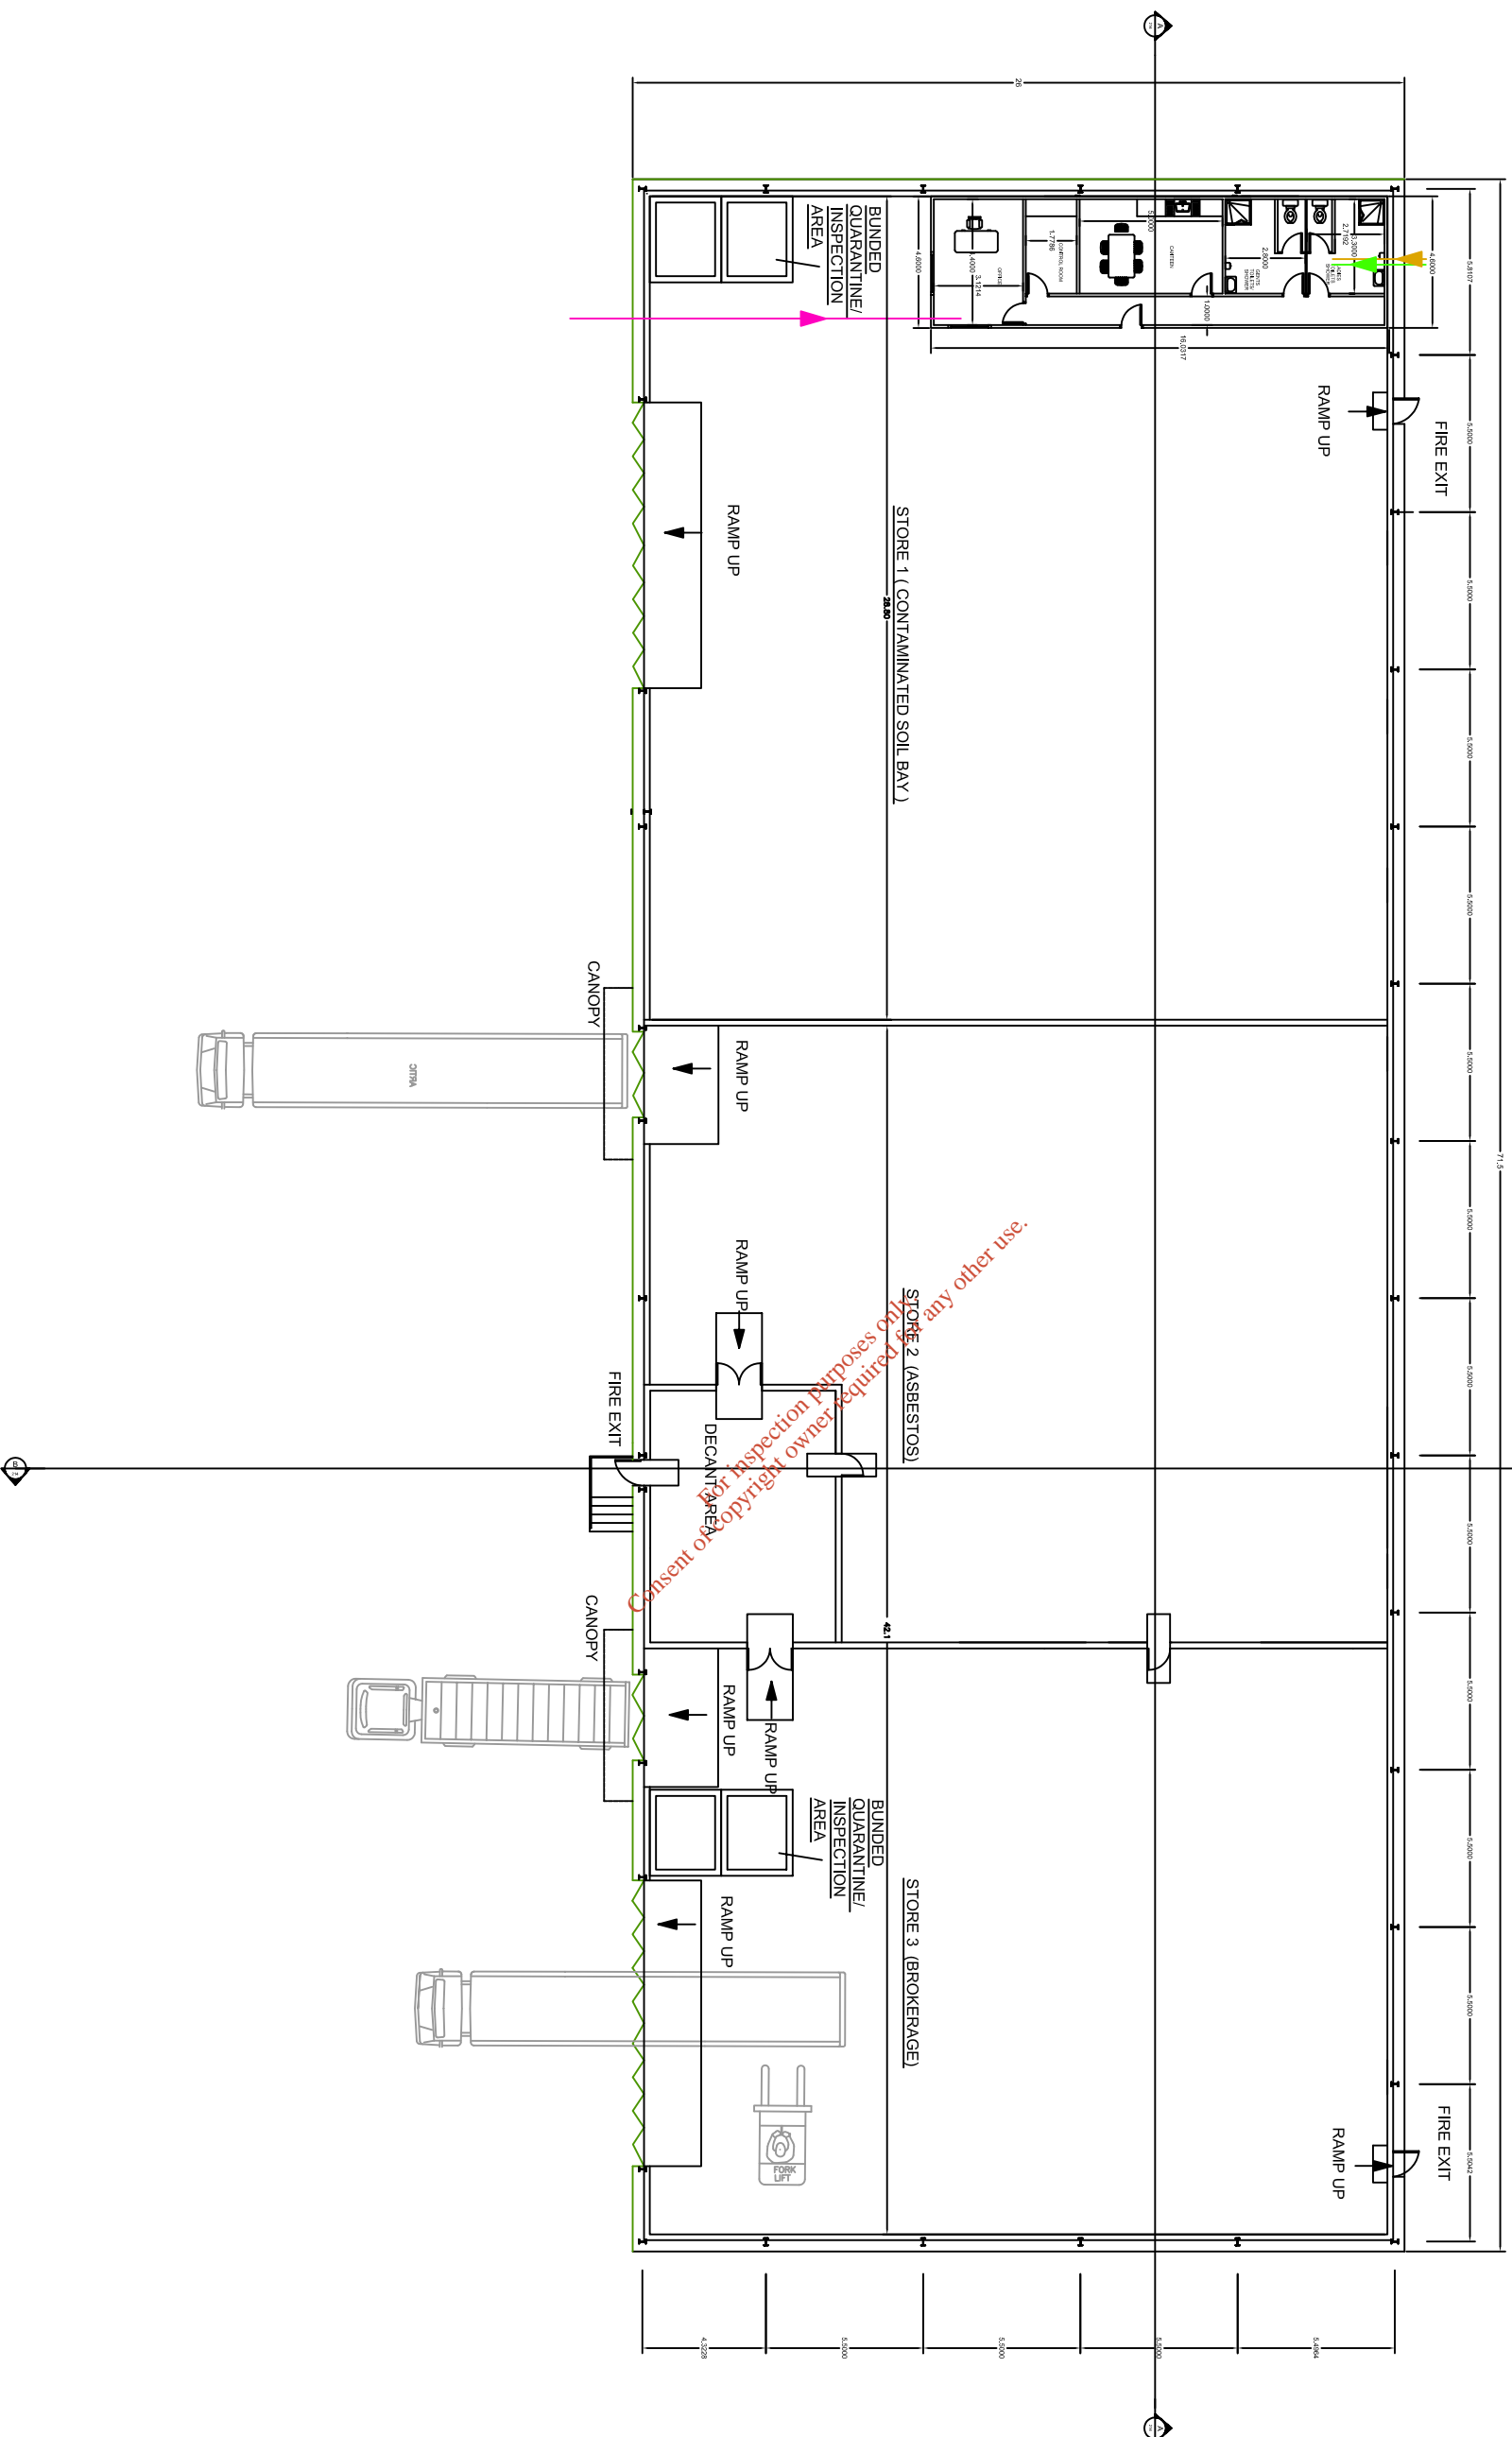
Drawing No.: 3684-01-213
 Issue: A

The specially designed warehouse is subdivided into two main storage areas for the storage of hazardous waste. The location of the Hazardous Waste Transfer Station is as shown on Drawing No. 3684/01/205. Floor Plans for the Hazardous Waste Transfer Station are provided on Drawing No. 3684/01/213. Sections and elevations of this building are as illustrated on Drawing No. 3684/01/214 and Drawing No. 3684/01/215 respectively.

As illustrated on these drawings the Hazardous Waste Transfer Station is a warehouse type structure with a gross floor area of 1859m² and is approximately 71.5m long by 26m wide. The building is 10.7m above ground level.

- 2 No. waste reception areas hazardous wastes;
- 2 No separately banded waste inspection and quarantine areas for hazardous wastes;
- 2 No storage areas for hazardous wastes;
- Decant unit;
- Site accommodation consisting of:
 - Office;
 - Control Room;
 - Toilets/Shower/Changing Rooms
 - Canteen and
- External sumped containers for the storage of hazardous waste.

RILTA Environmental Ltd. currently accept contaminated soil at its facility at Greenogue Business Park. The contaminated soil bay is included in Hazardous Waste Transfer Station, as shown in Drawing 3684/01/205 and Drawing 3684/01/213.
