10.0 FLORA & FAUNA

- 10.1 This chapter addresses flora and fauna for the proposed extension to Ballynacarrick Landfill Site. The chapter is subdivided into two parts, the first covering habitats, flora and fauna is detailed in paragraphs 10.2 to 10.91, whilst the second part covering farm animal health is detailed in paragraphs 10.92 to 10.119.

- 10.2 A study was carried out to assess the effects of a proposed extension to the existing landfill facilities at Ballynacarrick on flora and fauna in the receiving environment. The assessment has focused attention on the habitats, flora and fauna of the proposed development site and adjacent area. It makes reference to a number of designated conservation areas in the relevant locality, and points to the potential or likely effects on certain vulnerable habitats arising from both the current proposal and the existing landfill facility, taking account of other possible contributory impacts. The study period was from September 2002 to June 2003.

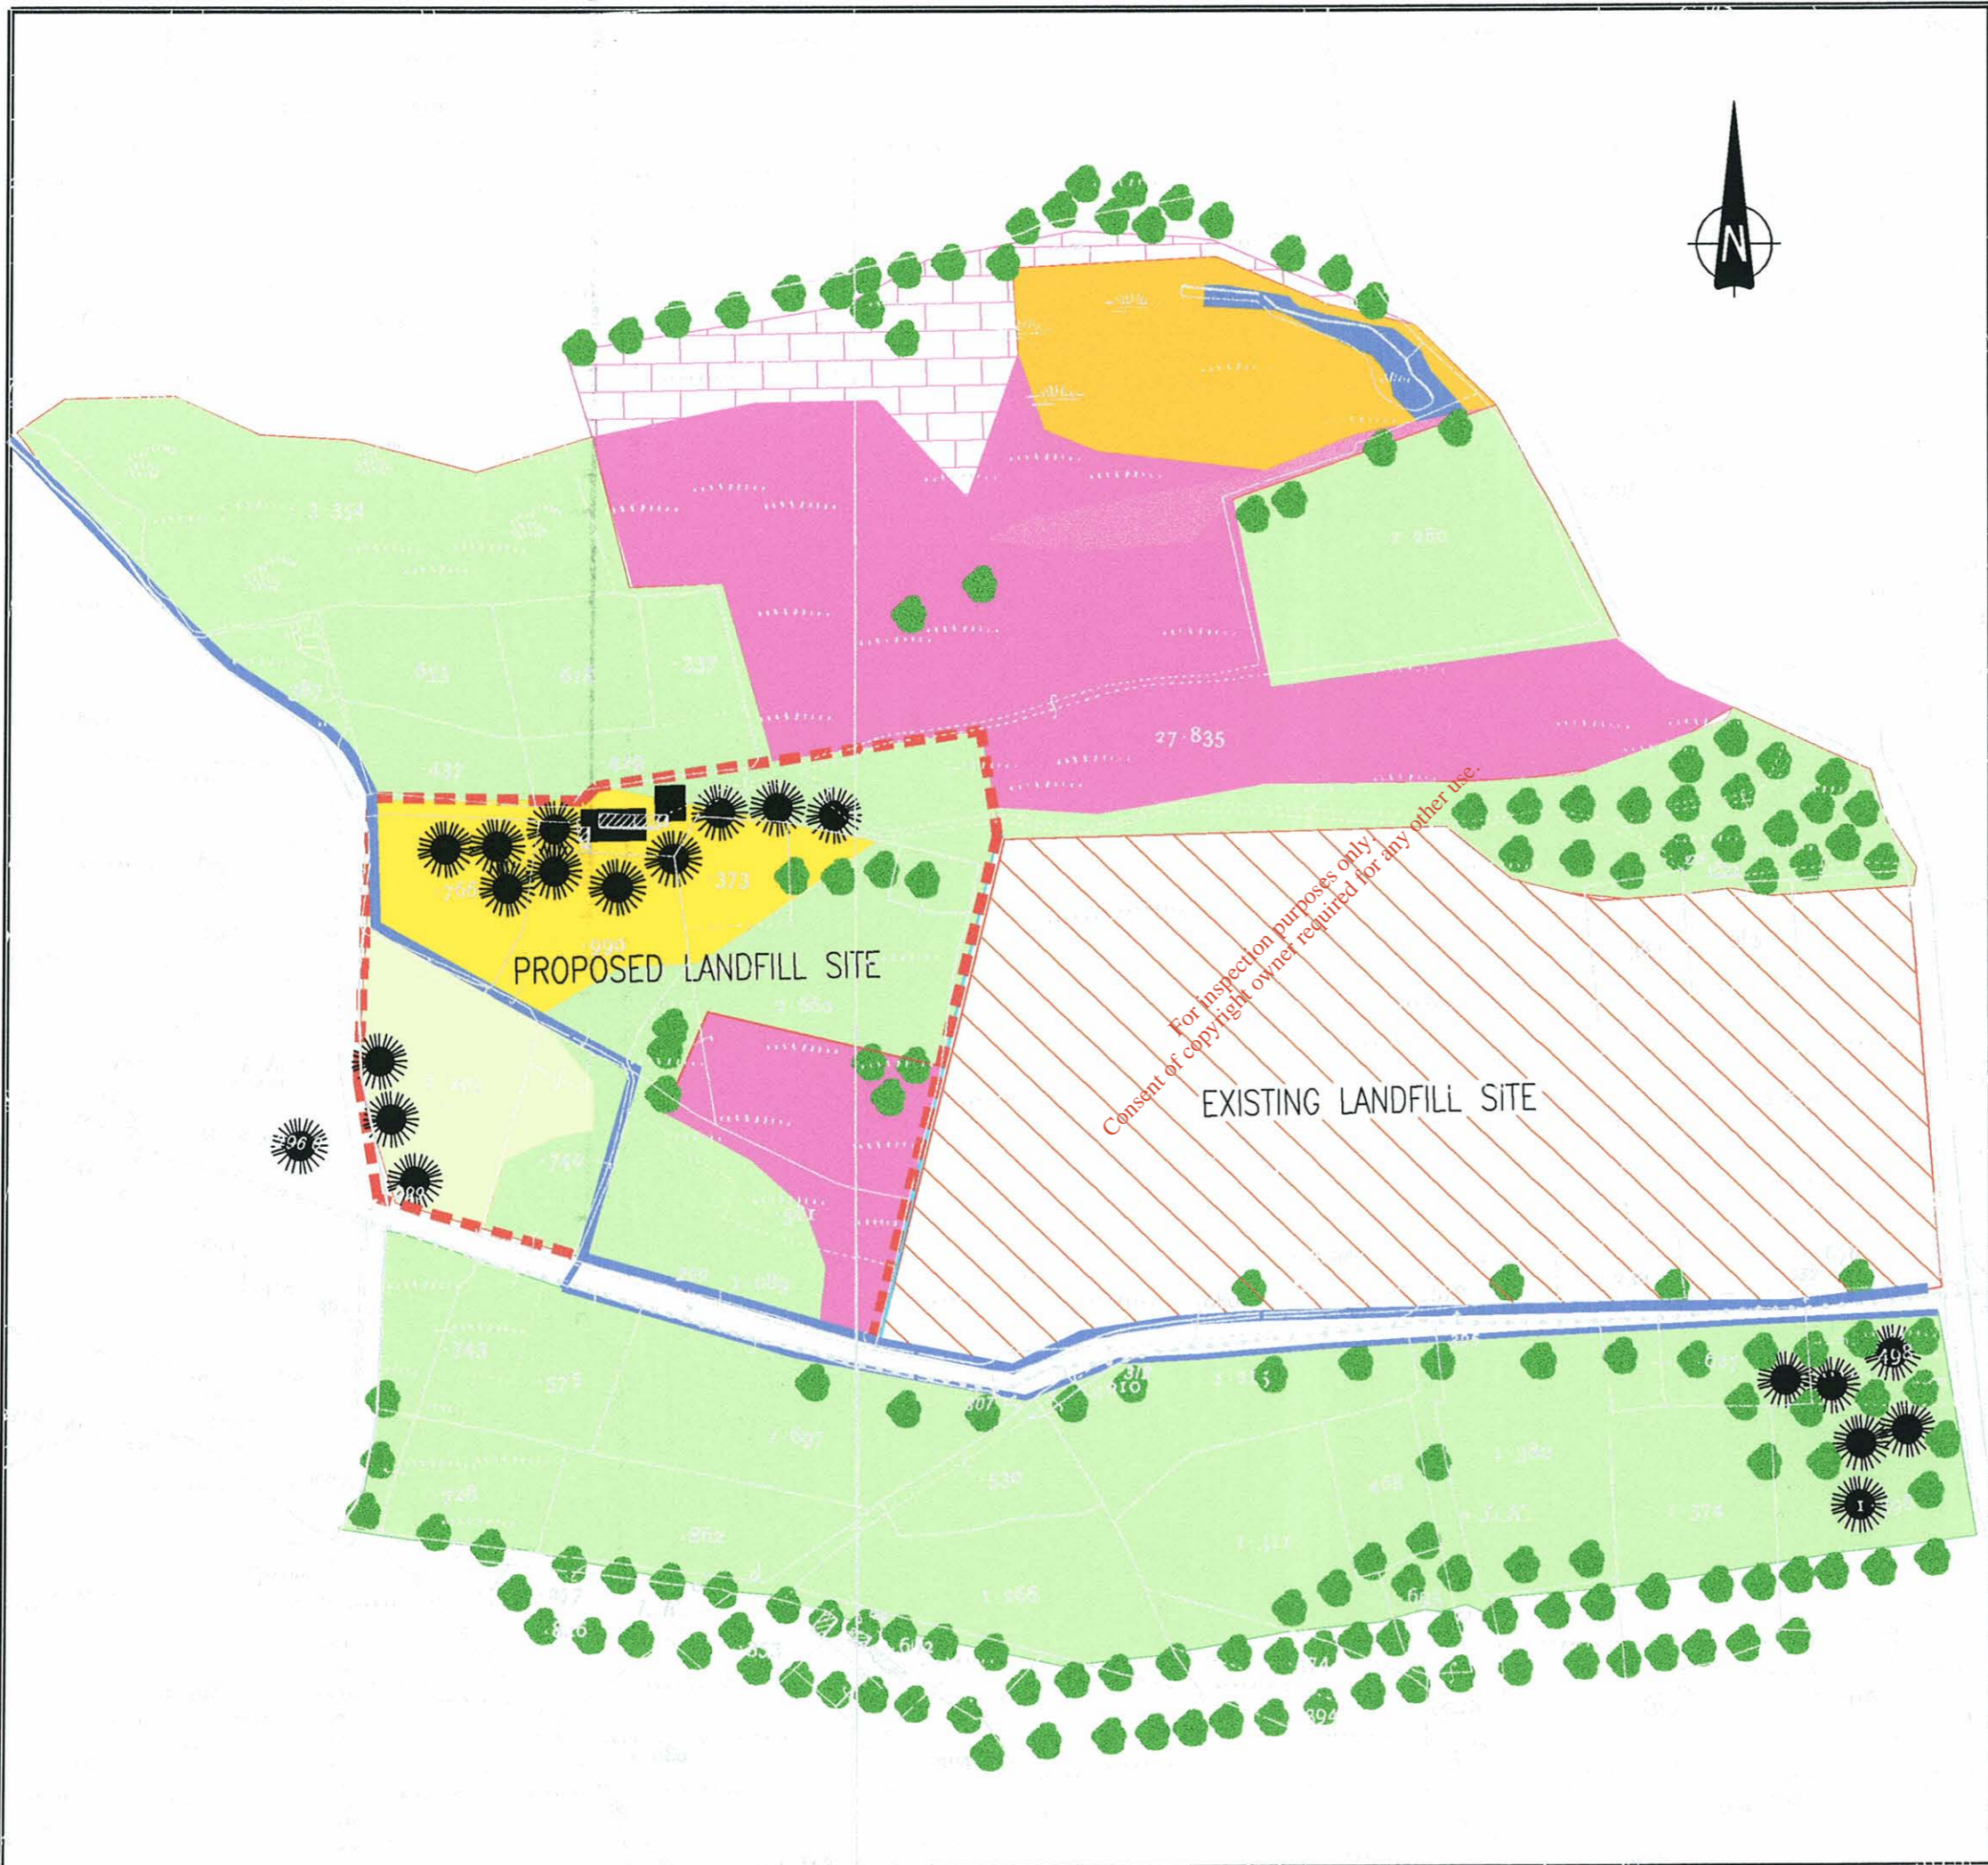
TITLE HABITATS OF THE STUDY AREA	FIGURE 10.1
-------------------------------------	----------------

- KEY:
- IMPROVED GRASSLAND
 - WET GRASSLAND
 - WET HEATH/ CUTOVER BOG
 - CALCAREOUS HEATH
 - REEDBED SWAMP
 - DITCH / STREAM / OPEN WATER
 - RICH FEN
 - SRCUB / HEDGEROW
 - TALL MATURE TREES

- 10.6 The ecology of the receiving environment was surveyed and described from a number of visits which involved walks over and around the proposed and existing landfill site. The proposed development site and the habitats associated with this site can be seen in Figure 10.1.

- 10.63 No protected, threatened or scarce plant species - as listed in the Irish Red Data Book (Curtis & McGough, 1988) or in relevant legislation - was found in or near the proposed development site. Bloody Cranesbill (*Geranium sanguineum*), recorded 200m north of the site, is locally frequent in Clare and Galway (e.g. the Burren), but 'very rare elsewhere' (Webb *et al*, 1996). The rare and protected plant species, Common Rockrose (*Helianthemum nummularium*) was not found in the survey area (i.e. in the habitat area mapped in Figure 10.1).

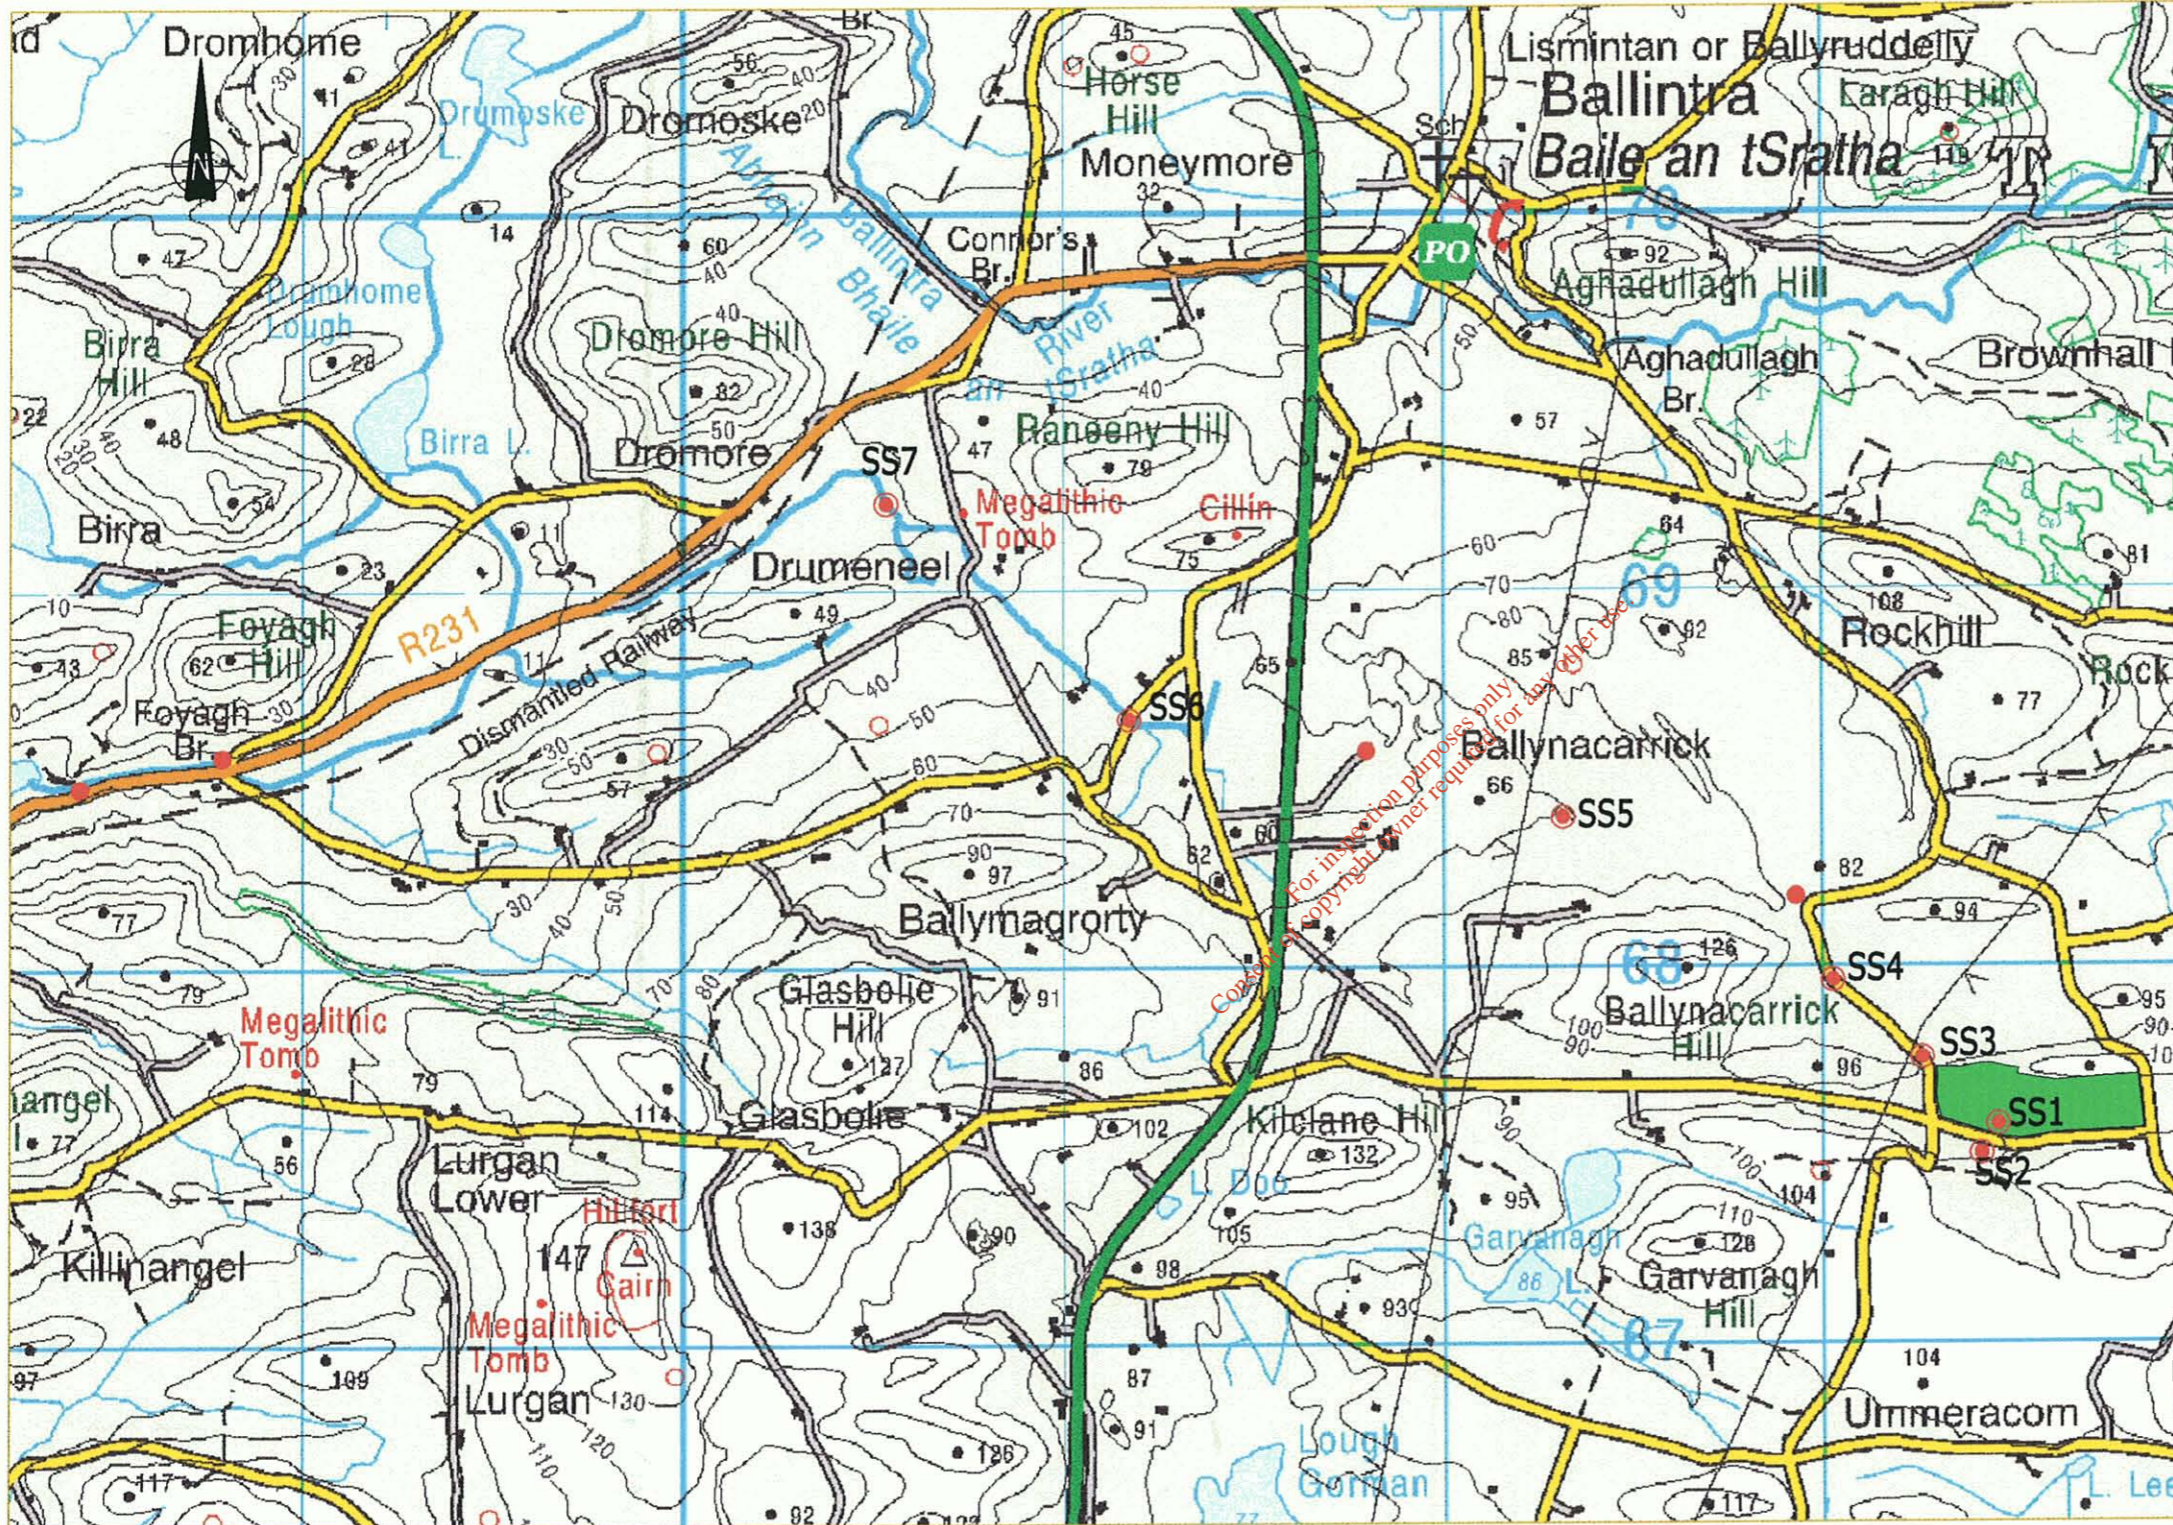
- BALLYNACARRICK LANDFILL SITE
- SS5 SAMPLE SITE
- OTHER REFERENCE POINT ON STREAM CHANNEL (SEE TEXT SECTION 10.36)

10.53 Chemical data are available from a number of sources and provide relevant parameters of the conditions affecting aquatic ecology. The main source is monitoring undertaken for 2002 by Donegal County Council for the existing Ballynacarrick landfill, under the Waste Licence 24-1. Relevant chemical parameters, measured at various locations around the site, are reproduced in the Tables 10.14, 10.15 and 10.16. The location of these points on the site is illustrated in Figure 10.3.

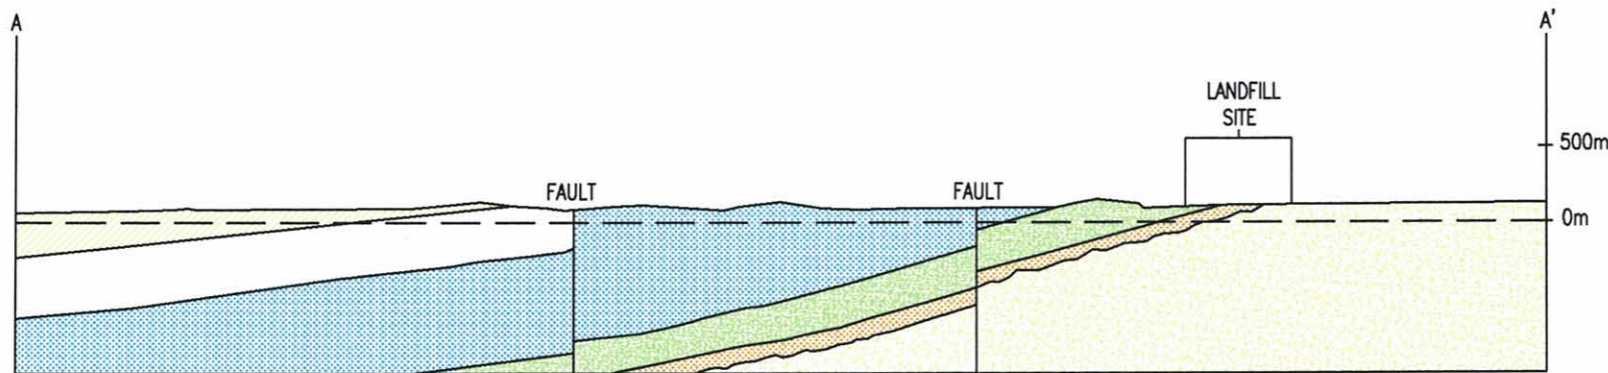
<p>TITLE SOLID GEOLOGY MAP AND SECTION</p>	<p>FIGURE 11.2</p>
--	------------------------

- KEY
- MULLAGHMORE SANDSTONE
 - BUNDORAN SHALE
 - UPPER BALLYSHANNON FORMATION - LIMESTONE
 - LOWER BALLYSHANNON FORMATION - MUDDY LIMESTONE AND CALCITIC SHALES
 - BASAL BALLYSHANNON FORMATION - GRITSTONES, SANDSTONES, LIMESTONES AND SHALES
 - SEMI-PELTIC BIOTITE SCHIST
 - LOUGH DERG PSAMMITE
 - FAULT

GEOLOGICAL SECTION

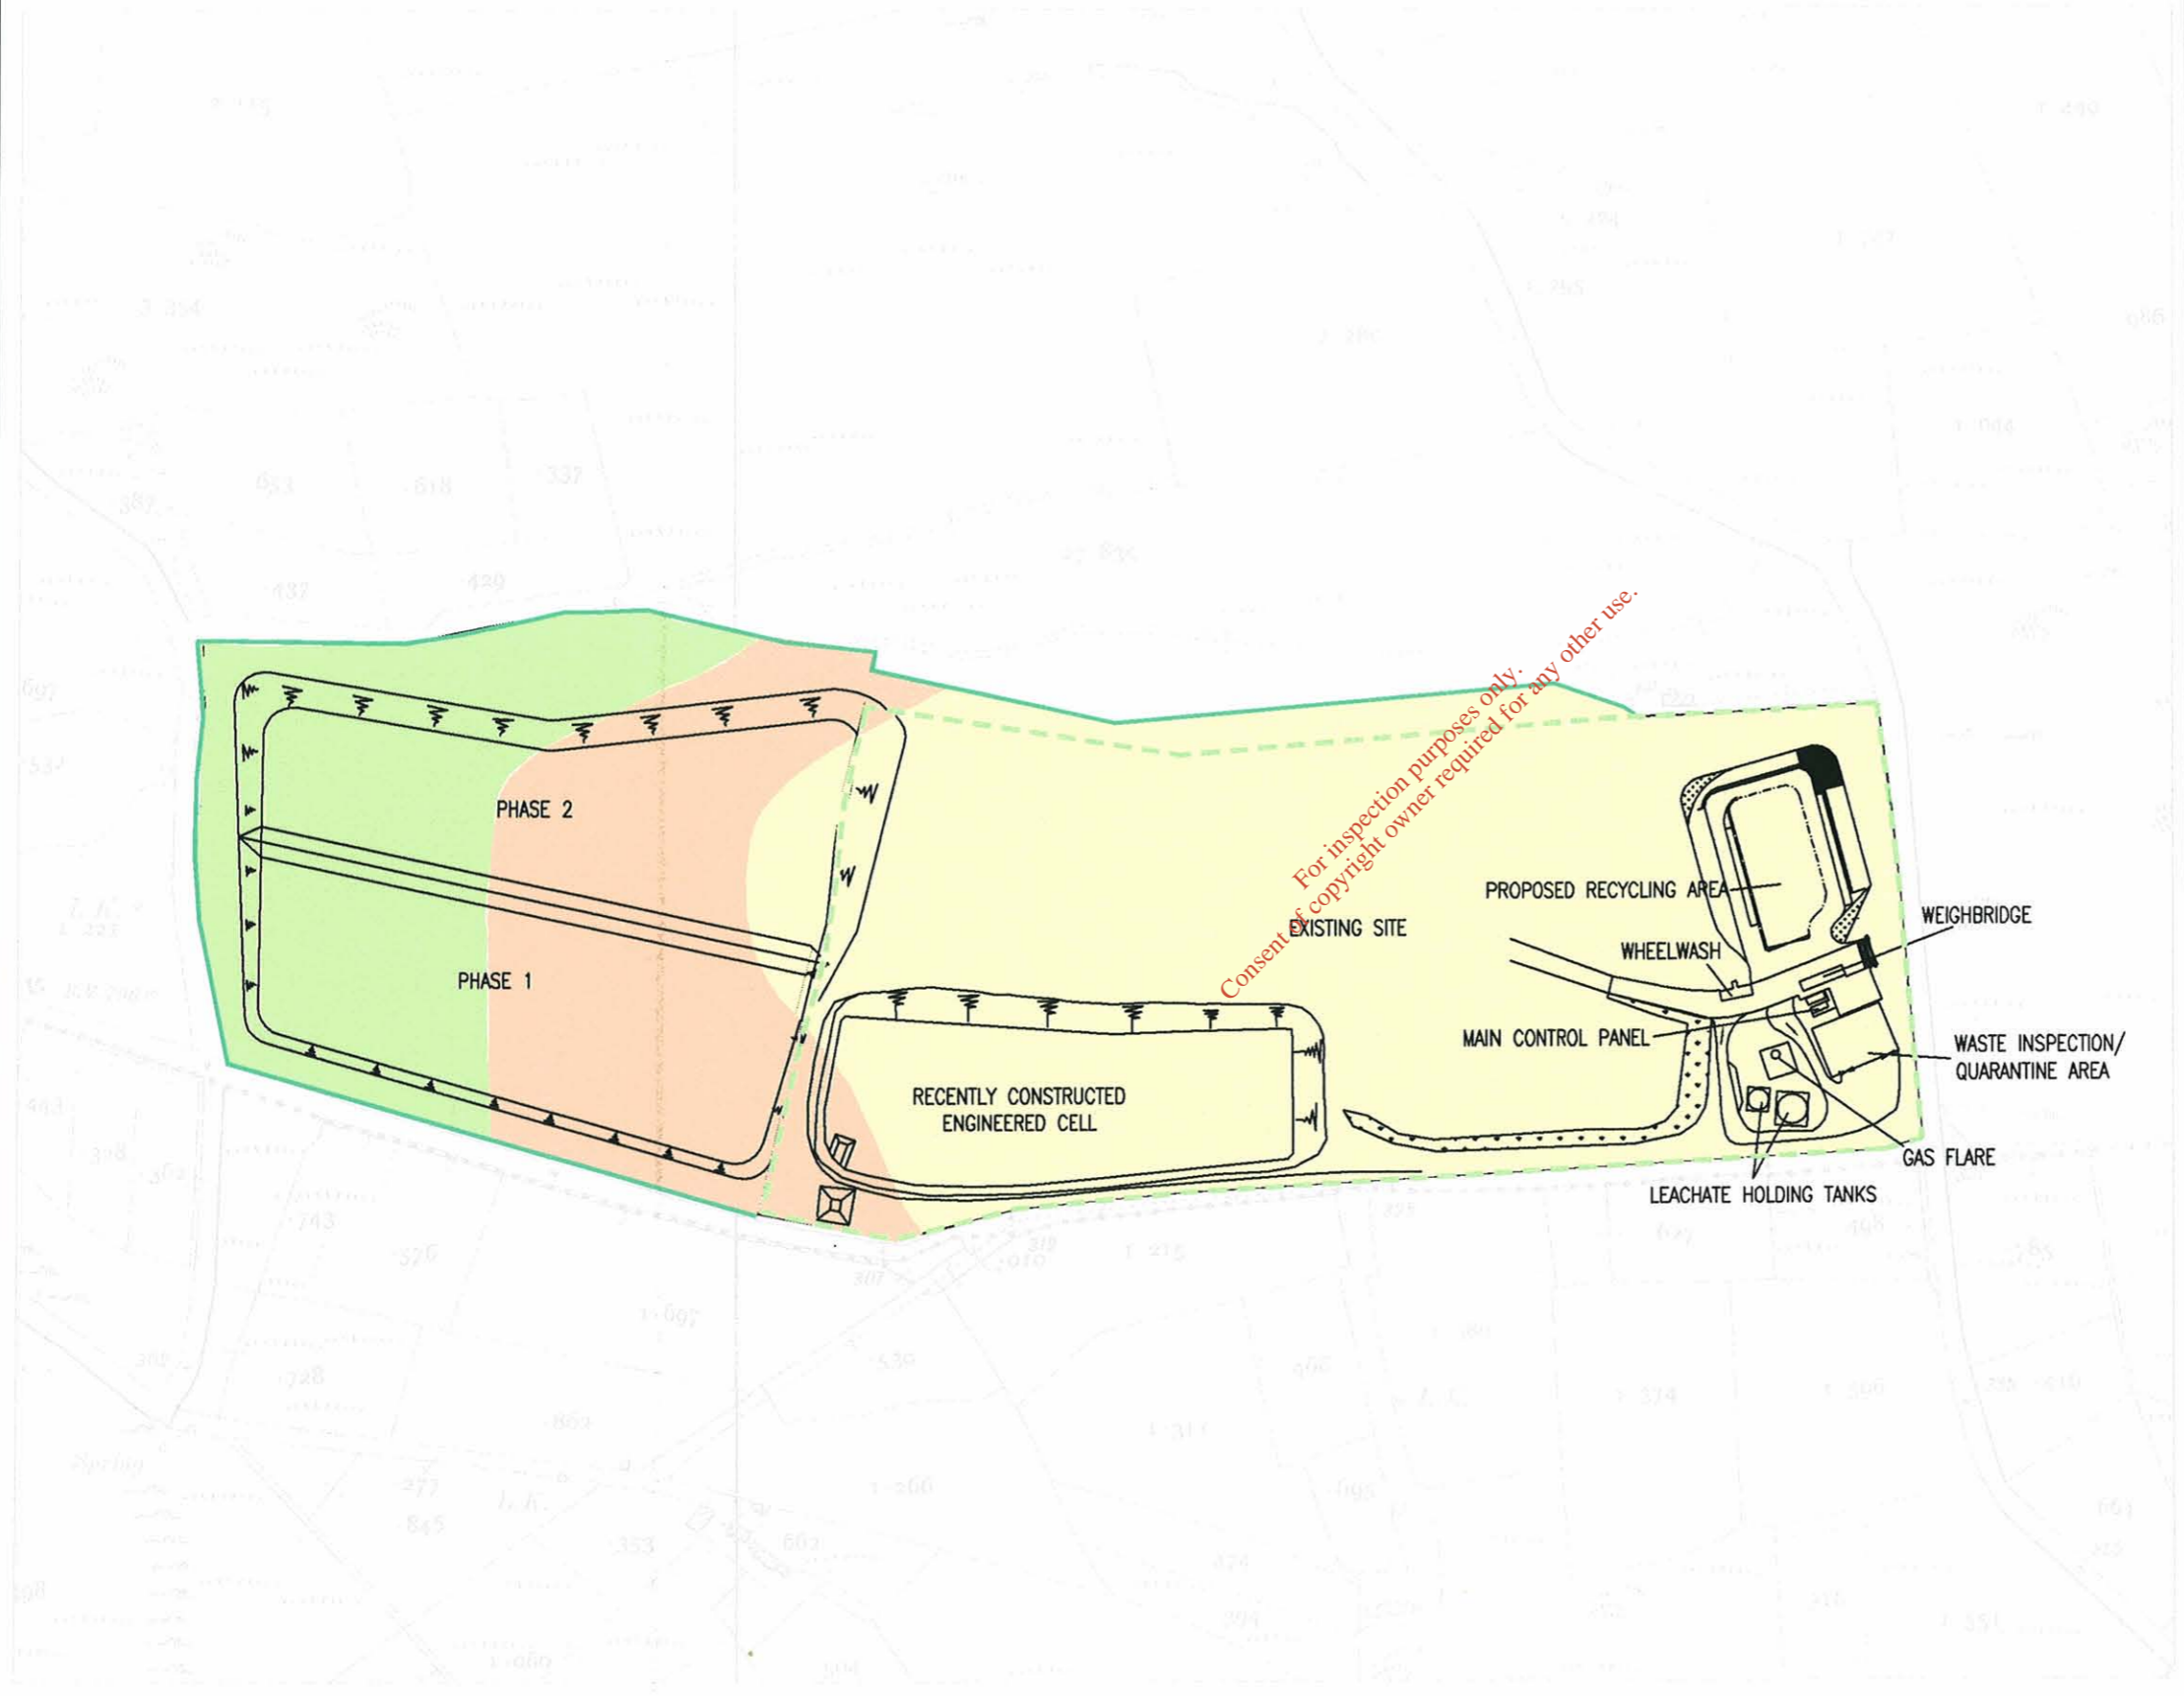
FIGURE
11.3

- KEY
- BOUNDARY OF EXISTING LANDFILL
 - BOUNDARY OF PROPOSED EXTENSION
 - LOWER BALLYSHANNON FORMATION (MUDDY LIMESTONE)
 - BASAL BALLYSHANNON FORMATION (GRITSTONE)
 - LOUGH DERG PSAMMITES

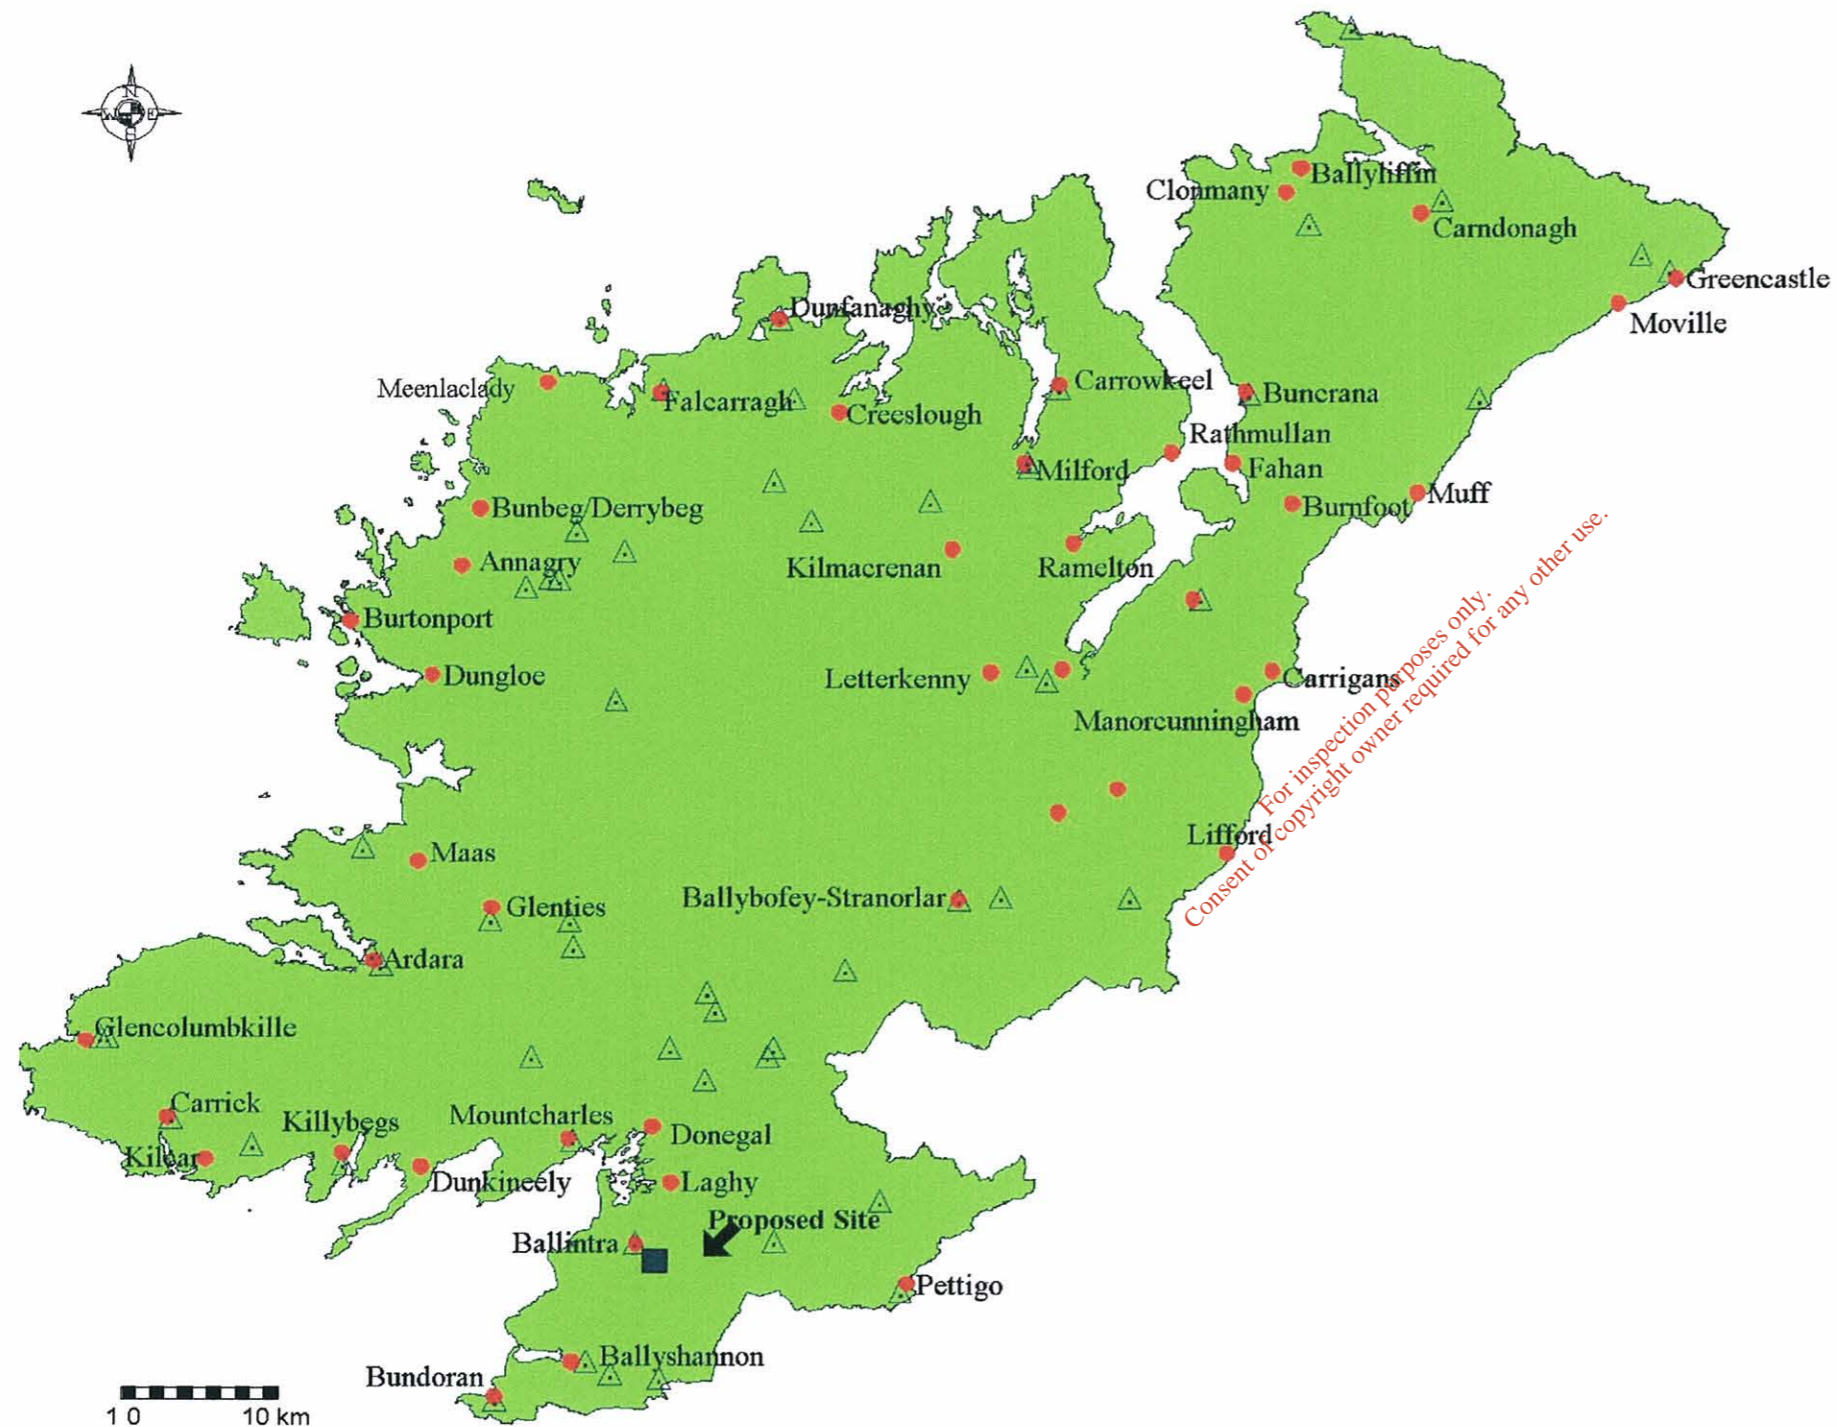
TITLE LOCATION OF RAIN GAUGES	FIGURE 12.4
----------------------------------	----------------

- KEY
- △ RAIN GAUGE STATIONS
 - TOWNS
 - PROPOSED LANDFILL SITE (BALLYNACARRICK)
