Carrigaline, Ringaskiddy, Shanbally, Coolmore, Cobh, Monkstown/ Passage West, and Crosshaven.

Archaeological assessment has been undertaken by Aegis Archaeology Ltd. for the site of the proposed treatment plant and all on-shore pipeline corridors. ADCO Ltd. has been contracted to carry out archaeological survey of the works corridor for a 390m long marine pipeline crossing and a c.2.4km long foreshore pipeline (Figure 2).

Project
Cork Harbour Lower Drainage Scheme

Title
Figure 1- Extract from OS Discovery Series
mapping showing location of ADSCO Survey Areas.

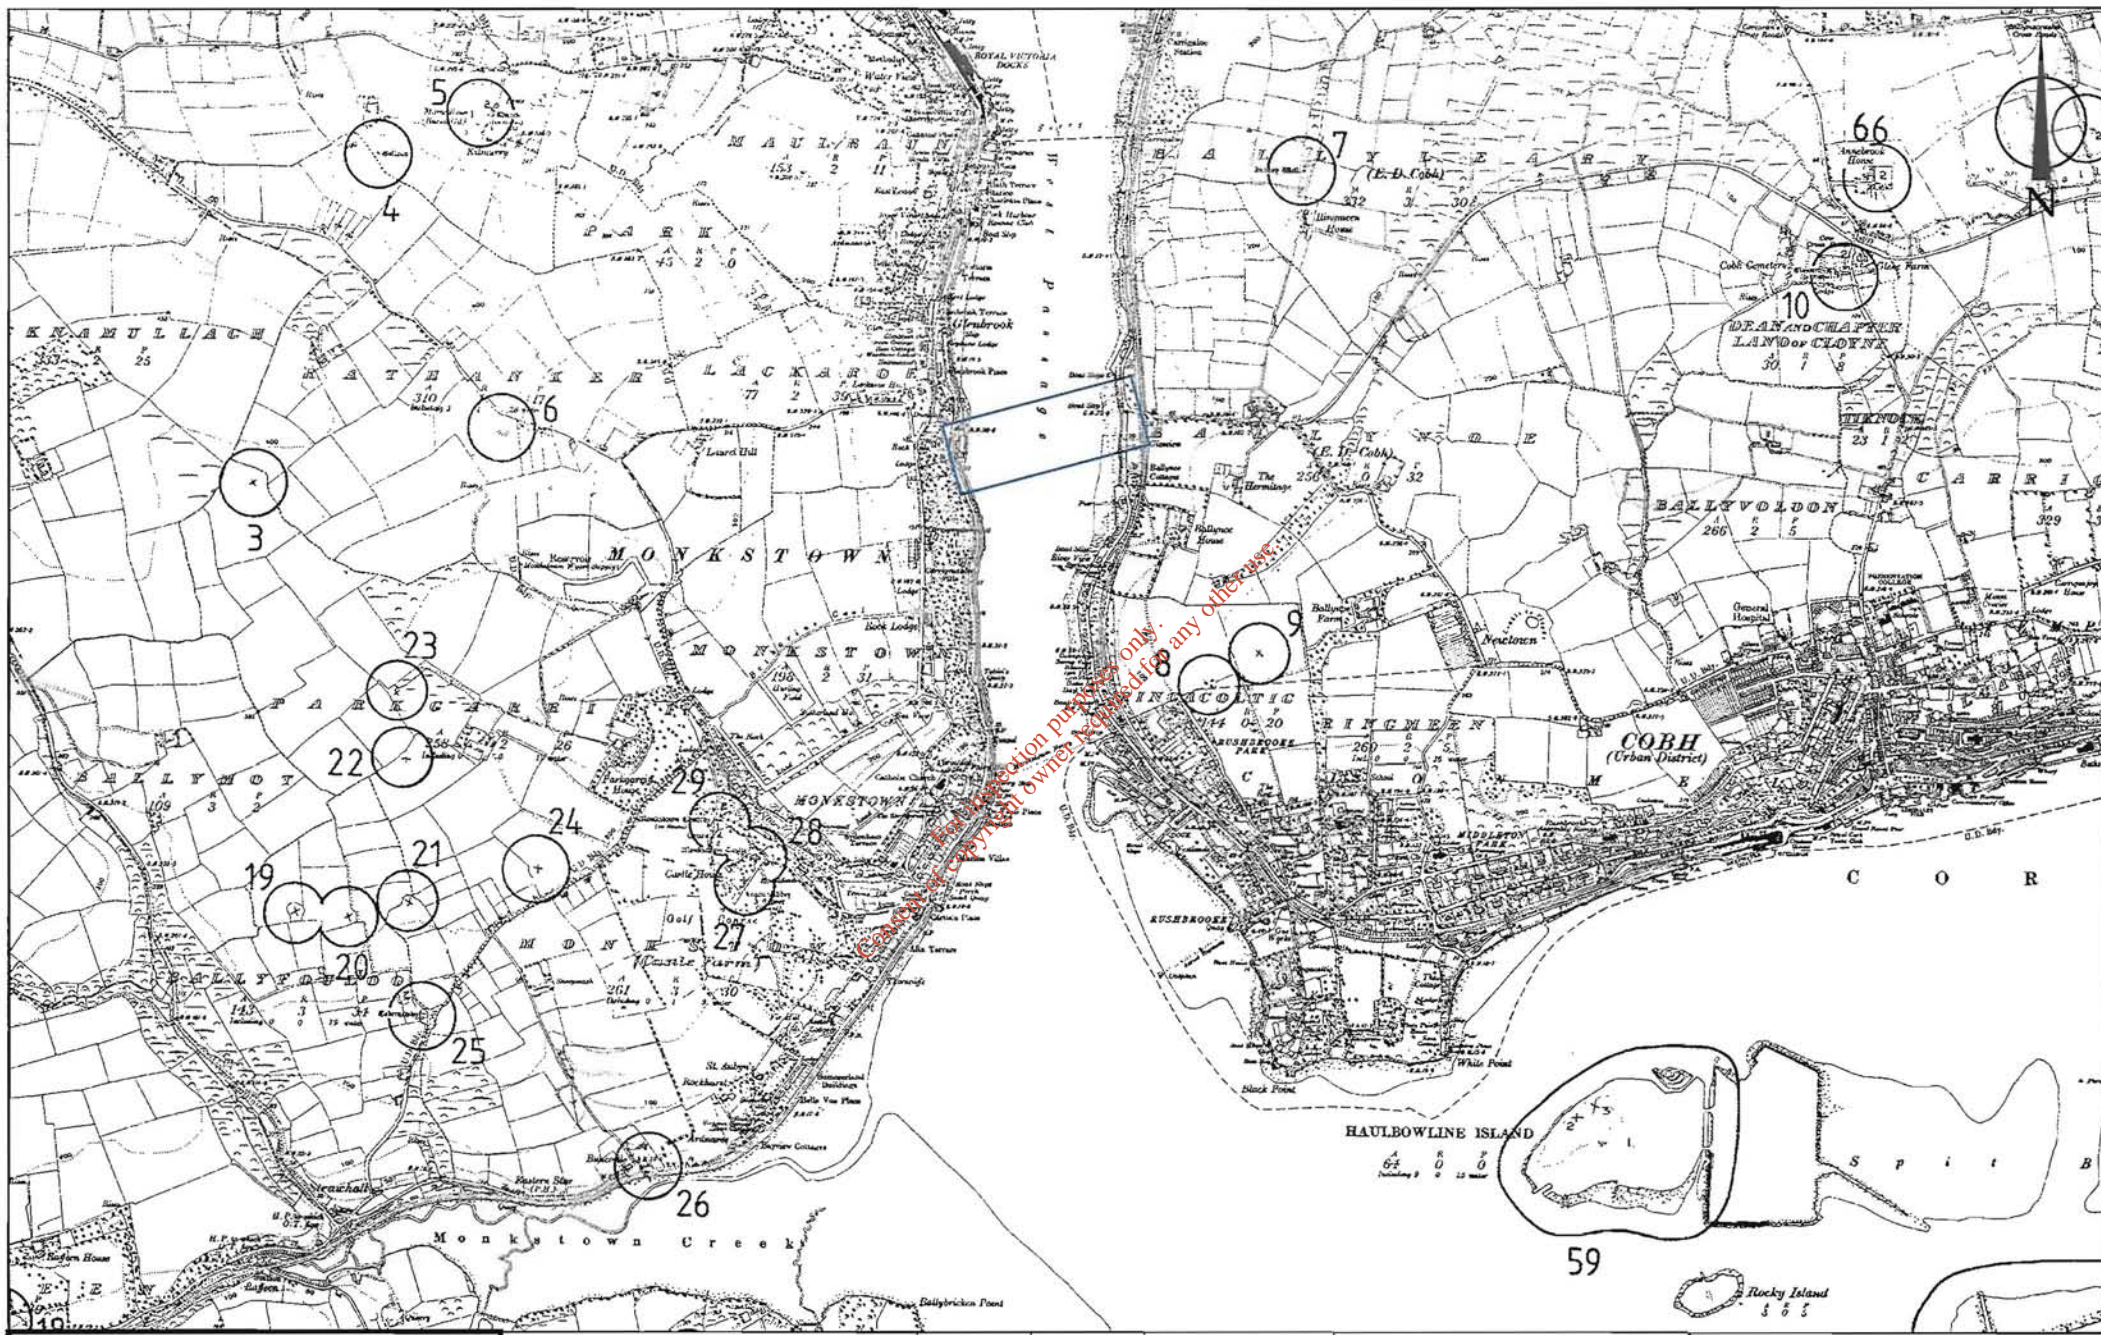
Title
 Figure 3- OS 6" mapping (RMP Sheet CO: 087)
 showing location of listed RMP sites within the
 vicinity of the proposed marine pipeline crossing
 site.

There are no archaeological sites listed in the Record of Monuments and Places for the immediate vicinity of the Marine Pipeline Crossing, the nearest sites lying 900m to the southeast of the proposed impact area; CO087:008: Possible Ringfort, and CO087:009: Graveyard (Figure 3). However, the history of maritime activity within this area is well established; an activity that is further attested to by the number of vessels listed in the Shipwreck Inventory for this stretch of coastline (Appendix 1)³.
