**LOCATION OF TEST PITS MONITORED  
ON ROUTE OF PIPELINE  
S. KILKENNY**

# **Report on Archaeological Monitoring of Engineers Test Pits, Waterford Main Drainage, Phase 2. Licence No.01E0959**

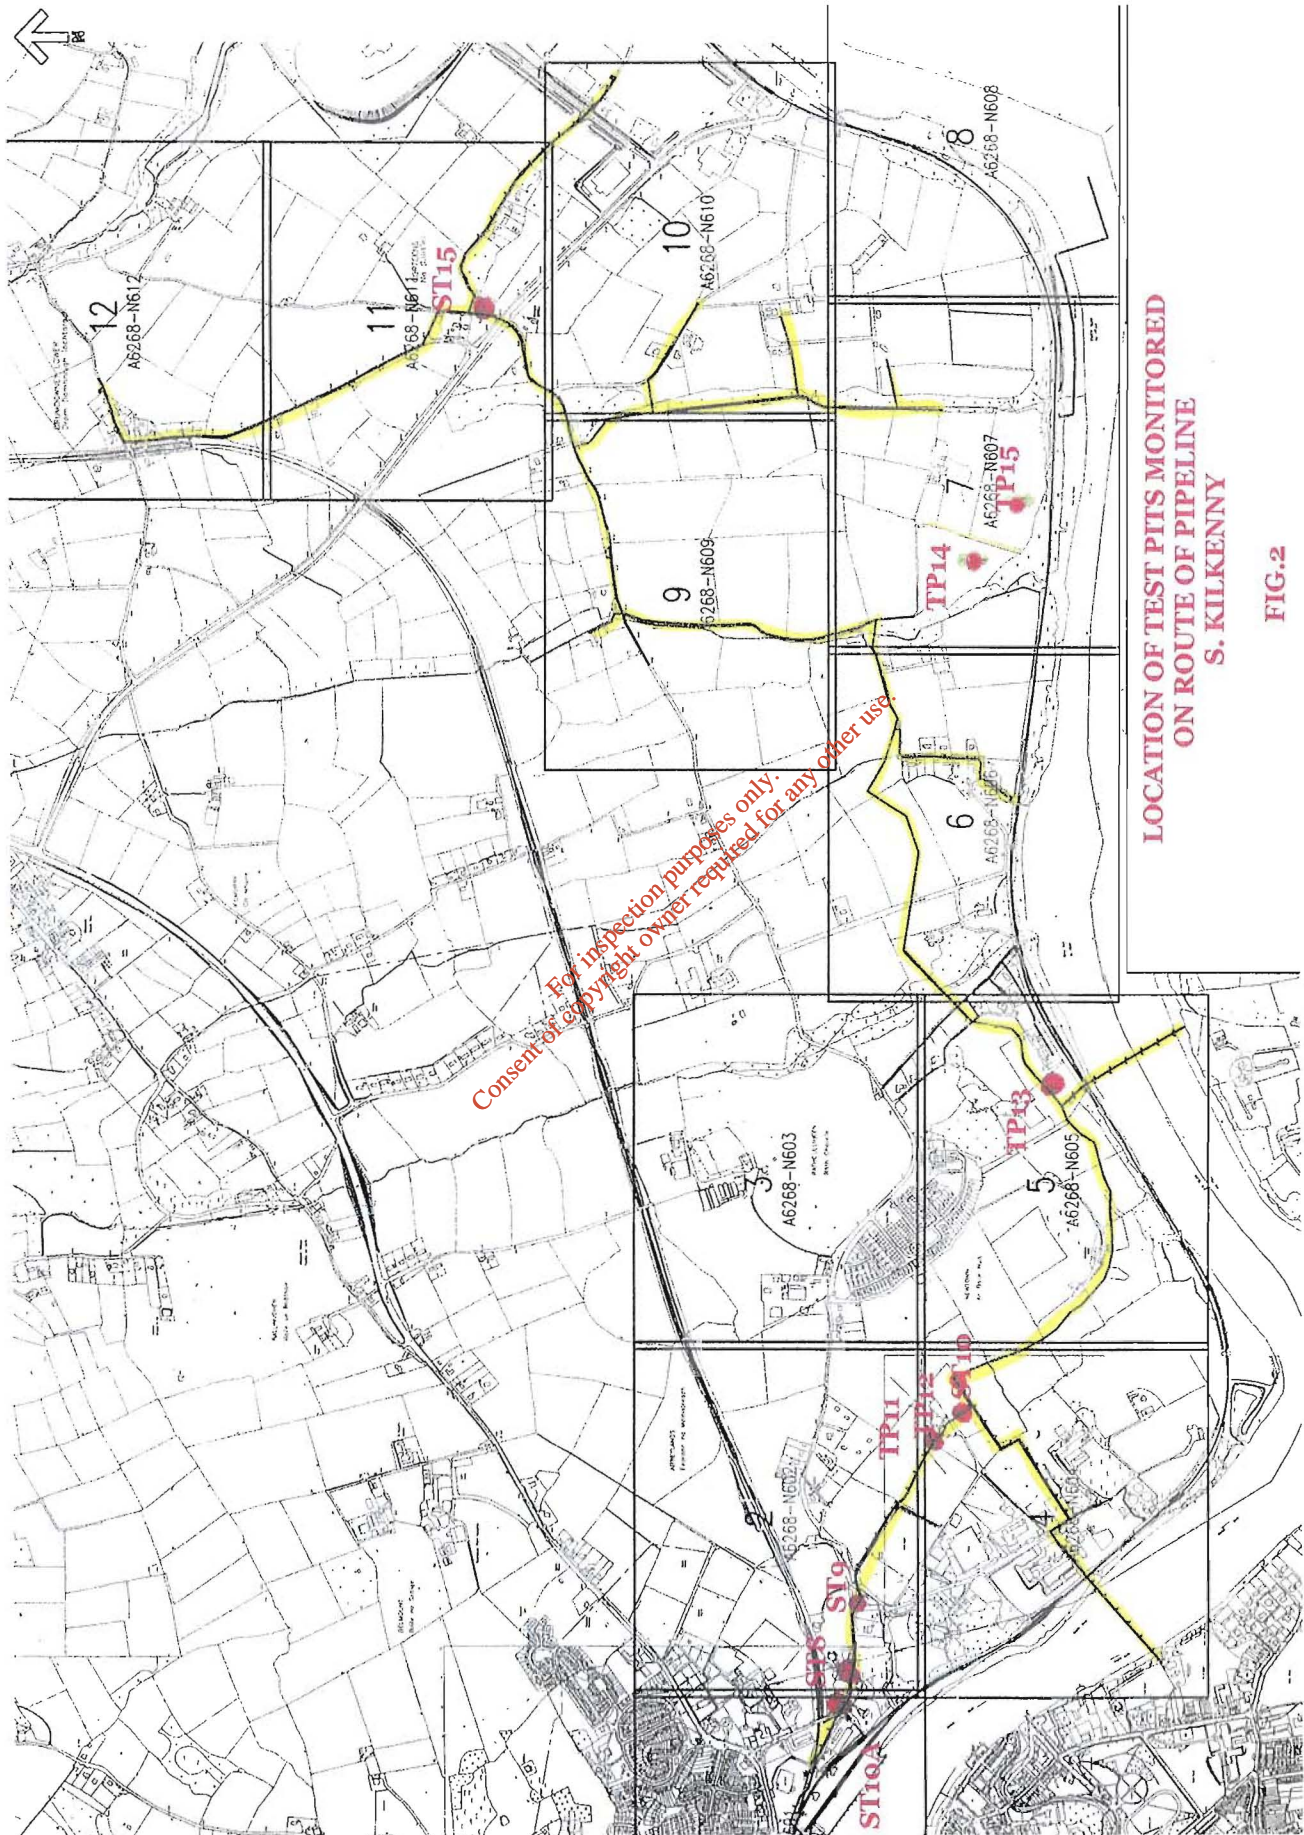
**FIG.2**

The test pits are described in order of location, from east to west. The engineers' titles of ST represents a slit trench, usually done to ascertain the location of services. The title TP indicates a test pit, normally dug to assess sub-surface depth and consistency of the soil and the level at which bedrock lies. The numbers allocated by the engineers have been adhered to for consistency between reports. The location of the test pits is shown in Fig. 2.

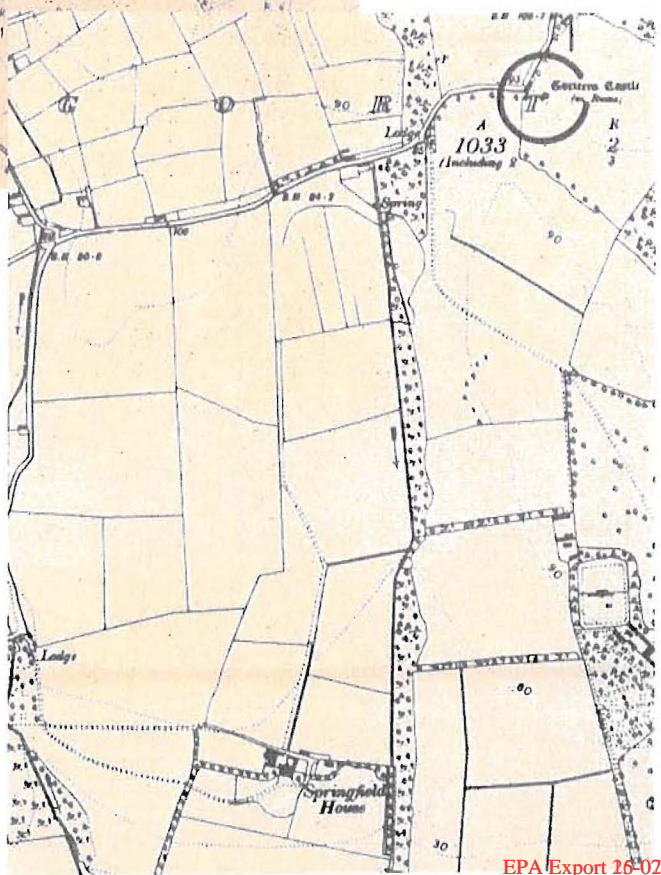
**FIG.  
3**

A more detailed account of the background is provided in the impact statement mentioned above. The locations of known monuments, which are in the vicinity of the route of the pipeline, are given in Fig.3.

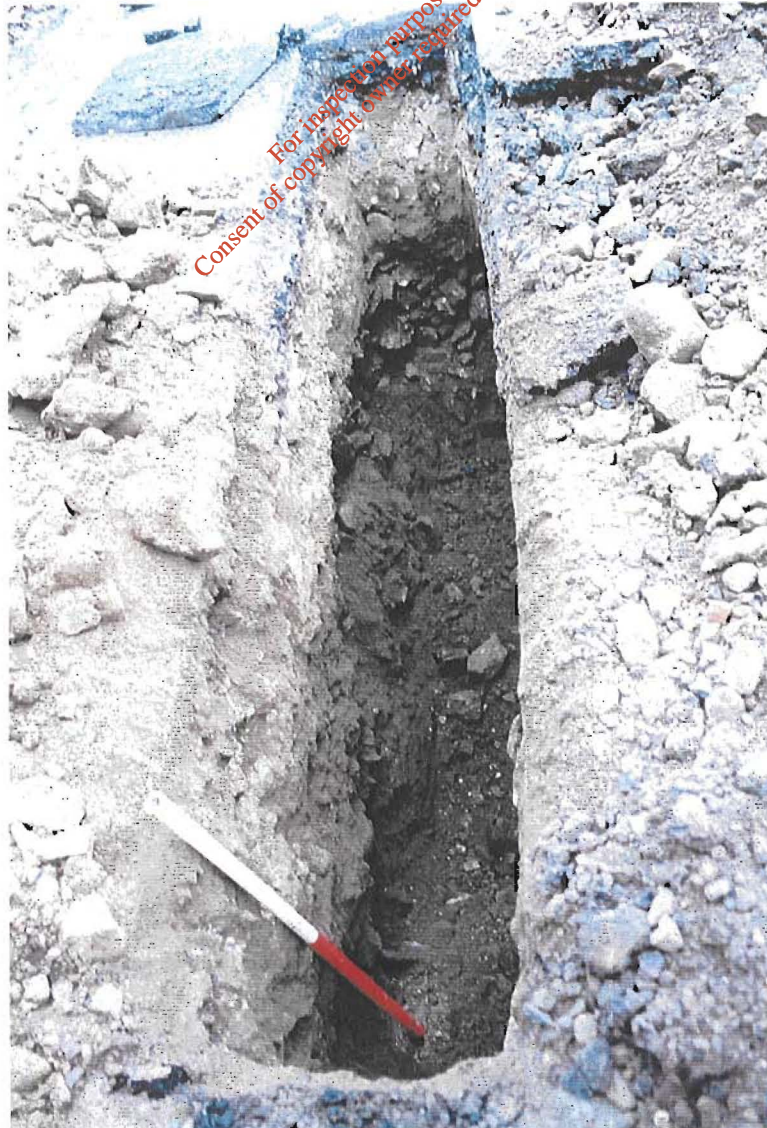
**Plate 2**  
**ST10A**

This was dug on the public road. in the vicinity of the gates of the C of I church in Abbeylands. The trench was dug parallel to the centre of the road, with its long axis lying east-west.

The surface of tarmac was removed with the underlying layer of industrial fill, a combined depth of 0.15m. Under this was an earlier surface of tarmac, c. 0.10m deep. Beneath this was a layer, 0.15m deep, of brown gritty soil with frequent fragments of red brick and occasional pieces of yellow brick. A layer of orange clay, almost 0.10m thick underlay the soil layer. This had occasional fragments of charcoal. The clay in turn overlay a dense layer of stones. These stones were assorted, including shale, igneous and limestone and were angular. It is reasonable to infer that these must have been introduced, dumped or used to backfill the area. The layer reached a depth of 1.27m at the east side of the trench, and 1.40m at the west, following the natural incline. This overlay boulder clay.

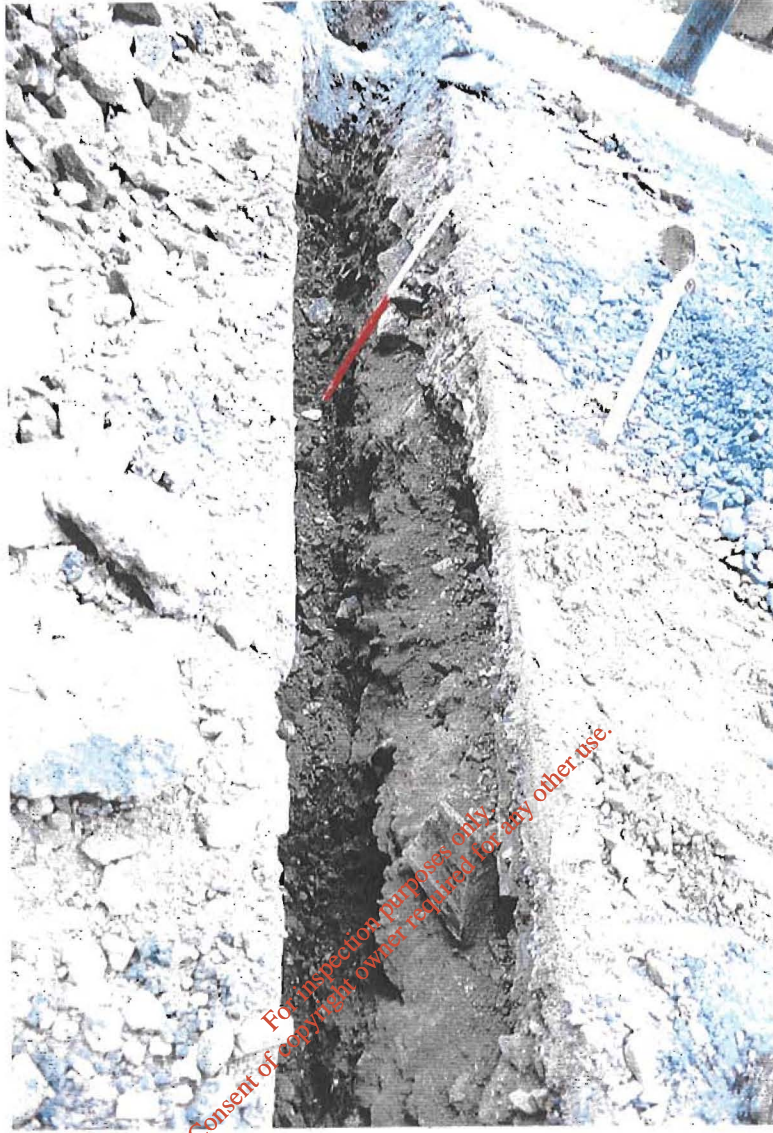
**Plate 3  
ST8**

The trench extended across the road, 16m east of the gates of Abbey House, the property at the east end of the church grounds. At the south side of the trench an organic rich garden soil was removed, exposing ESB cables at a depth of 0.62m. beneath the surface, 0.80m from the wall at the south. Outside the backfilled cable trench the soil was more stony and a light orange colour. There was a cast iron pipe, 0.84m down, at a distance of 3.10m from the wall. At the opposite side of the trench, 0.84 m below the surface of the road, was a gas pipe, the cut for which was backfilled with concrete. The layer contained some rubble, concrete with brick, including some pieces of cast concrete, which may have originally been a gate pillar. The layer became stonier towards the base, and was dug to a maximum of 0.90m.

Of the ten trenches monitored, only ST8A and TP14 yielded any indicators for archaeological potential. ST8A had an anomalous fill of angular stones which, because of its proximity to the site of an early church (underneath or in the vicinity of the present Abbeylands Church), should be flagged for attention during further monitoring in the event of the pipeline passing through this area. The possibility exists that an earlier enclosure associated with the early church was backfilled to level the area.

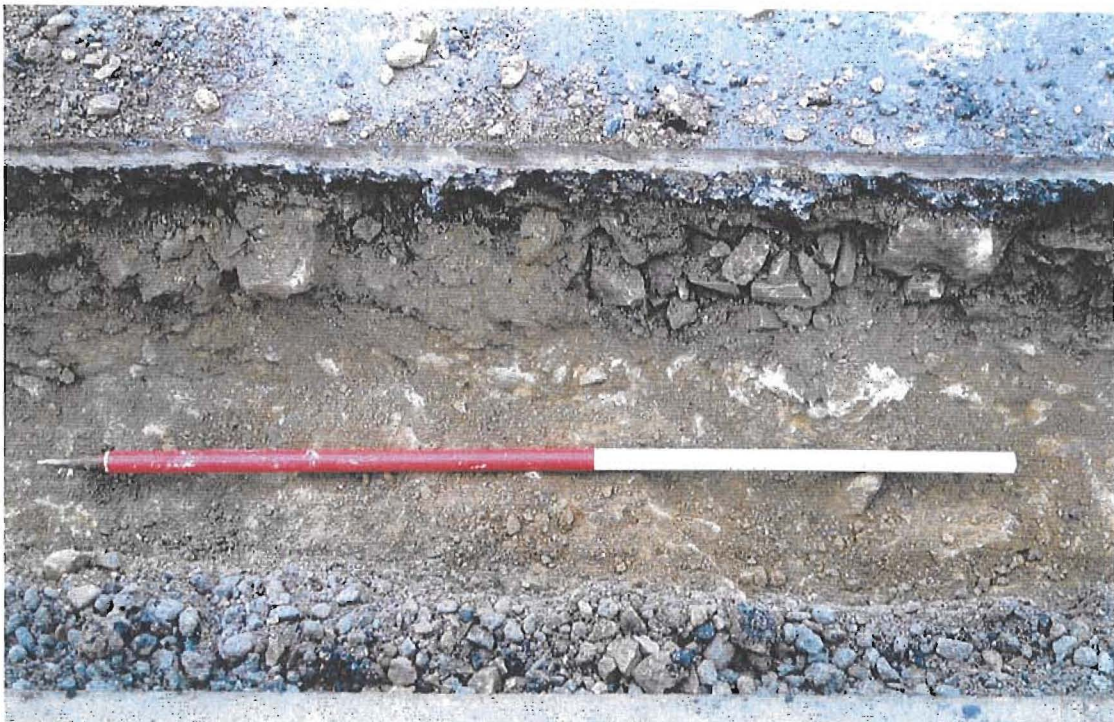
**Plate 4  
ST9**

This is located at the corner of the road which leads south at the bottom of the hill to the east of Abbeylands church.

The tarmac and sub-road fill, a pinkish crushed stone, measured 0.27m in depth. Beneath this was undisturbed yellow silty boulder clay with angular stones. The maximum depth was 0.90m. At the southern end water seeped in, indicating the presence of a land drain.

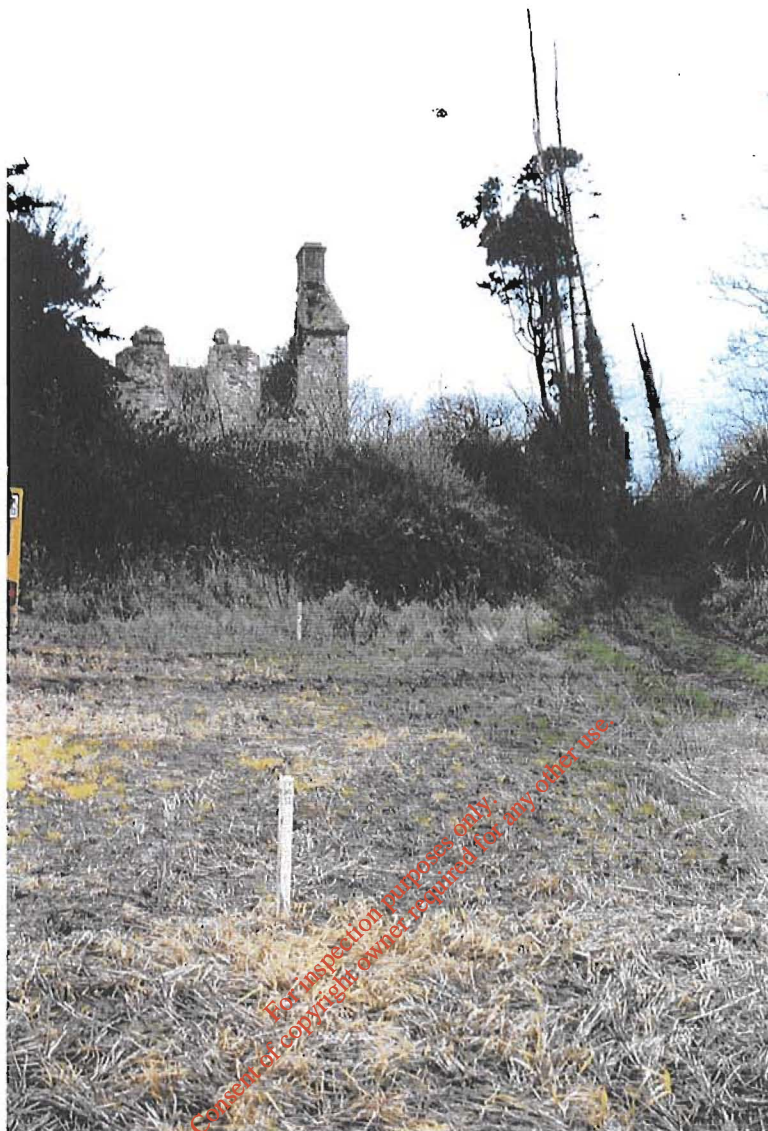
**Plate 5**  
**TP11 (location)**

This trench was dug in the field immediately west of Christendom House. The surface cover was stubble. The topsoil measured 0.30m in depth and yielded a sherd of chinaware and a sherd of red earthen tile. The subsoil was a mid-brown sandy soil with fragments of coal cinders. The basal layer was beige/yellow boulder clay. The maximum depth was 1.20m. No features were exposed.

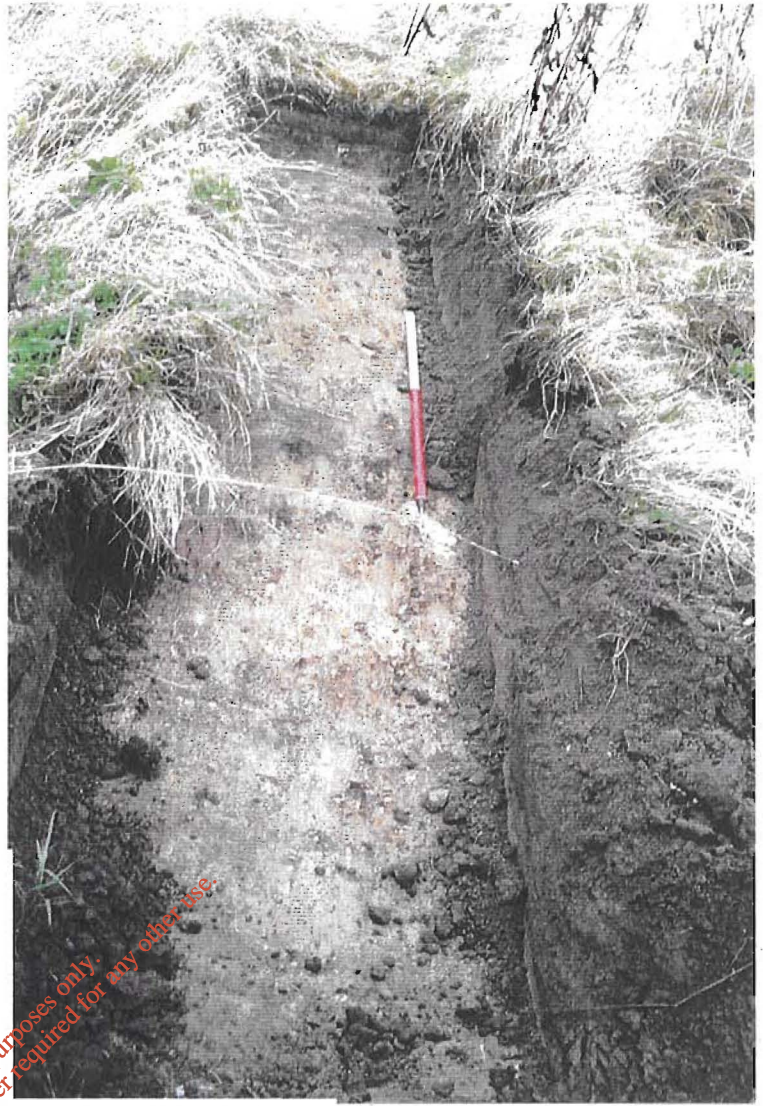
**Plate 7  
Tp12**

This trench was dug in the field to the east of Christendom house. The field had not recently been cultivated, with a grass cover including dock and nettles. The terrain was bumpy and ridged indicating previous ploughing. The topsoil was 0.30m deep and overlay undisturbed pale brown boulder clay in an even horizon. The trench was dug to 0.60m.

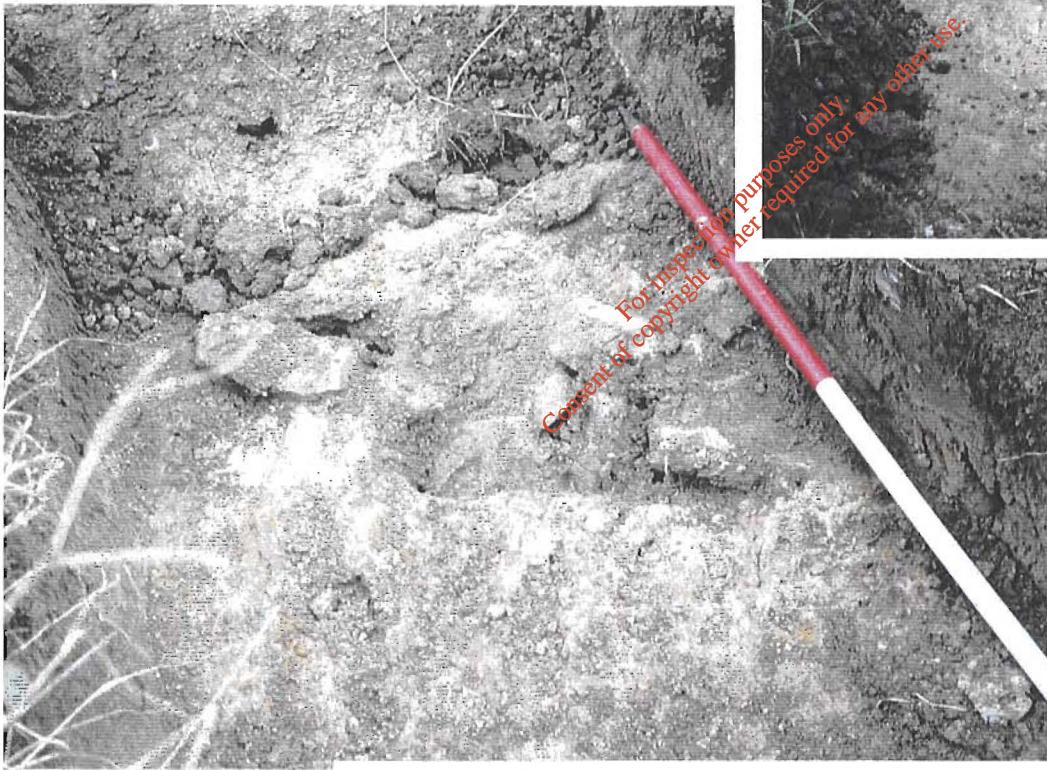
**Plate 8  
ST10**

The objective in digging this slit trench was to locate water pipes associated with the meat factory at the river to the south. The endeavour was unsuccessful, but the trench but the length of the trench was extended in the search to c. 6m. east -west. The topsoil, with grass cover, was mid to dark brown silty soil, measuring 0.30m in depth. The underlying orange/buff-coloured clay had some black speckles, which was identified by the geologist present as degraded rock particles. The only feature exposed was a land drain at the western end of the trench. At the northern (uphill) face of the trench it was 0.40m below the surface, and at the southern face it was 0.50m. its base was at 0.70m at the northern side, and 0.9m at the southern side. The average width was 0.27m, The drain consisted of an earth-cut trench filled with broken, angular shale stones. It crossed the slit trench diagonally, NNW to SSE. The maximum depth of the slit trench was 1.2m, and the basal layer was consisted of gritty pinkish boulder clay, including rounded small boulders of sandstone.

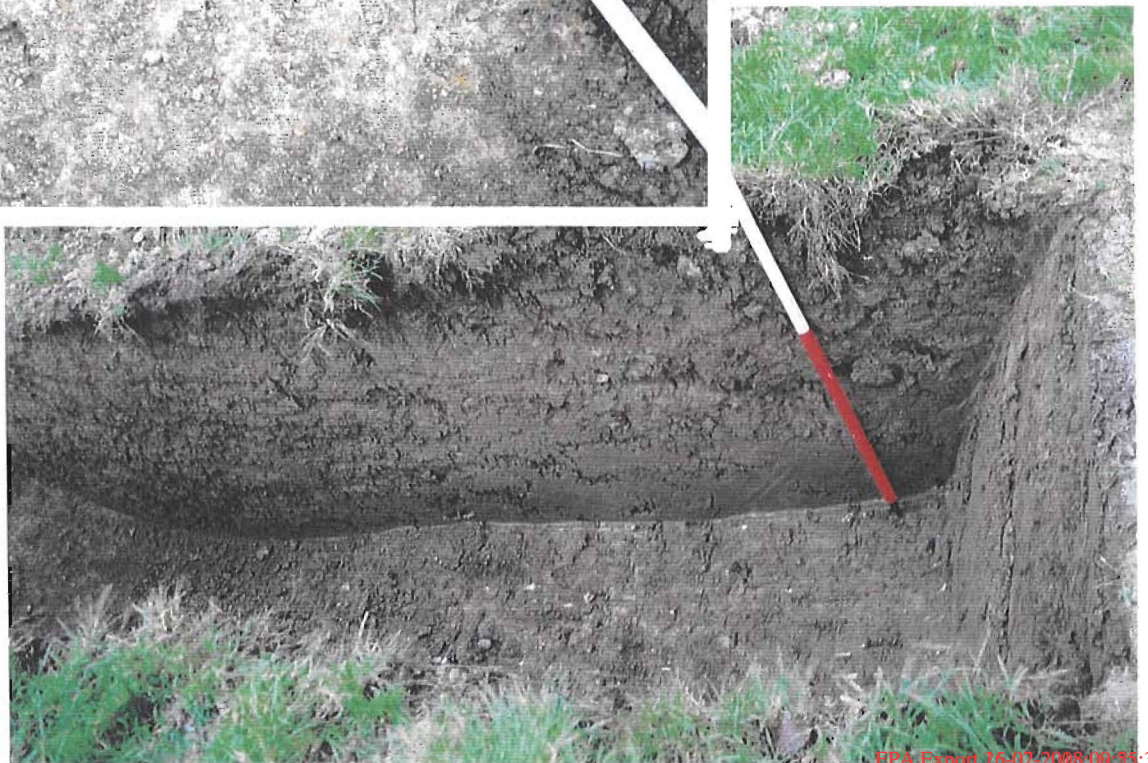
**Plate 9  
TP13**

This trench was located on the slope to the river below the site of a walled garden and ruined lodge at Rathculliheen. The topsoil was 0.23m in depth. This overlay orange/red loose stony subsoil, which extended to 0.55m below the surface. Beneath this was boulder clay. At the west face of the trench only, a lens of soft clay was evident at a depth of 0.57m.

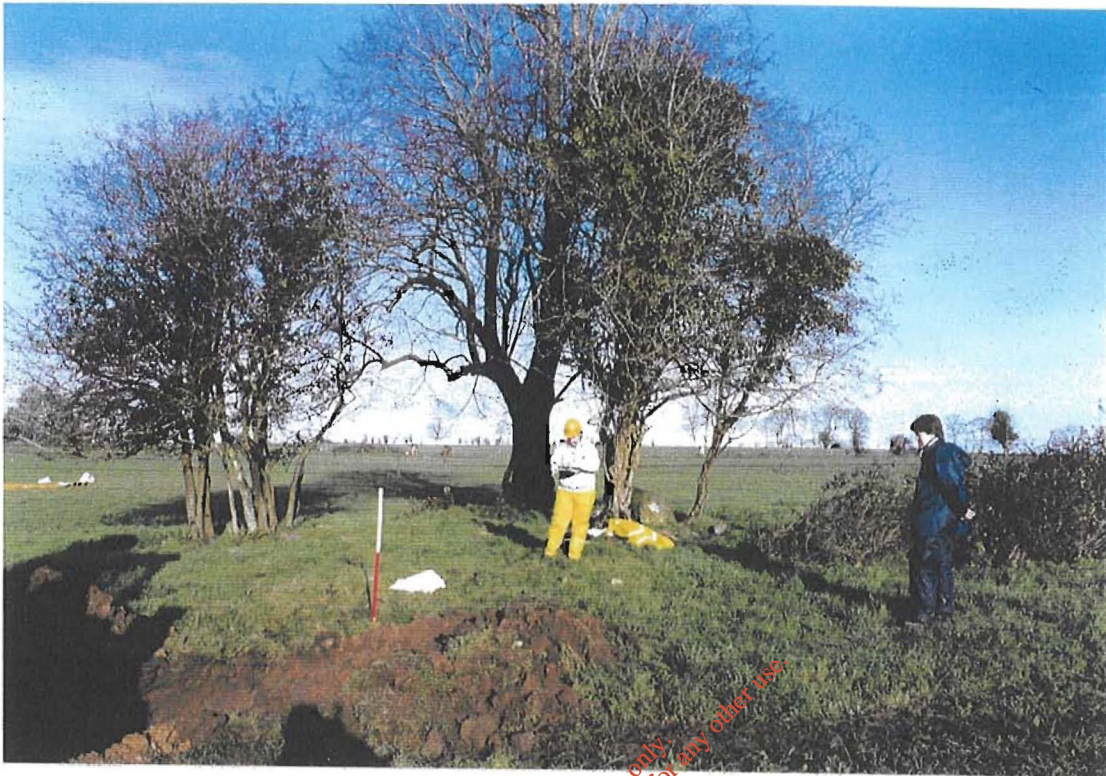
**Plate 10**  
**TP14 (center)**

The trench was intended to be excavated in the centre of a small stand of trees, (plate 10). Lying against the base of eastern most of the trees was a large boulder. Due to the testing happening in winter, grass and undergrowth was at a minimum. Close examination of the stone revealed some markings at the south-facing end of the stone, (plates 14, 15 & 16). These were deemed by geological/engineering staff not to be slickensides -resultant abrasion from glacial action. The stone measures 1.44m x 0.80m x 0.73m.

The trench was relocated to the south of the "baseline" created by the triangle of trees, 4.7m due south of the boulder (plate 10). The trench measured 3.6m N/S, 1.45m E/W and was dug to a maximum of 1.1m deep.

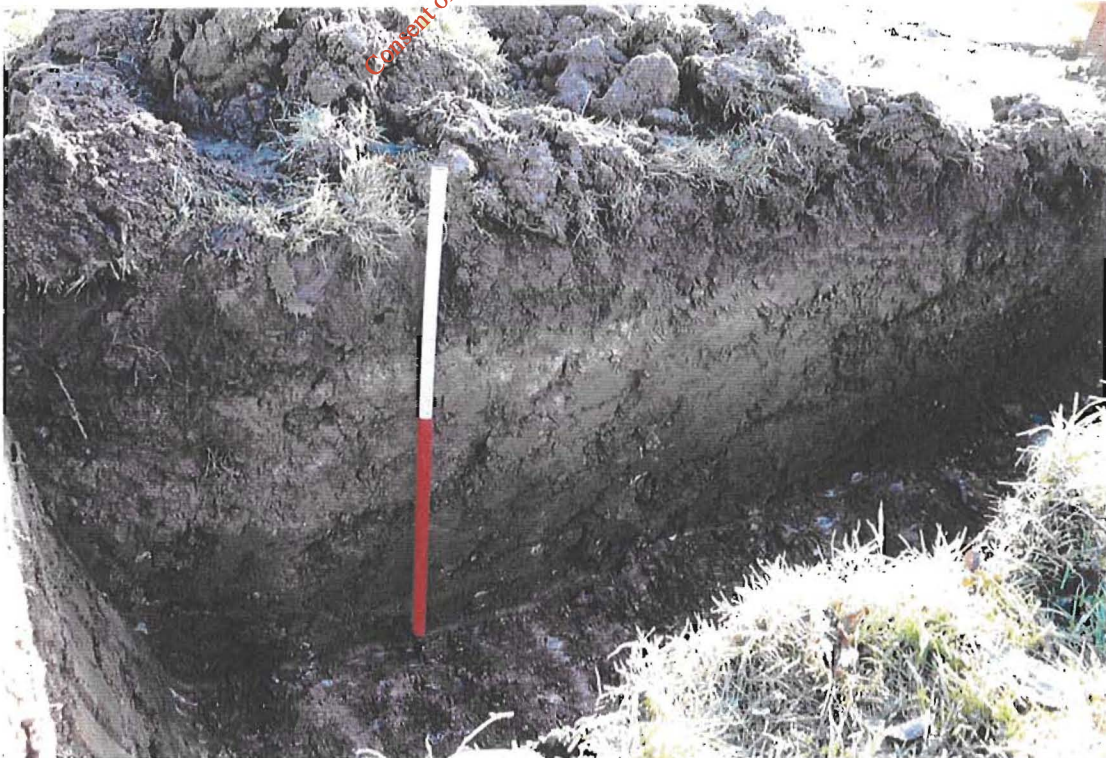
**Plate 11**  
**TP14 (from west)**

The topsoil was 0.12m deep, under which was 0.17m of brown slightly sandy subsoil. The west-facing side of the trench (plate 11) had an undisturbed profile of light brown/yellow clay mottled with red, with occasional stones and a lens of sand near the base. The east-facing side of the trench showed disturbance of the upper levels. This was consistent with the uprooting of a tree. The disturbance appeared as a cut in the subsoil and the boulder clay to a maximum depth of 0.60m. The fill was stony loose clay with a slightly darker colour than the 'natural' deposits in the area, with occasional rootlets. The cut and fill was also apparent in the south-facing side of the trench. At the base of the cut, in the south-facing section, was a sherd of blue willow patterned ware, (plate 13). The likely explanation is that the piece is intrusive at this depth, having fallen in from the surface when the socket of the tree roots was open.

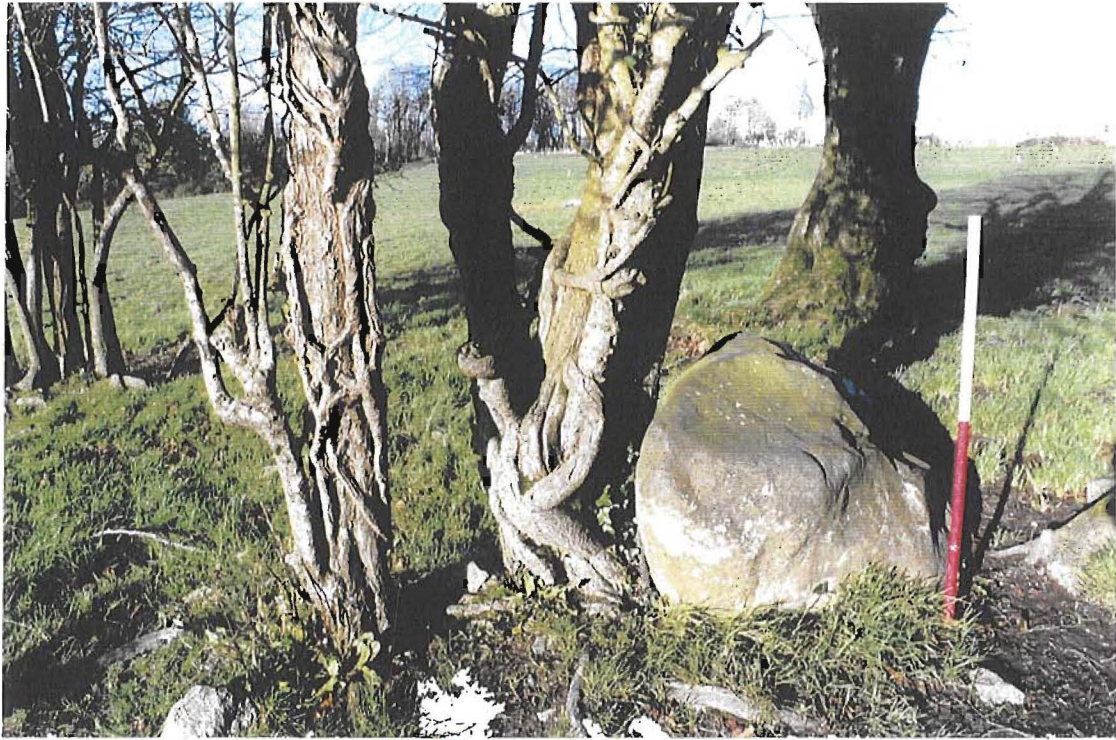
Stone with markings north of TP14

In the case of the marked stone at TP14 it is a precaution to have it looked at further. The shape of the stone is not rectangular, or tapered in the shape often associated with Ogham stones, but nevertheless it would be advisable to have personnel from Duchas, with expertise in this area, to review the marks. It has been suggested that either Finbarr Moore or Paul Walshe of Duchas be consulted. The possibility exists that the markings could be the remains of an Ogham inscription, though it is far from certain.

In the case of the marked stone at TP14, the opinion of an archaeologist in Duchas with expertise in this area, Mr Finbarr Moore, was sought. He concluded that the stone was not an Ogham stone. However, he did not rule out the possibility that the stone was from an earlier period. The marks appear to have been chiselled, and are not consistent with scrapes from a ploughshare. Chris Corlett of the licensing section of Duchas suggested the planning authority of Kilkenny, (in consultation with Maeve O Callaghan or Mark Keegan, the Duchas archaeologists with responsibility for planning in Co. Kilkenny), stipulate that the stone be retained. My recommendation would be that the stone should be displayed either on site, incorporated into the landscaping, or given to the care of Waterford Treasures, a designated repository for the National Museum.

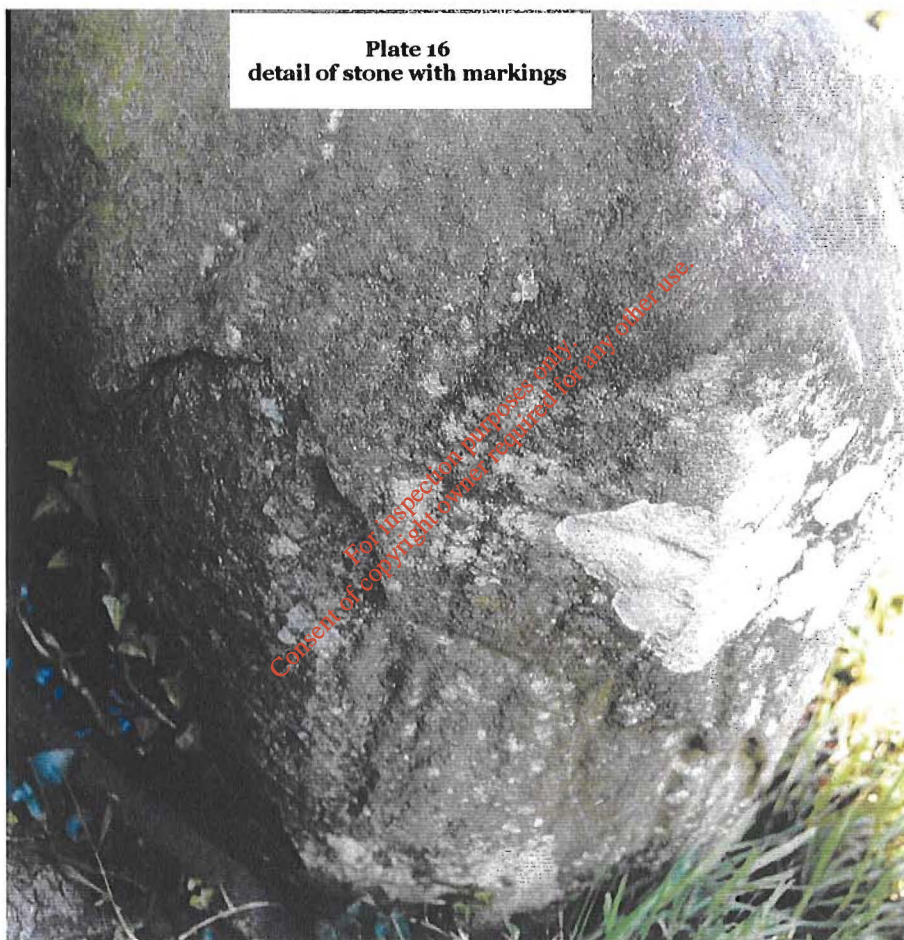
**Plate 16**  
**detail of stone with markings**

The markings on the boulder at the original location of TP14 may or may not be archaeologically significant. No archaeological features or finds (other than the modern potsherd) were noted in the testing of TP14.

As a general conclusion, it is recommended that all further works associated with the excavation of the pipeline and the construction of the wastewater treatment plant be monitored by a licensed archaeologist. This archaeologist should be fully appraised of the original location of the stone, and of the cautions attached to its potential function as a marker of some sort. The monitoring archaeologist should be provided, in advance, with the impact assessment and test pit monitoring report.

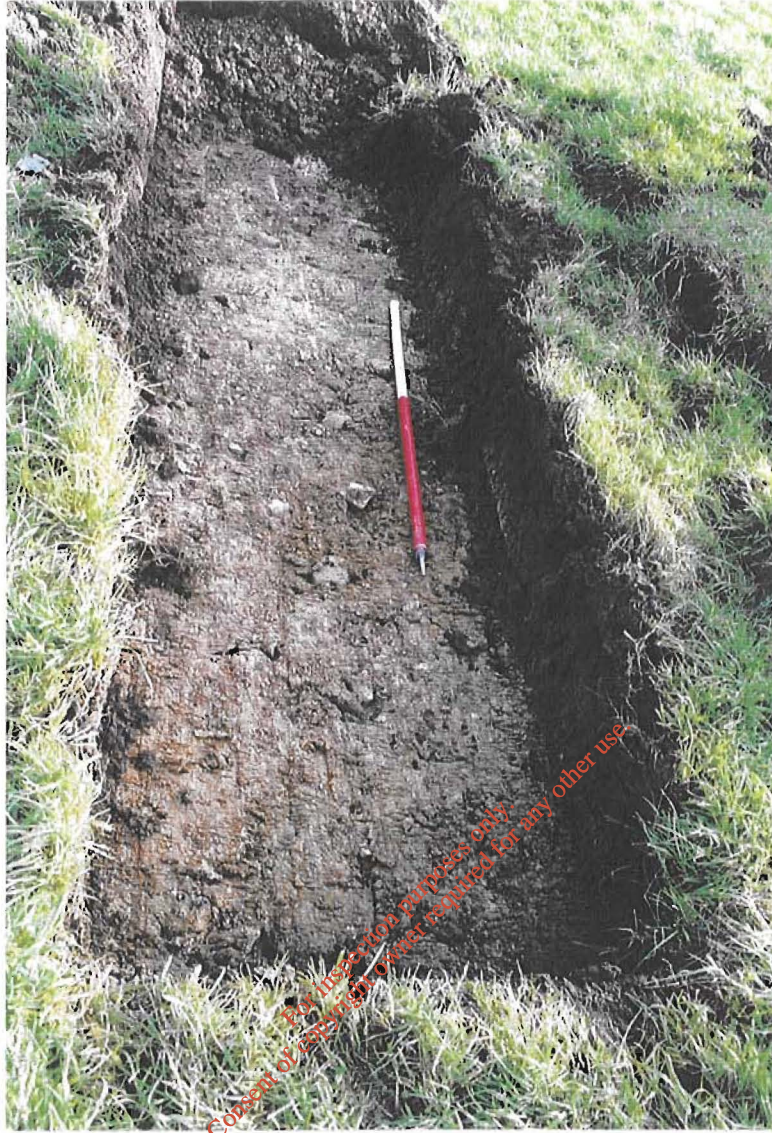
**Plate 17**  
**TP15**

This trench was located in the field in front of Springfield house, bordered at the south by the railway line, which runs alongside the river in this area. The field has some linear ridges, which may be soil creep resultant from intermittent flooding in the past. The topsoil was mid to dark brown soil, which lightened in colour towards the base at 0.25m below the surface. This overlay a sandy clay with small stones. There were no features or finds in the trench, which was 3.60m in length E-W and was dug to a maximum depth of 0.80m.

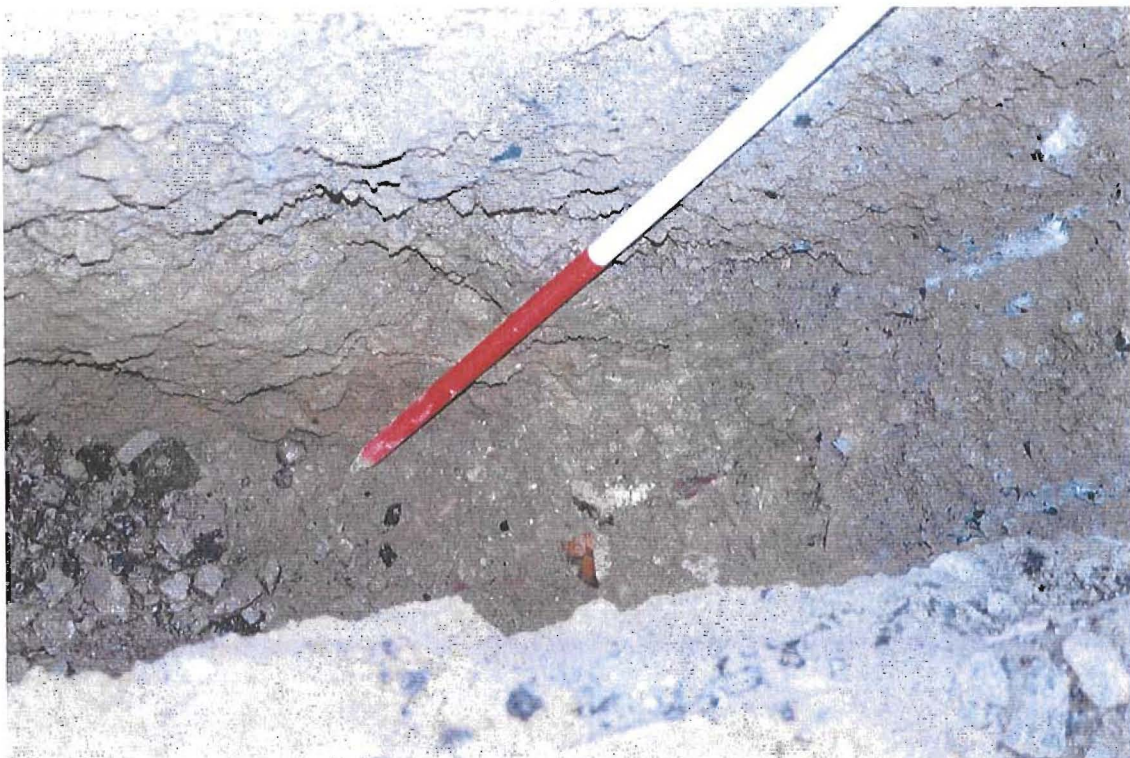
**Plate 18**  
**ST15**

This was excavated on the proposed route of the pipeline, at the margin of the road east of Gortens Castle. (A new road was built in the 1990's passing north of the castle, leading to the port at Belview). The trench had an unusually thick layer of road fill under the tarmac, up to 0.80m beneath the surface. Under this was sandy gravel rich clay. The bedrock showed at less than one metre below the road surface.
