Molaisín Compost Ltd
Waste Licence Application

**Existing Composting Facility
At
Kilmolash, Cappoquin, Co. Waterford
For
McGill Environmental Systems (Ireland) Limited**

LANDSCAPE ASSESSMENT

**MAY 2008
REFERENCE: J_132108**

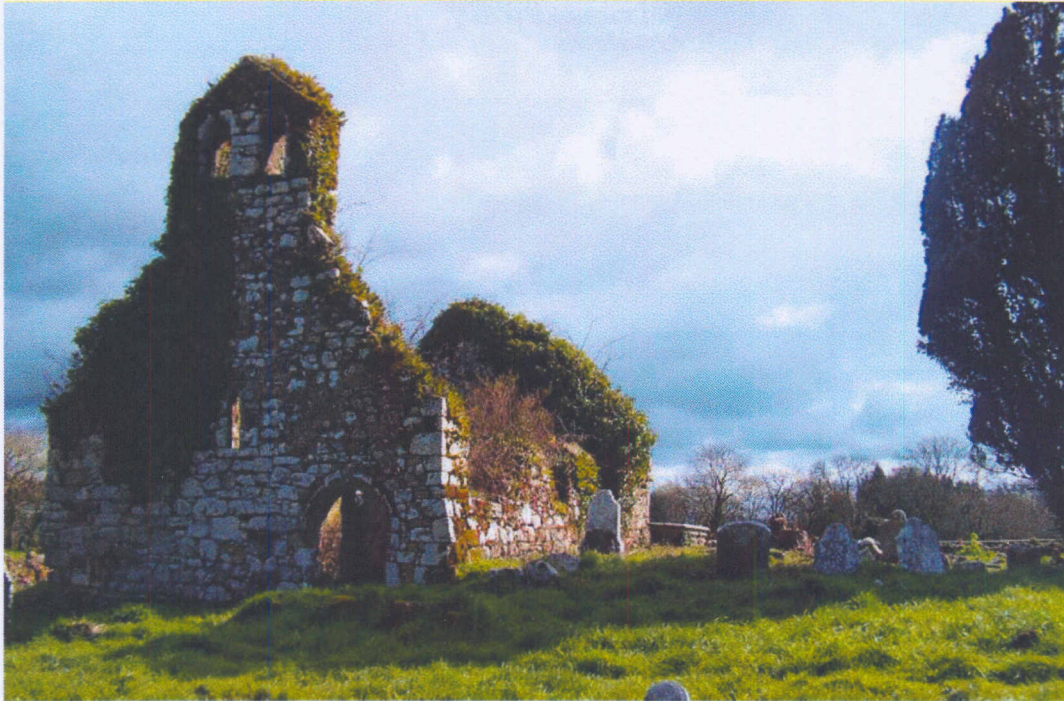
Plate 1: The ancient Kilmolash Church and graveyard, located on a third class road 0.5 kilometres north west of the site.

Existing rural views to the site are seen from the area of Kilmolash Church and Kilmolash Bridge approximately 0.5 kilometres to the northwest. The ancient Kilmolash Church and graveyard (Plate 1), now in ruins is a prominent historical feature in this landscape. Conversely, views from this location show the woodland area on the higher ground to the south of the site as predominant on the skyline.

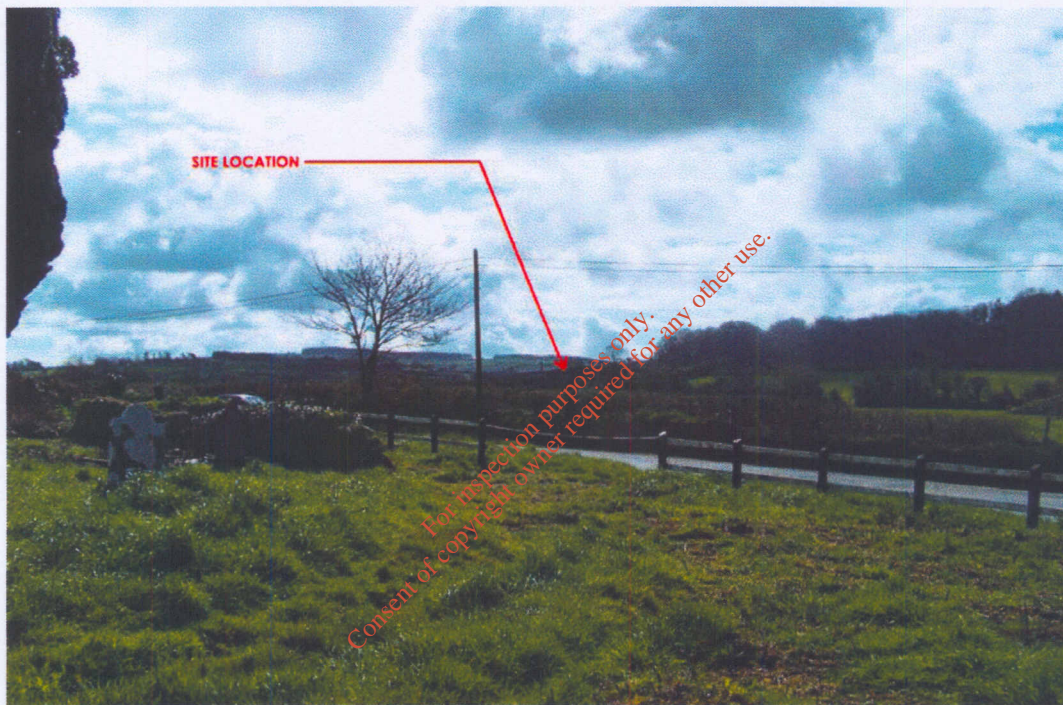
This exposure in turn affects the aesthetic value of the site, compared to that of a location hidden from view by a ridge or mountain range, for example. The cladding on the facility building is of a green colour which blends with the landscape. The roofline does not impact on the skyline. (See Plate 2).

Plate 2: View from Kilmolash church, which shows the site in the centre of the picture. The existing facility building is visible from this location.

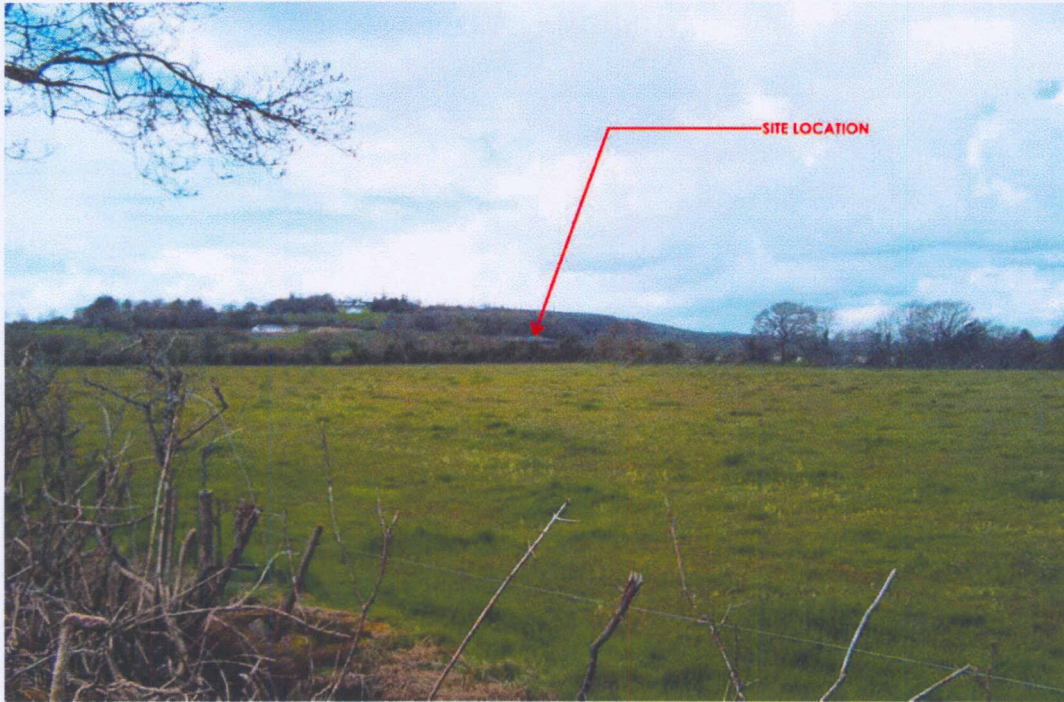
There are interrupted views to the site from locations along the N671, particularly along the road in locations north east of the site (Plate 3). The site is in part naturally screened by existing mature field boundary hedgerows.

Plate 3: View of the site from N671 which shows the site in the centre of the picture. The existing facility building is visible from this location also.

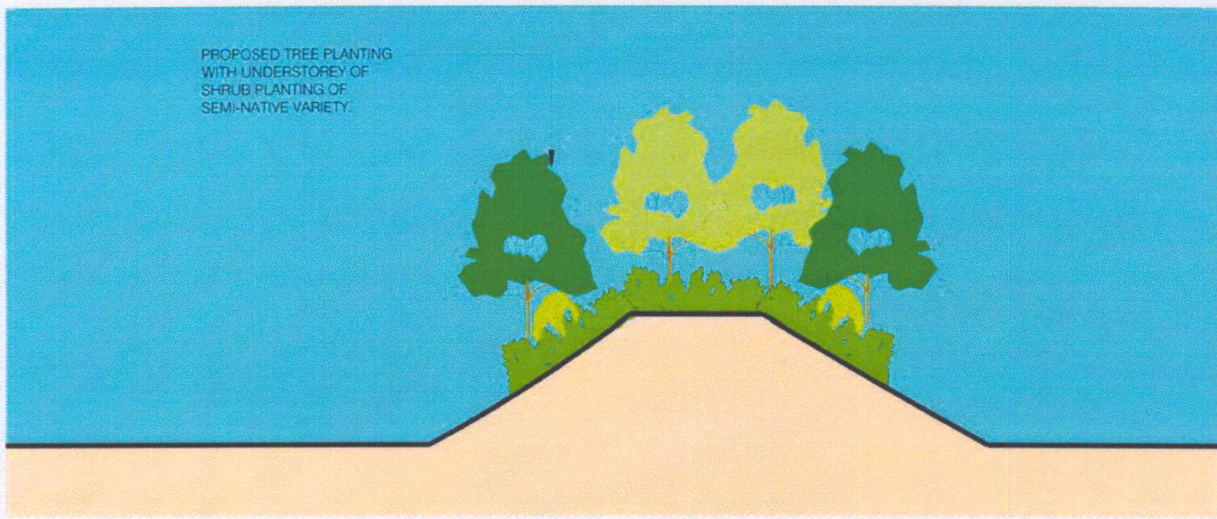
Figure 3.

Refer to Figure No. 3, which shows details of the site including the existing site boundary treatment and proposals for landscape works such as retainable hedgerows and proposed planting.

PROPOSED TYPICAL SECTION OF EARTH BERM

EXISTING SITE LAYOUT

The proposed mitigation measures aim to propagate the feeling of a rural agriculturally influenced environment with strategies such as:

- Removal of all existing *Ulex spp.* (gorse) which has established on the northern and western earth berms. There are young trees, previously planted on these embankments but are being suffocated and damaged by the existence of the *Ulex* (gorse).

- Supplement indigenous native species hedgerow planting should occur on these earth berms such as *Crataegus monogyna* (Hawthorn) and *Fraxinus excelsior* (Ash), *Ilex aquifolium* (Holly).

- Retaining and protecting all hedgerows and mature trees that exist along boundaries on the site.
- An ongoing maintenance management programme should be implemented to ensure the establishment of all boundary plantings, particularly the northern and western earth berms.

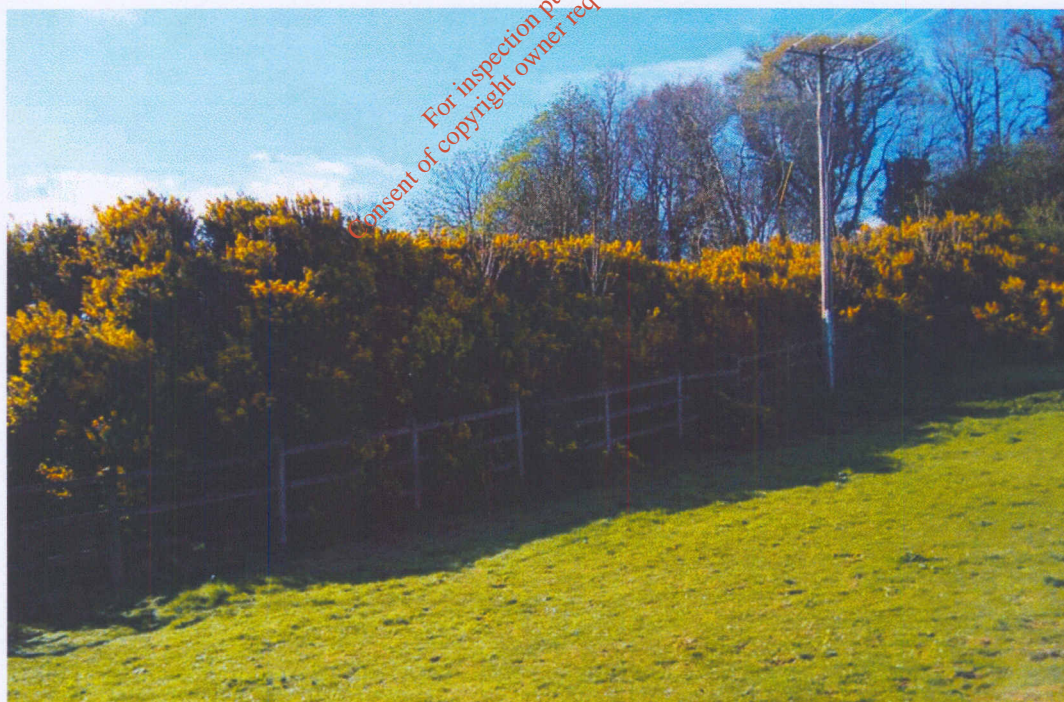
Western boundary: The vegetation along this boundary earth berm mainly comprises establishing Ulex (gorse) and some grasses. There is an existing concrete post and concrete three rail and wire boundary fence, which is broken along some sections.

Plate 4: Western earth berm from outside site. *Ulex* (gorse) and grasses have naturally established on this embankment thus suffocating the existing young tree plantings. Some of these trees are visible in the photograph.

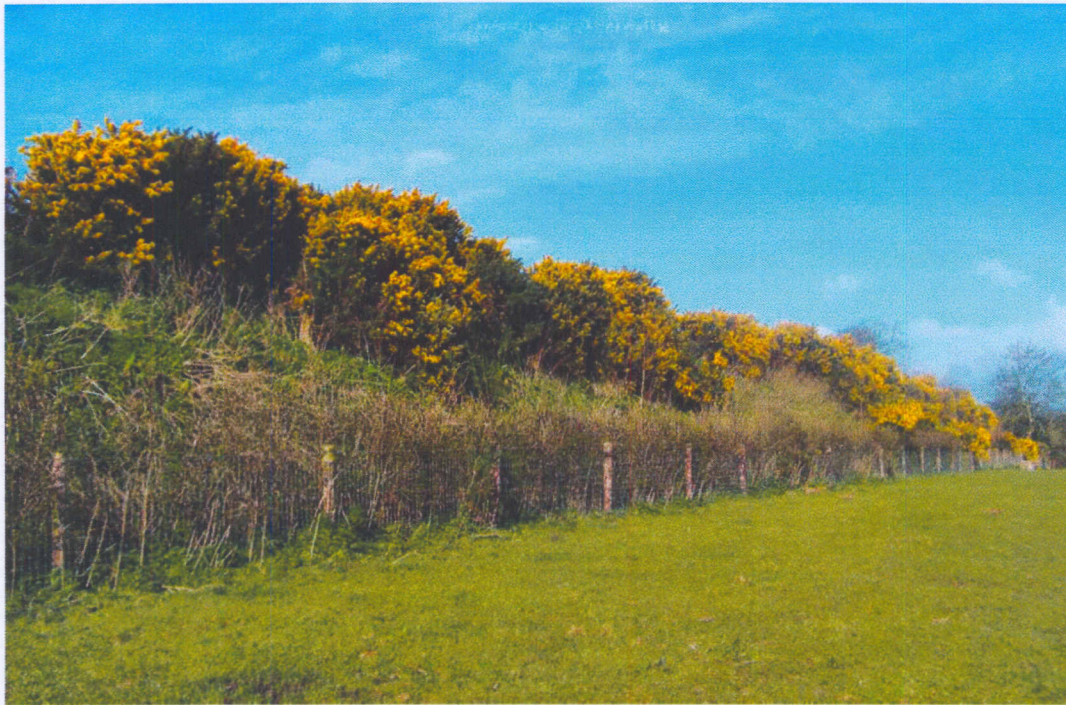
Northern boundary: Likewise, the vegetation along this boundary earth berm is similar to the west boundary, mainly establishing Ulex (gorse) and some grasses. There is an existing timber post and mesh chainlink boundary fence.

Plate 5: Northern earth berm from outside site. Again Ulex (gorse) and grasses have naturally established on this embankment thus suffocating the existing young tree plantings. There are no trees in existence in this view.

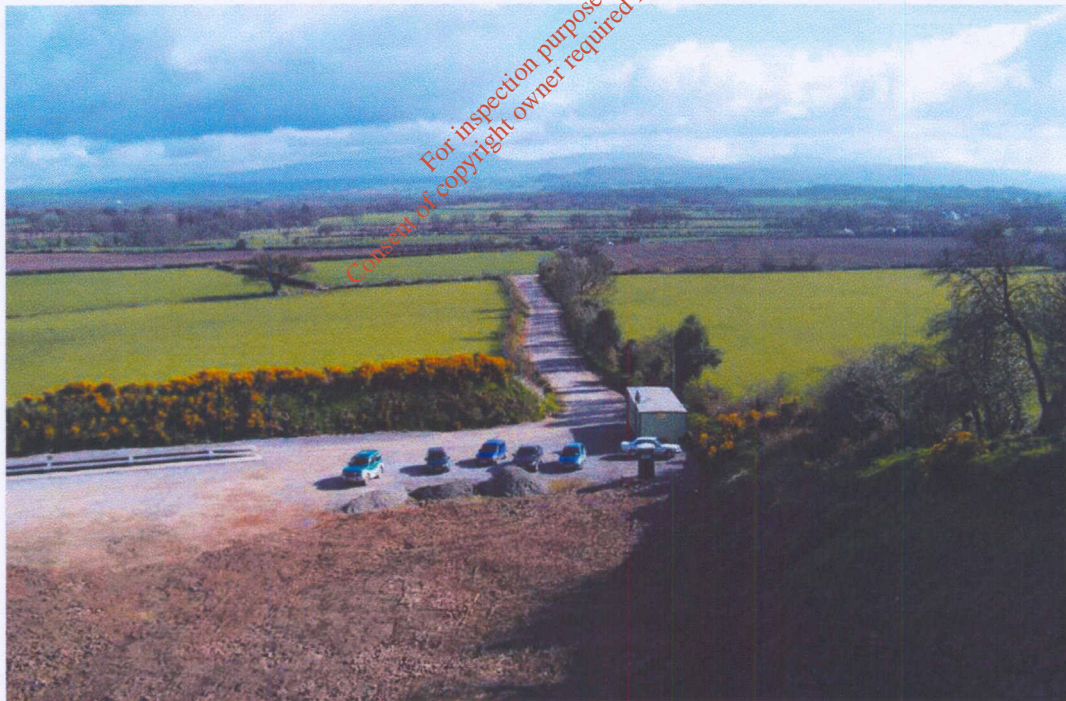
An existing mature native species hedgerow is located along much of the sod and stone ditch at the east side of the access road. An establishing native species hedgerow is located along a sod and stone ditch which runs along the west side of this access road. The vegetation in these hedgerows consists mainly of *Crataegus monogyna* (hawthorn), *Ilex aquifolium* (holly), *Fraxinus excelsior* (ash) and *Acer pseudoplatanus* (sycamore), *Rubus fruticosus* (bramble).

Plate 6: View looking north. The existing mature hedgerow can be seen on the right of the access road and the establishing native species hedgerow is on the left hand side of the access road. The northern boundary earth berm is in the middle of picture at the left side. The eastern boundary, on the right hand side rises to higher ground to join with the southern boundary.

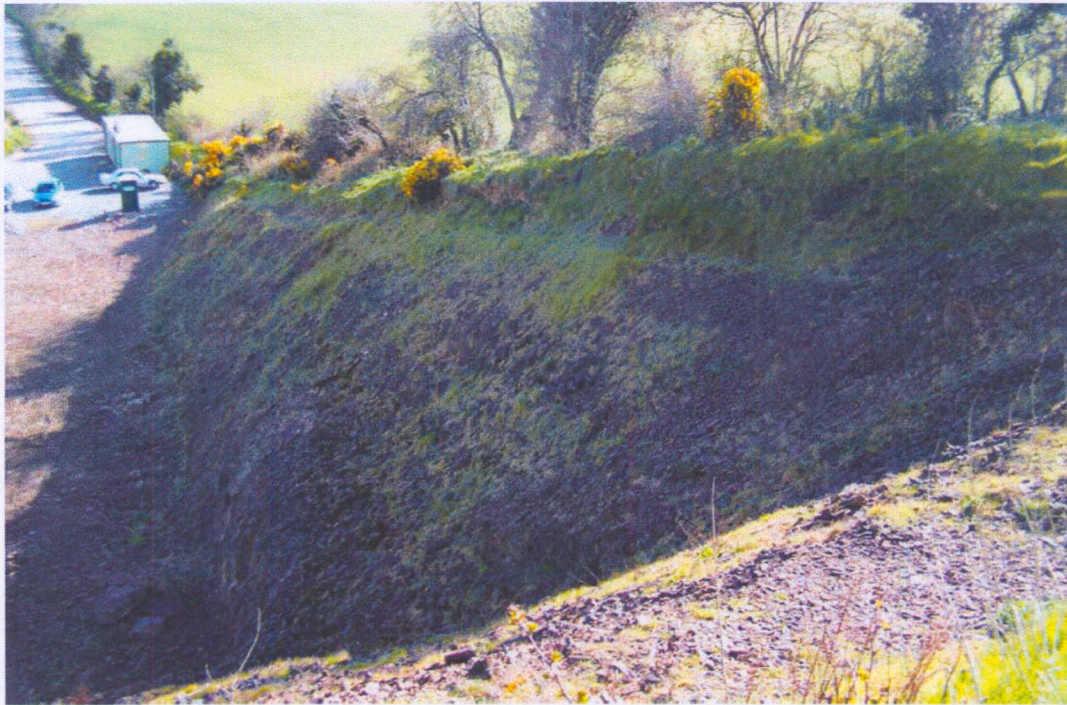
Eastern boundary: The eastern boundary of the site consists of mature and regenerating native species hedgerow vegetation growing on the higher regions of the steeply sloped boundary. Existing supplement planting has occurred along this boundary where it was deemed necessary.

Plate 7: View showing the eastern boundary. The existing mature hedgerow can be seen along the top of this boundary. Gorse can be seen establishing in certain areas along the boundary at the top of the earth berm. This should be removed.

- Gorse has begun to establish in some areas along the eastern boundary and should be removed. Previous supplement hedgerow planting exists along this boundary.

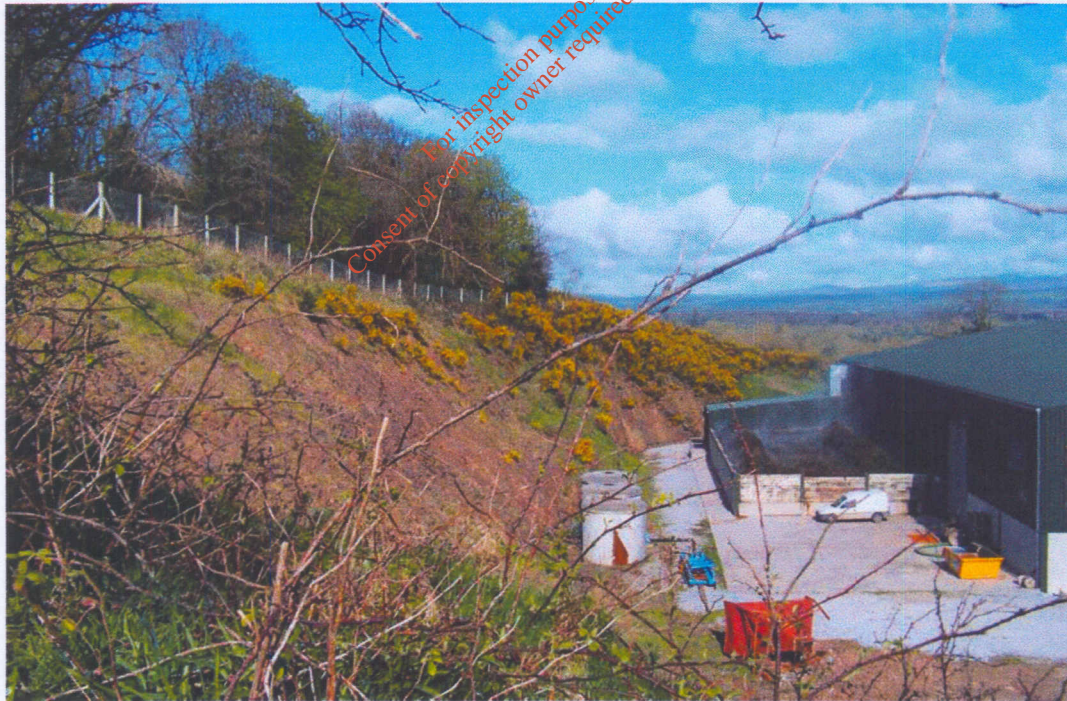
Plate 8: View showing the compost building facility and the southern boundary slope.

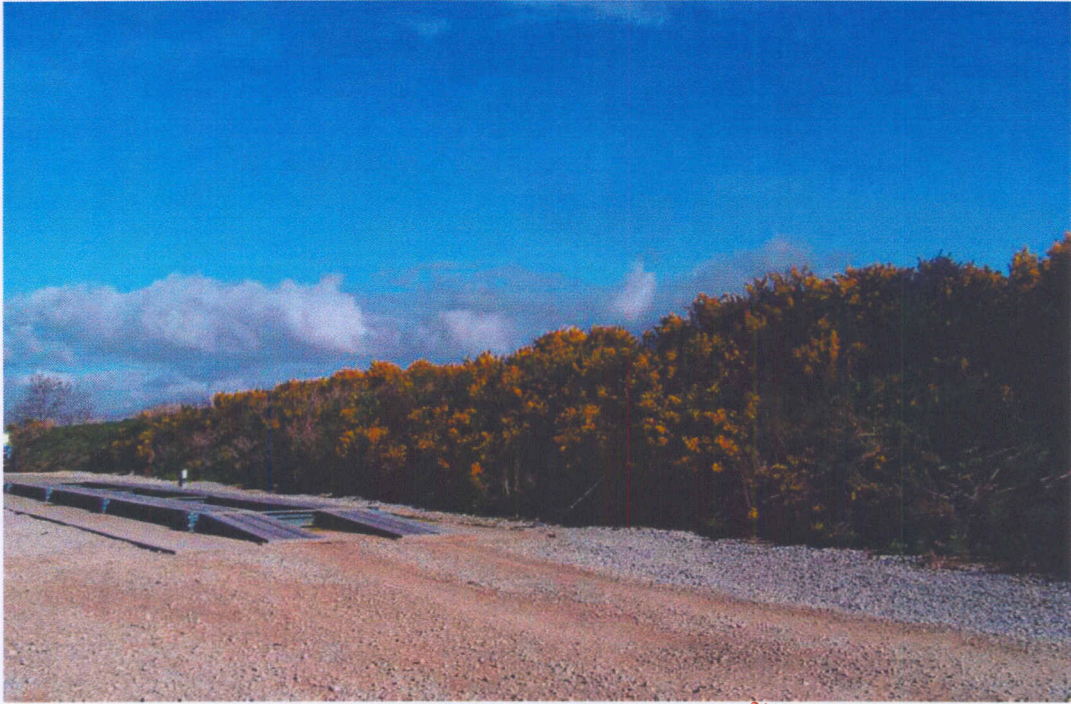
Plate 9: View from inside the site showing the northern boundary earth berm.

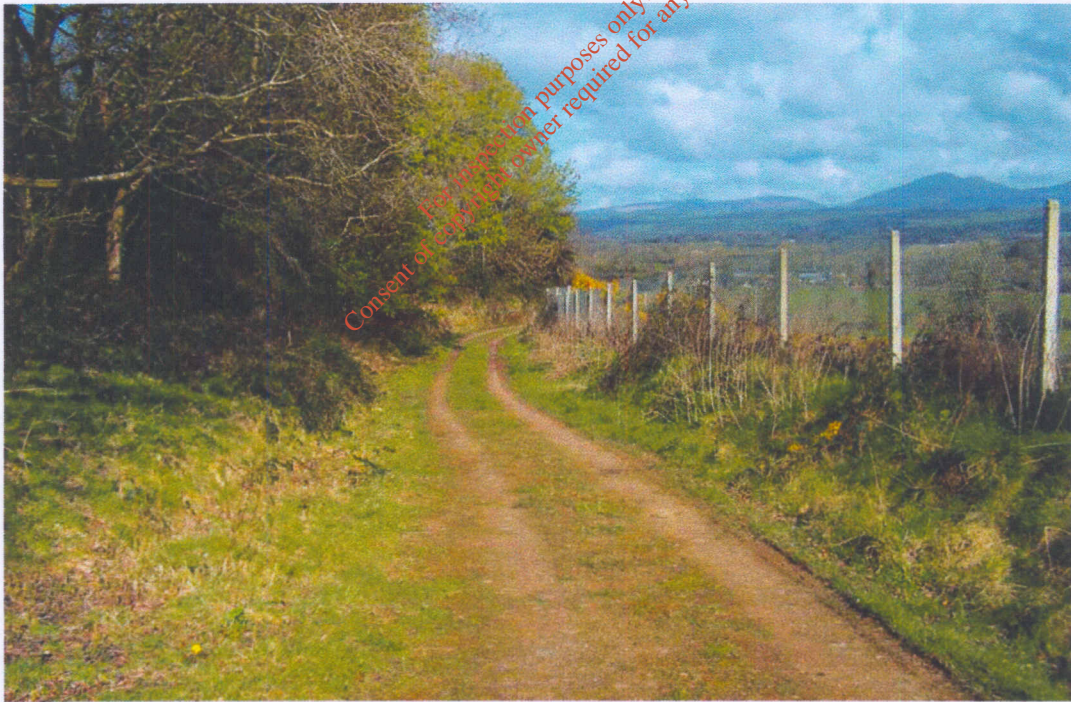
Southern boundary: Existing vegetation is evident in the higher regions of this boundary between the concrete post and chainlink fence at the top of the slope and the public road. Mature trees containing mid and understorey vegetation exist here. Existing supplement planting has occurred along the boundary in proximity to the road where it was deemed necessary. There is a track which runs along the outside of the fence. An old world agricultural gate is located at the end of this track. This gate should be retained. The steep slope runs the full extent in proximity to the southern boundary. Ulex (gorse) and some grasses are establishing in some areas on the predominantly rocky slope.

Plate 10: View inside the site which shows track and the safety fence located along the top of the steep slope on the southern side of the site. The mature indigenous trees on the left hand side are within the site. The public road is on the left of these trees (road not in view).

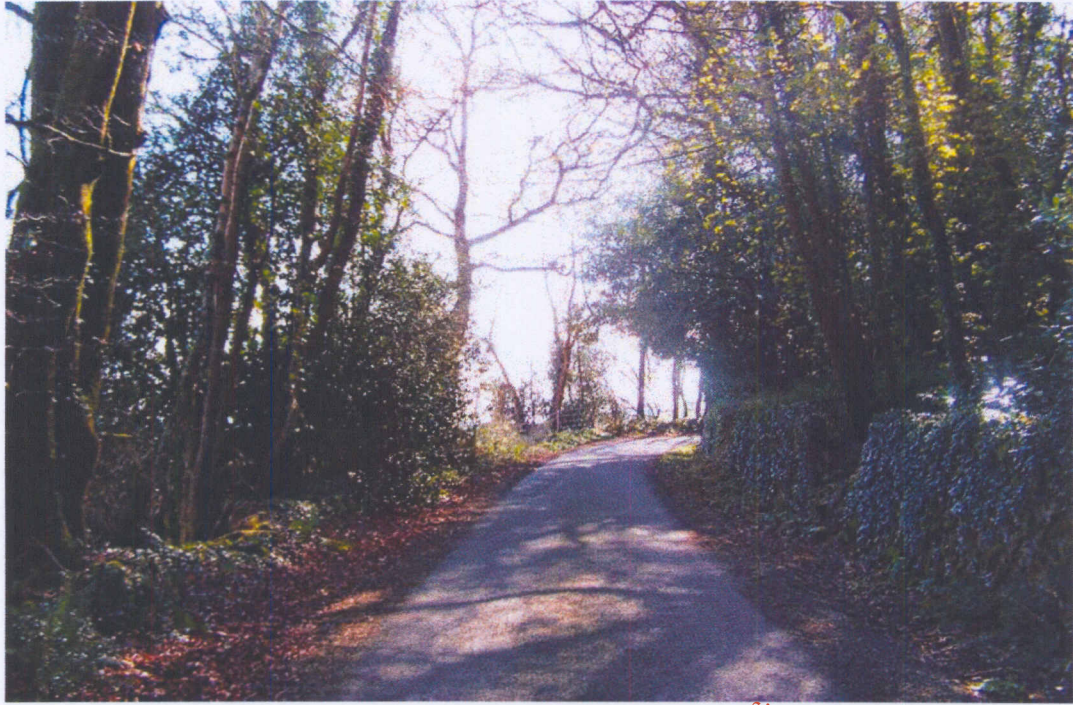
Plate 11: The public road located along the southern boundary. The site is on the left hand side.

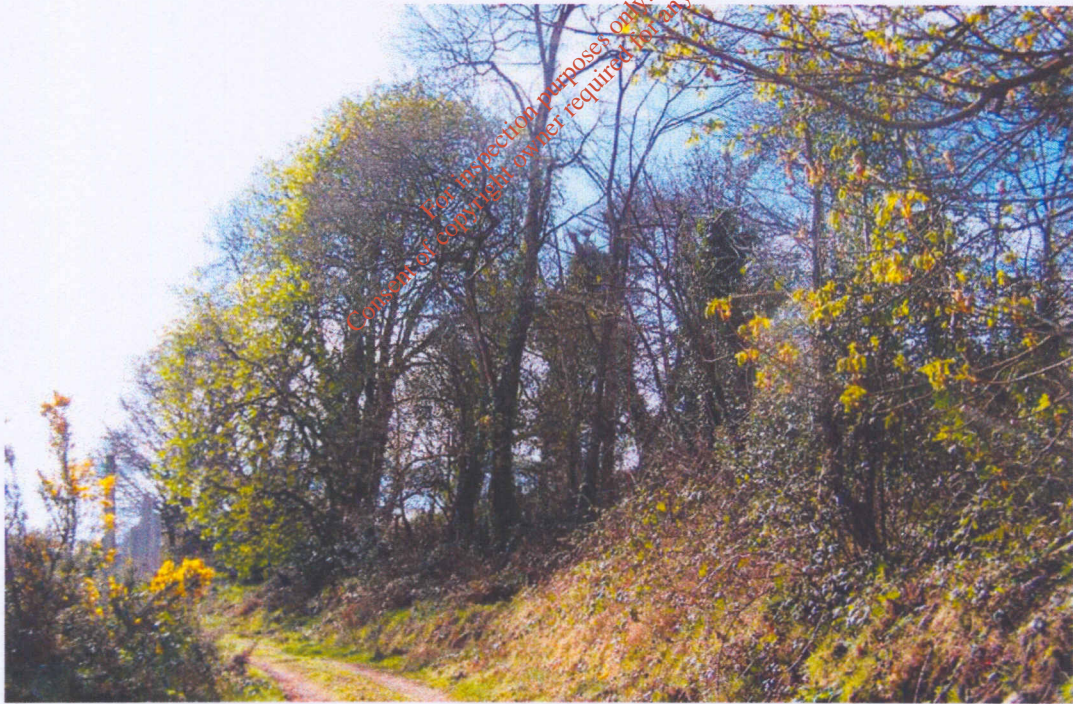
Plate 12: Another view showing the mature vegetation which forms the southern boundary.

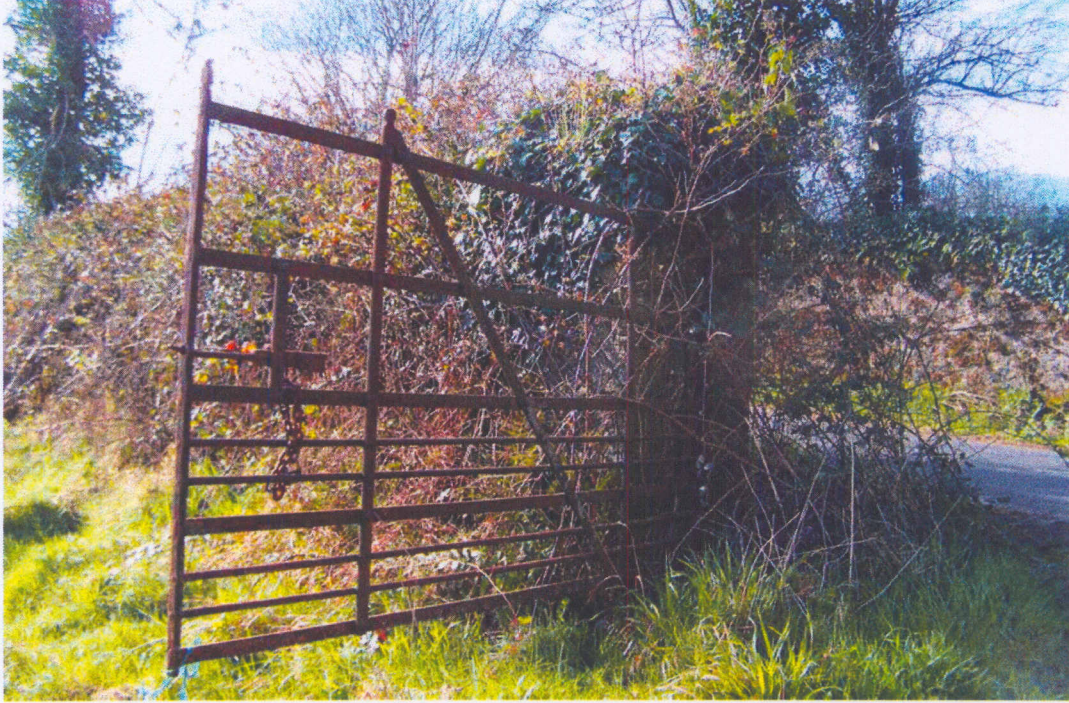
Plate 13: The old agricultural gate located at the end of the track in proximity to the southern boundary.

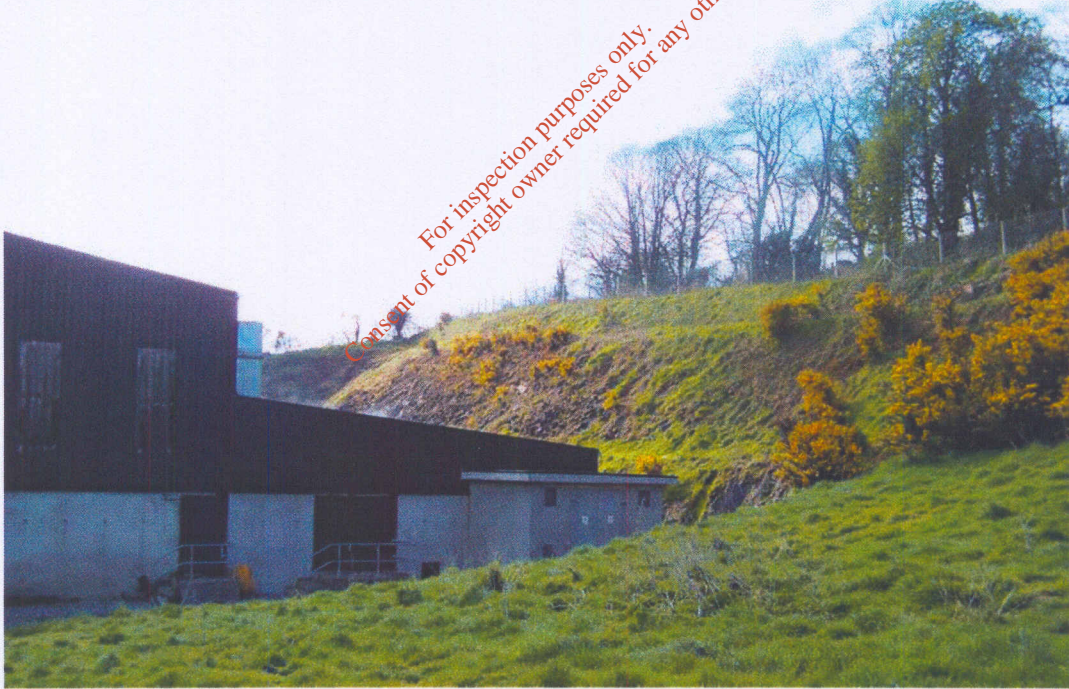
Plate 14: A view looking towards the southern boundary. Note the concrete post and chainlink fence on top of the steep slope.

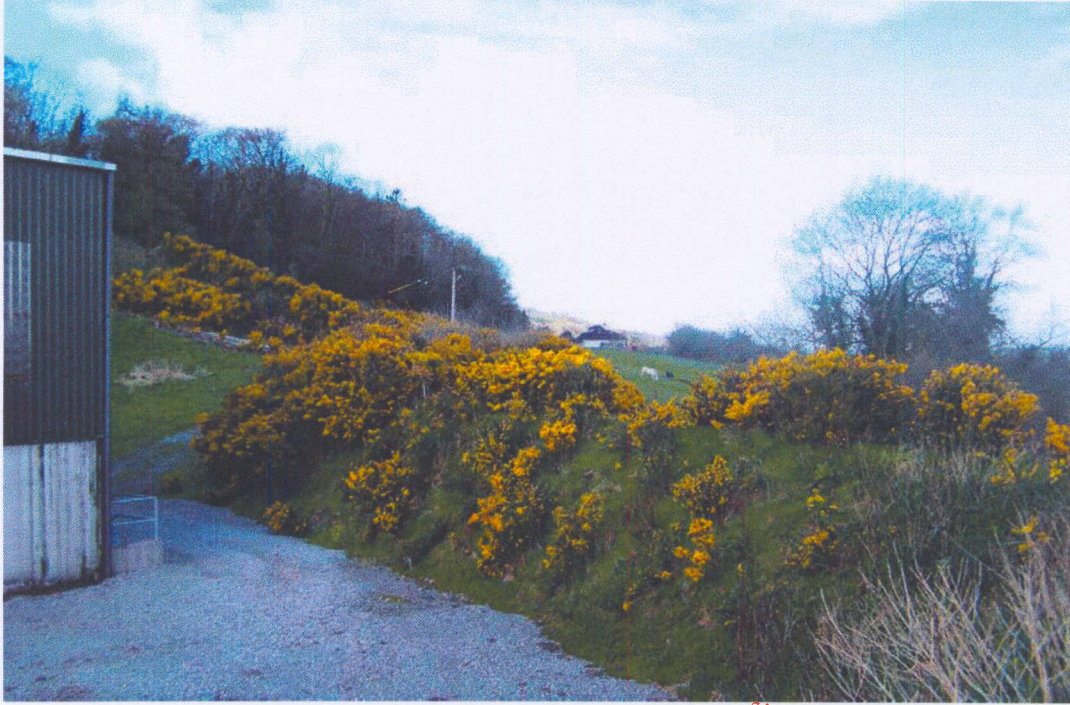
Plate15: This view from inside the site showing the western earth berm.

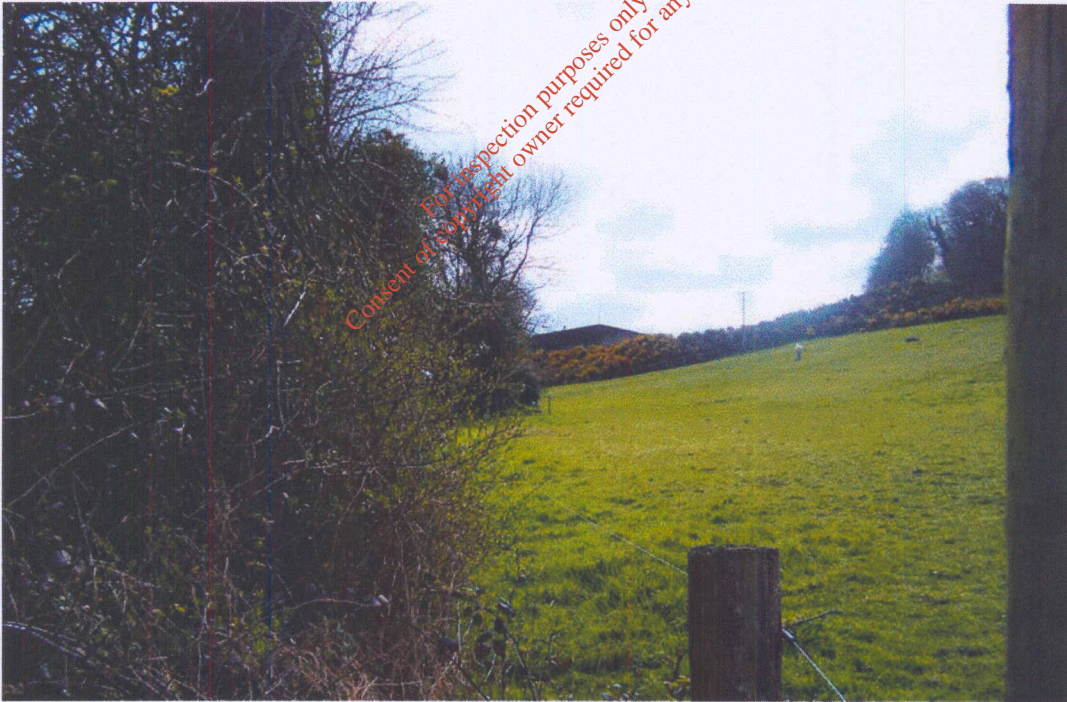
Plate 16: A view taken from outside the site looking towards the western boundary.
