# **APPENDIX 2.5.3**

## **Hydrometric Station Hydrographs**

project. Drehid WMF

element. Surface Water Attenuation

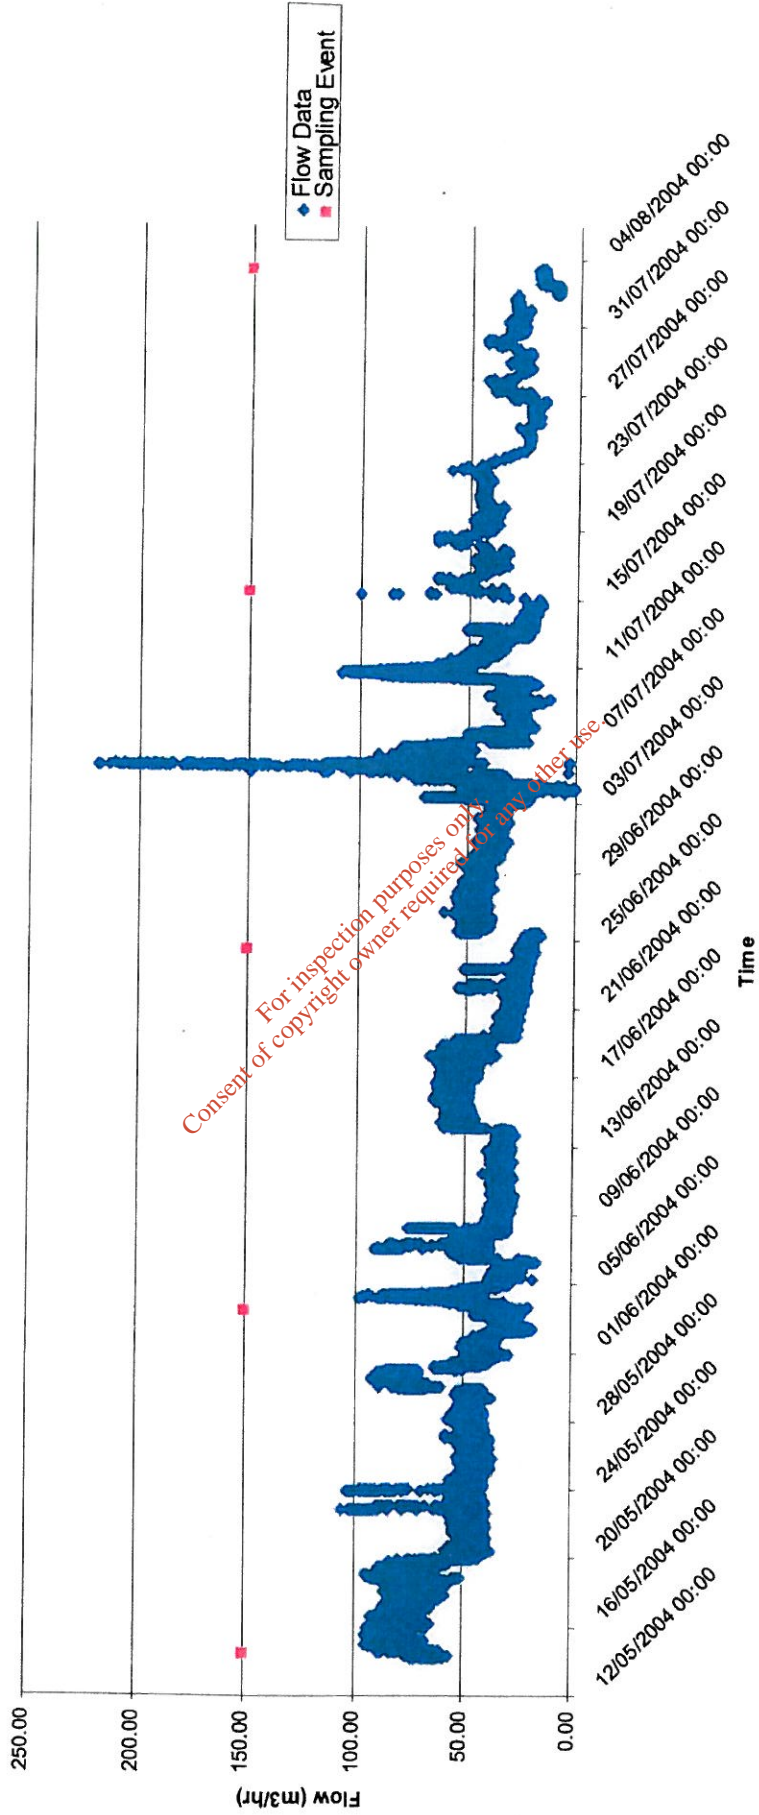
# Flow at THAWS1 Drehid Outfall

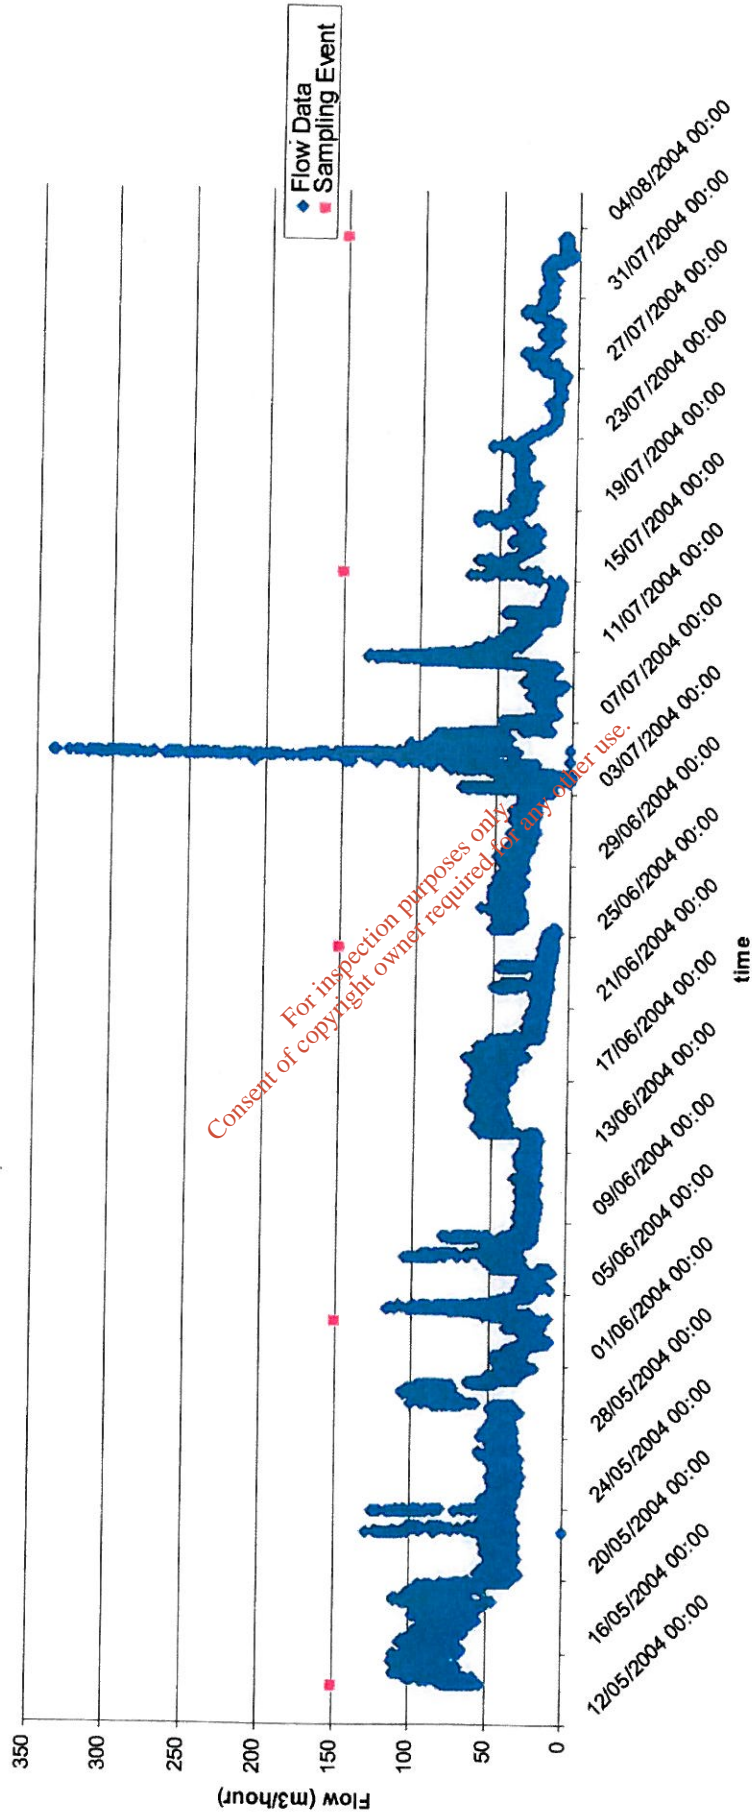
Flow at THASW2 Temporary Weir

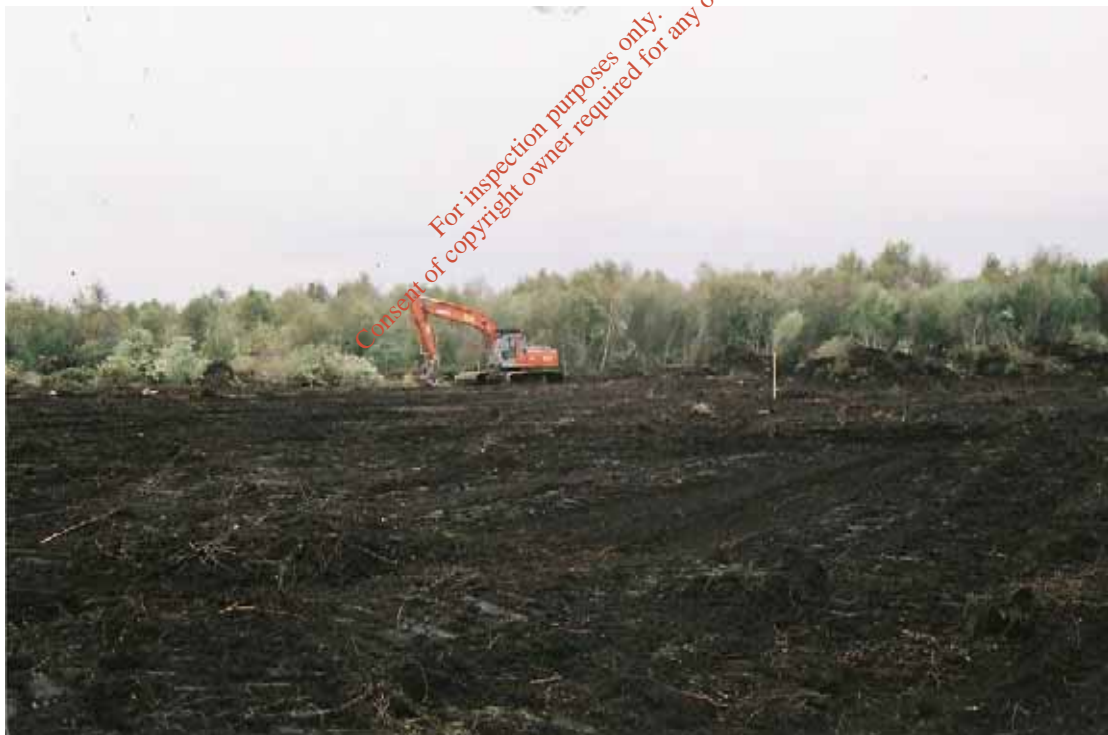
**Plate 2.** Stripping the cell of vegetation, note vegetation growth in background as an indication of how long the bog has been out of production.

It was interesting to note the surface growth on the bog after a minimum of ten years uninterrupted growth after peat harvesting and other Bord na Móna works had ceased (Plate 2). In many areas *caluna* and *eriophorum* were the dominant species but in areas that had a lot of growth, broad-leaved bushes and trees colonised the bog. Birch trees especially seemed suited to the environment there. Only very occasionally was a coniferous tree noted in the bog but with very little growth. There were some pine trees on the reclaimed land west of the quarry but these appeared to be the exception.

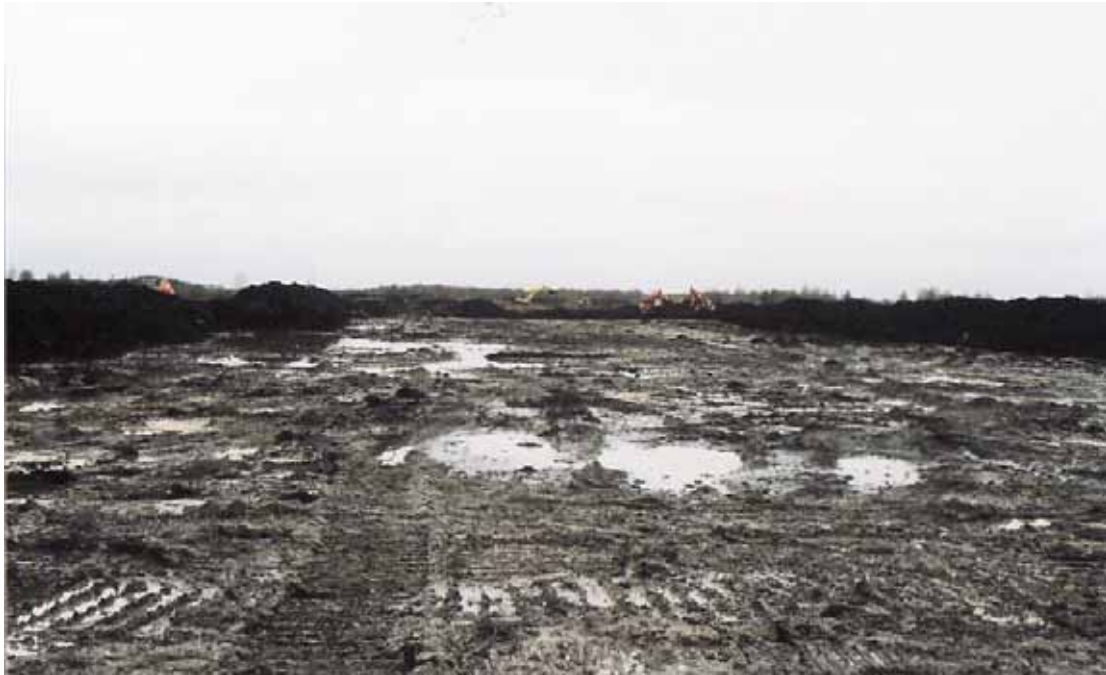
**Plate 3.** The cell stripped of peat.

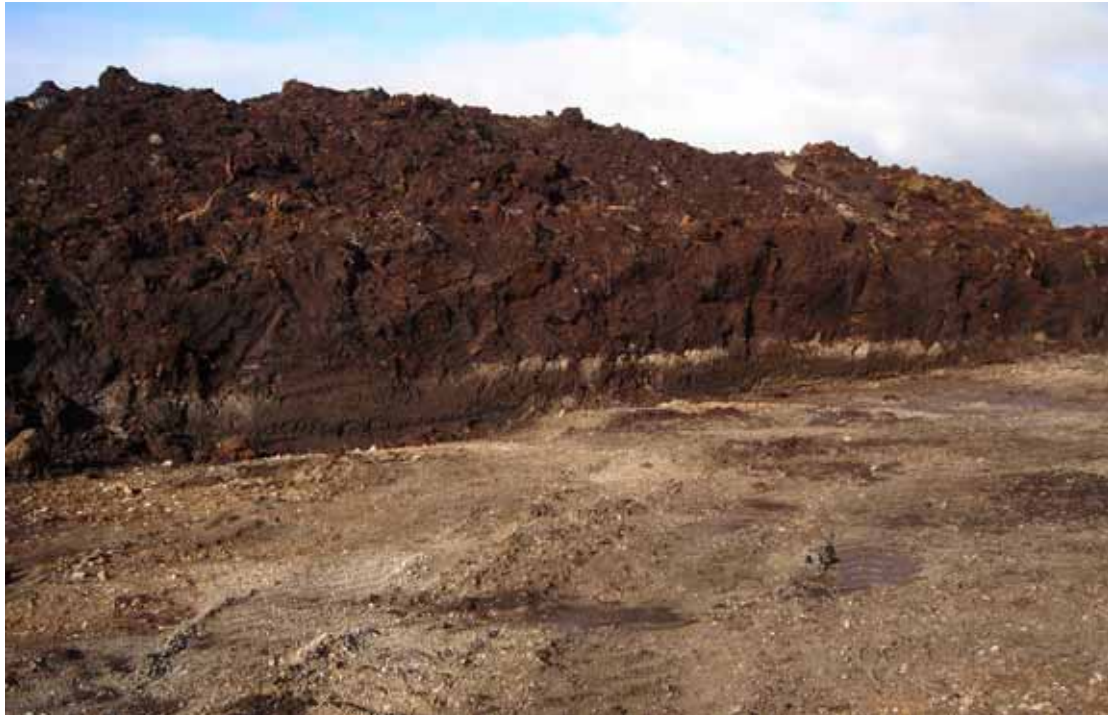
**Plate 5.** Quarry, showing thin layer of gravely marl within peat section.

Putting this evidence together then, it can be seen that the area was under water, hence the formation of marl above the gravel. This was followed by a period of relative dryness when peat began to form, which became even dryer when trees began to root in areas throughout the bog. Eventually climatic conditions worsened and the peat began to form again, as evidenced by the pool moss found throughout the bog. The thin layer of marl within the peat in the quarry may be explained as a localised pond or small lake that obviously formed for a relatively short time, early in the bog's development.

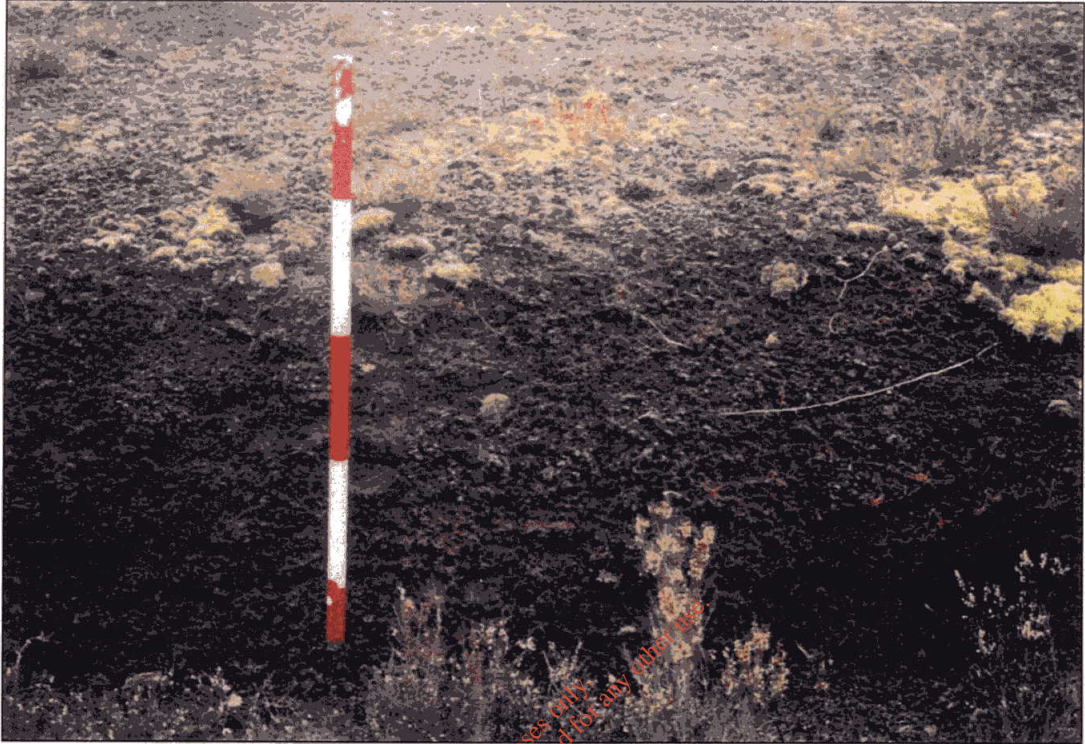
**Plate 5** Drain section face in eastern sector of bog.

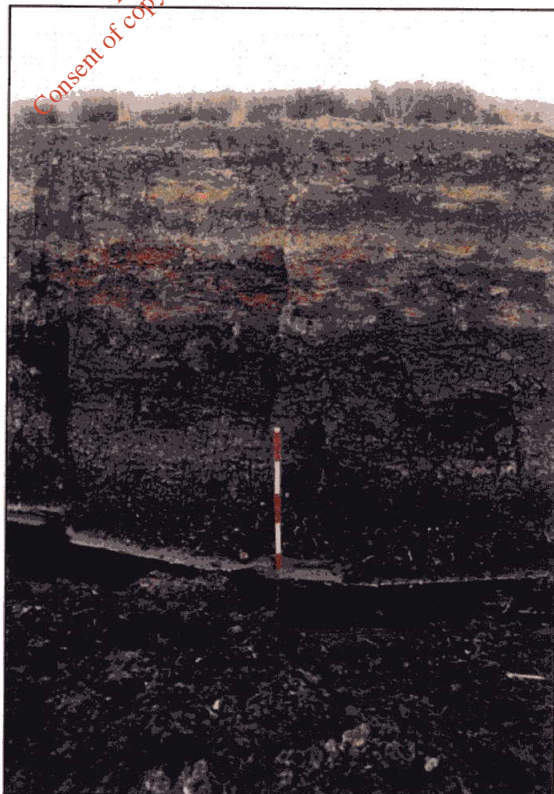
**Plate 8** Detail of peat bank in northernmost area of bog.
