CORRANURE LANDFILL

1.0 INTRODUCTION

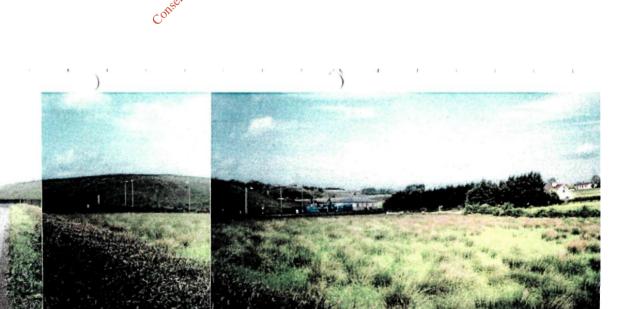
View 1 - from RI 88 Regional Road looking north west into site

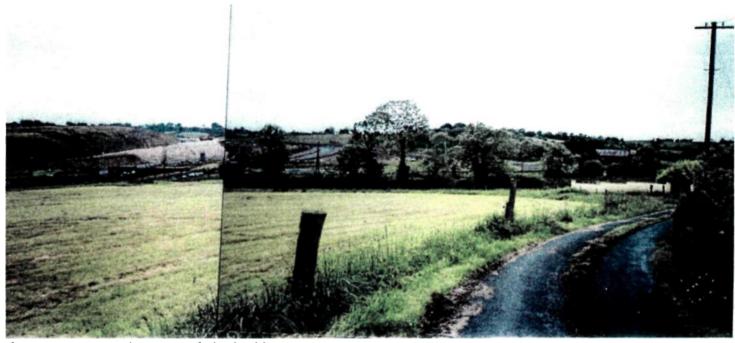
View 2 - from access road to east of site looking west

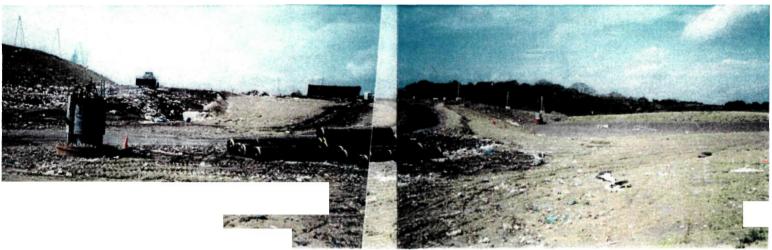
View 4 - from looking north-west towards site from south-eastern end of existing Jandfii!
