## 5. Constraints Inventory, Predicted Impacts & Suggested Mitigation

## 5.1 Archaeological Monuments Constraints Inventory (figs 19-23; Table 5)

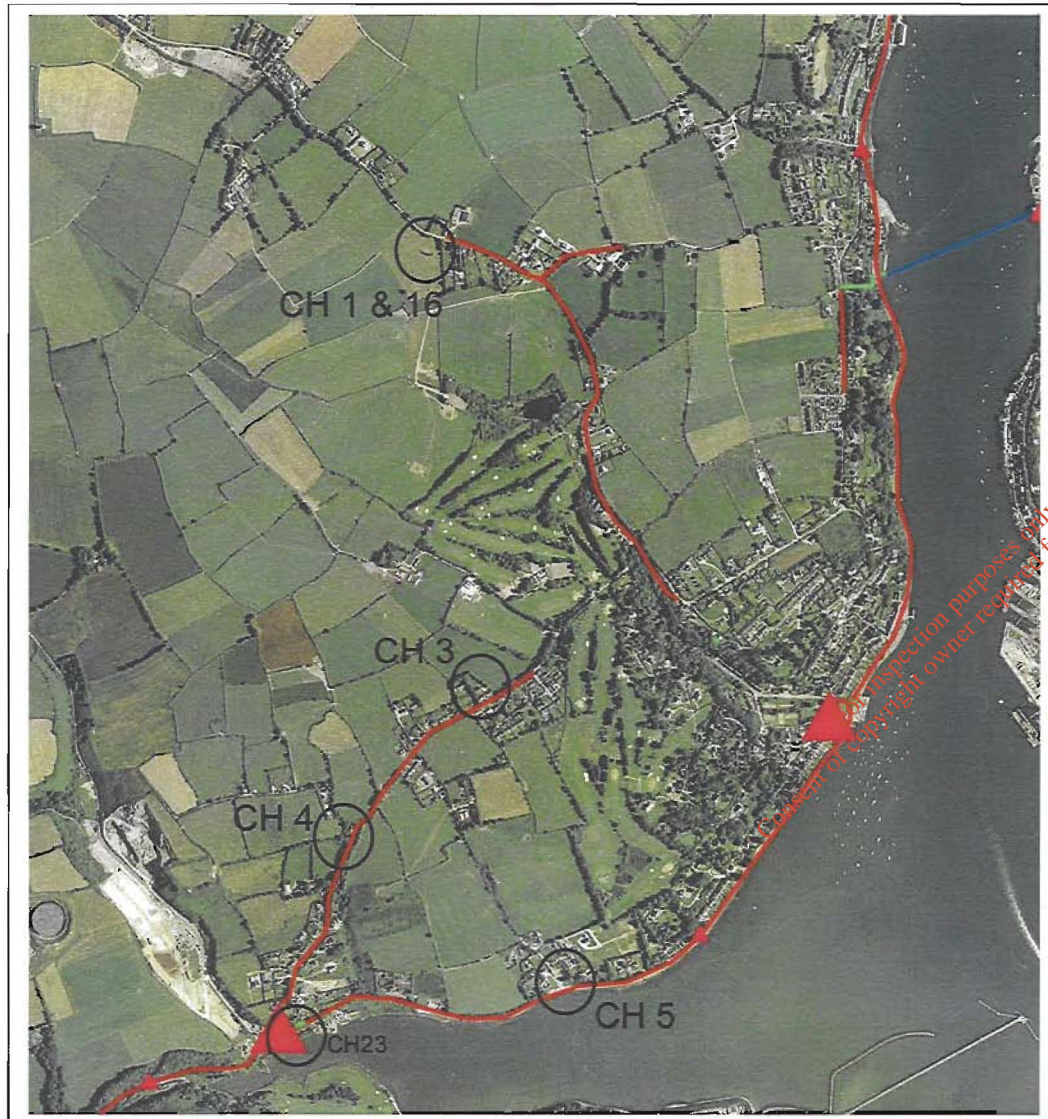
Figure 19. Aerial photo showing CH locations along pipeline routes in the Monkstown area (north to top not to scale, for indication only)

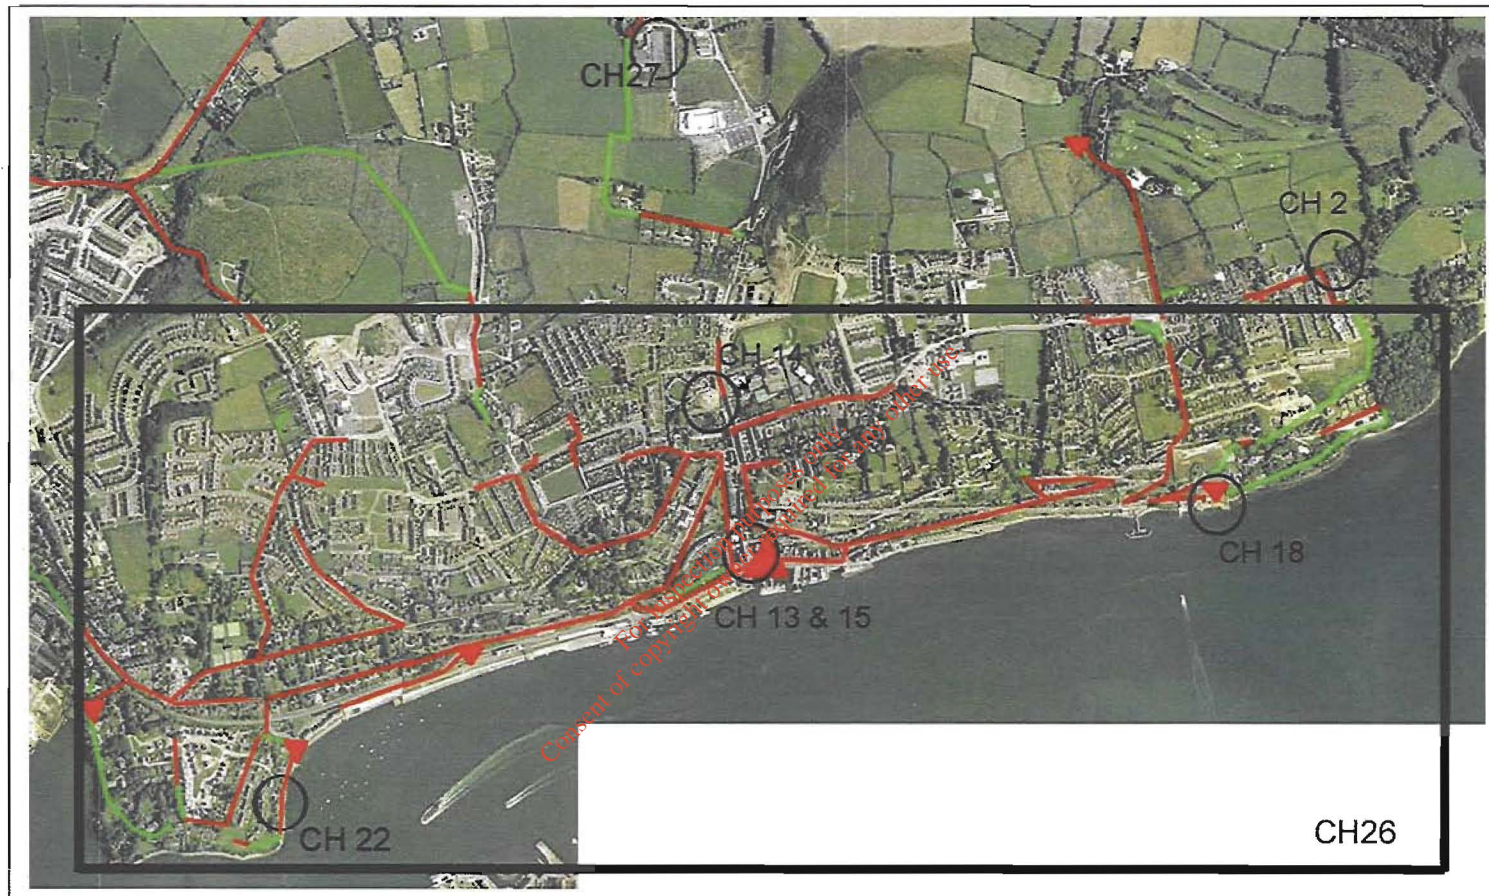
Figure 20. Aerial photo with CH locations in Cobh and environs (north to top not to scale, for indication only)

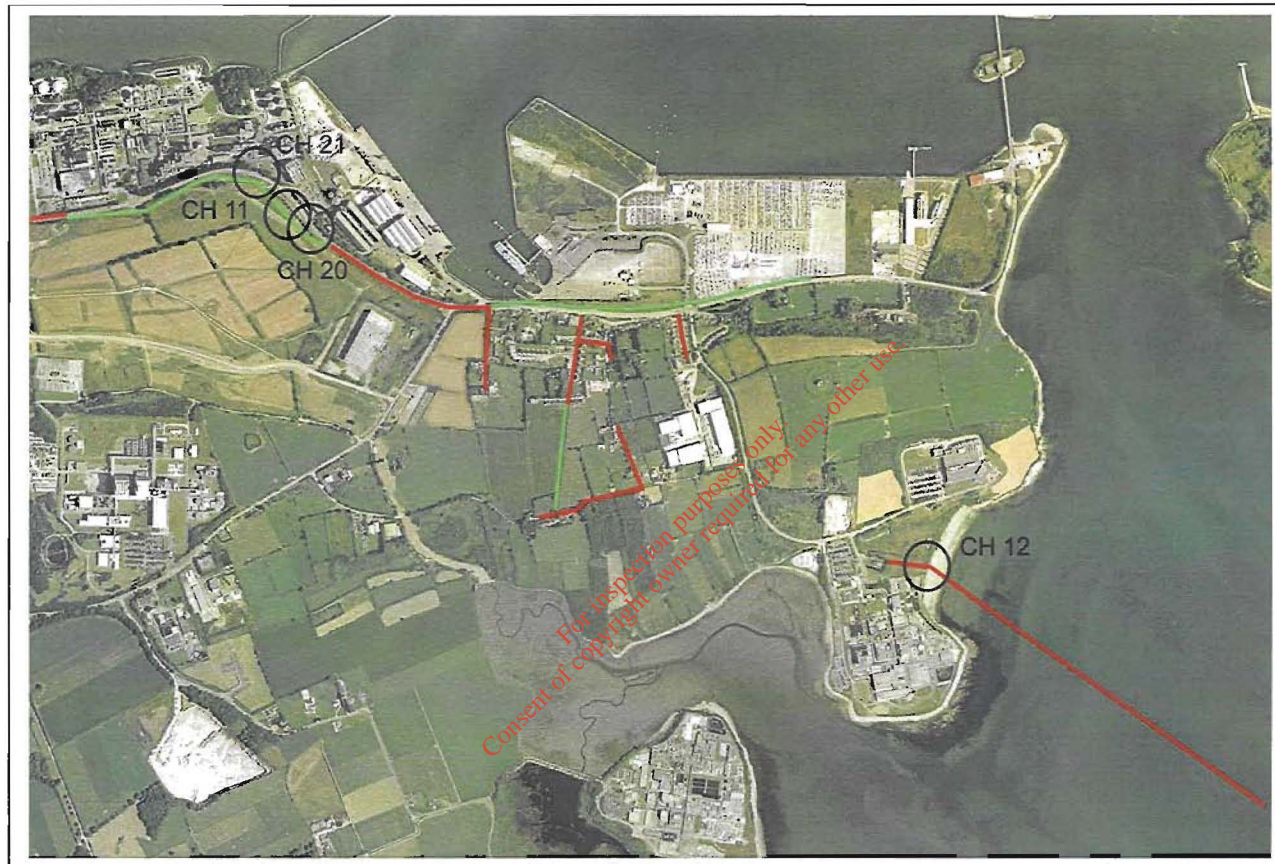
Figure 22. Aerial photo showing CH locations along pipeline routes in the Ringaskiddy area (north to top not to scale, for indication only)
