Attachment I

Existing Environment & Impact of the Facility

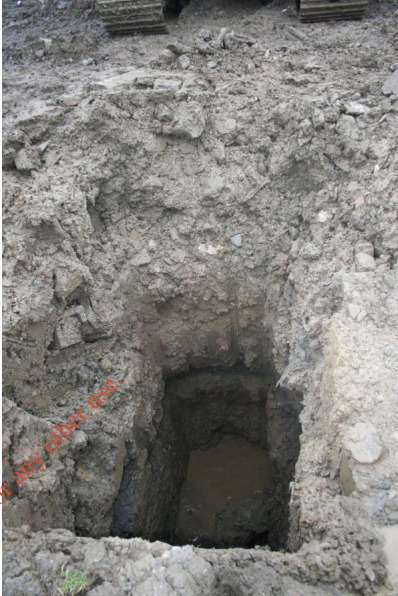
TP 1	Description	
0 – 4m	Firm Brown Silts / Clays with gravels Water rapid seepage @ 2.5m B.G.L. Minor Timber, Plastic, Steel concrete blocks <5% (1 to 2%),

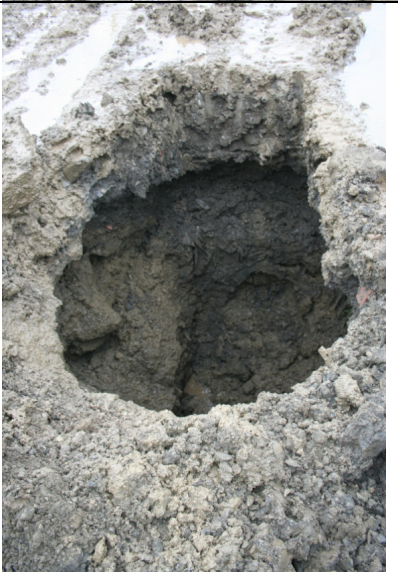
TP 2	Description	
0 – 3m	Gravels & Silts with clays Water seepage @ 2.5m B.G.L. Minor Timber, Plastic, Steel concrete blocks <5% (1 to 2%),

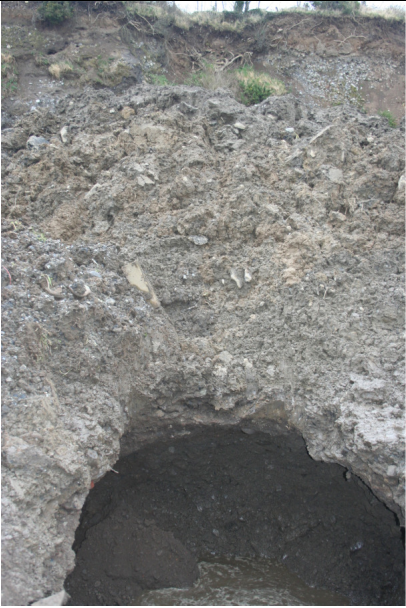
TP 3	Description

0 – 2m	Firm Brown Silts / Clays with gravels Water rapid seepage @ 2.5m B.G.L. Minor Timber, Plastic, Steel concrete blocks <5% (2%)	
2 – 3.5m	Firm Brown Silts / Clays with gravels Minor Timber, Plastic, Steel concrete blocks <5% (2%),

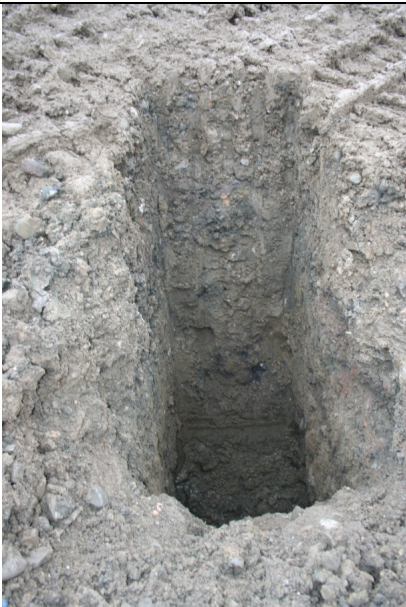
TP 4	Description

0 – 3.3m	Mottled brown/black tills with gravel & cobbles occasional red bricks...	
3.3 – 4m	Brown indigenous Silts with gravels and cobbles Water Seepage

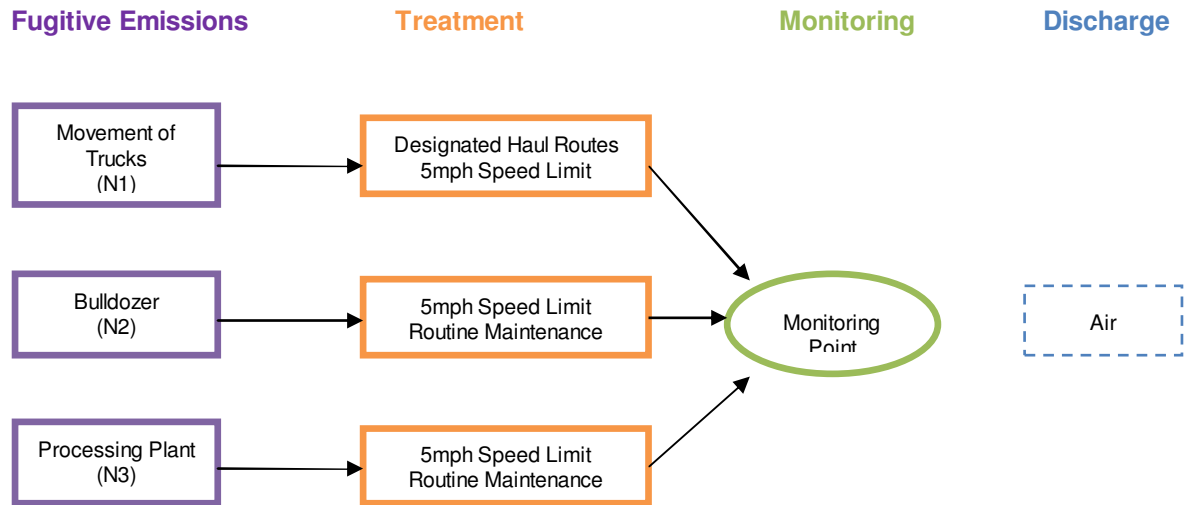
The following flow diagram shows the main sources of noise emissions arising on site and the methods of treatment/abatement employed.
