### **ASSESSMENT OF FILLED SUBSOILS FOR WASTE LICENCE APPLICATION AT THORNBERRY, COUNTY KILDARE**

**ASSESSMENT OF FILLED SUBSOILS FOR WASTE LICENCE APPLICATION  
AT  
THORNBERRY, KILL, COUNTY KILDARE**

**FINAL REPORT**

<b>Project No.:</b>	17004
<b>Report Title:</b>	Assessment of filled subsoils for Waste Licence Application at Thornberry, Kill, County Kildare
<b>Report Status:</b>	FINAL
<b>Date:</b>	10/02/2009
<b>Prepared by:</b>

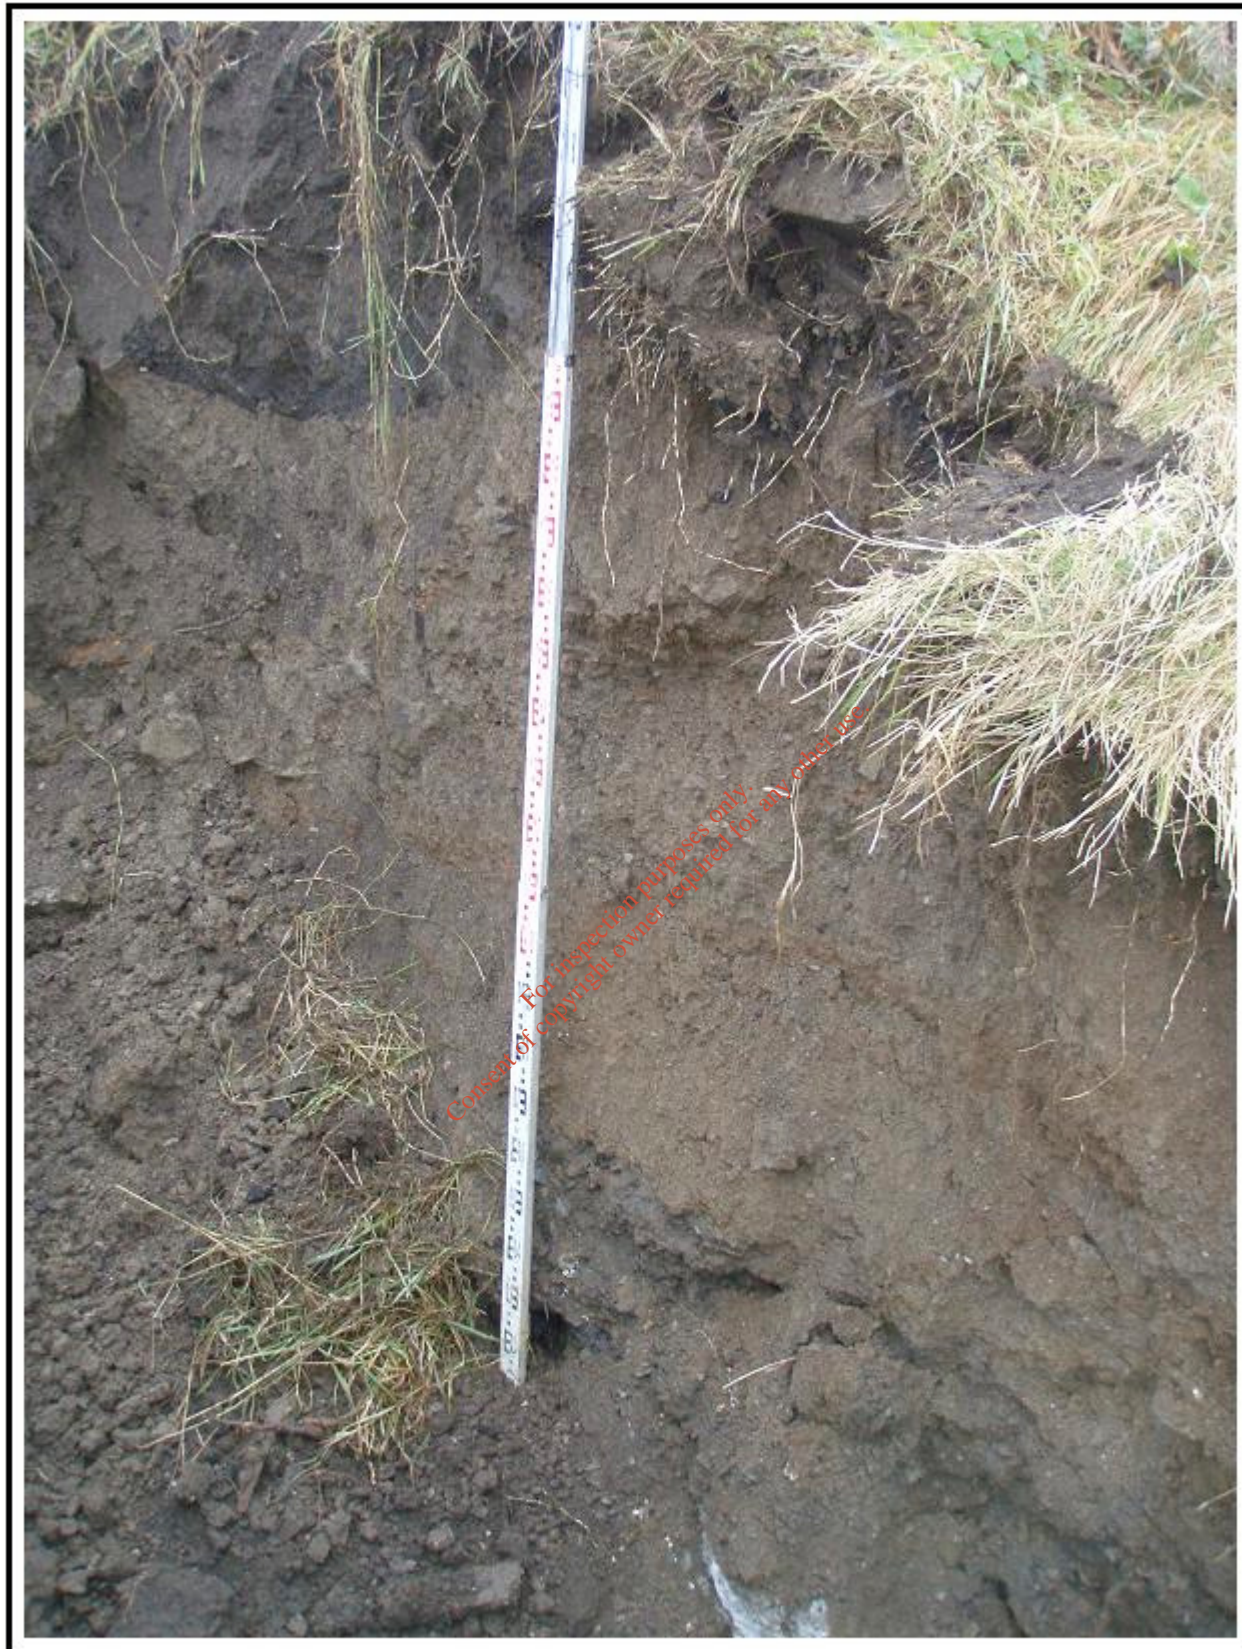
**Plate A1: Profile of deep, imported topsoil overlying subsoil in trial hole no. 1. See the absence of construction and demolition material from the profile and the well aerated nature of the material, with no groundwater seepages throughout the sequence.**

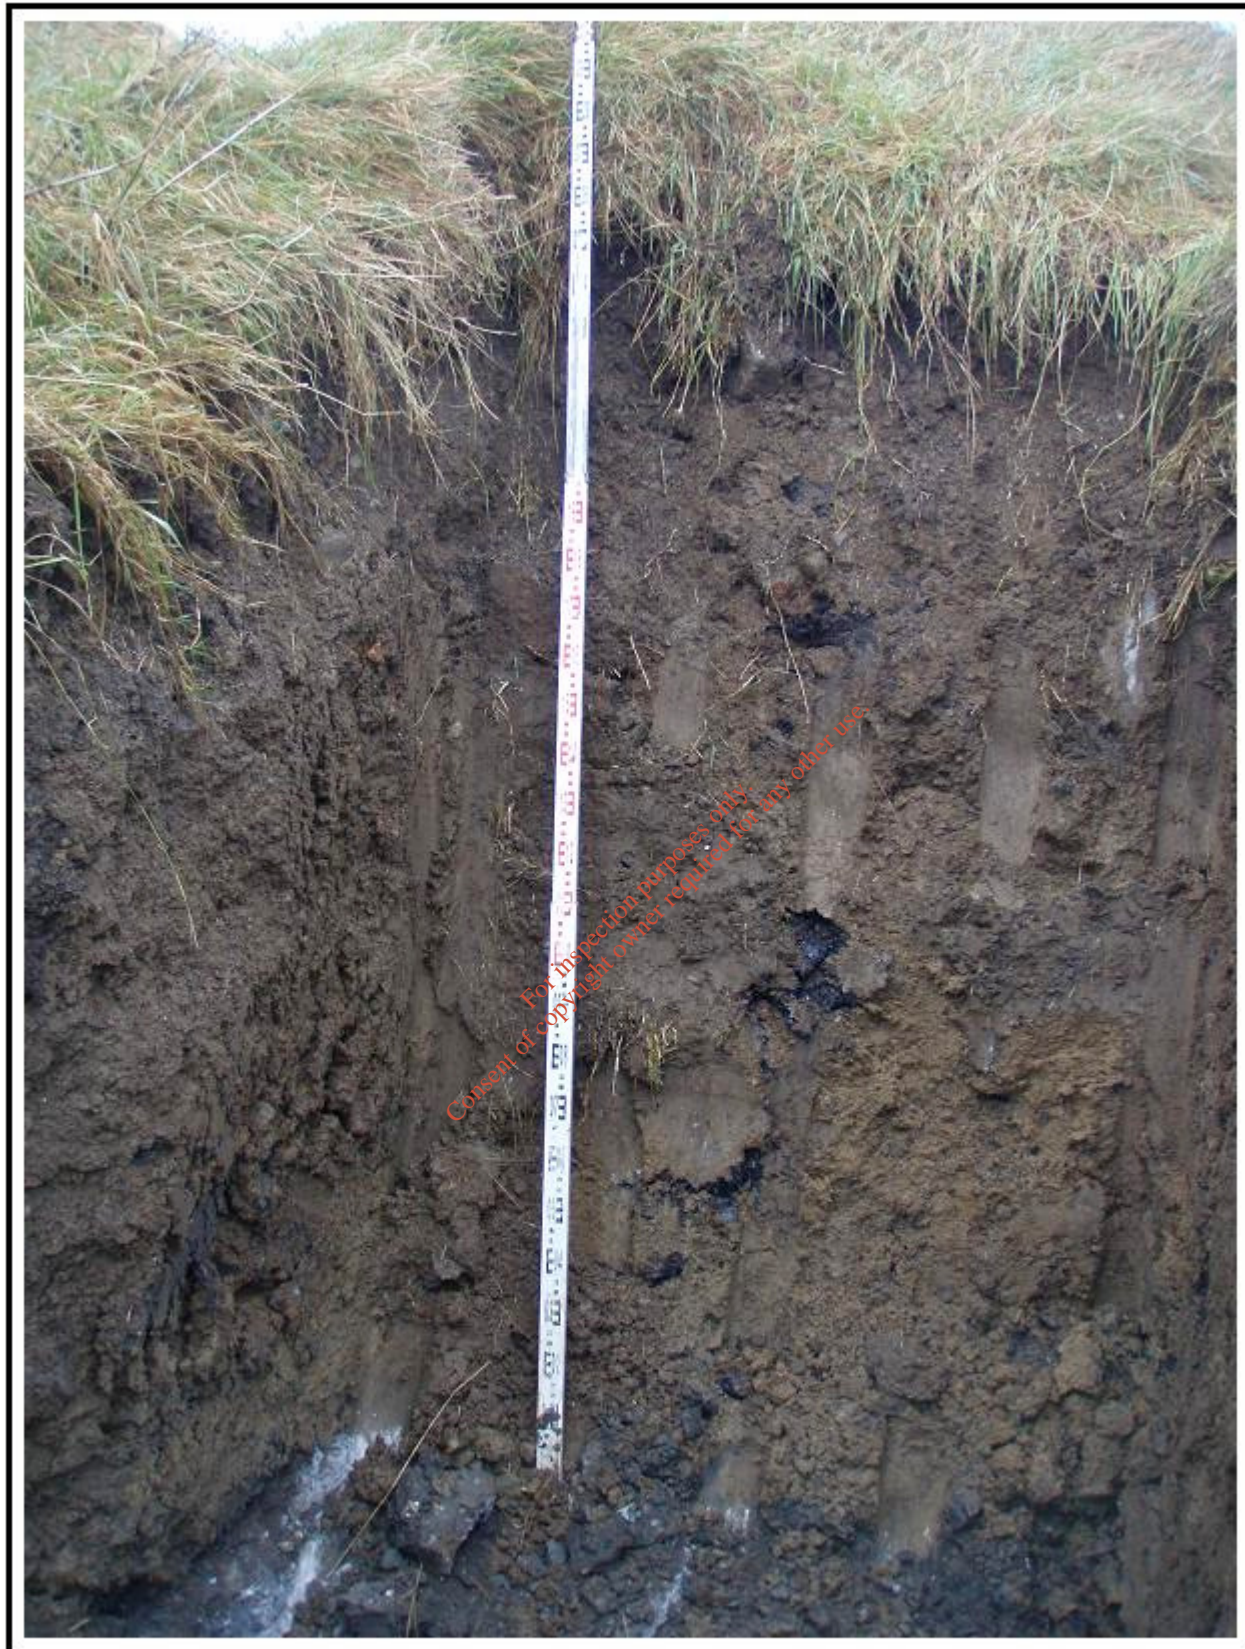
<p><b>Bearing</b> : 135° (NW-SE)</p>	<p><b>Stability :</b></p> <p>Trial pit walls consolidated, but upper material prone to collapse. Subsoil material very competent.</p>	
	<p><b>General remarks :</b></p> <p>Dug in northern portion of the central fill area, into a dry, grass-covered pile. Dug on a 33° slope, falling eastwards.</p>	
	<table border="1"> <tr> <td> <p><b>Groundwater :</b></p> <p>Dry.</p> </td> <td> <p><b>Sequence summary:</b></p> <p>Well drained, deep, 'filled' topsoil over filled boulder clay, 'lifted' on-site.</p> </td> </tr> </table>	<p><b>Groundwater :</b></p> <p>Dry.</p>
<p><b>Groundwater :</b></p> <p>Dry.</p>	<p><b>Sequence summary:</b></p> <p>Well drained, deep, 'filled' topsoil over filled boulder clay, 'lifted' on-site.</p>

**Plate A2: Profile of deep, imported topsoil overlying subsoil in trial hole no. 2. See the absence of construction and demolition material from the profile and the well aerated nature of the material, again with no groundwater seepages throughout the sequence.**

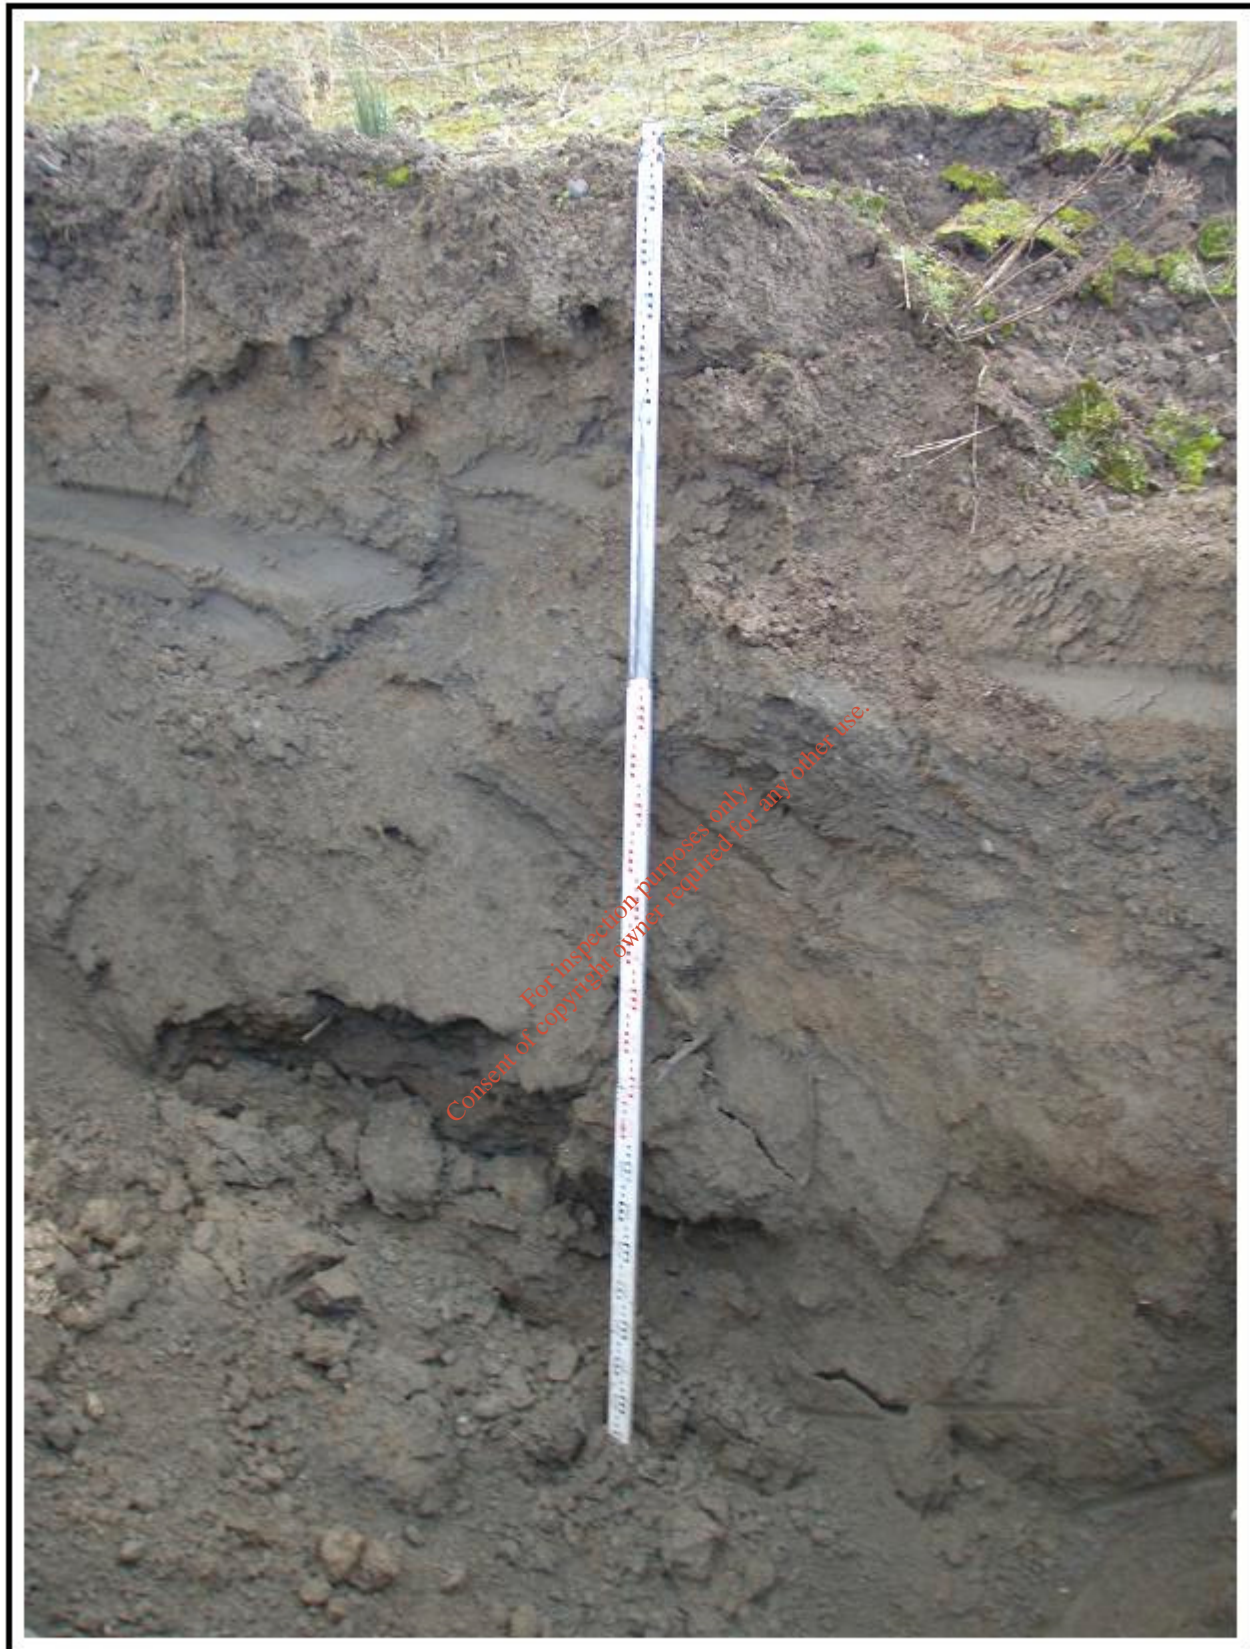
**General remarks :**  
 Dug in southeastern, highest portion of the site, into the southern portion of the eastern fill area (a dry, grass- covered pile. Dug in a flat plateau area on a ridge summit.

**Sequence summary:**  
 Well drained, deep, 'filled' silty SAND topsoil and subsoil.

**Plate A3: Profile of imported silty SAND topsoil and subsoil in trial hole no. 3. This is well drained topsoil taken from the adjacent gravel pit, with virtually no construction and demolition material within.**

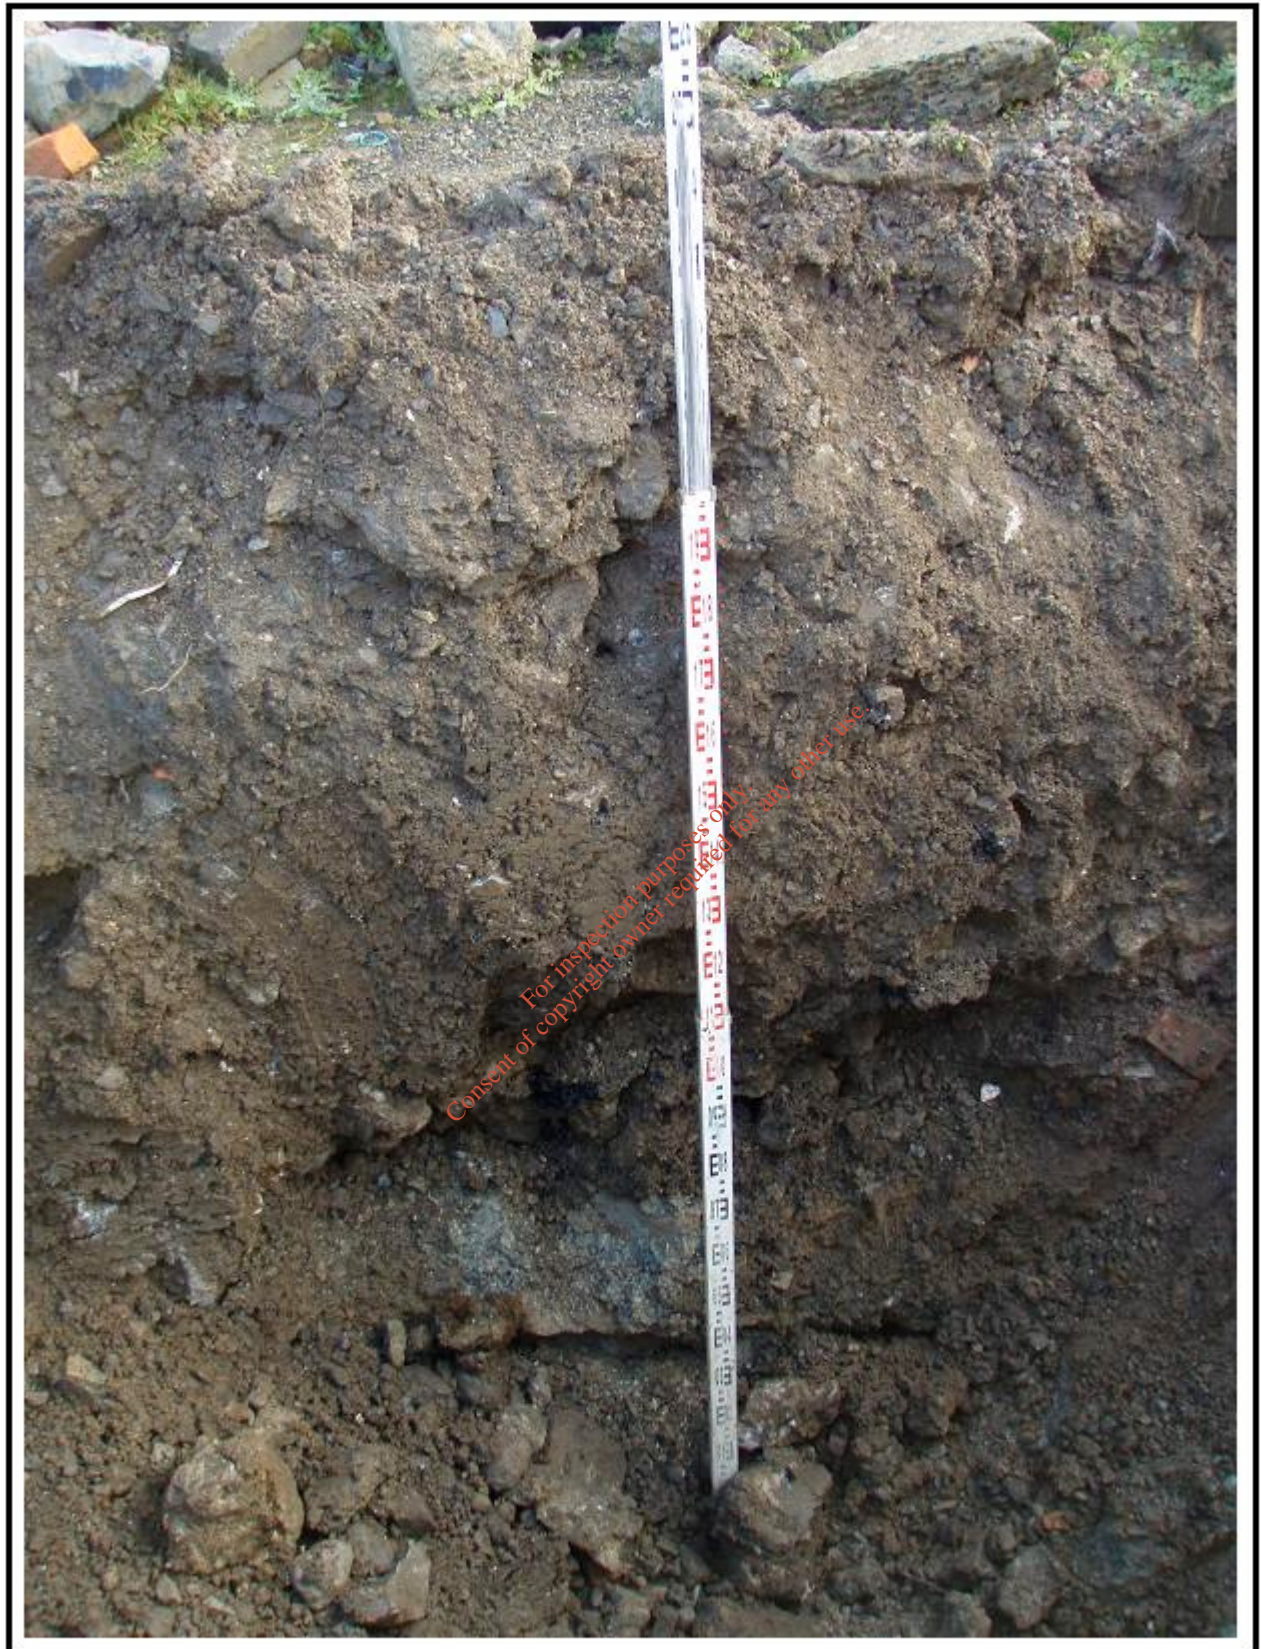
<p><b>Bearing : 24° (NNE-SSW)</b></p>	<p><b>Stability :</b></p> <p>Trial pit walls consolidated, but material prone to collapse.</p>	
	<p><b>General remarks :</b></p> <p>Dug in southern portion of the central fill area, into a dry, bare, recently-filled area. Dug on a 2° slope, falling southwards.</p>	
	<table border="1"> <tr> <td> <p><b>Groundwater :</b></p> <p>Dry.</p> </td> <td> <p><b>Sequence summary:</b></p> <p>Well drained, shallow, 'filled' topsoil over filled boulder clay and rubble, 'lifted' on-site.</p> </td> </tr> </table>	<p><b>Groundwater :</b></p> <p>Dry.</p>
<p><b>Groundwater :</b></p> <p>Dry.</p>	<p><b>Sequence summary:</b></p> <p>Well drained, shallow, 'filled' topsoil over filled boulder clay and rubble, 'lifted' on-site.</p>

**Plate A4: Profile of recently-filled topsoil and subsoil in trial hole no. 4. Pieces of concrete and boulders are common in this area of the site, with alternating compacted layers below ground level.**

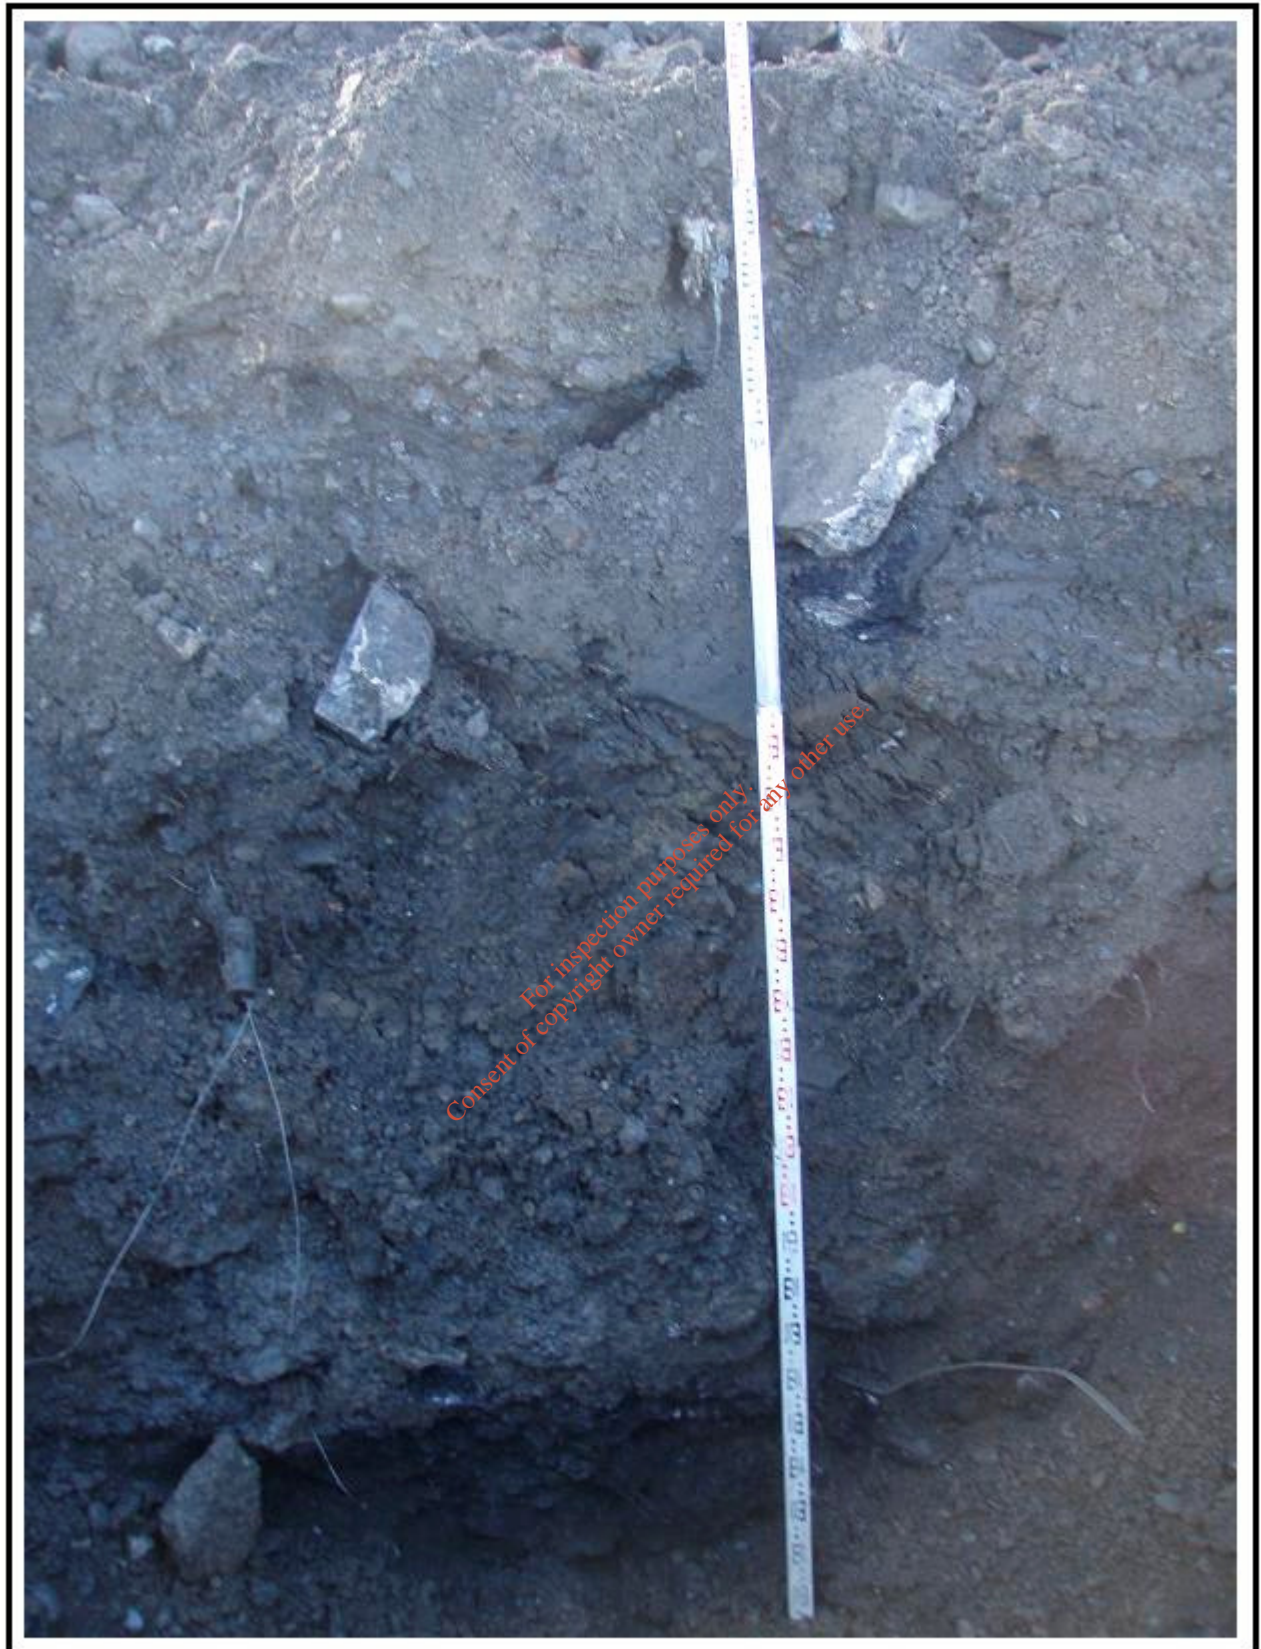
Well drained, deep, 'filled' boulder clay subsoil, 'lifted' on-site.

**Plate A5: Profile of recently-filled subsoil in trial hole no. 5. Pieces of concrete and boulders are common in this area of the site also, with alternating compacted layers and occasional construction and demolition material.**

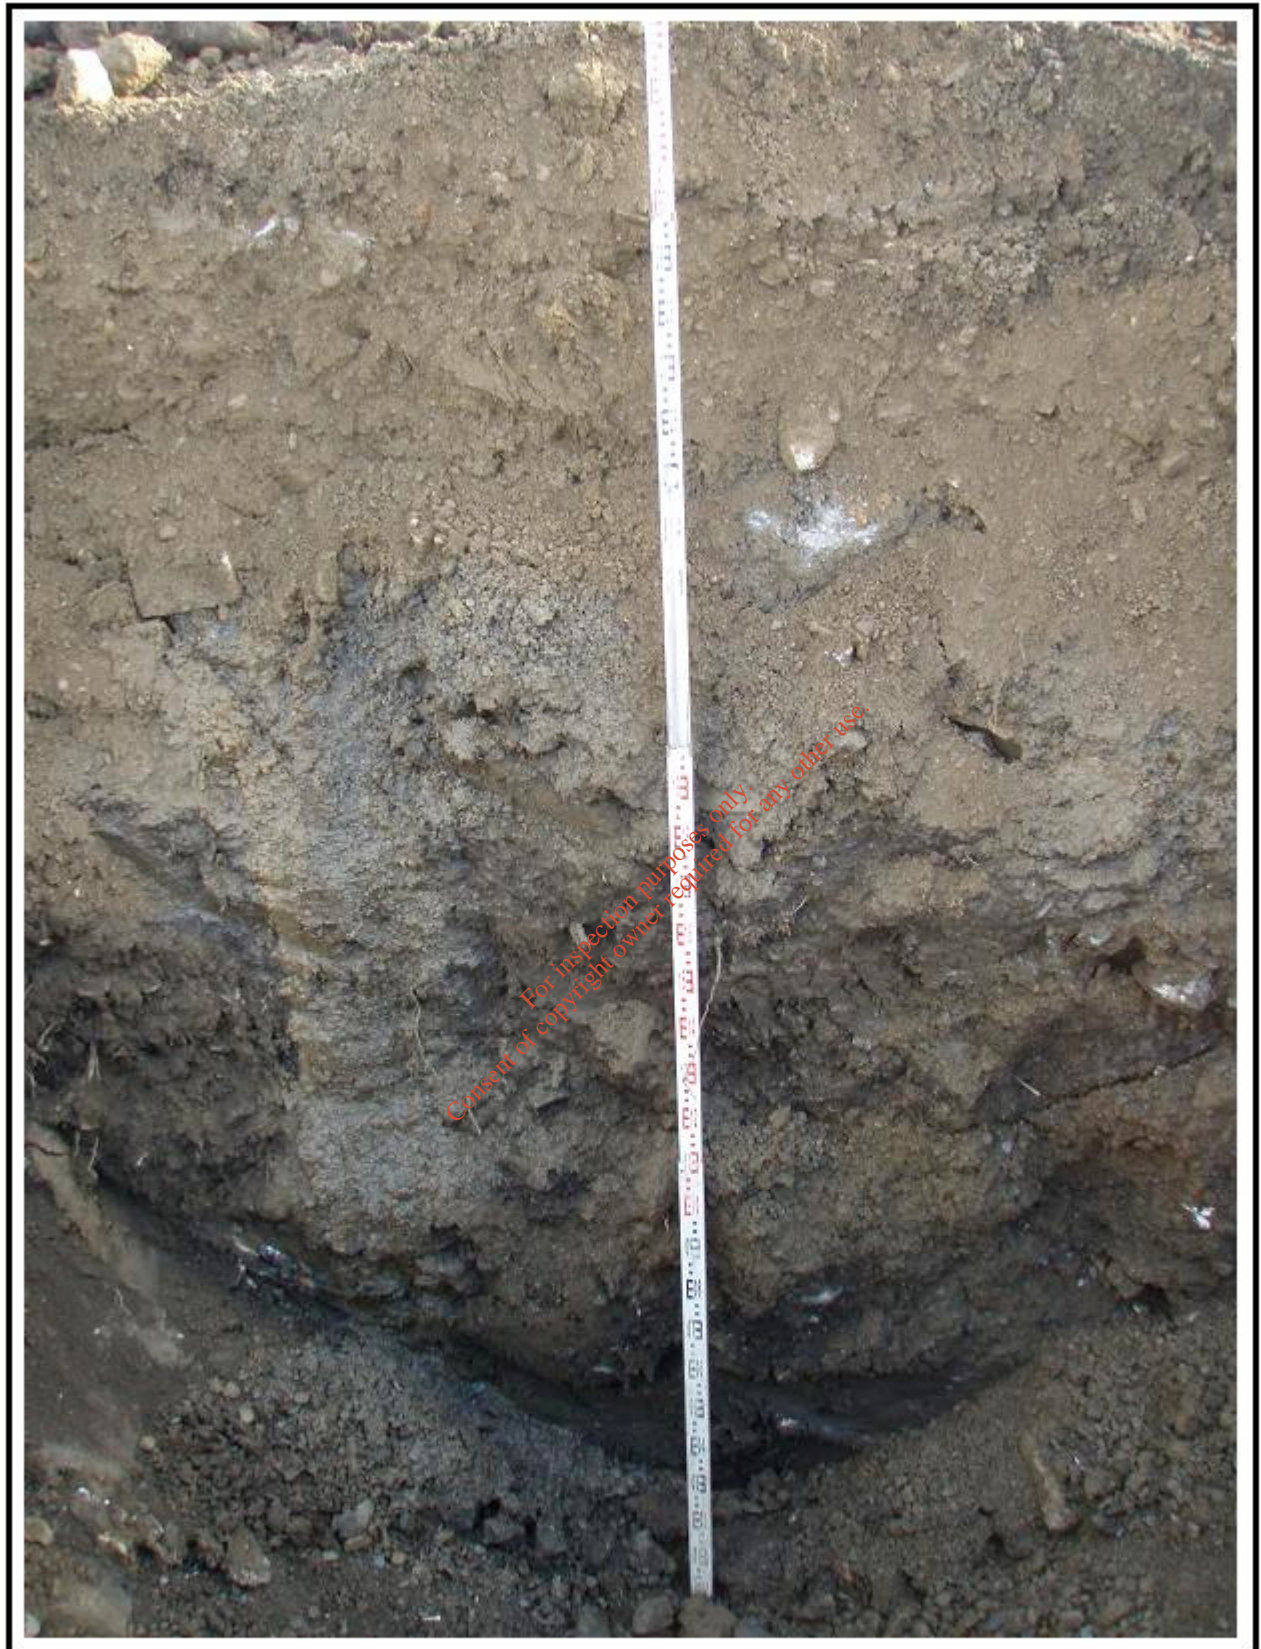
<p><b>Bearing : 172° (N-S)</b></p>	<p><b>Stability :</b></p> <p>Trial pit walls consolidated, and subsoil material very competent.</p>	
	<p><b>General remarks :</b></p> <p>Dug in southern portion of the main, western fill area, into a dry, bare, recently-filled pile. Dug in a flat summit area.</p>	
	<table border="1"> <tr> <td> <p><b>Groundwater :</b></p> <p>Dry.</p> </td> <td> <p><b>Sequence summary:</b></p> <p>Well drained, deep, 'filled' boulder clay subsoil, 'lifted' on-site.</p> </td> </tr> </table>	<p><b>Groundwater :</b></p> <p>Dry.</p>
<p><b>Groundwater :</b></p> <p>Dry.</p>	<p><b>Sequence summary:</b></p> <p>Well drained, deep, 'filled' boulder clay subsoil, 'lifted' on-site.</p>

**Plate A6: Profile of recently-filled subsoil in trial hole no. 6. Pieces of concrete and boulders are common in this area of the site also, with alternating compacted layers and occasional construction and demolition material.**

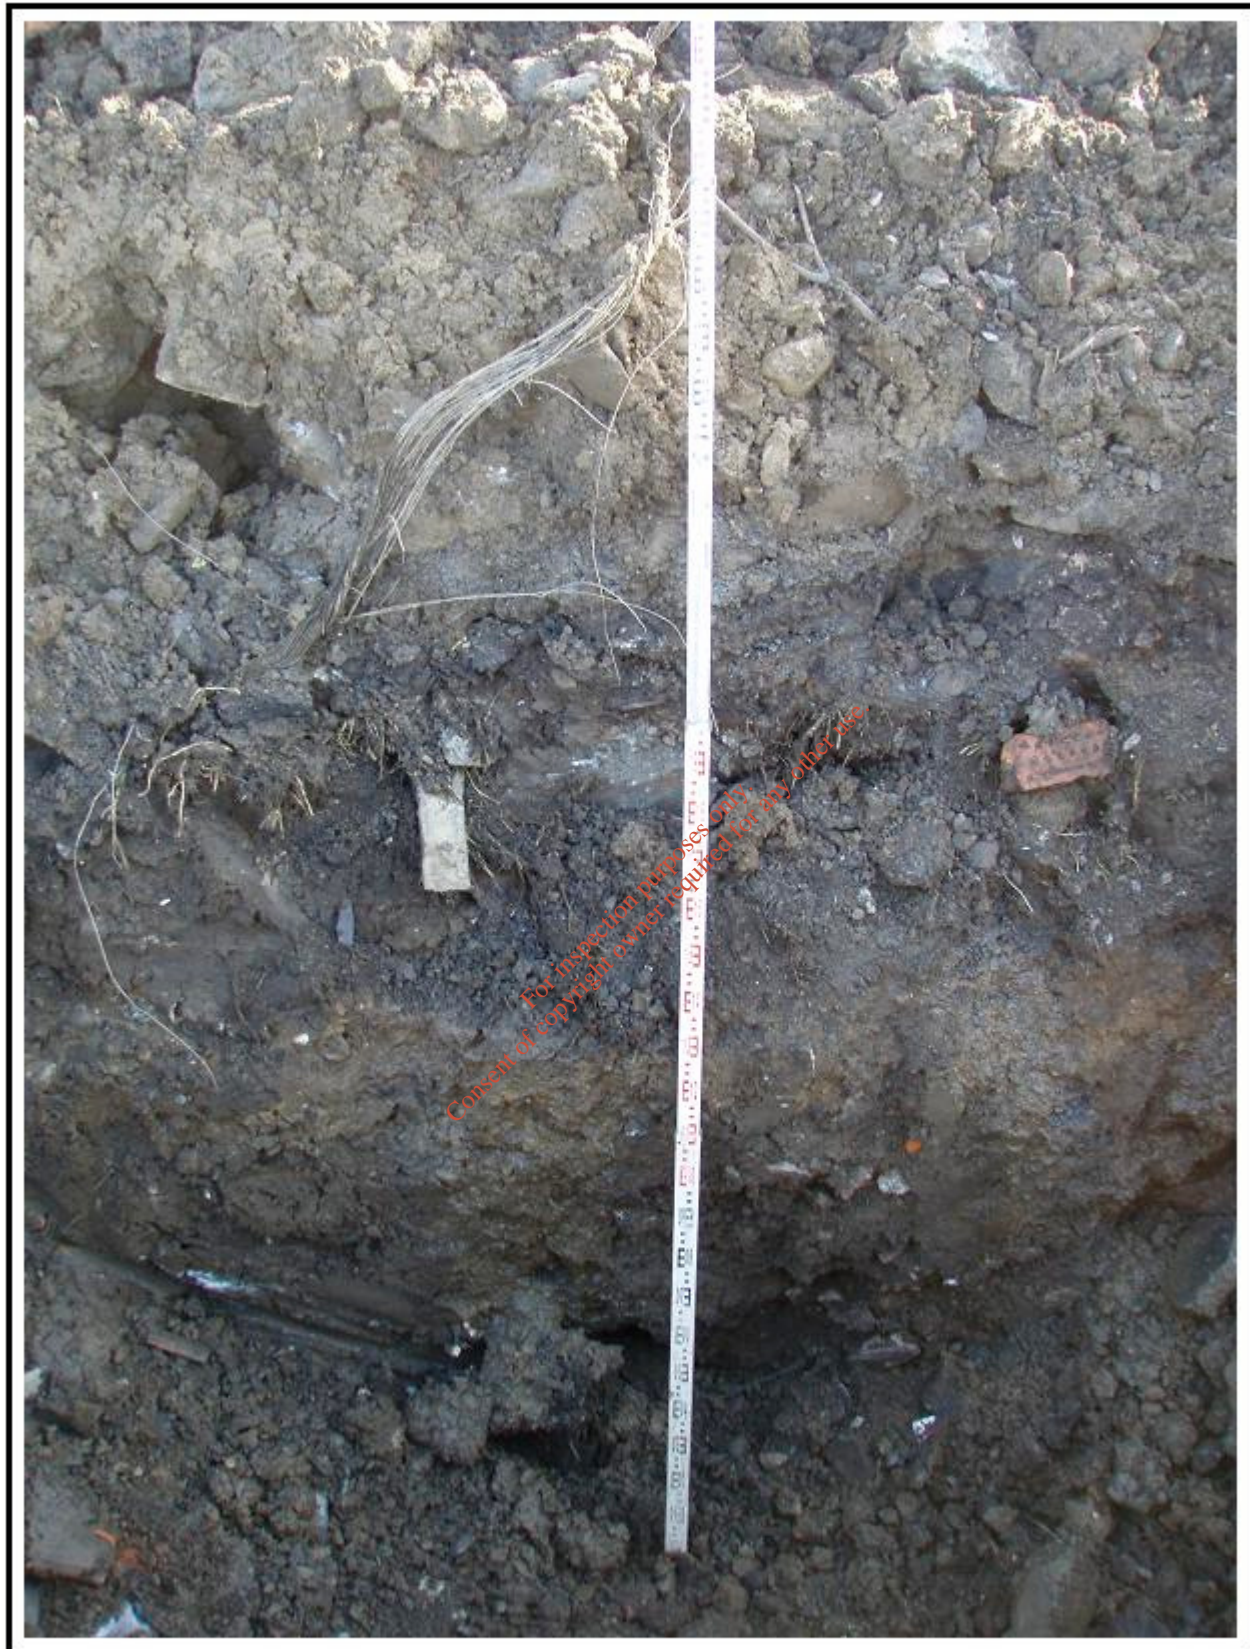
<p><b>Bearing</b> : 48° (SW-NE)</p>	<p><b>Stability :</b></p> <p>Trial pit walls consolidated, but uppermost material prone to collapse. Deep subsoil material very competent.</p>	
	<p><b>General remarks :</b></p> <p>Dug in south central portion of the main, western filled area, into a dry, bare pile. Dug on a 1° slope, falling southwards.</p>	
	<table border="1"> <tr> <td> <p><b>Groundwater :</b></p> <p>Dry at base, but seep seen at 1 m depth.</p> </td> <td> <p><b>Sequence summary:</b></p> <p>Well drained, deep, 'filled' topsoil over filled boulder clay and rubble, 'lifted' on-site.</p> </td> </tr> </table>	<p><b>Groundwater :</b></p> <p>Dry at base, but seep seen at 1 m depth.</p>
<p><b>Groundwater :</b></p> <p>Dry at base, but seep seen at 1 m depth.</p>	<p><b>Sequence summary:</b></p> <p>Well drained, deep, 'filled' topsoil over filled boulder clay and rubble, 'lifted' on-site.</p>

**Plate A7: Profile of recently-filled topsoil and subsoil in trial hole no. 7. Pieces of concrete, bricks, steel, wire and plastic are seen occasionally, within alternating layers of compacted subsoil.**

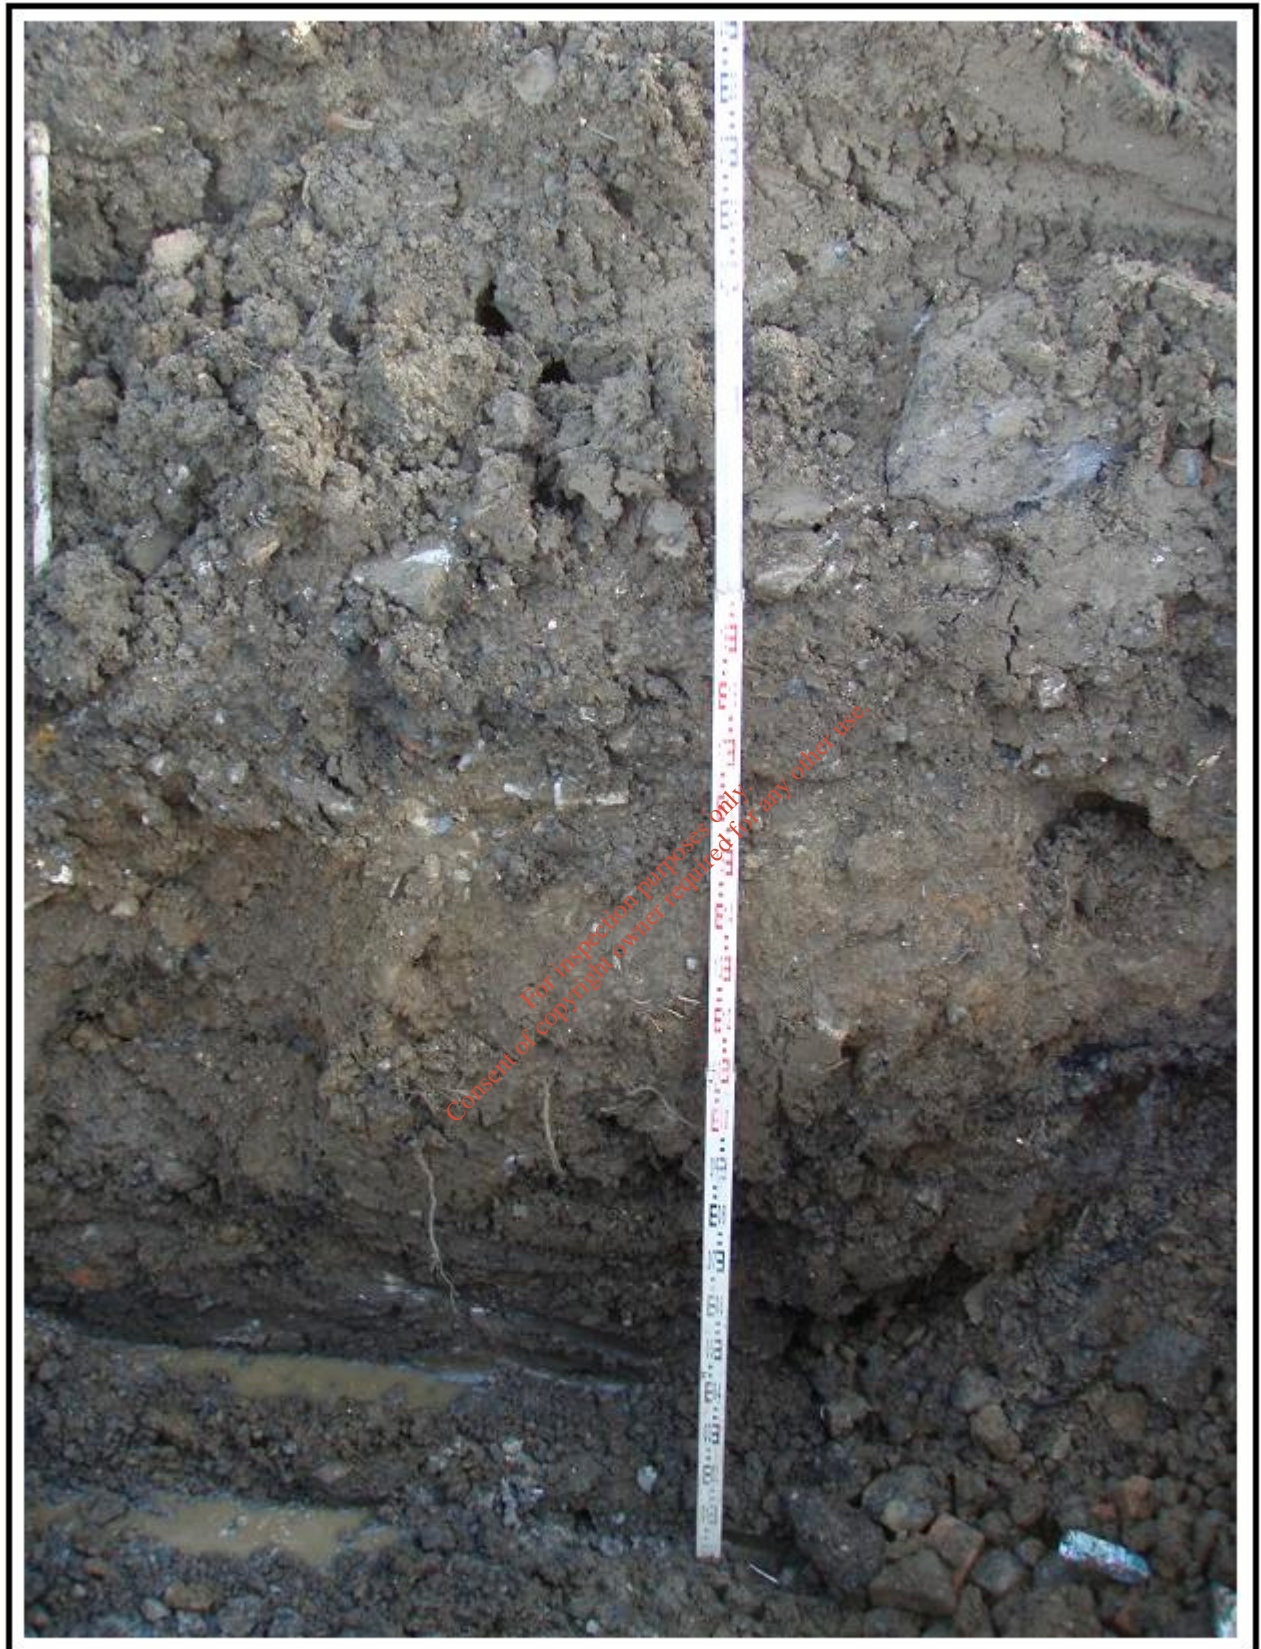
**General remarks :**  
 Dug in central portion of the main, western fill area, into a dry, bare pile. Dug on a 1° slope, falling southwards.

<b>Groundwater :</b> Wet base, following runoff entering hole from surface.	<b>Sequence summary:</b> Well drained, deep, 'filled' subsoil and rubble, 'lifted' on-site.
--	--

**Plate A8: Profile of recently-filled subsoil in trial hole no. 8. Pieces of concrete, bricks, wire, branches and plastic piping are seen occasionally, within alternating layers of compacted subsoil.**

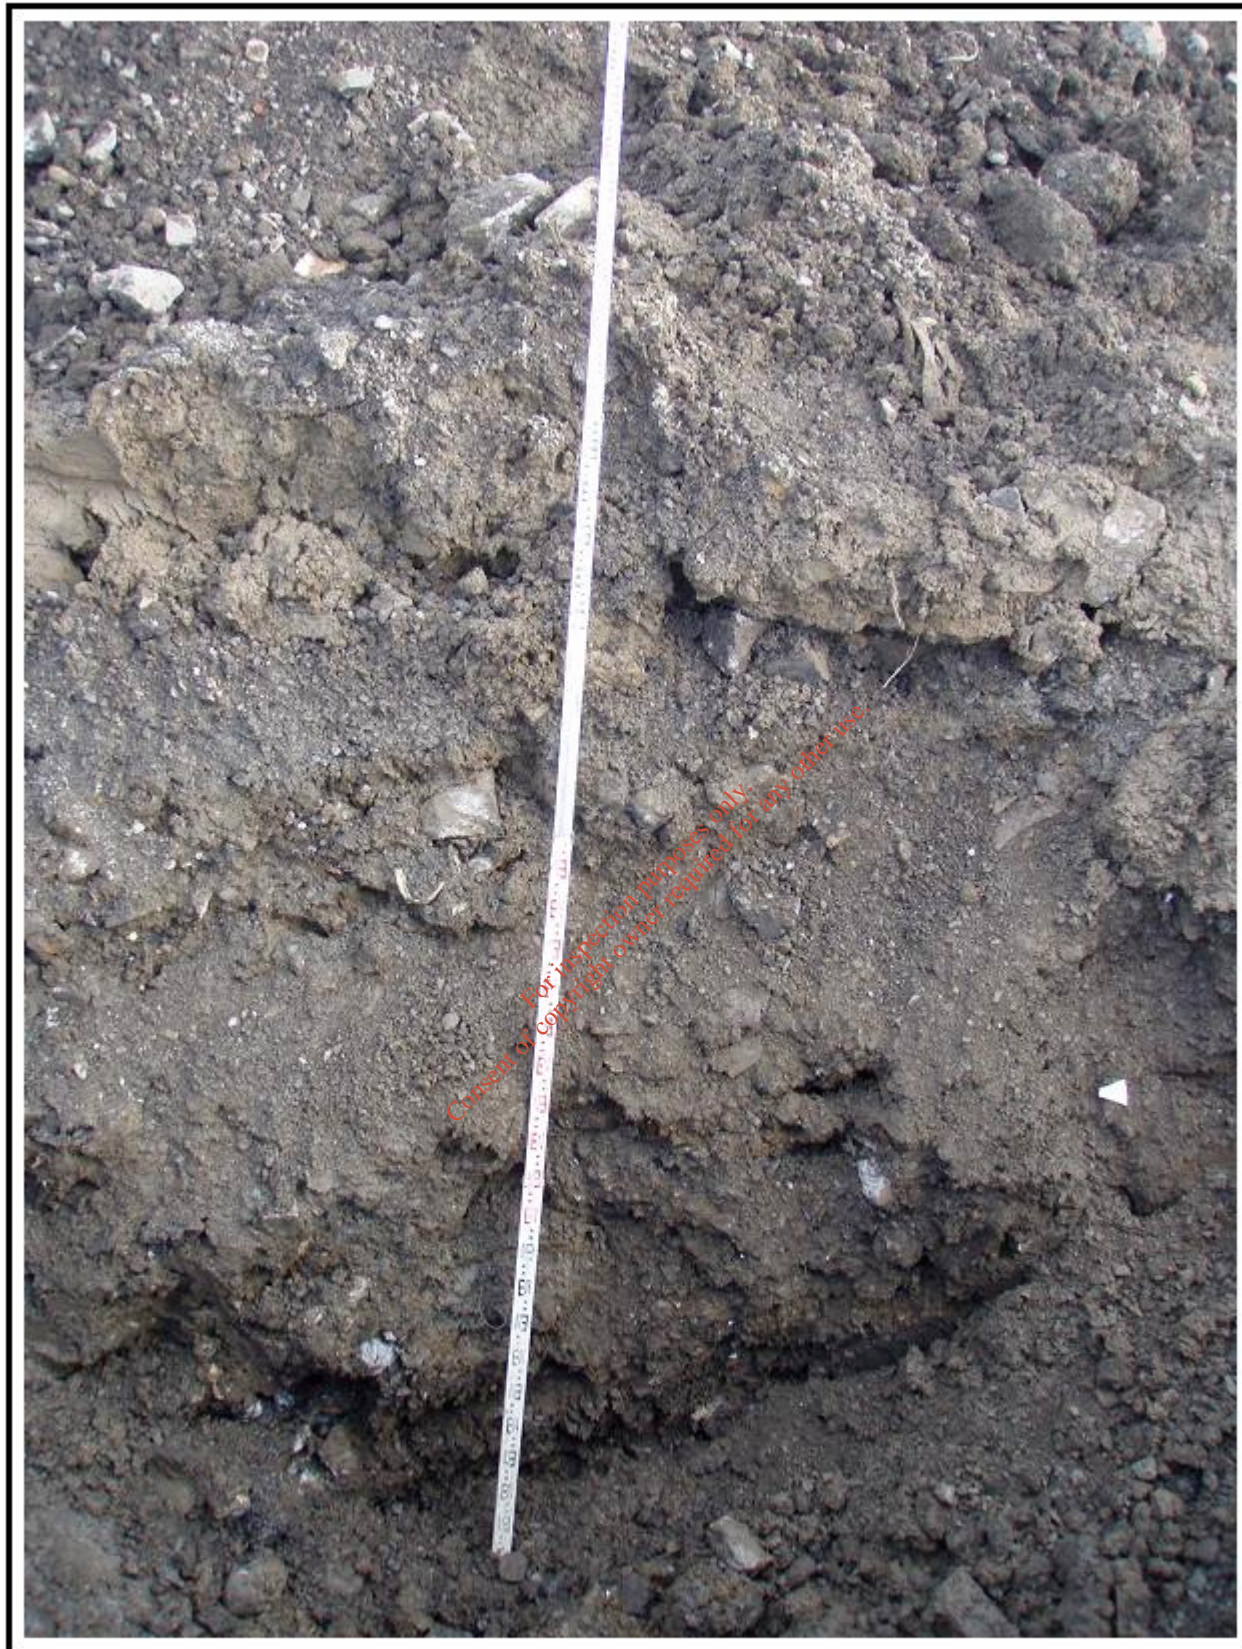
**General remarks :**  
 Dug in northern portion of main, western fill area, into a dry, bare pile.  
 Dug on a 1° slope, falling southwards.

**Sequence summary:**  
 Well drained, deep, 'filled' subsoil and rubble, 'lifted' on-site.

**Plate A9: Profile of recently-filled subsoil in trial hole no. 9. Occasional pieces of concrete, branches and steel are seen, within alternating layers of compacted subsoil.**

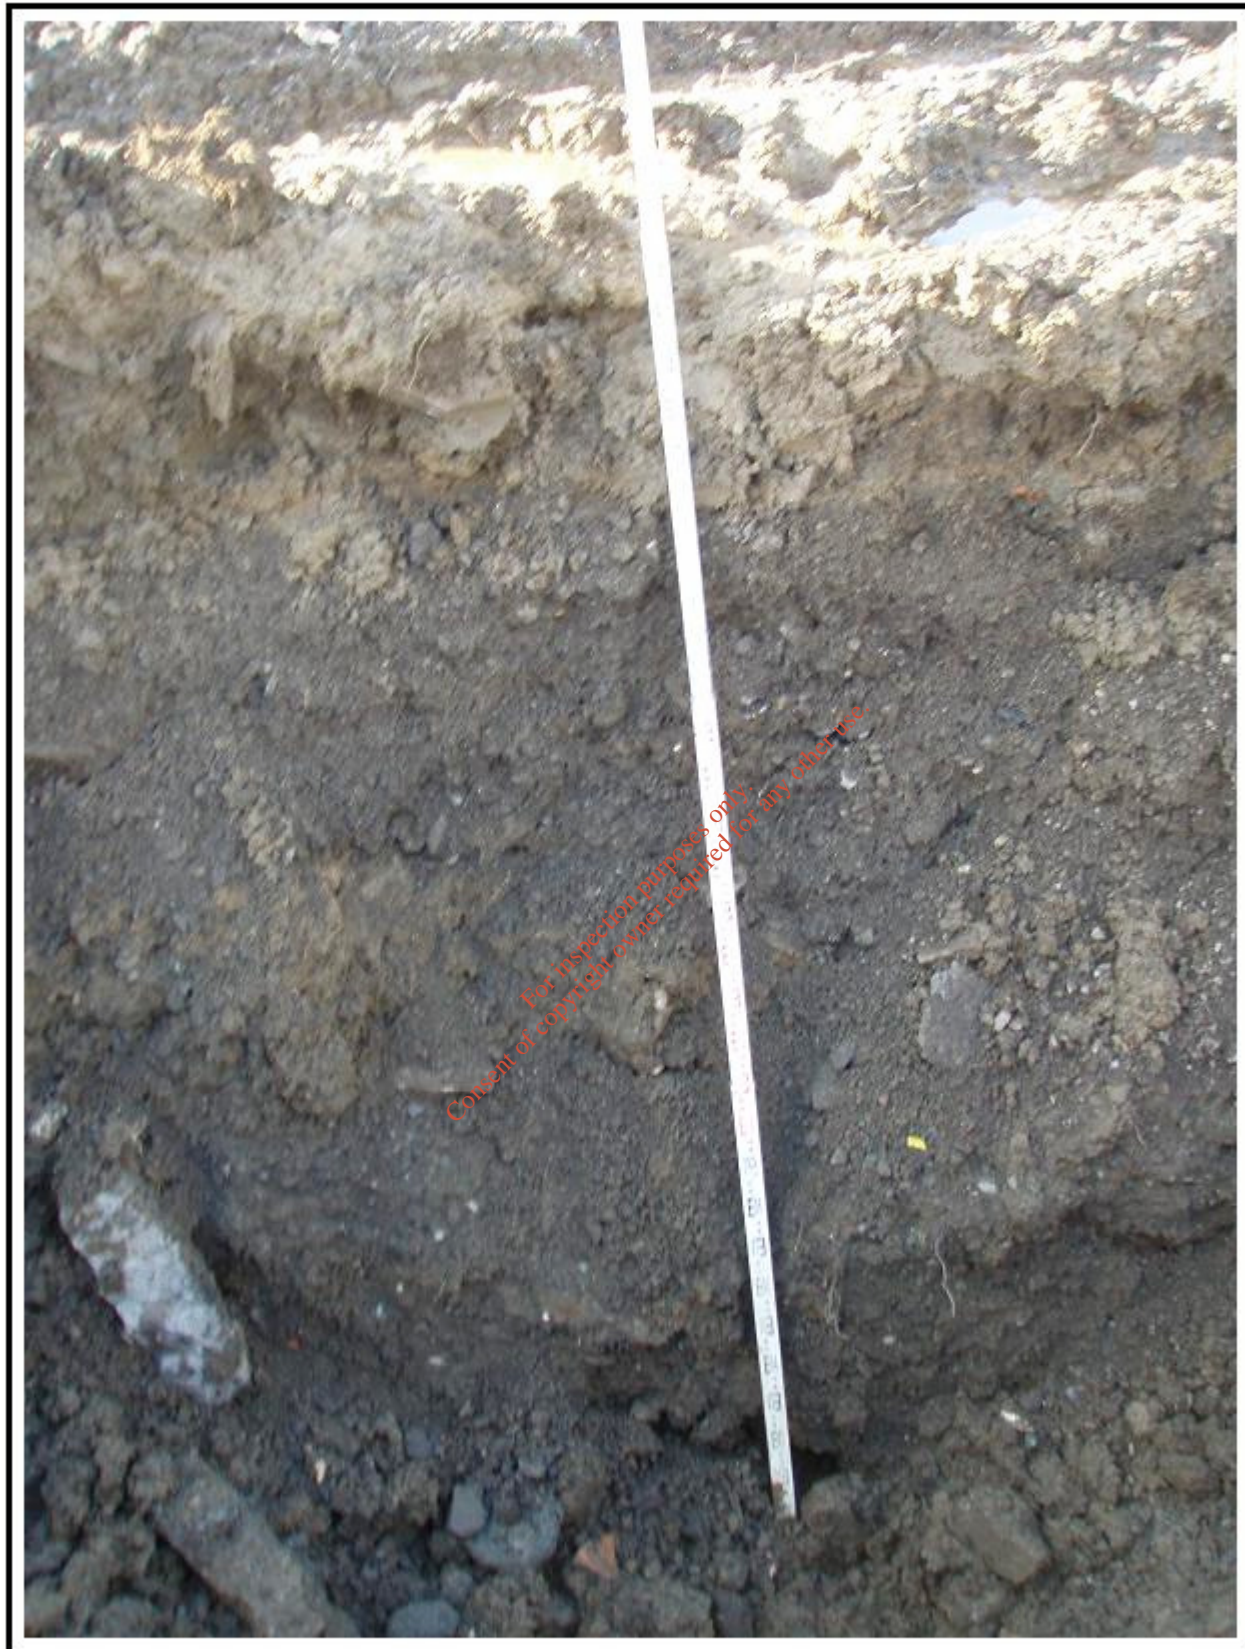
<p><b>Bearing</b> : 36° (SW-NE)</p>	<p><b>Stability :</b></p> <p>Trial pit walls consolidated, and subsoil below 0.5m depth very competent.</p>	
	<p><b>General remarks :</b></p> <p>Dug in northernmost extreme of main, western fill area, into a dry, bare pile. Dug on a 1° slope, falling southwards.</p>	
	<table border="1"> <tr> <td> <p><b>Groundwater :</b></p> <p>Wet base, following runoff entering hole from surface.</p> </td> <td> <p><b>Sequence summary:</b></p> <p>Well drained, deep, 'filled' subsoil, 'lifted' on-site.</p> </td> </tr> </table>	<p><b>Groundwater :</b></p> <p>Wet base, following runoff entering hole from surface.</p>
<p><b>Groundwater :</b></p> <p>Wet base, following runoff entering hole from surface.</p>	<p><b>Sequence summary:</b></p> <p>Well drained, deep, 'filled' subsoil, 'lifted' on-site.</p>

**Plate A10: Profile of recently-filled subsoil in trial hole no. 10. This exposure shows little construction and demolition material, within alternating layers of compacted subsoil.**
