### **ASSESSMENT OF FILLED SUBSOILS FOR WASTE LICENCE APPLICATION AT THORNBERRY, COUNTY KILDARE**

**ASSESSMENT OF FILLED SUBSOILS FOR WASTE LICENCE APPLICATION  
AT  
THORNBERRY, KILL, COUNTY KILDARE**

**FINAL REPORT**

<b>Project No.:</b>	17004
<b>Report Title:</b>	Assessment of filled subsoils for Waste Licence Application at Thornberry, Kill, County Kildare
<b>Report Status:</b>	FINAL
<b>Date:</b>	10/02/2009
<b>Prepared by:</b>

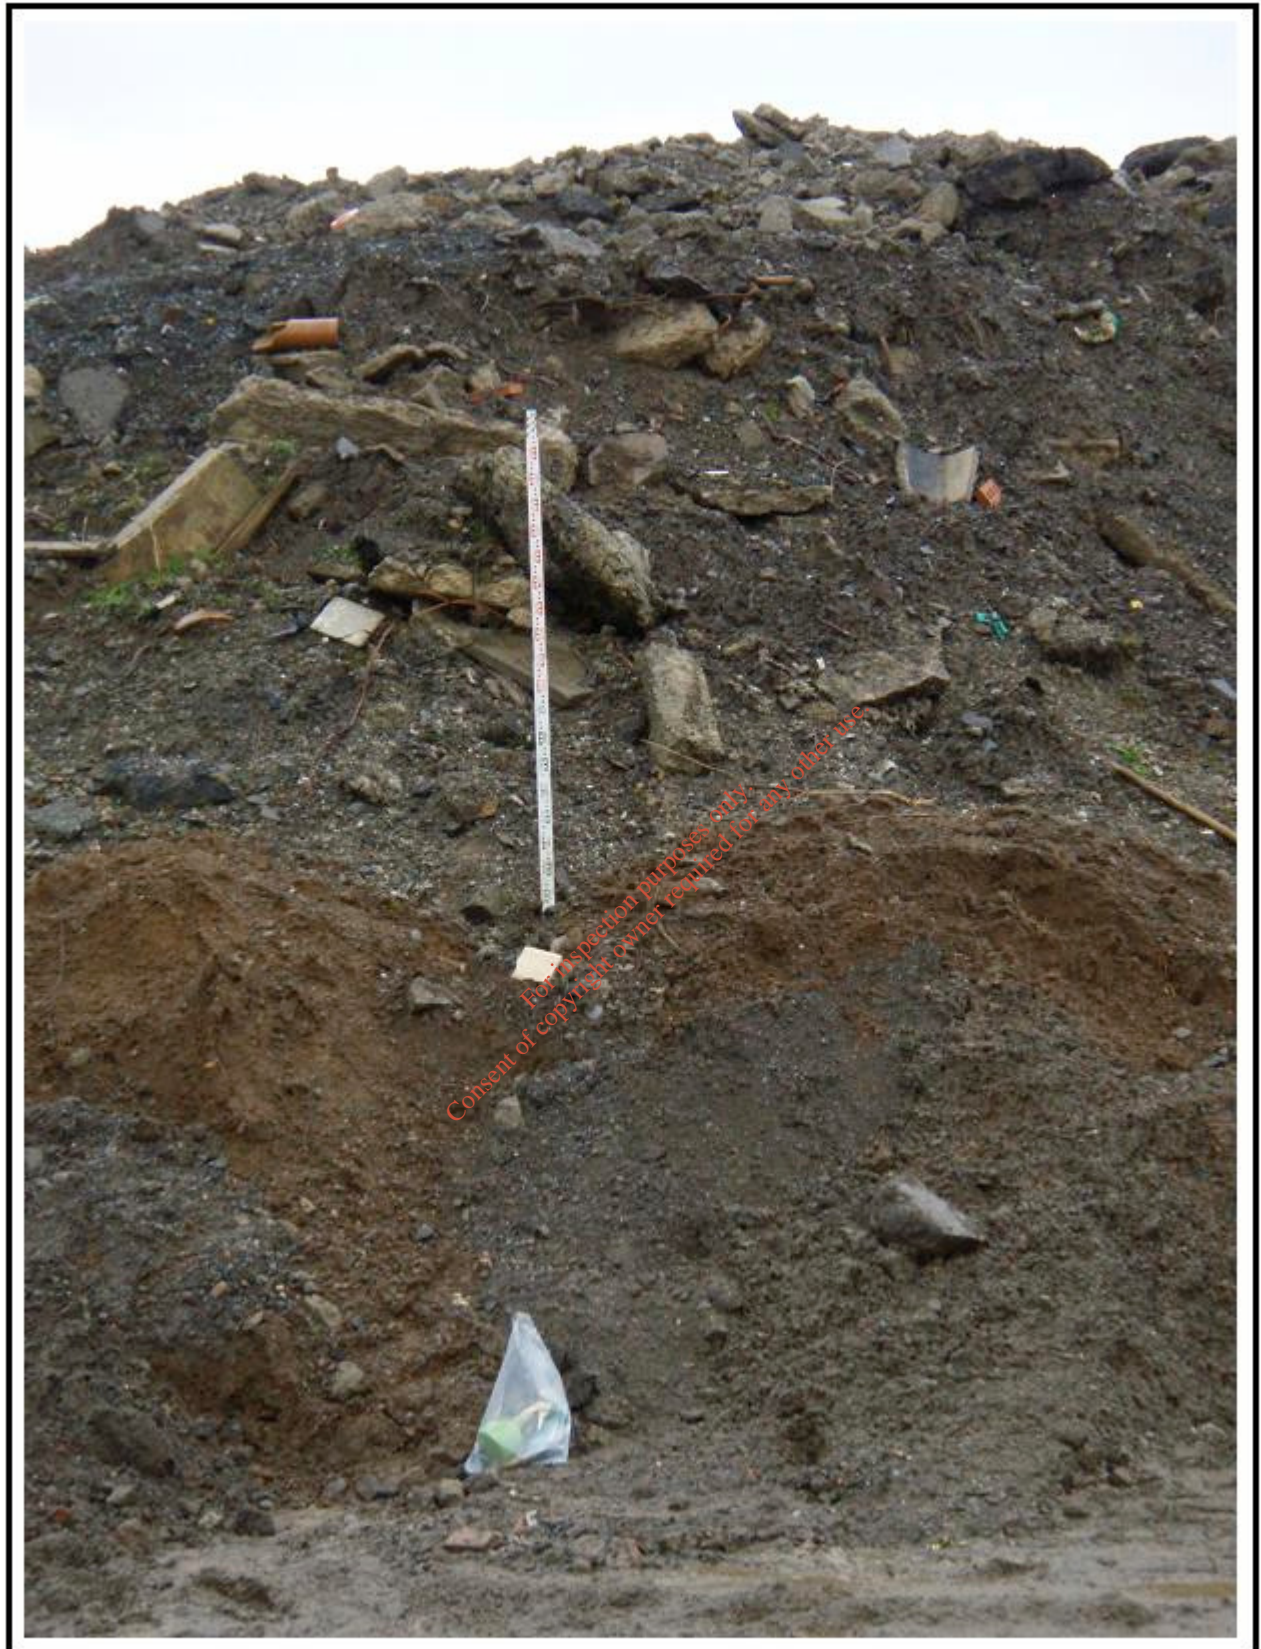
<b>Plan</b>           <b>Bearing : 43° (SW-NE)</b>	<b>Stability :</b>  Material consolidated and competent.	
	<b>General remarks :</b>  Profile is into the northwestern edge of the main (western) fill area.	
	<table border="1"> <tr> <td> <b>Groundwater :</b>                               Dry.                         </td> <td> <b>Sequence summary:</b>                               Well drained, deep, 'filled' topsoil over filled boulder clay, 'lifted' on-site.                         </td> </tr> </table>	<b>Groundwater :</b>  Dry.
<b>Groundwater :</b>  Dry.	<b>Sequence summary:</b>  Well drained, deep, 'filled' topsoil over filled boulder clay, 'lifted' on-site.

**Plate A11: Profile of skim of recently-lain topsoil overlying consolidated subsoil at the northwestern corner of the main (western) fill area. Though containing much concrete at the face, this material is very clean throughout.**

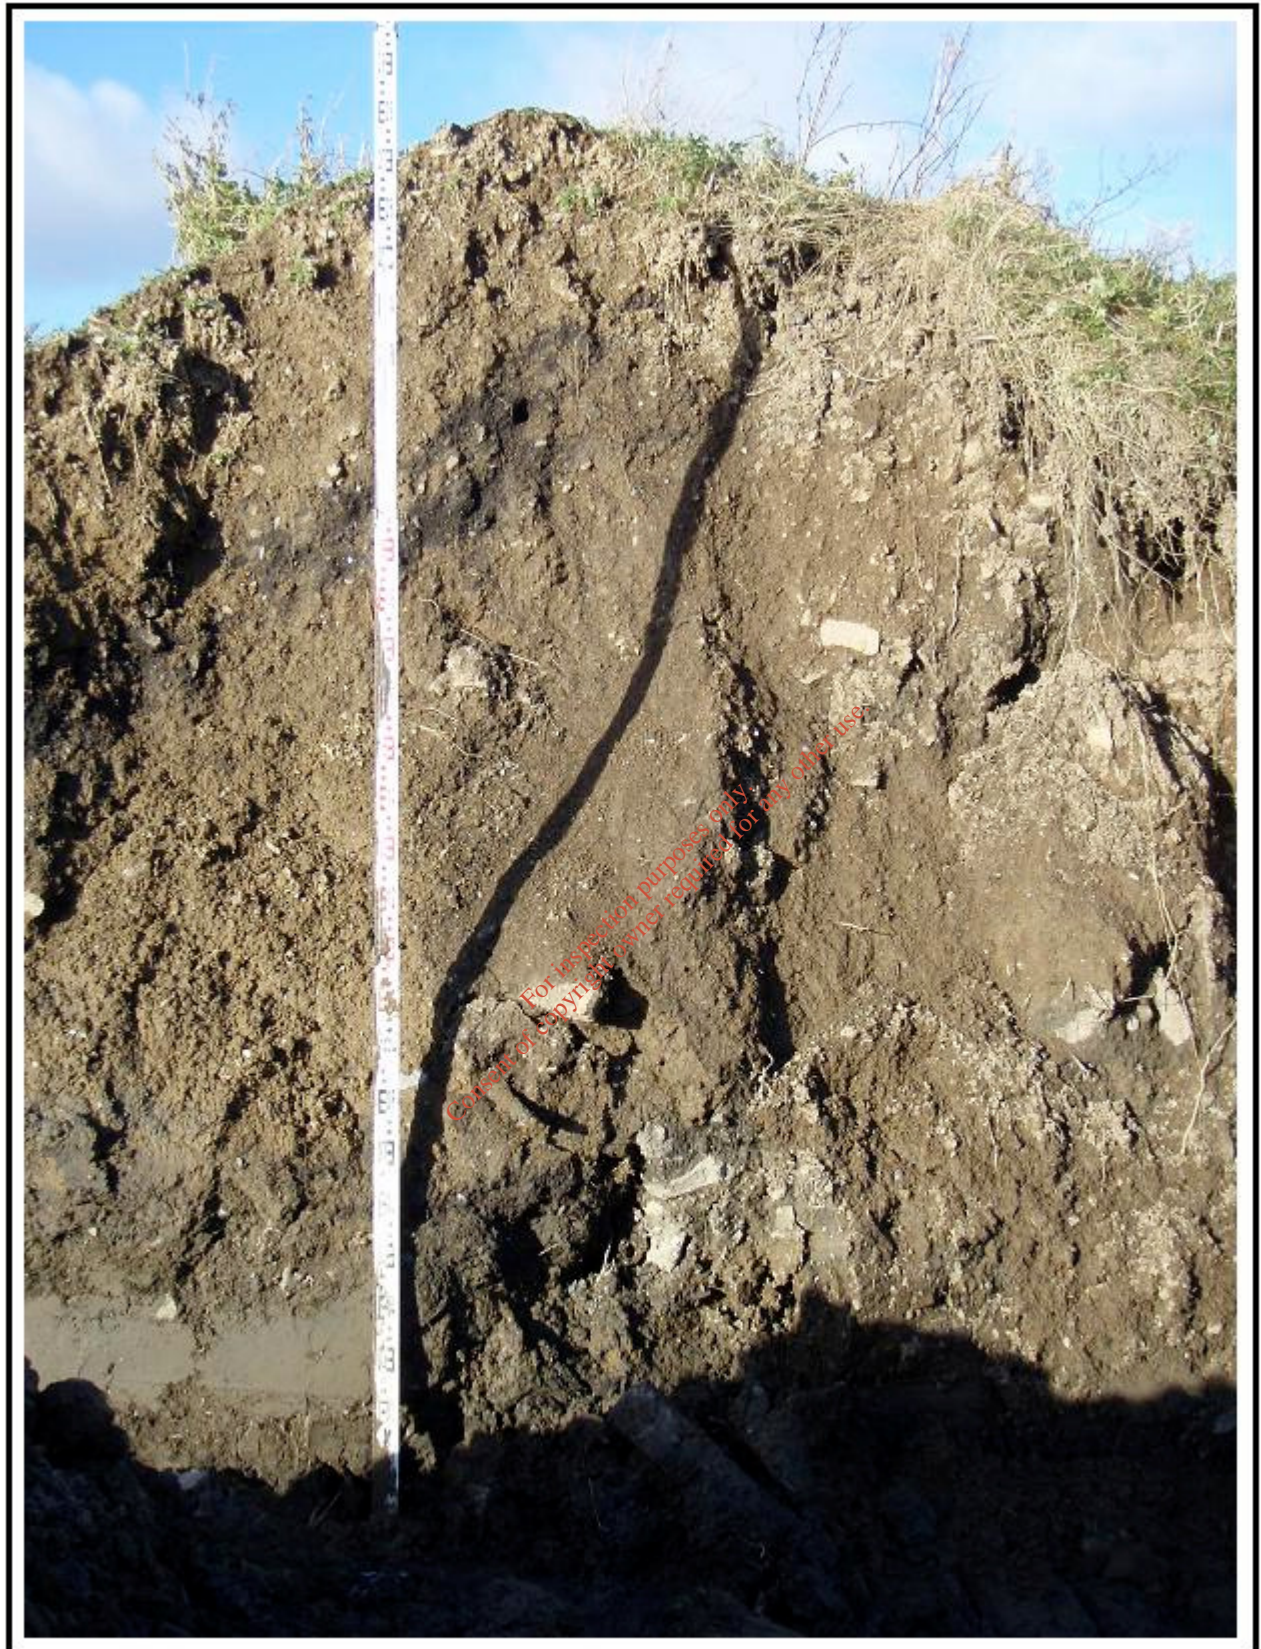
**Plate A12: Profile of deep, recently-lain topsoil overlying consolidated subsoil at the northern edge of the eastern fill area. This material is very clean throughout.**

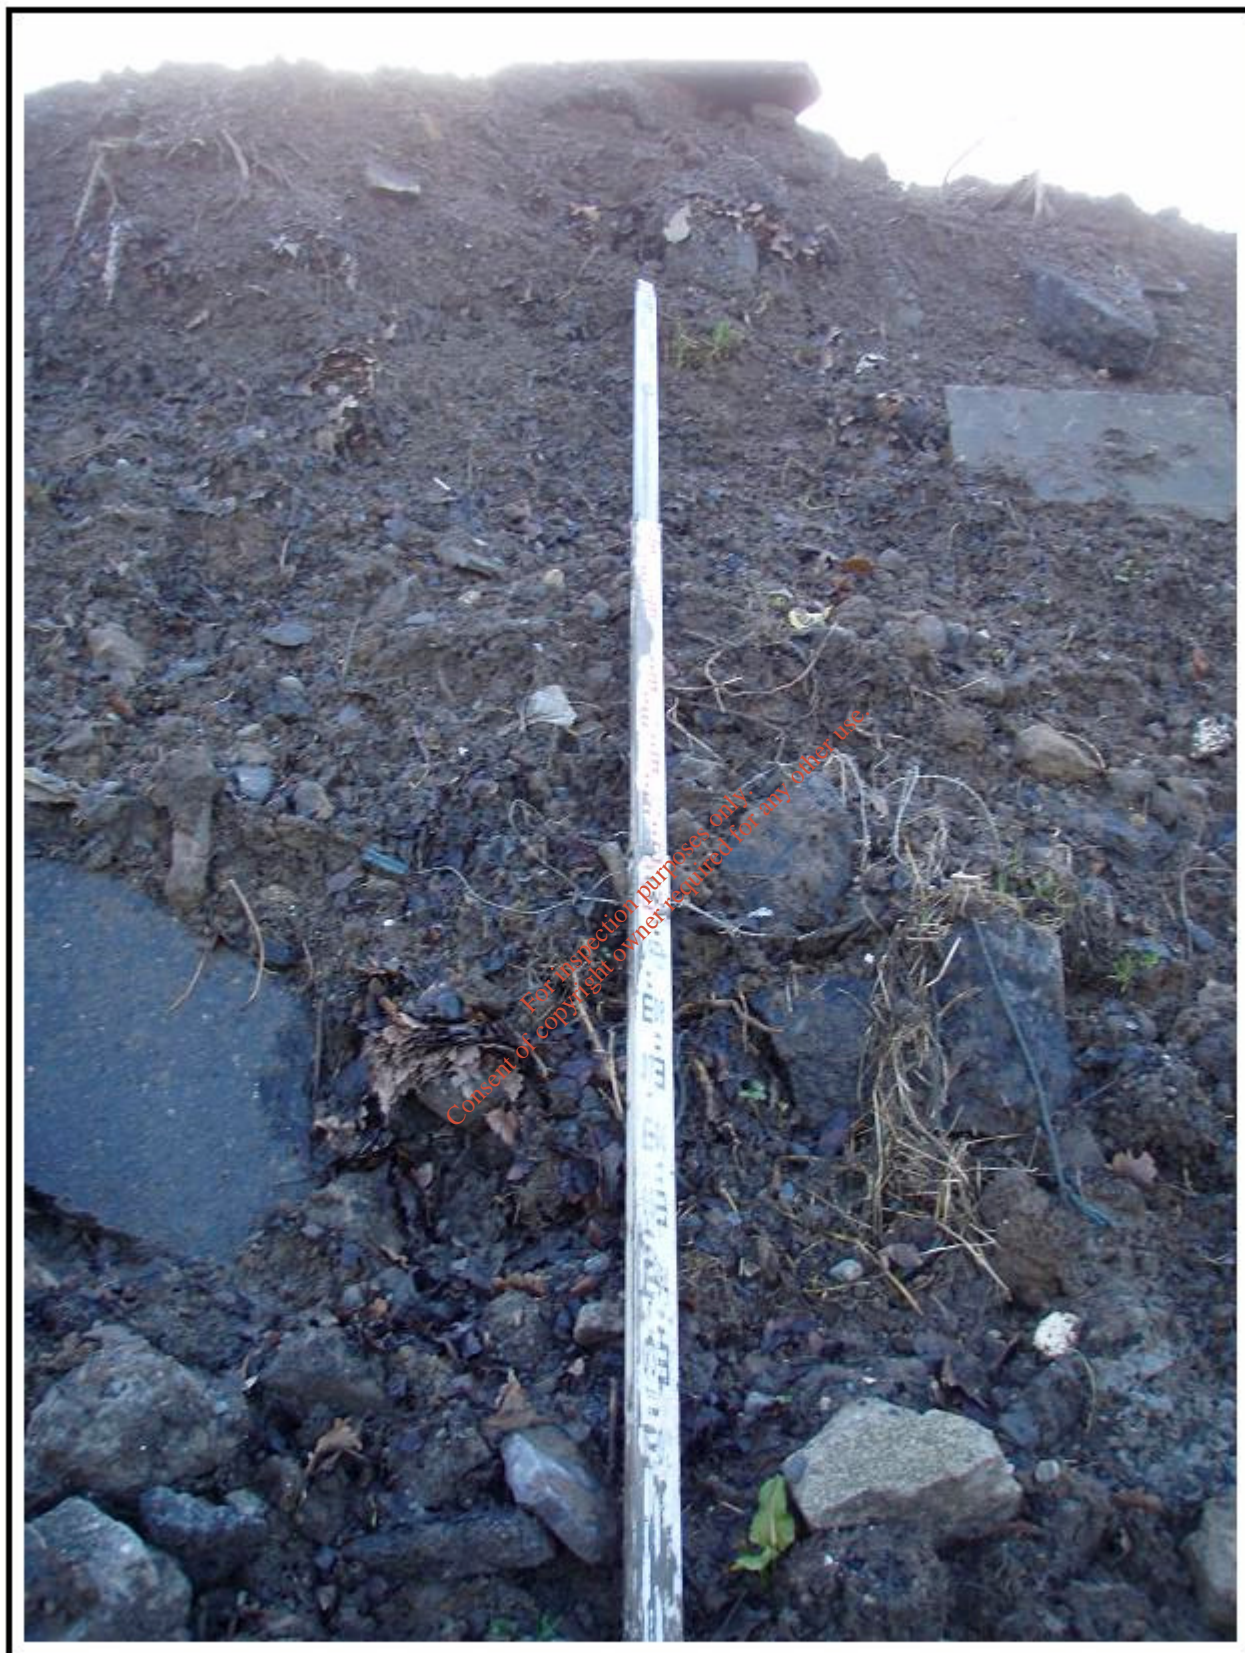
<b>Bearing :</b> 100° (N-S)	<b>Plan</b>	<b>Stability :</b> Material consolidated and competent.	
		<b>General remarks :</b> Profile is into the southeastern edge of the main (western) fill area.	
		<table border="1" style="width: 100%;"> <tr> <td> <b>Groundwater :</b>                      Dry.                 </td> <td> <b>Sequence summary:</b>                      Well drained, deep, 'filled' boulder clay subsoil, 'lifted' on-site.                 </td> </tr> </table>	<b>Groundwater :</b> Dry.
<b>Groundwater :</b> Dry.	<b>Sequence summary:</b> Well drained, deep, 'filled' boulder clay subsoil, 'lifted' on-site.

**Plate A13: Profile of recently-lain consolidated subsoil at the southeastern edge of the main (western) fill area. Though containing much construction and demolition material at the face, this material is again very clean throughout.**

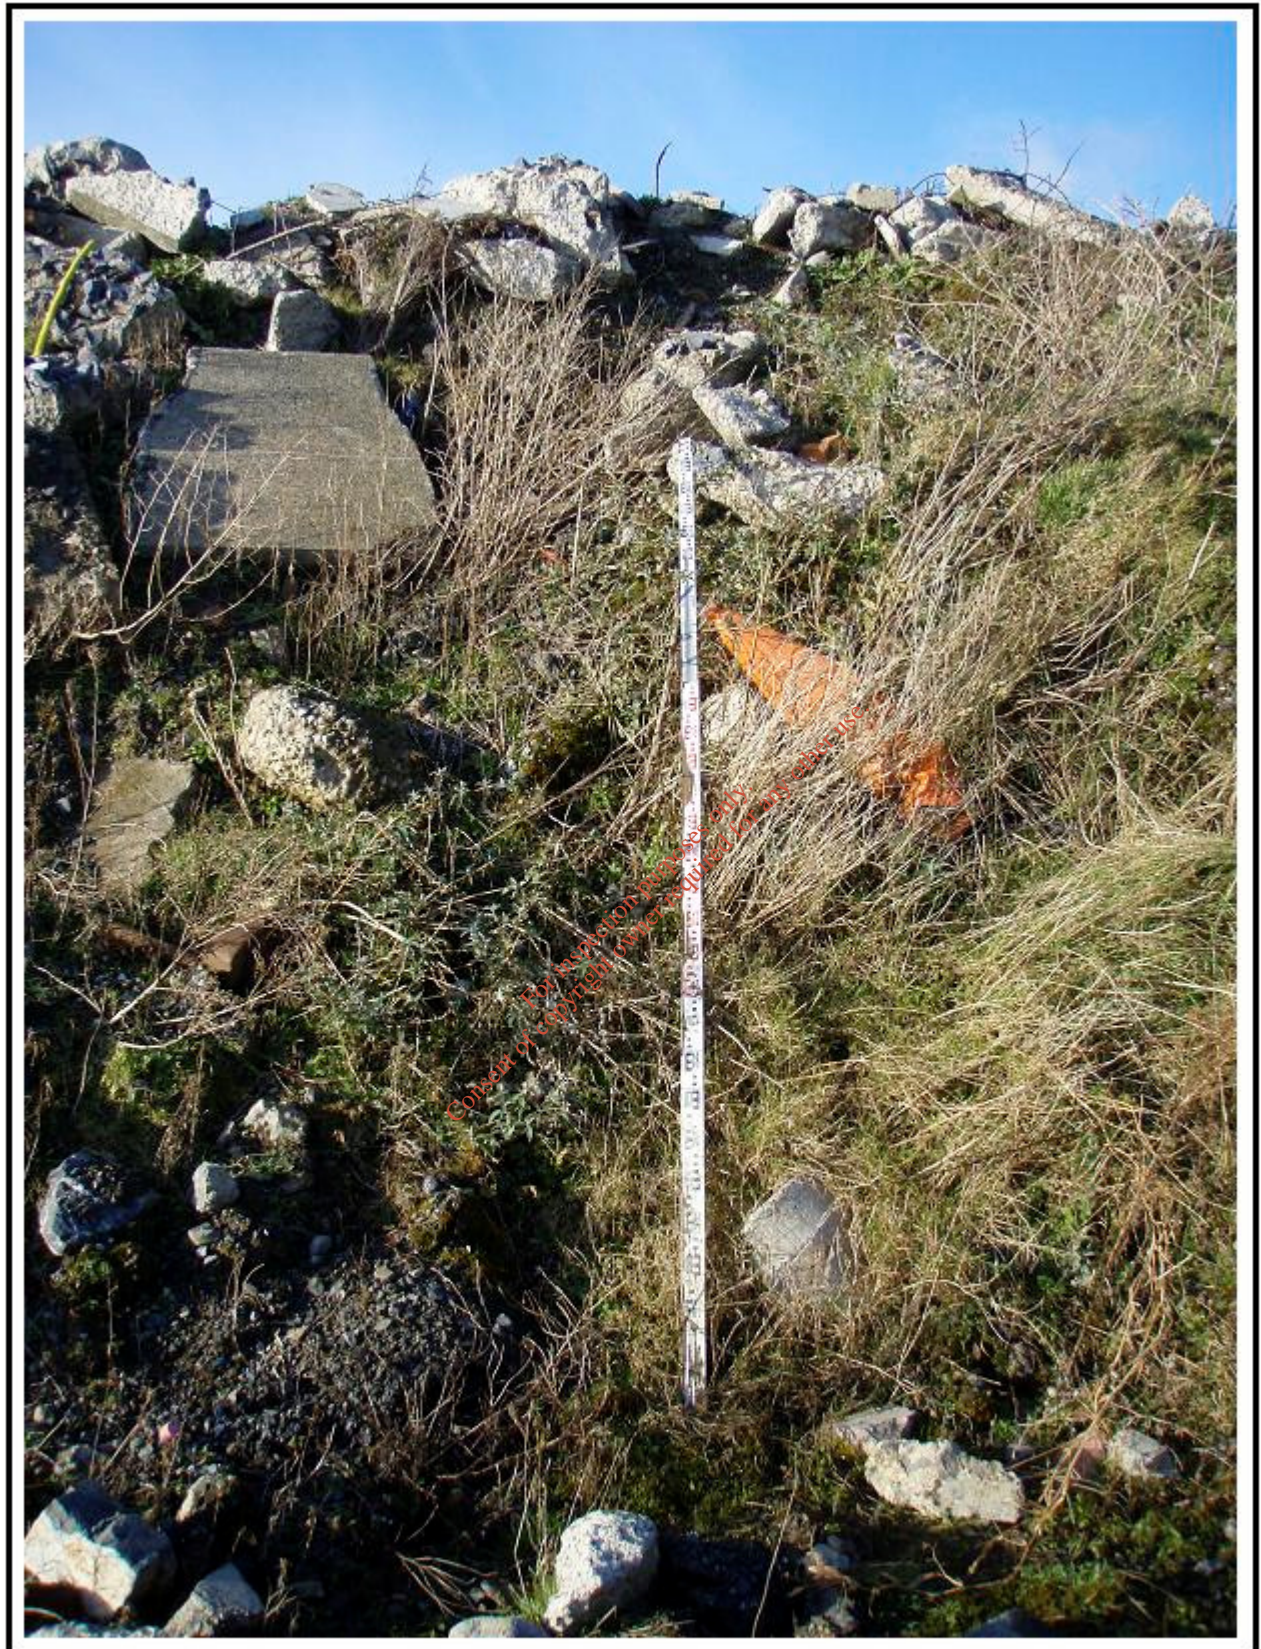
<b>Plan</b>         <b>Bearing : 44° (SW-NE)</b>	<b>Stability :</b>  Material consolidated and competent, with vegetation adding extra stability.	
	<b>General remarks :</b>  Profile is into the eastern edge of the main (western) fill area.	
	<table border="1"> <tr> <td> <b>Groundwater :</b>                               Dry.                         </td> <td> <b>Sequence summary:</b>                               Well drained, deep, 'filled' boulder clay subsoil, 'lifted' on-site.                         </td> </tr> </table>	<b>Groundwater :</b>  Dry.
<b>Groundwater :</b>  Dry.	<b>Sequence summary:</b>  Well drained, deep, 'filled' boulder clay subsoil, 'lifted' on-site.

**Plate A14: Profile of recently-lain consolidated subsoil at the eastern edge of the main (western) fill area. Though containing much construction and demolition material at the face, this material is also relatively clean throughout.**

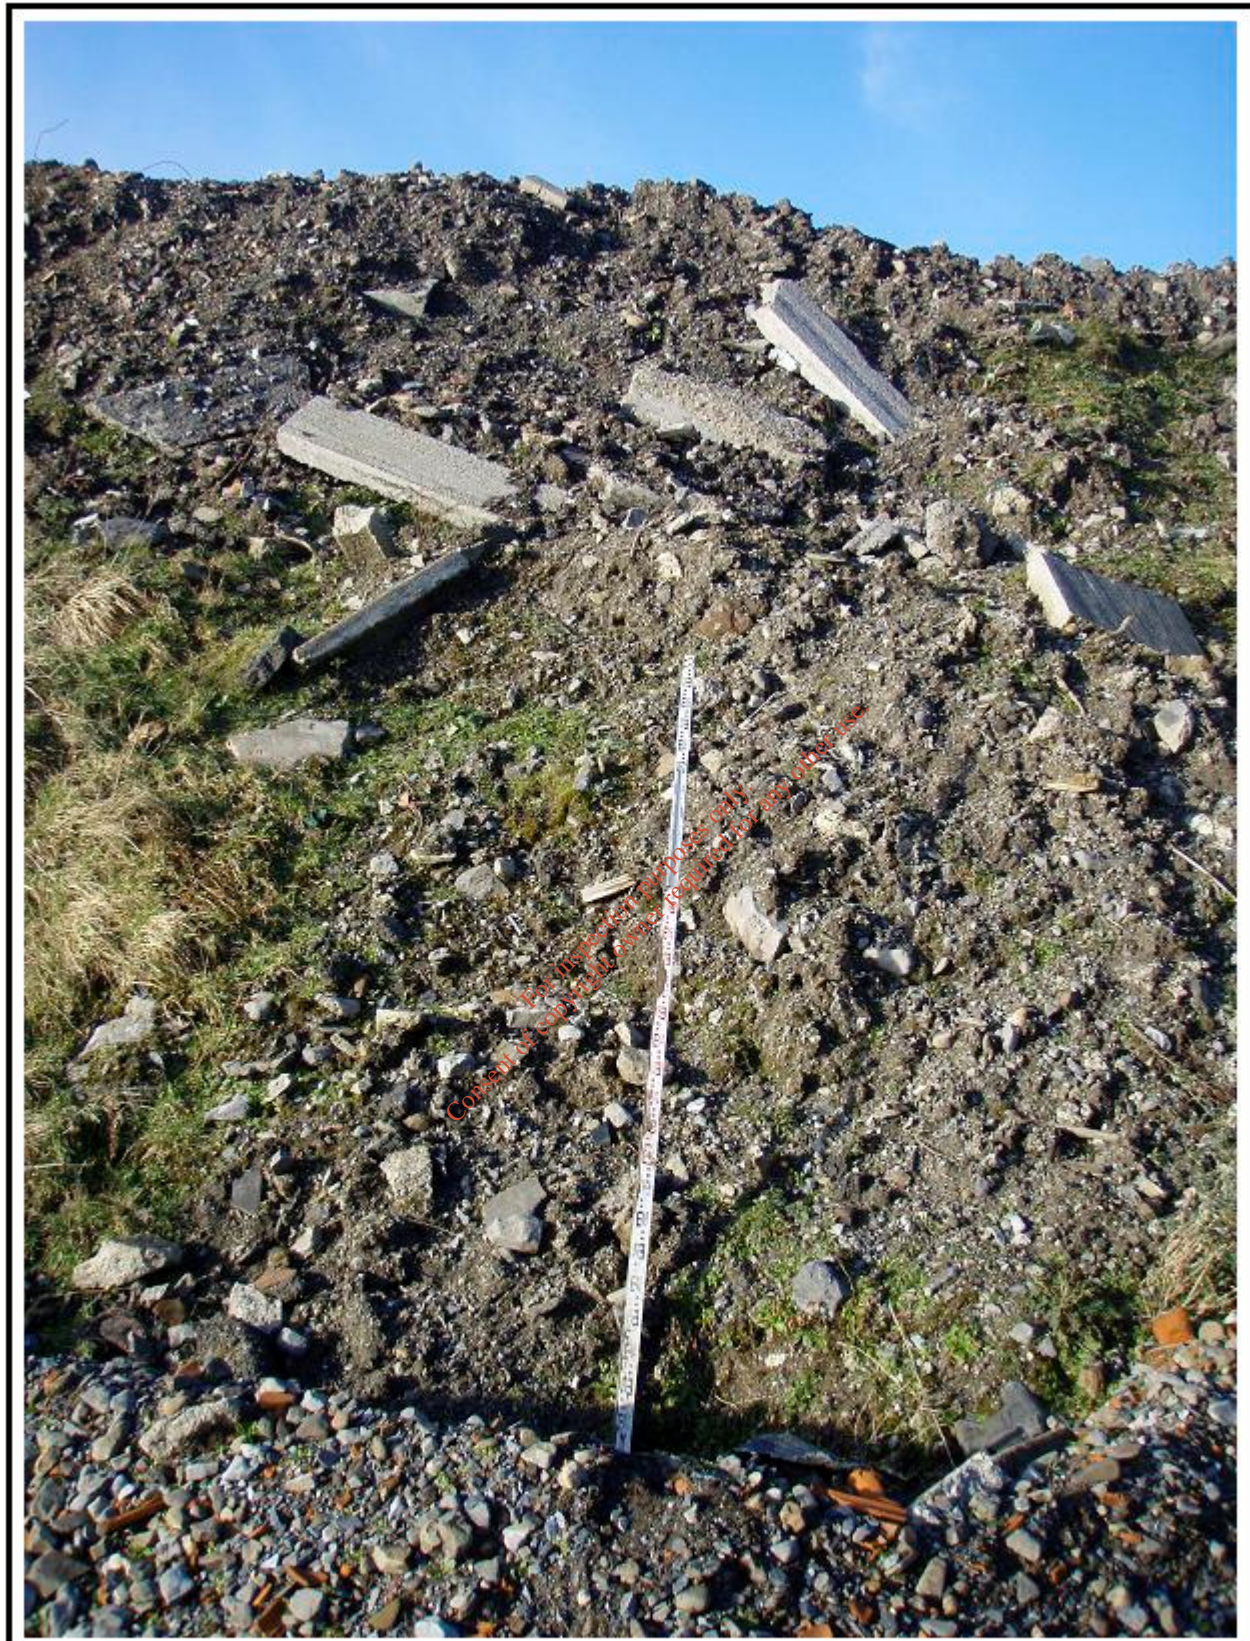
<p><b>Plan</b></p> <p style="text-align: right;"><b>Bearing : 46° (SW-NE)</b></p>	<p><b>Stability :</b></p> <p>Material consolidated and competent, with occasional vegetation adding extra stability.</p>	
	<p><b>General remarks :</b></p> <p>Profile is into the eastern edge of the main (western) fill area.</p>	
	<table border="1" style="width: 100%;"> <tr> <td style="width: 50%;"> <p><b>Groundwater :</b></p> <p>Dry.</p> </td> <td style="width: 50%;"> <p><b>Sequence summary:</b></p> <p>Well drained, deep, 'filled' boulder clay subsoil, 'lifted' on-site.</p> </td> </tr> </table>	<p><b>Groundwater :</b></p> <p>Dry.</p>
<p><b>Groundwater :</b></p> <p>Dry.</p>	<p><b>Sequence summary:</b></p> <p>Well drained, deep, 'filled' boulder clay subsoil, 'lifted' on-site.</p>

**Plate A15: Profile of consolidated subsoil at the eastern edge of the main (western) fill area. This material is again relatively clean throughout.**

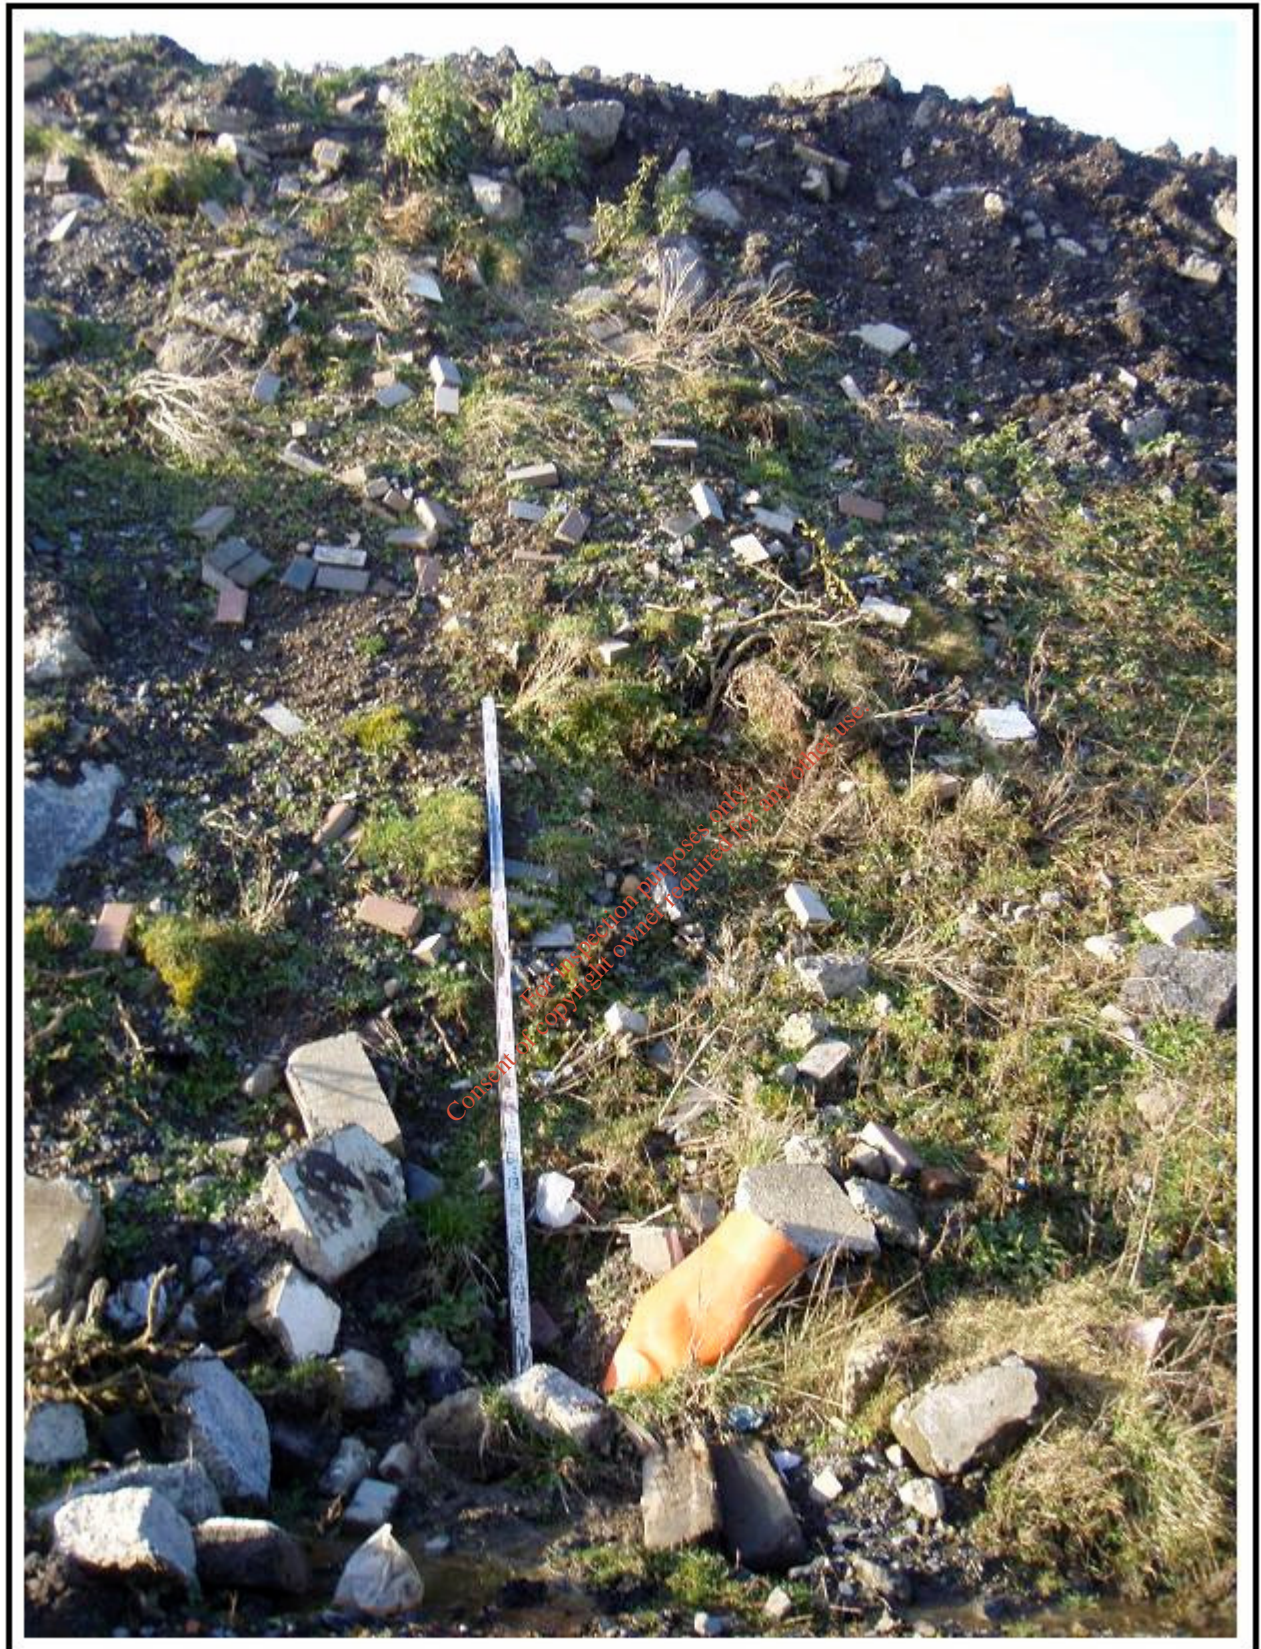
<p><b>Plan</b></p> <p><b>Bearing : 38° (SW-NE)</b></p>	<p><b>Stability :</b></p> <p>Material consolidated and competent, with vegetation adding extra stability.</p>	
	<p><b>General remarks :</b></p> <p>Profile is into the northeastern edge of the main (western) fill area.</p>	
	<table border="1"> <tr> <td> <p><b>Groundwater :</b></p> <p>Dry.</p> </td> <td> <p><b>Sequence summary:</b></p> <p>Well drained, deep, 'filled' boulder clay subsoil, 'lifted' on-site.</p> </td> </tr> </table>	<p><b>Groundwater :</b></p> <p>Dry.</p>
<p><b>Groundwater :</b></p> <p>Dry.</p>	<p><b>Sequence summary:</b></p> <p>Well drained, deep, 'filled' boulder clay subsoil, 'lifted' on-site.</p>

**Plate A16: Profile of consolidated subsoil at the northeastern edge of the main (western) fill area. This material is also relatively clean throughout.**

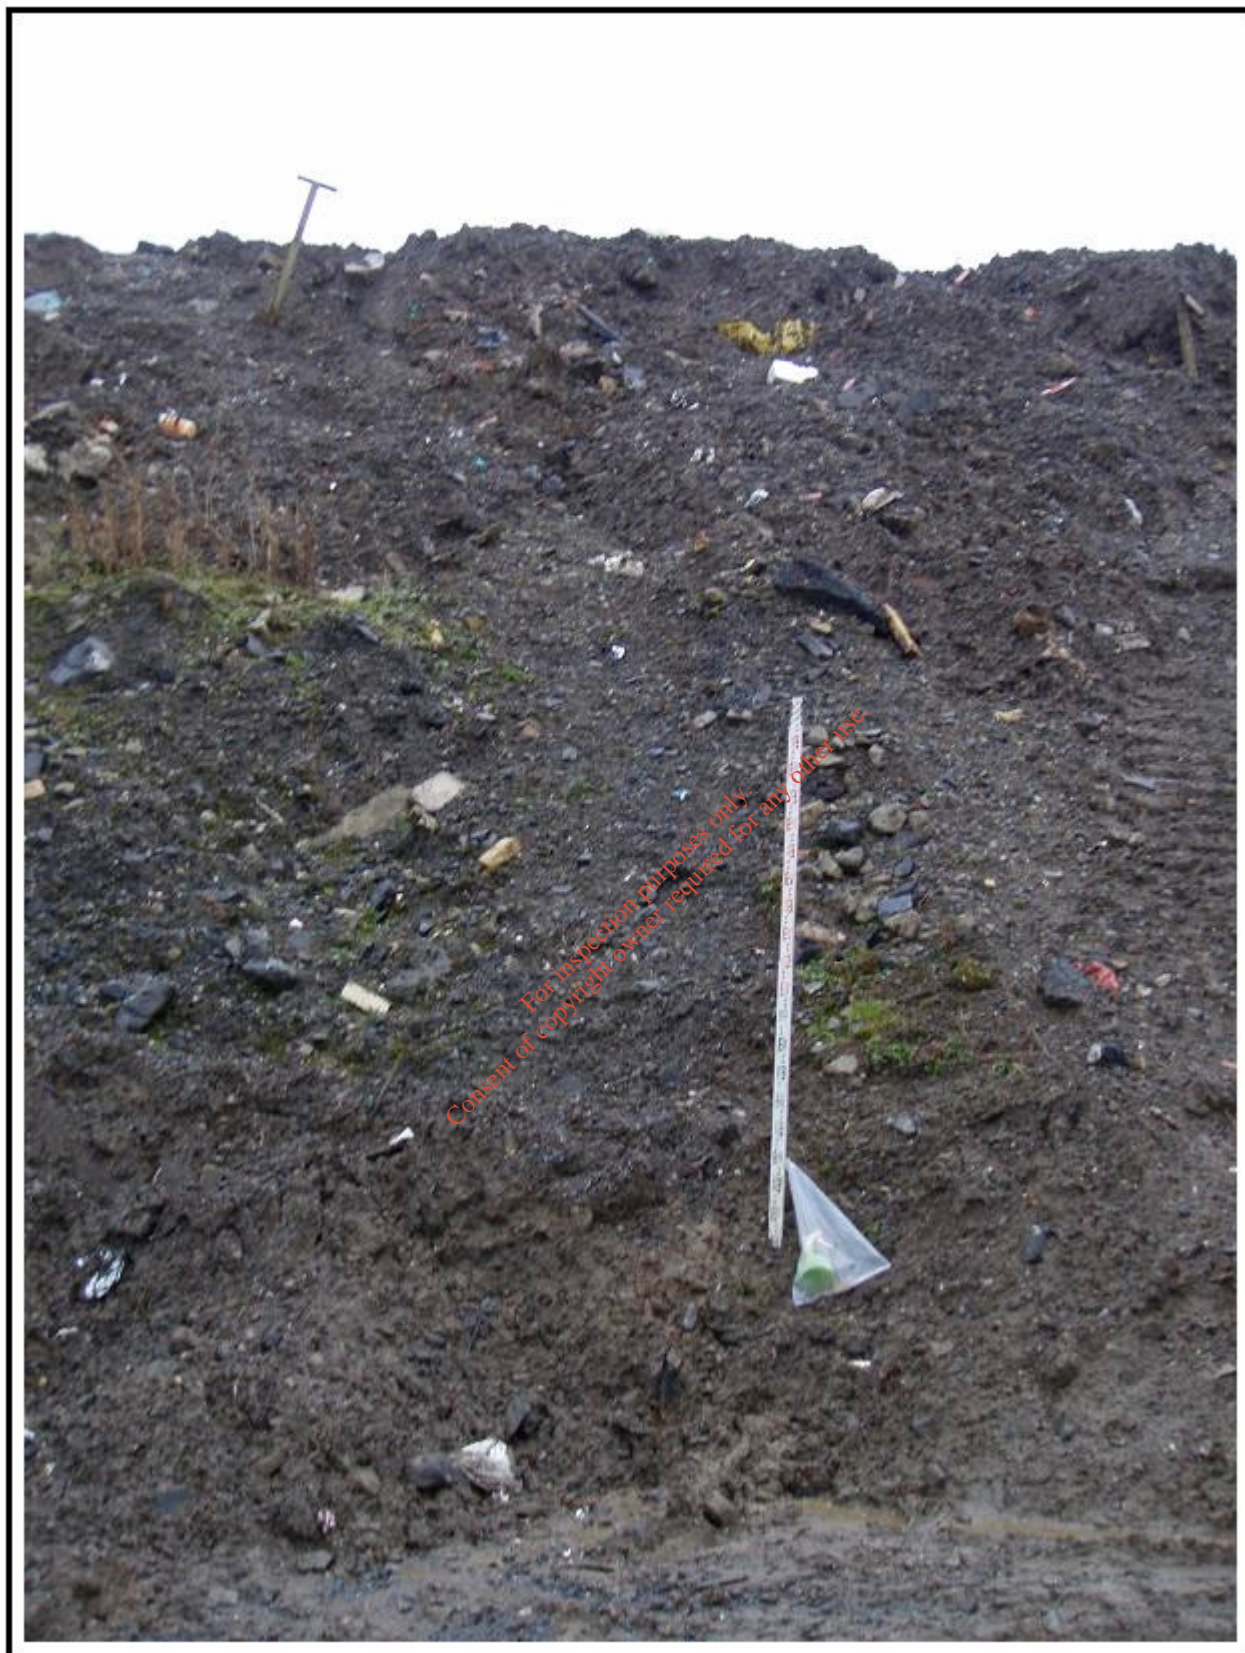
<p><b>Plan</b></p> <p><b>Bearing : 20° (SSW-NNE)</b></p>	<p><b>Stability :</b></p> <p>Material consolidated and competent.</p>	
	<p><b>General remarks :</b></p> <p>Profile is into the western edge of the main (western) fill area.</p>	
	<table border="1"> <tr> <td> <p><b>Groundwater :</b></p> <p>Dry.</p> </td> <td> <p><b>Sequence summary:</b></p> <p>Well drained, deep, 'filled' topsoil over filled boulder clay, 'lifted' on-site.</p> </td> </tr> </table>	<p><b>Groundwater :</b></p> <p>Dry.</p>
<p><b>Groundwater :</b></p> <p>Dry.</p>	<p><b>Sequence summary:</b></p> <p>Well drained, deep, 'filled' topsoil over filled boulder clay, 'lifted' on-site.</p>

**Plate A17: Profile of consolidated subsoil at the western edge of the main (western) fill area. This material is relatively clean throughout.**

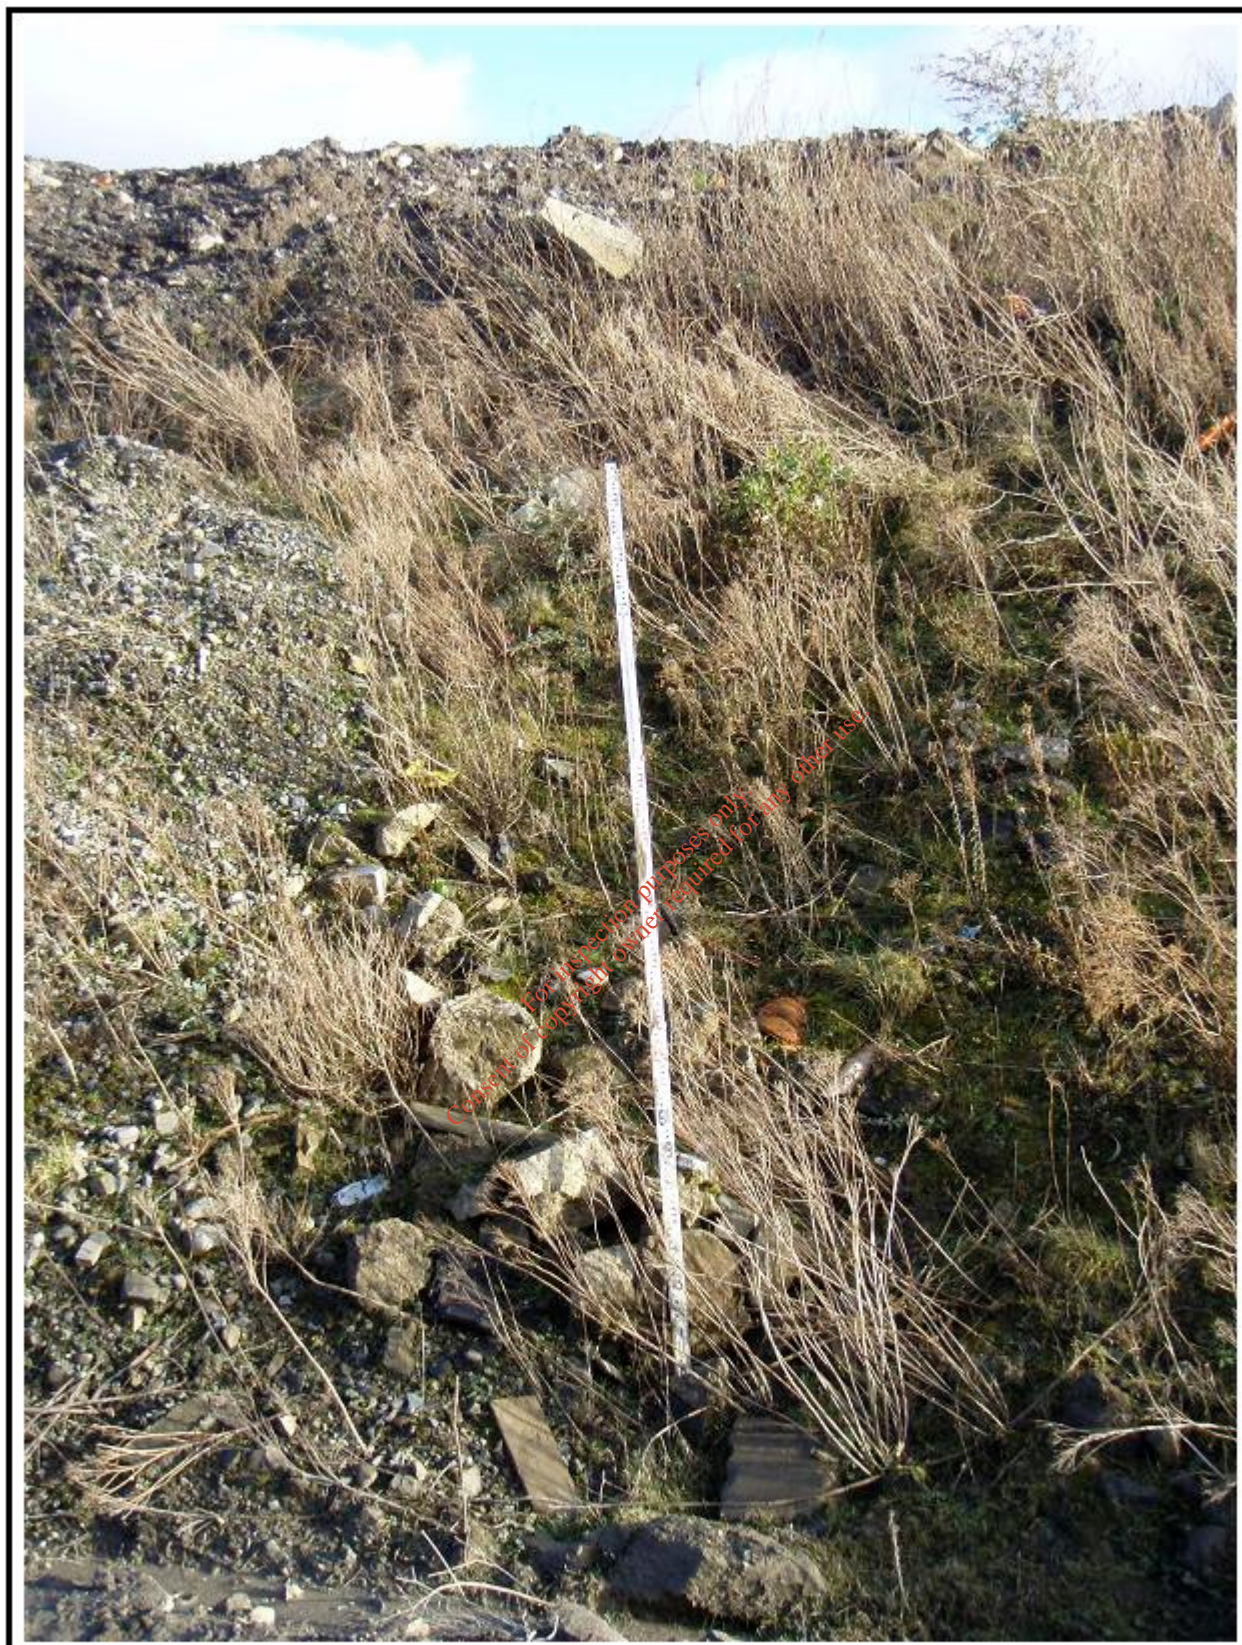
<p><b>Plan</b></p> <p><b>Bearing : 28° (SSW-NNE)</b></p>	<p><b>Stability :</b></p> <p>Material consolidated and competent, with vegetation adding extra stability.</p>	
	<p><b>General remarks :</b></p> <p>Profile is into the southwestern edge of the main (western) fill area.</p>	
	<table border="1"> <tr> <td> <p><b>Groundwater :</b></p> <p>Dry.</p> </td> <td> <p><b>Sequence summary:</b></p> <p>Well drained, deep, 'filled' boulder clay subsoil, 'lifted' on-site.</p> </td> </tr> </table>	<p><b>Groundwater :</b></p> <p>Dry.</p>
<p><b>Groundwater :</b></p> <p>Dry.</p>	<p><b>Sequence summary:</b></p> <p>Well drained, deep, 'filled' boulder clay subsoil, 'lifted' on-site.</p>

**Plate A18: Profile of consolidated subsoil at the southwestern edge of the main (western) fill area. This material is also relatively clean throughout.**
