SECTION 9 –SOILS AND GEOLOGY

SECTION 10 – GROUNDWATER / HYDROGEOLOGY

SECTION 11 – SURFACE WATER

SECTION 12 – ECOLOGY

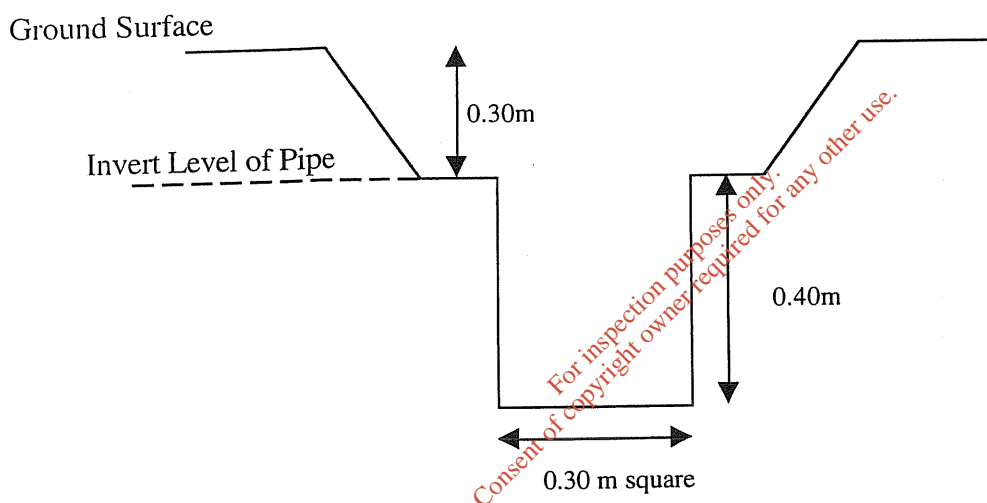
Figure 2: Design of the Percolation Pits as recommended by EPA Wastewater Treatment Manual.

Four percolation pits were dug at the site of the proposed percolation area. The top 0.30 metres of soil was removed at the location of each of the four pits by the JCB. 0.30 metres was chosen as this is the depth at which effluent will be introduced to the soil according to Puraflo™ Agrément Certificate 97/00060. The pits were then dug in these depressions with in accordance to dimensions specified in the EPA's Wastewater Treatment Manuals. The percolation pits measured 0.3 m by 0.3 m and were completed at a depth of 0.4 m-approximately 0.7 m below the ground surface.

The sides of the percolation pits were scored with a trowel and filled with water to simulate fully saturated soil conditions. The pits were then left overnight to soak.

Figure 2: Design of the Percolation Pits as recommended by the EPA Wastewater Treatment Manual.

The site has failed the percolation test as the T value obtained was greater than 50 (EPA Wastewater Manual). This is due to the presence of clays beneath the site which had become highly saturated during the recent bad weather.

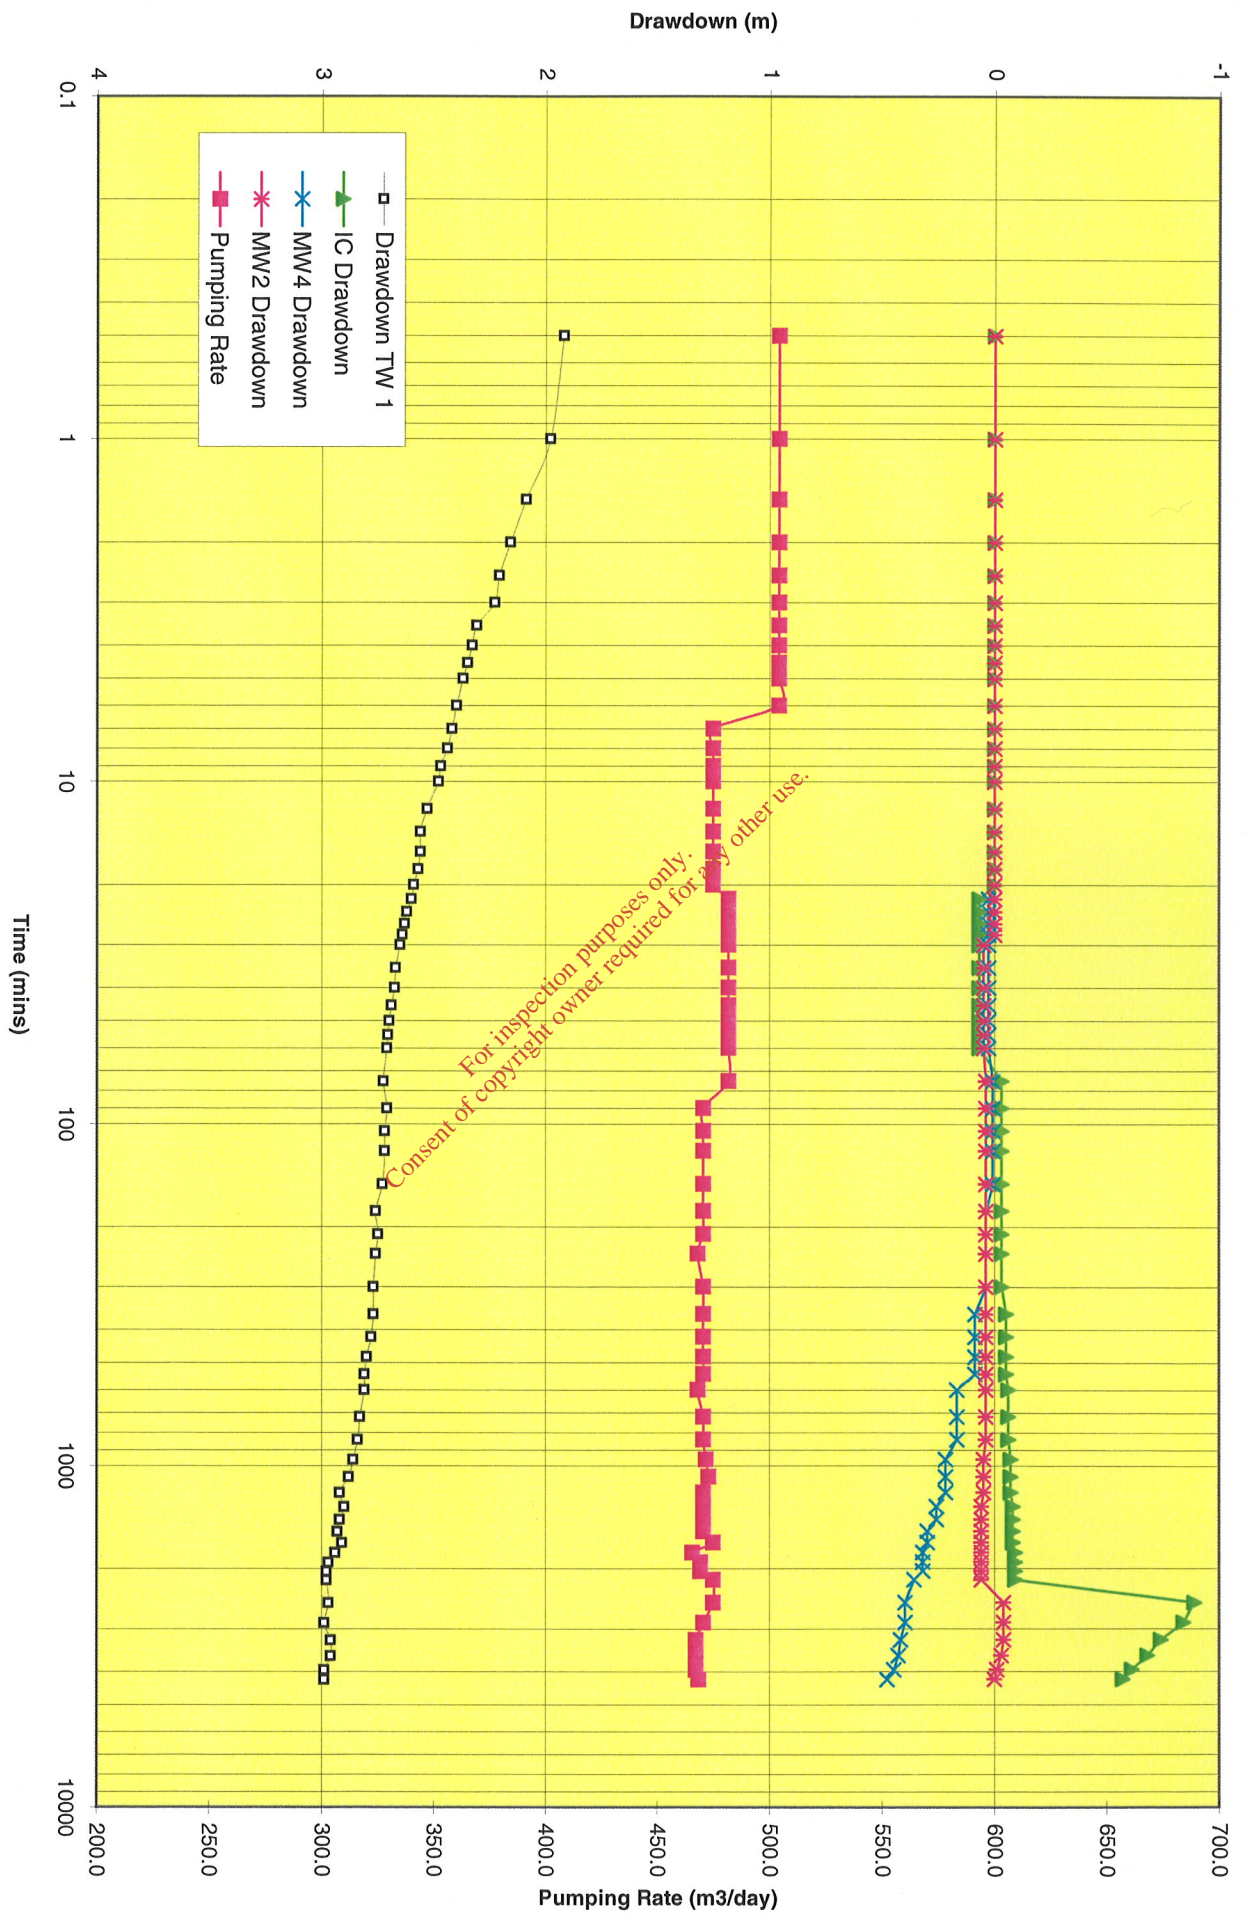
Pumping Rate and Drawdown versus Time for TW 1 and Monitoring Wells 70hr Pumping Test, at Carranstown, Co. Meath, May 2000

Elapsed Time (MINS)	WATER LEVEL	DRAWDOWN	YIELD
	BELOW G.L. (m.)	(METRES)	(M3/DAY)
	TW 1		
0	20.73	0.00	0.0
0.5	22.65	1.92	504.0
1	22.71	1.98	504.0
1.5	22.82	2.09	504.0
2	22.89	2.16	504.0

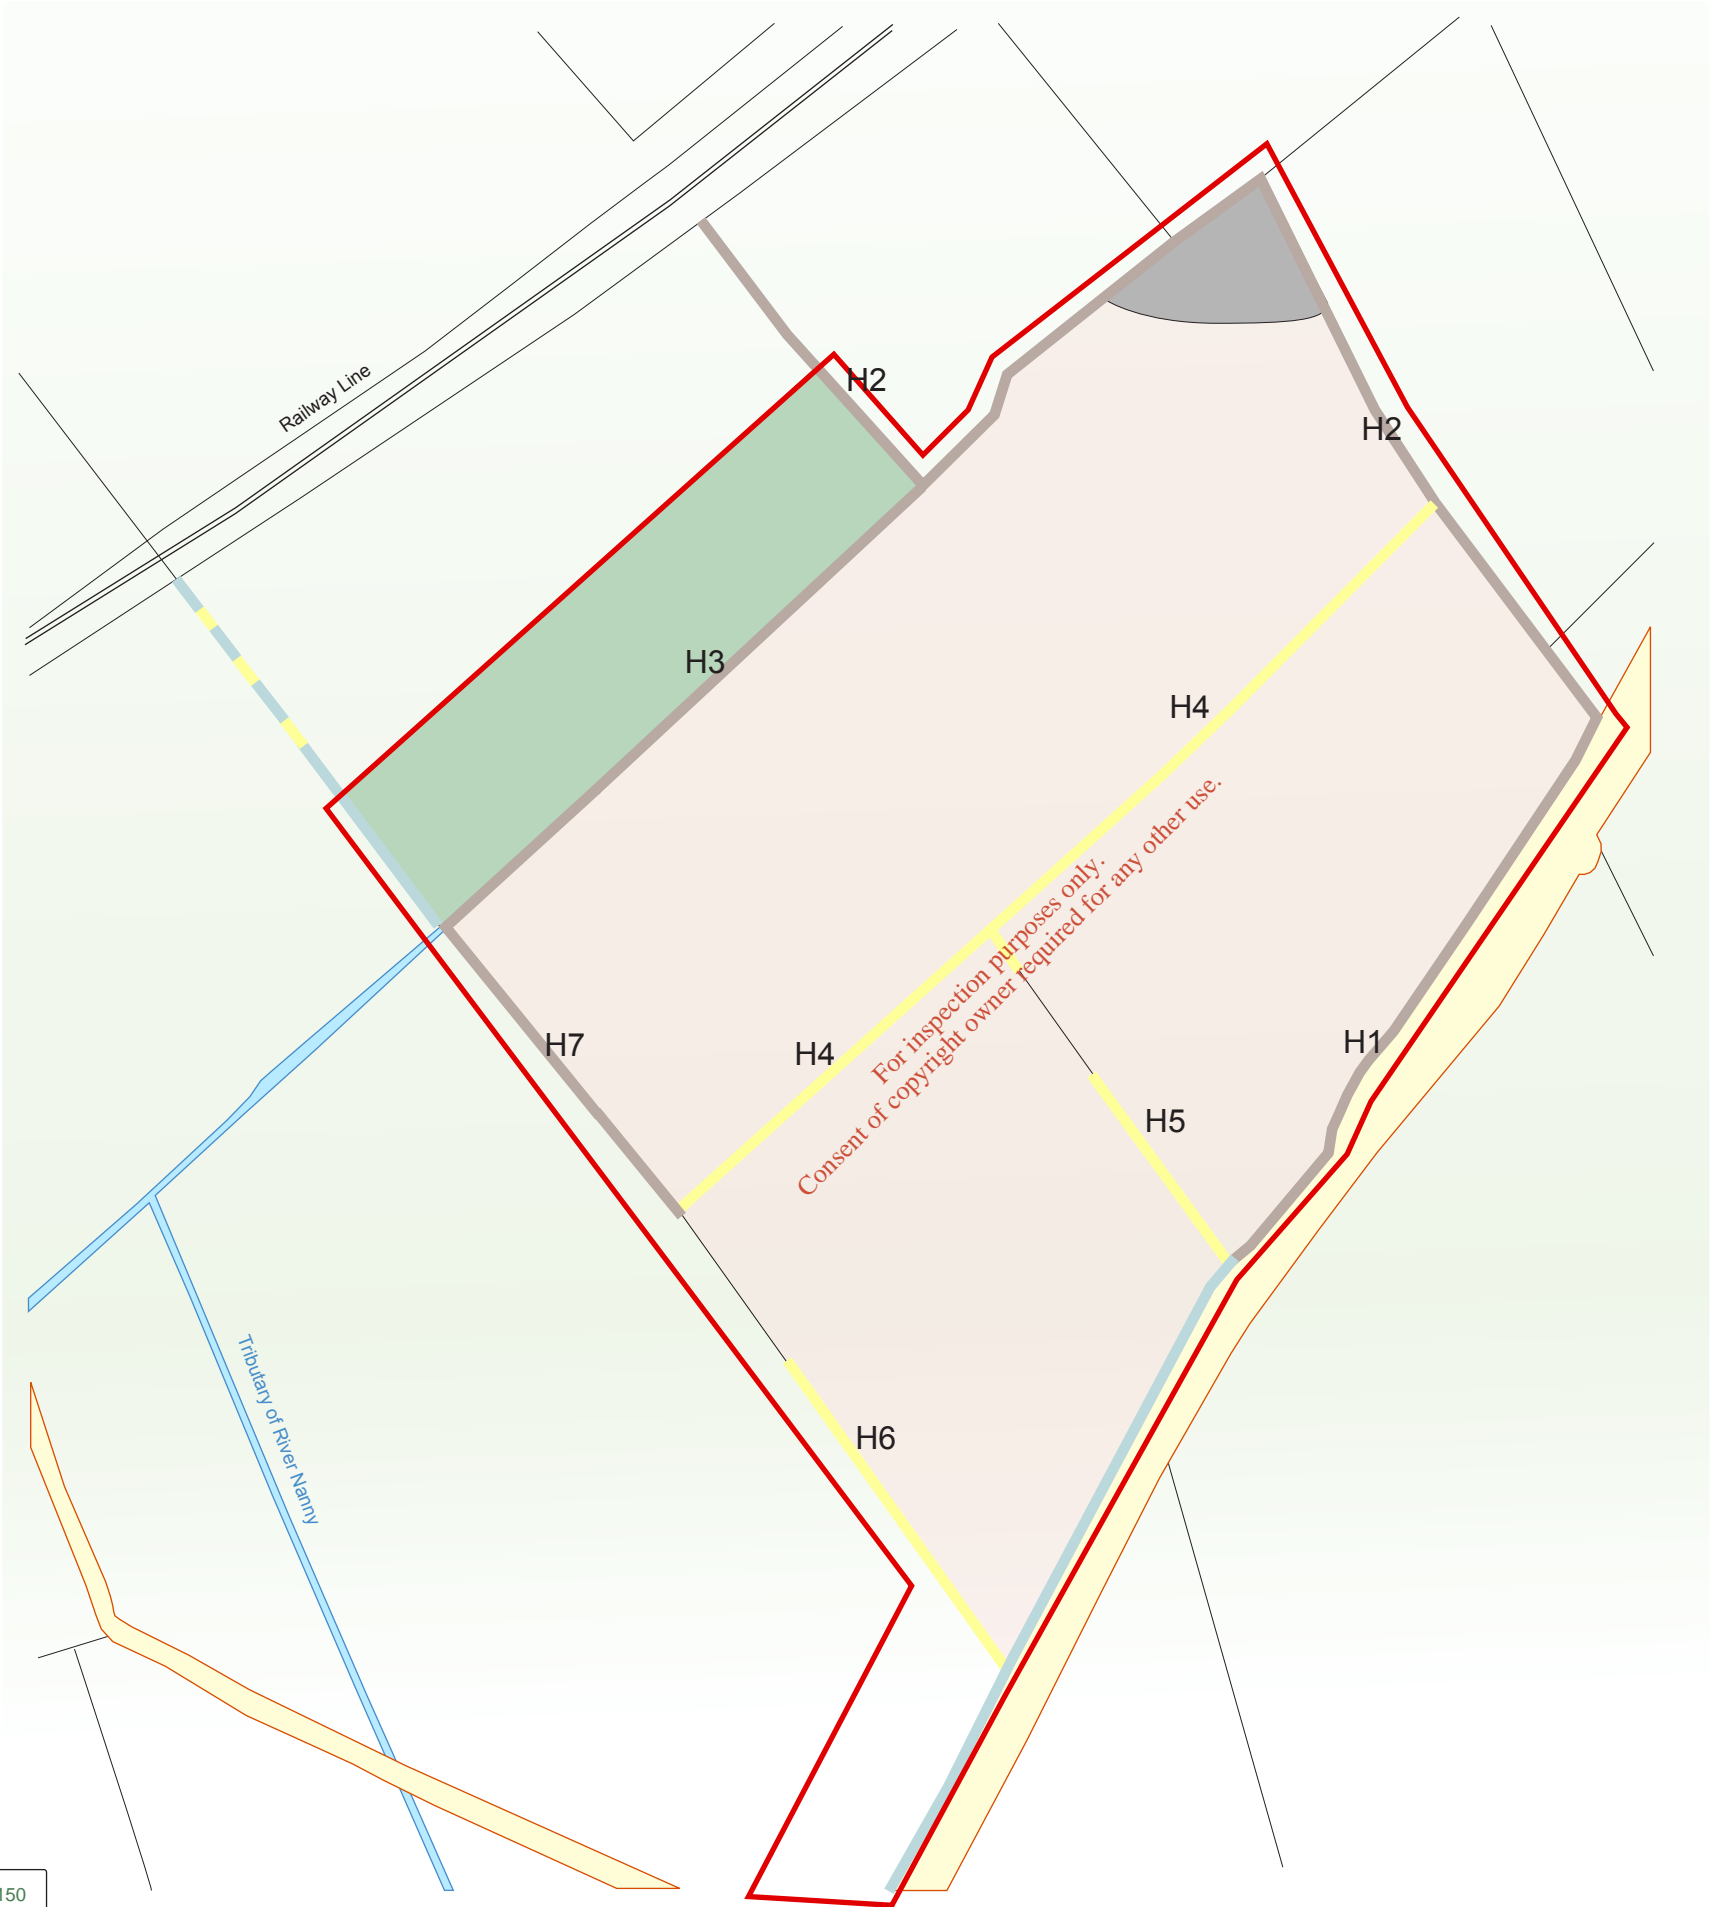
Indaver Habitat Map			
Figure No. 12.2	Job No. C003425 Finalised By - CB	Date. July 2005

- Site Boundary
- Improved agricultural grassland
- Arable crops
- Spoil & bare ground
- Hedgerow (intact)
- Hedgerow (gappy)
- Treeline
- Drainage ditch
