**Ballynagran Residual Landfill
EPA Waste Licence W0165-01**

Annual Environmental Report

January 2008 - December 2008

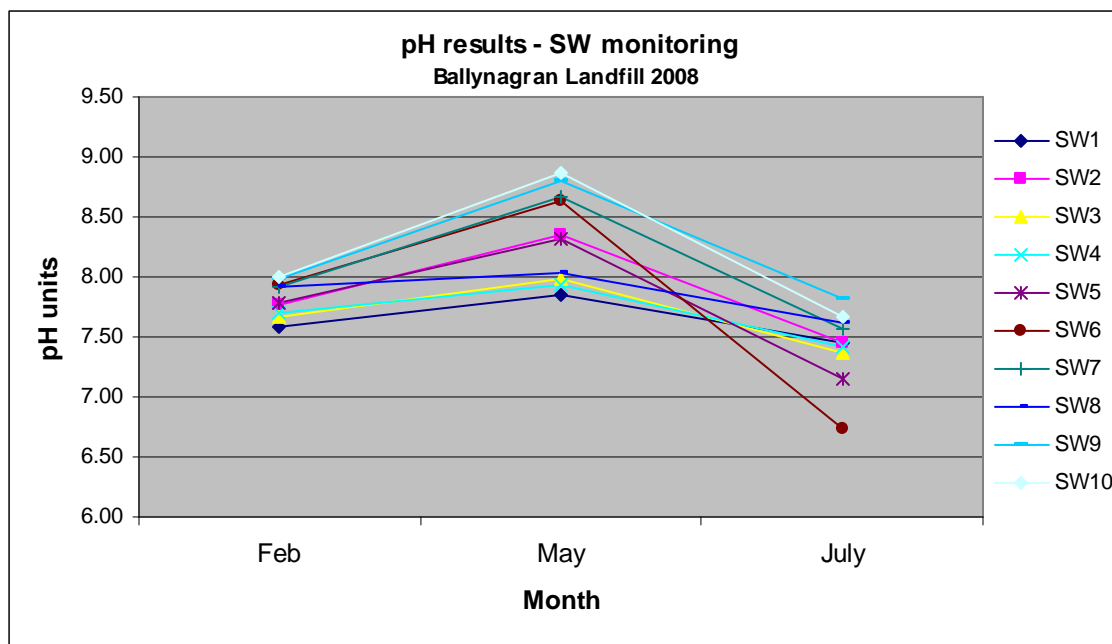
Figure 7.2.2 Surface Water pH results 2008

No measurement during Q4 due to instrument error
