**Clare County Council**

**Waste Licence W0031-01**

**Annual Environmental Report for 2008**

**Location of facility: Doora Landfill, Bunnow, Ballaghboy,**

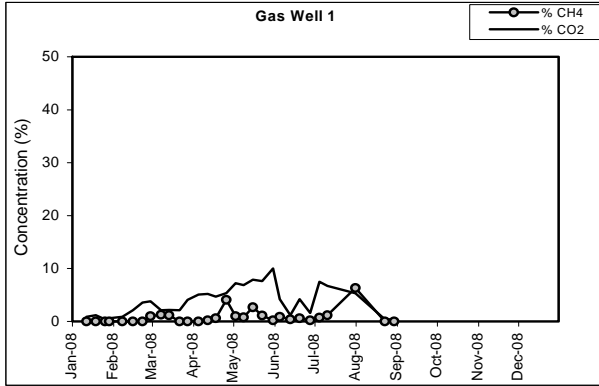
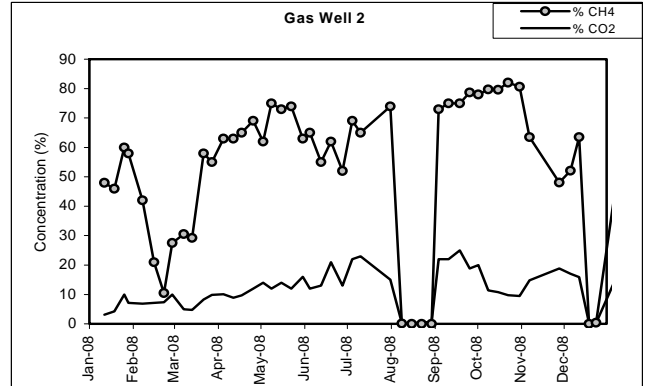
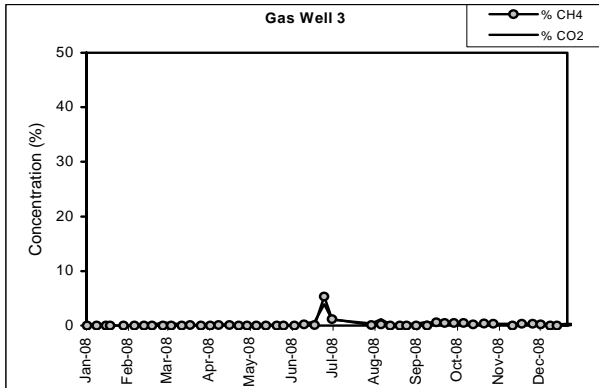
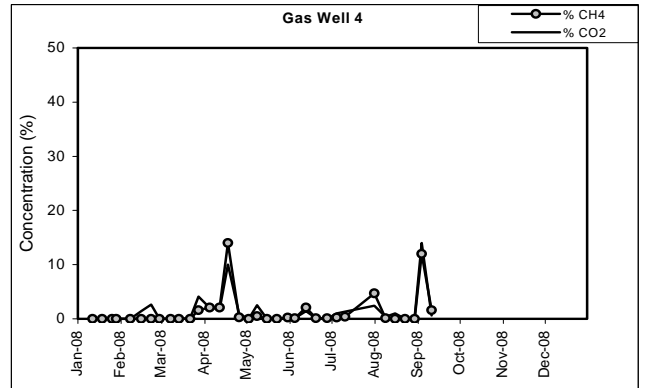
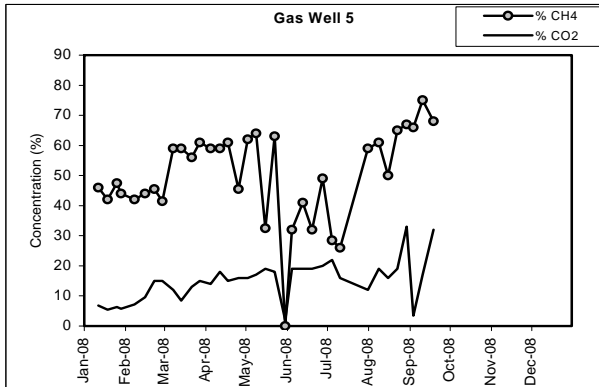
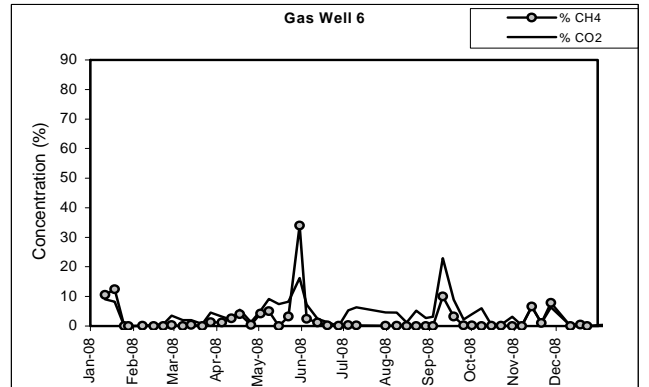
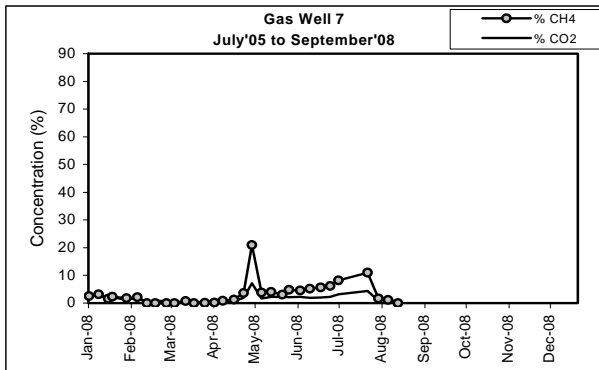
### Landfill Gas Levels at LG1 to LG7, 2008

Clare County Council staff conducted landfill gas monitoring at weekly and monthly intervals during the reporting period, in accordance with Schedule E.1 of the waste licence. Gas monitoring locations are shown in Drawing No. 1 "Environmental Monitoring Points" in Appendix I. Monitoring was undertaken at forty-two locations across the three zones of Doora landfill. Thirty-five of these locations were tested on a monthly basis primarily to enable field balancing to be carried out to optimise gas collection and flare efficiency. The remaining seven locations are the original gas monitoring wells (LG1 to LG7) that are not connected to the gas network. A number of these wells were damaged during the last quarter due to earthworks carried out during the landfill remediation project. Replacement monitoring wells will be installed on completion of the project. Undamaged wells were monitored on a weekly basis during the reporting period. Gas monitoring results from January to December 2008 are shown in figures 1a to 1g. As can be seen from these graphs, higher concentrations of landfill gas were detected in LG2, LG5 and to a lesser extent in LG7. Methane levels were higher than CO<sub>2</sub> levels in these wells. Methane and CO<sub>2</sub> levels were similar in LG1, LG3, LG4 and LG6, where lower landfill gas levels have been measured. The ratio of CH<sub>4</sub> to CO<sub>2</sub> is related to the age and stage of decomposition of the waste.

Weekly gas monitoring surveys were carried out during the year at offsite gas monitoring wells, OSW1 and OSW2. No methane was detected in either of the wells. Carbon dioxide levels occasionally exceeded the 1.5%v/v trigger level in OSW2 during the year, due most likely to the presence of peat in the area around the wells. These exceedences were notified to the EPA in incident reports during the year.

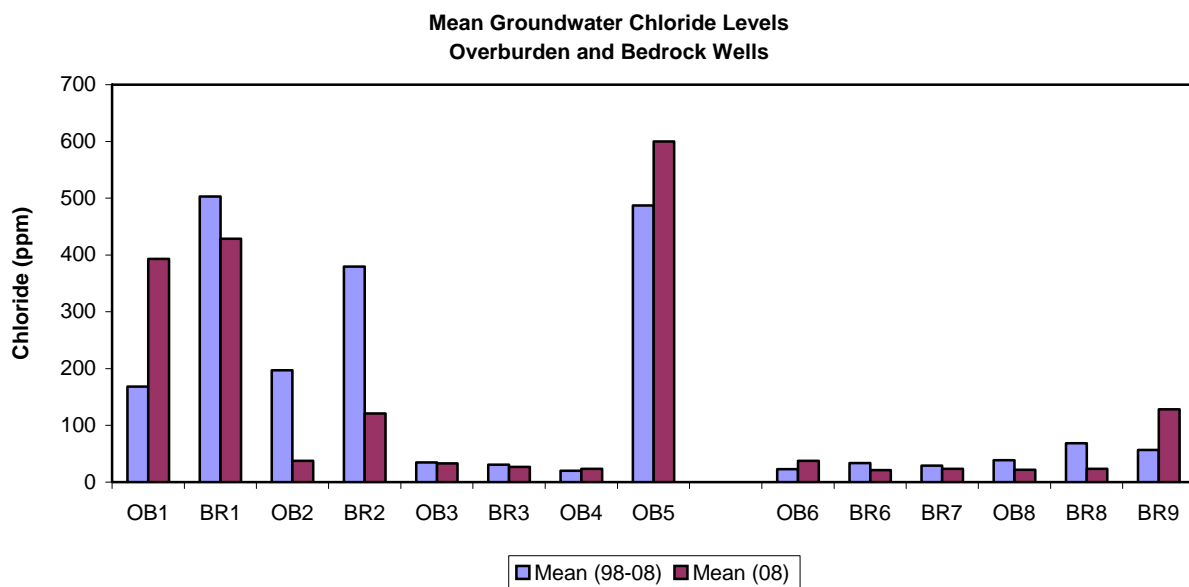
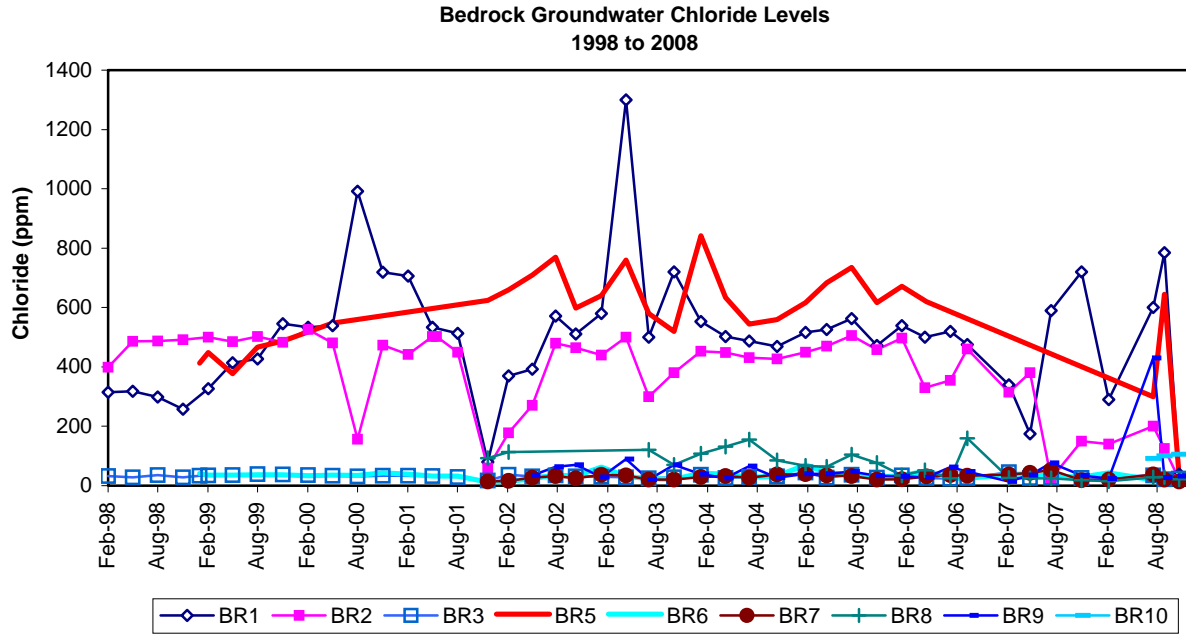
Figure 2

Groundwater chloride levels are graphed in figures 2 and 3 below. As can be seen from the graphs, higher chloride levels were observed in wells located close to the River Fergus (OB1, BR1, OB2, BR2, and OB5). These elevated chloride levels may be in part attributed to the influence of the Fergus river. Groundwater contamination from landfilling activities at the site may also be a factor (see section on ammonia below).

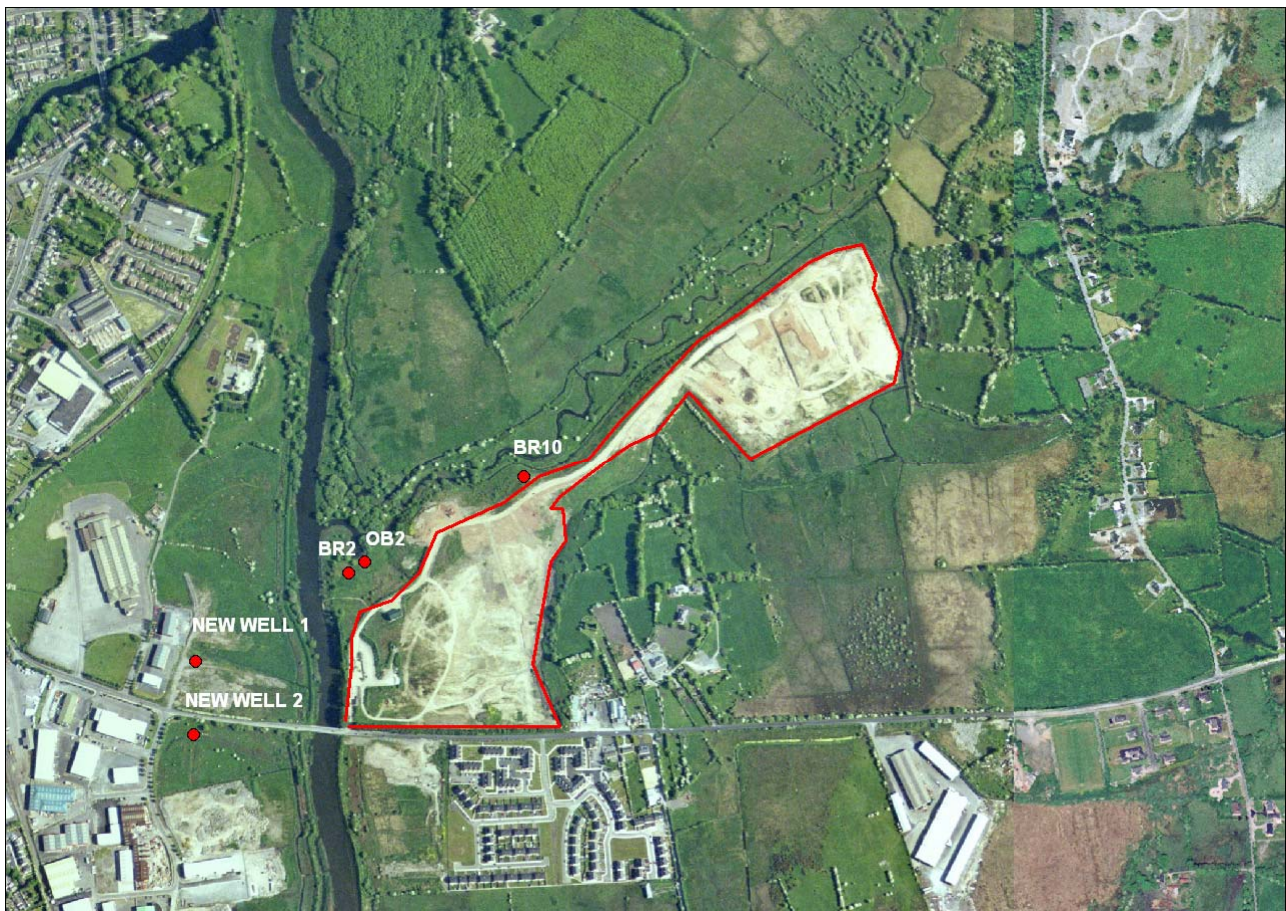
Results obtained between June and November 2008 are presented below in figure 12. As can be seen from the graph, BR10 ammonia results were unusually elevated. This indicates that the elevated ammonia levels observed at BR2 (and at BR10) are likely to be due to migration of leachate from Zone 3. Monitoring results for the Fergus river to date do not indicate that this leachate plume is causing problems in the Fergus river. However, further investigation is needed to confirm whether the Fergus river is fed by groundwater flowing from the landfill direction. To this end, it is proposed to install two offsite bedrock monitoring wells on lands to

the west of the Fergus river. Tentative locations for these wells are presented in the map below. The exact locations will be determined based on accessibility and site ownership and will be notified to the EPA in advance of installation.

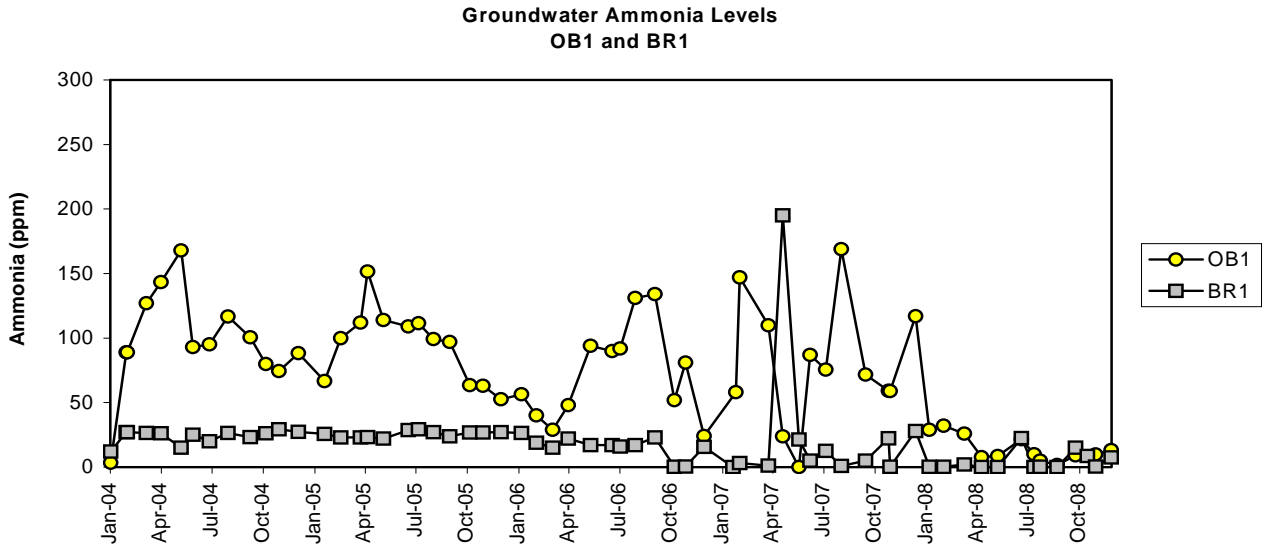
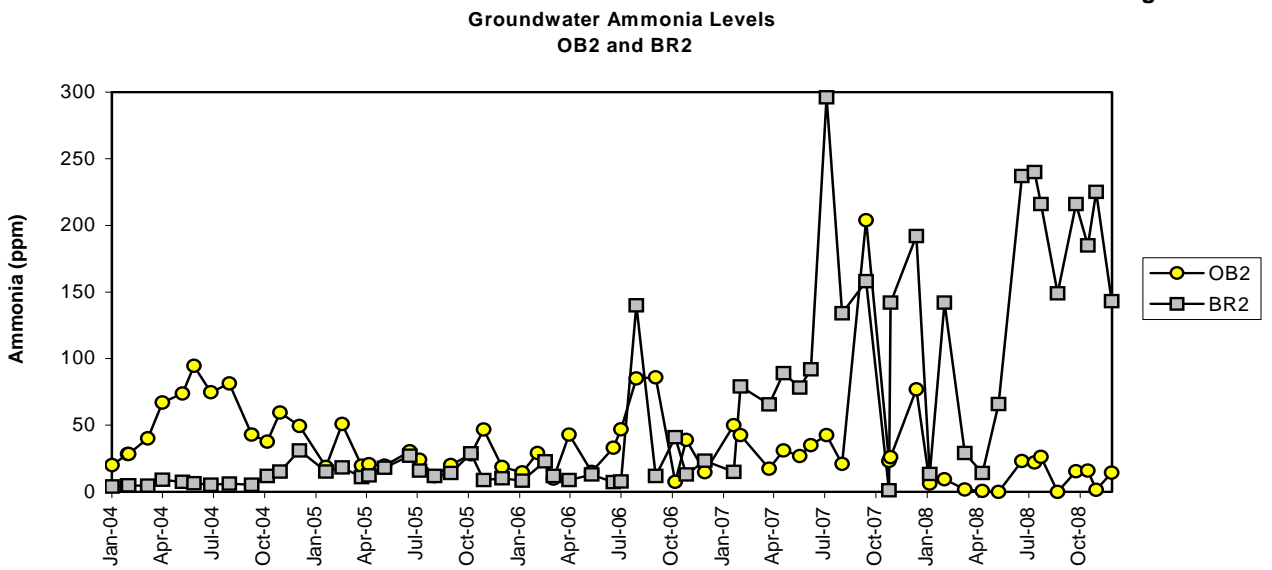
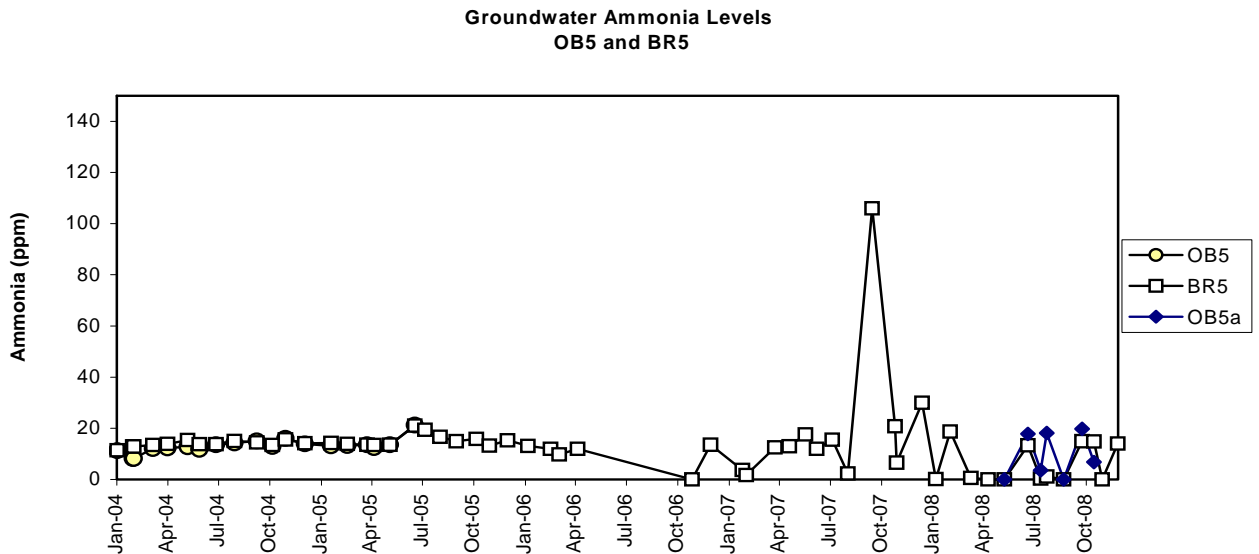
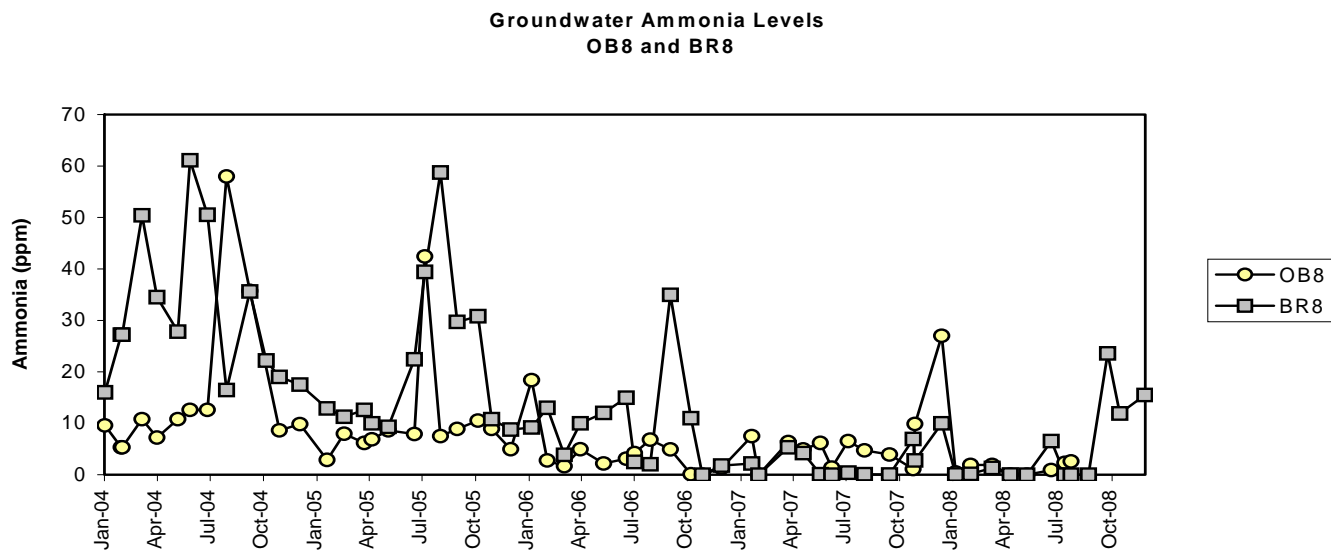
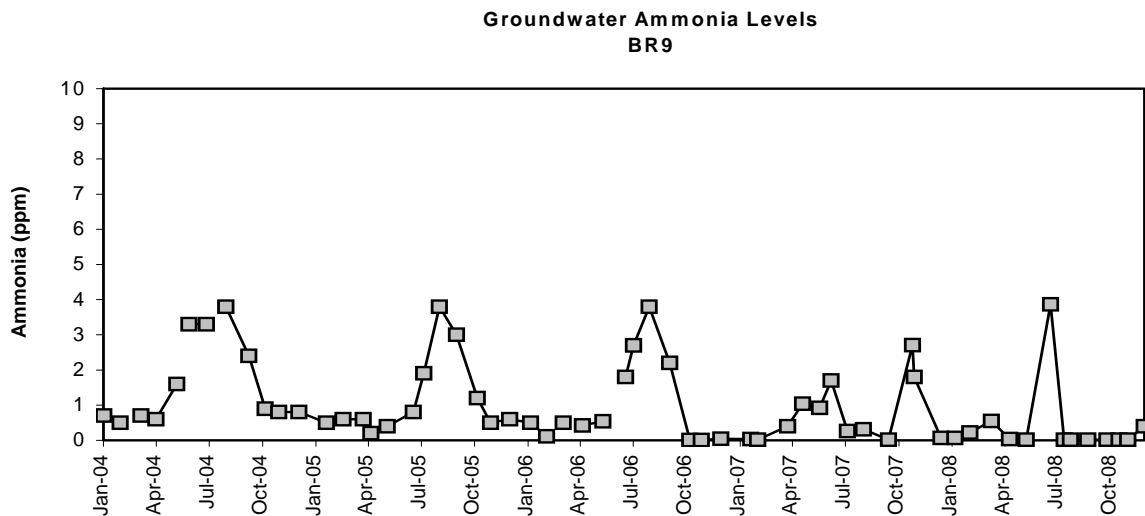
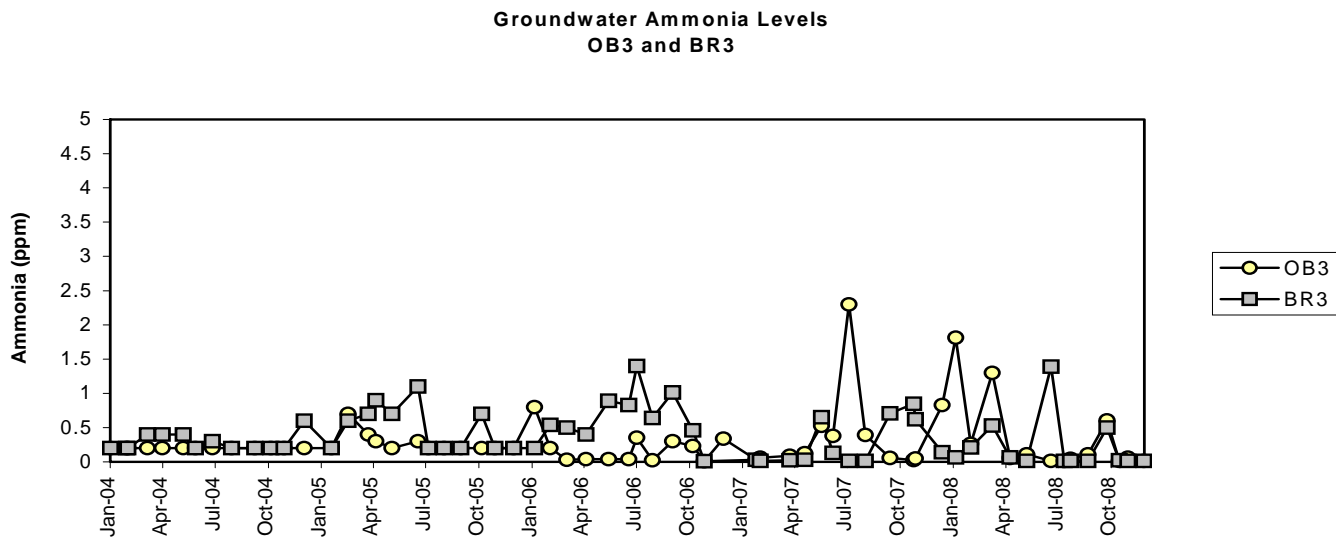
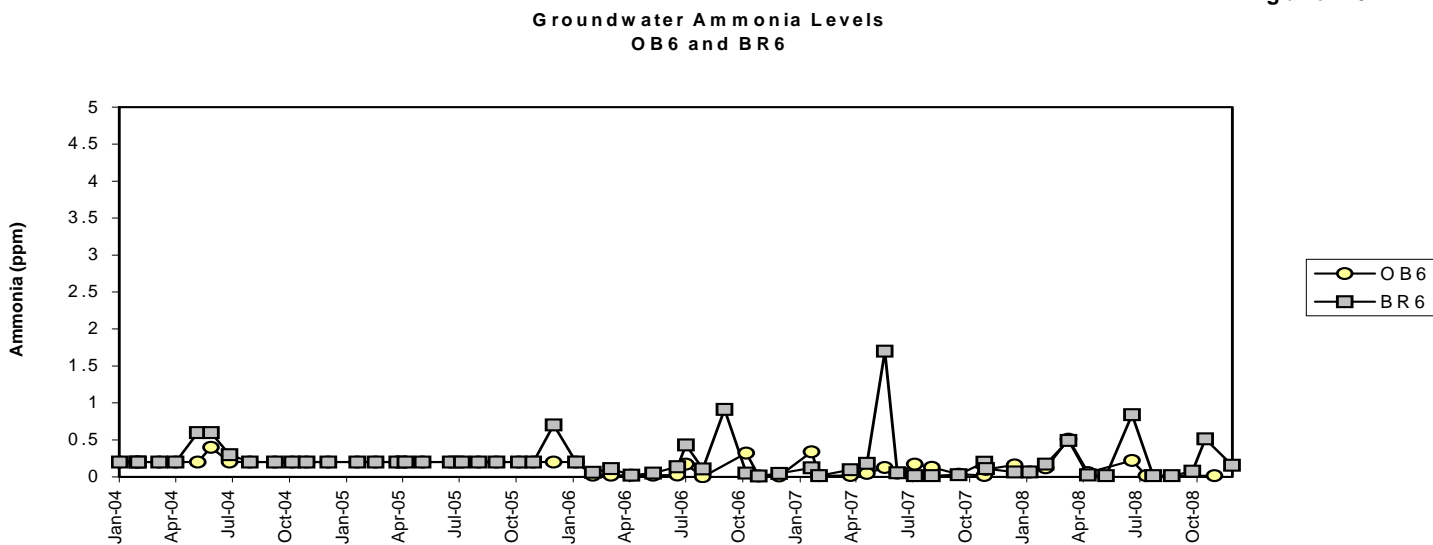
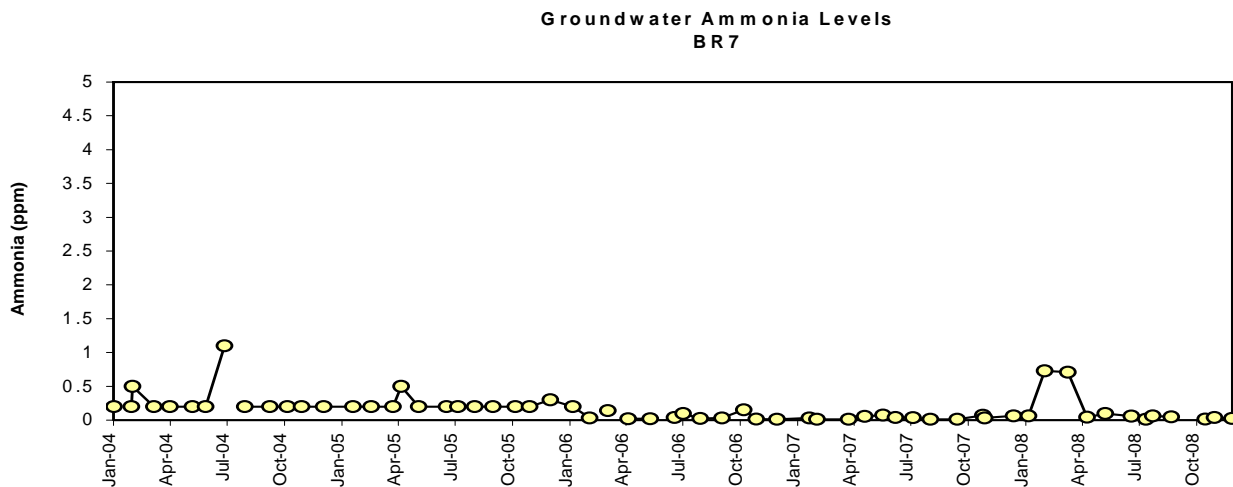
Figure 4

Groundwater ammonia levels for the five-year period from January 2004 to December 2008 are graphed below in figures 4 to 12. Mean ammonia levels for the period are graphed in figure 13. As can be seen from the graphs, groundwater ammonia results have been elevated for onsite monitoring wells (OB1/BR1 and OB2/BR2) since monitoring commenced at the site. Highest results for 2008 were obtained at these four wells, particularly at BR2, which is located close to the southwestern boundary of the site. Ammonia levels at BR2 have increased gradually in the past two years. BR2 is downgradient of zones 2 and 3 of the landfill. To determine whether the elevated ammonia levels at BR2 are due to a local problem around the well or to migration of leachate from zone 3 of the landfill, a new bedrock well (BR10) was installed upgradient of BR2 and downgradient of zone 3 in May 2008. Monitoring of this well commenced in June 2008 but ceased in November 2008 when the landfill remediation contractors accidentally destroyed the well when carrying out earthworks in the vicinity.

As expected, lowest ammonia levels were found in upgradient wells OB3, BR3 and BR7 and in the cross-gradient nested pair of wells OB6 and BR6. Mean ammonia levels at these locations were below 0.5ppm for this twelve-month monitoring period (see figures 9 to 11 and 13)

Leachate is currently being abstracted from four purpose built wells in zones 2 and 3. A dedicated leachate storage tank was installed as part of the landfill remediation project. This tank is due to be commissioned shortly. It is hoped that installation of the final capping layer, combined with ongoing leachate abstraction, will effect a reduction in groundwater ammonia levels over time.

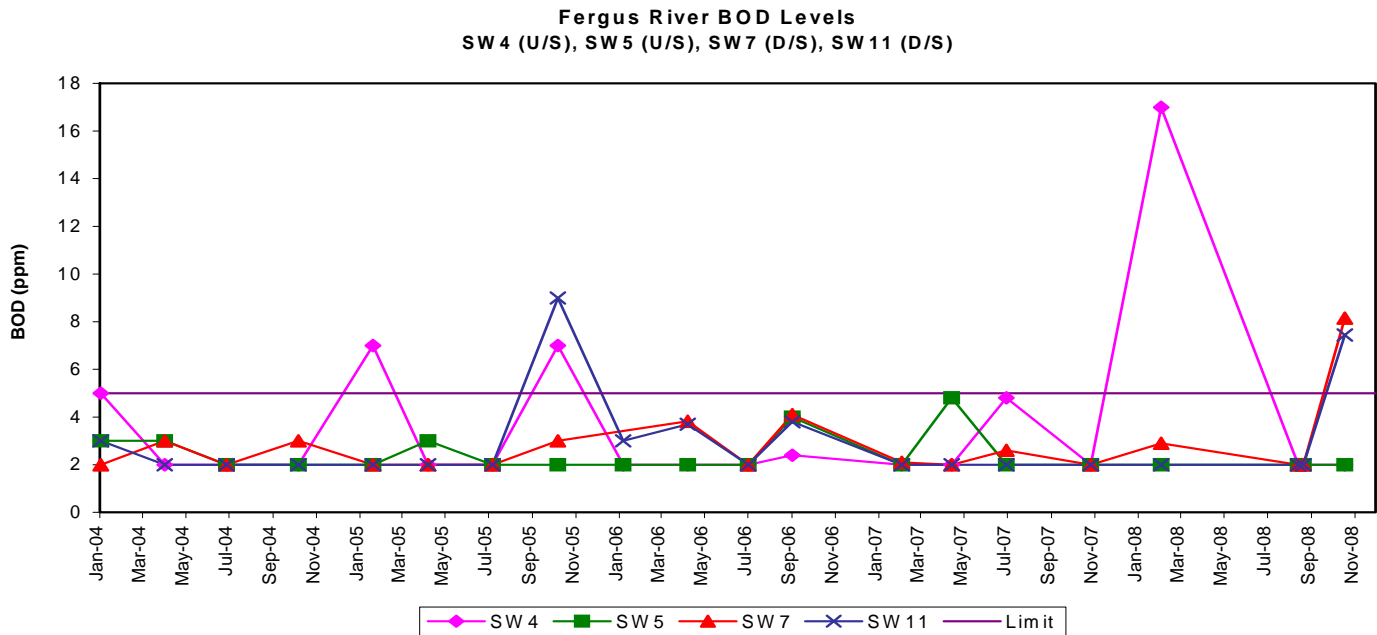
**Figure 14**

BOD results for the Fergus and Gaurus rivers for the five-year period from 2004 to 2008 are graphed in figures 14 and 15 respectively. The Fergus river is classified as a Salmonid water<sup>1</sup> to which a 5ppm BOD limit applies. This limit is shown in figure 14. As can be seen from the graph, Fergus river BOD results exceeded the salmonid limit on three occasions in 2008. Results at SW4 (upstream in Ennis Town) were unusually elevated in February at 17ppm. However, the COD level of this sample was only 5ppm, indicating that the BOD result may have been due to laboratory error.

BOD results downstream at SW7 and SW11 were slightly above the 5ppm salmonid limit in October 2008 (see figure 14). These results are not believed to be due to landfill discharges because BOD levels were not particularly elevated in site drains/streams discharging to the Gaurus and Fergus rivers at that time.

There are three significant combined storm overflows (CSO's) discharging to the Fergus river upstream of SW7 and SW11. With the heavy rainfall that occurred during 2008, particularly in August and October, it is very likely that the discharge from these CSO's is responsible for the intermittent elevated BOD levels observed at SW7 and at SW11.

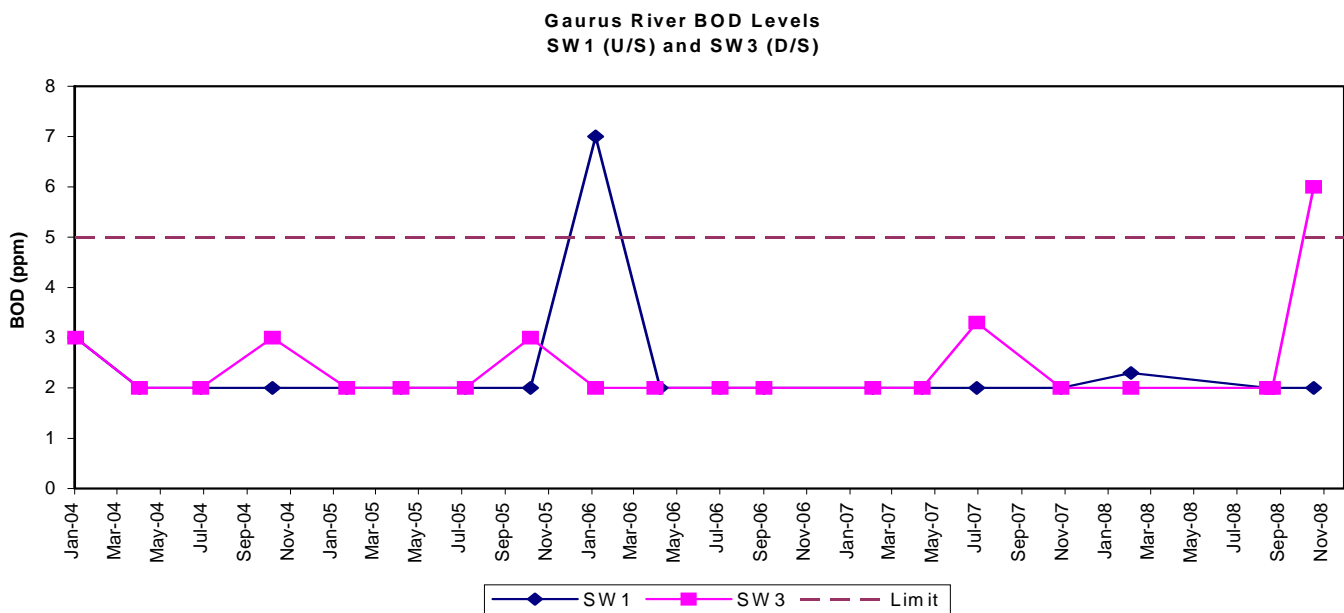
**Figure 15**

Gaurus River BOD results are graphed in figure 15. The 5ppm salmonid limit is also shown on this graph for comparative purposes.

As can be seen from the graph, results for one upstream sample and one downstream sample have exceeded this comparative limit during the past five years.

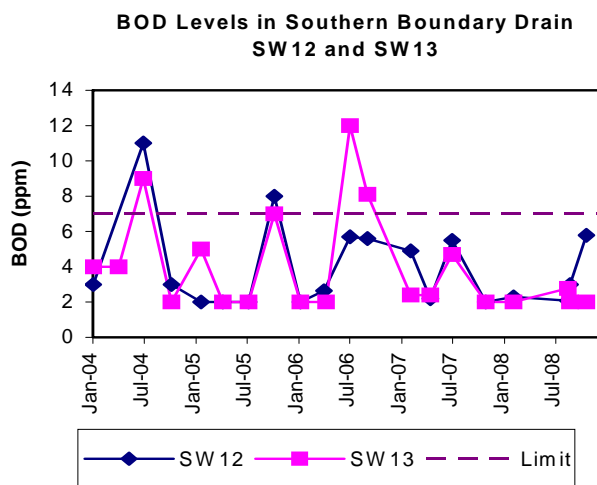
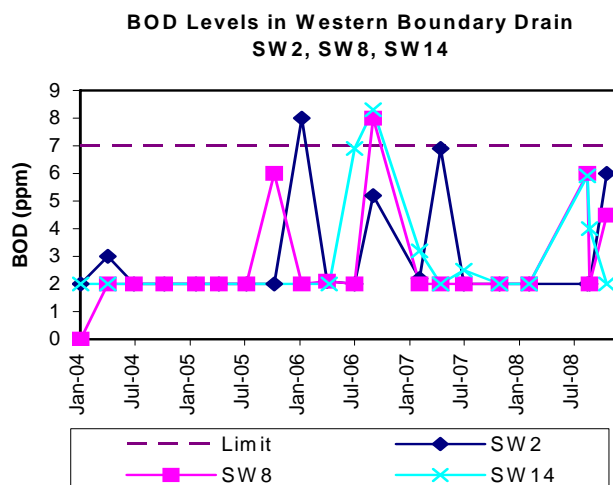
**Figure 16**

There are two surface water sampling locations (SW12 and SW13) on the eastern boundary drain. This drain runs in a southerly direction along the eastern boundary and is piped underground close to the southern site boundary, feeding into the Fergus river upstream of Doora Bridge. BOD levels in the eastern boundary drain are graphed in figure 16. There are three sampling locations on the western boundary drain (SW2, SW8 and SW14) which feeds into the Gaurus river downstream of SW2. Results for this drain are graphed in figure 17. Also included on the graphs is the 7ppm BOD for A3 waters from the Surface Water Regulations (1989). This limit is included for comparative purposes only; no limits exist for BOD levels in site drains.

BOD results for both site drains have been within this comparative BOD limit since September 2006.

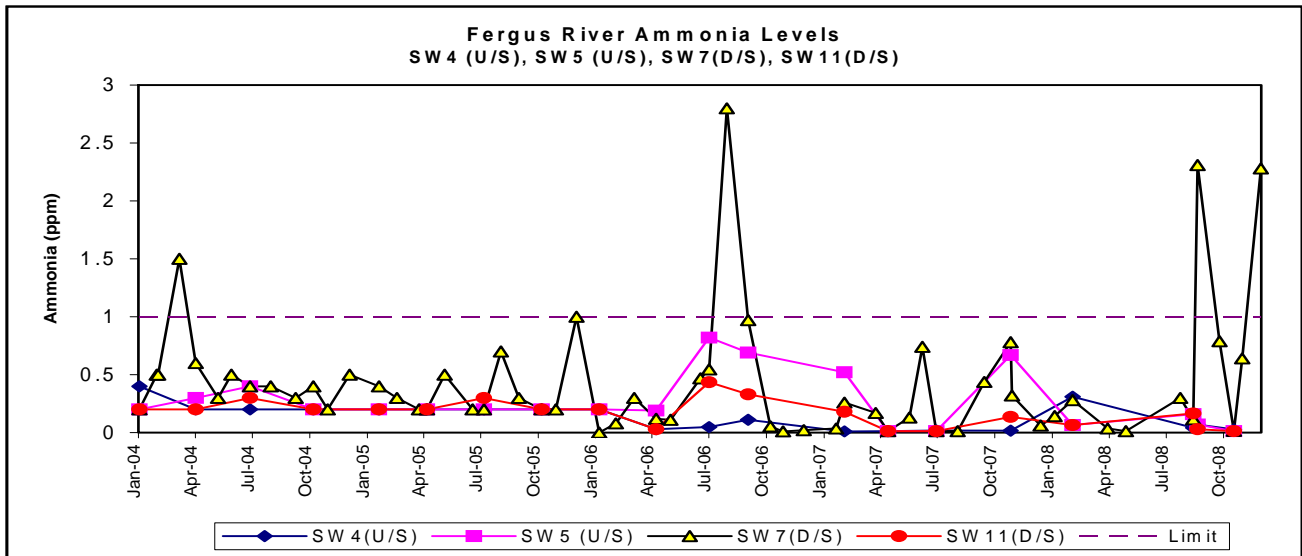
**Figure 18**

Ammonia results for Gaurus and Fergus river samples for the five-year period from January 2004 to December 2008 are graphed in figures 18 and 19 respectively. Also shown on the graphs is the 1ppm ammonia limit for Salmonid Waters. This limit is included in the Gaurus river graph for comparative purposes only.

As can be seen from figure 18, ammonia levels at SW7 (Doora bridge) exceeded the 1ppm salmonid limit on two occasions in 2008, on the 25<sup>th</sup> August and on the 4<sup>th</sup> December 2008.

The limit was not previously exceeded at this location since September 2006. The elevated ammonia levels may be associated with discharges to the Fergus from the combined storm overflows mentioned above, taking account of the elevated rainfall during the sampling events. SW7 is also monitored on a monthly basis under a separate monitoring programme for compliance with the salmonid waters regulations. Clare County Council staff and the Roscommon Regional Laboratory carry out this monitoring programme. Ammonia results obtained under this monitoring regime were all within the limits for salmonid waters. These results are shown below in figure 18a.

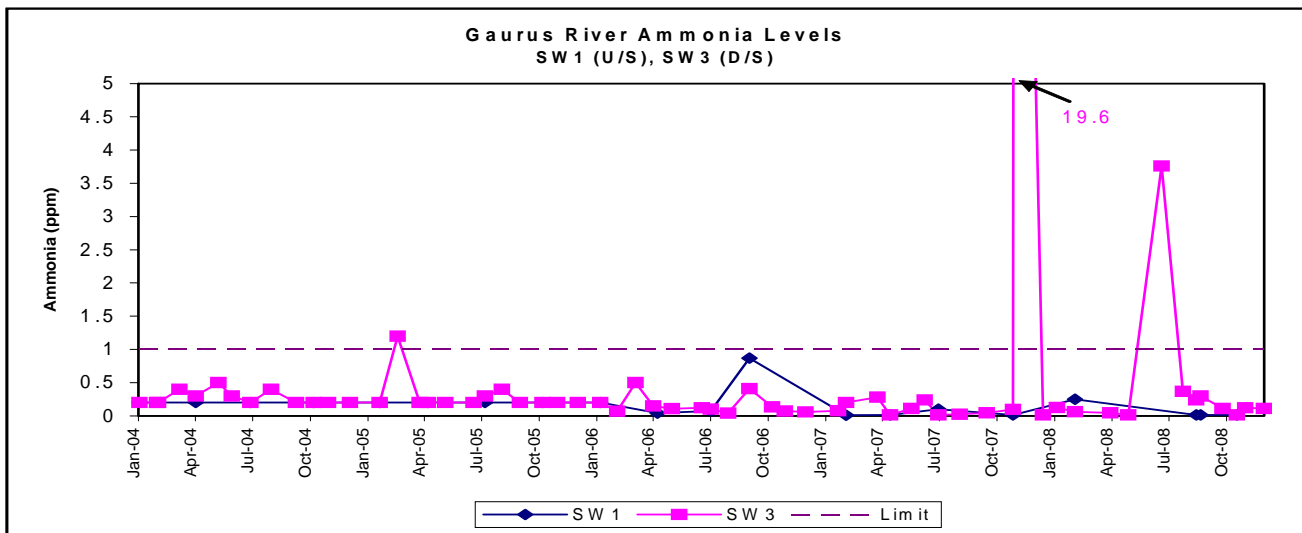
Ammonia results for Gaurus river location SW1 (upstream of the landfill) have been below 1ppm for the five-year period from January 2004. Ammonia results at SW3 (downstream of the landfill) have also been below 1ppm except for two occasions, in November 2007 and in July 2008. The SW3 result for November 2007 was unusually elevated at 19.6ppm (see 2007 AER). Results for a repeat sample taken at the end of November 2007 were satisfactory (0.013ppm). The SW3 ammonia result in June 2008 was also slightly elevated at 3.76ppm. The results for the rest of the year were well below 1ppm. **Figure 19**

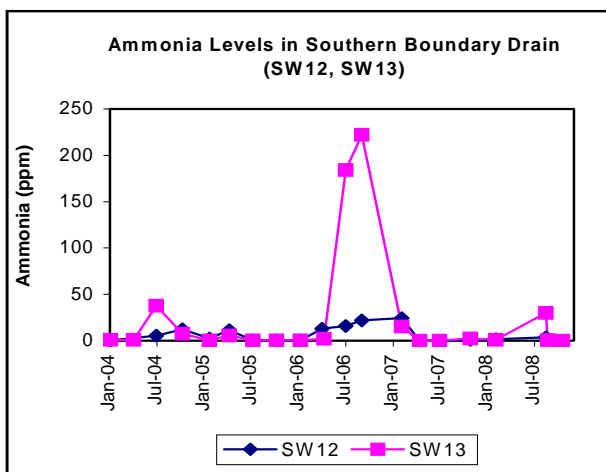
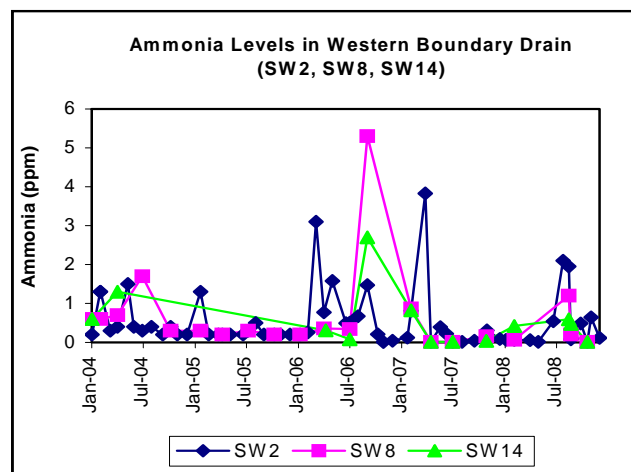
**Figure 20**

Ammonia results for the western and eastern boundary drains from January 2004 to December 2008 are shown in figures 20 and 21.

On the eastern boundary drain, ammonia levels at SW13 and to a lesser extent at SW12 were elevated on a number of occasions in mid 2006 (see figure 20 above). This was attributed to leachate breakout in the vicinity of SW13 and was reported to the EPA in a separate communication (see quarterly monitoring report for August to November 2006). The breakout area was sealed in early 2007. A full report of the investigation was included in the quarterly monitoring report for August to November '06. Results since February 2007 have been consistently quite low (<4ppm) with the exception of an elevated ammonia result for SW13 on the 18<sup>th</sup> July 2008 (30.1ppm). Monitoring at this sample location was repeated one week later and a result of 0.6ppm ammonia was obtained.

Ammonia results for western boundary drain samples have been consistently quite low throughout the monitoring period (see figure 21).

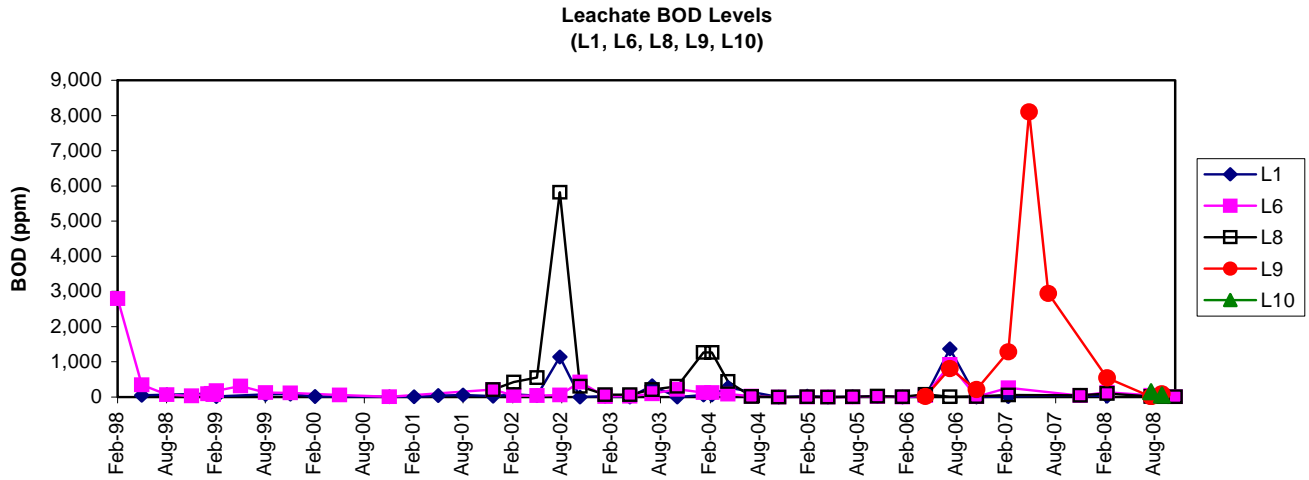
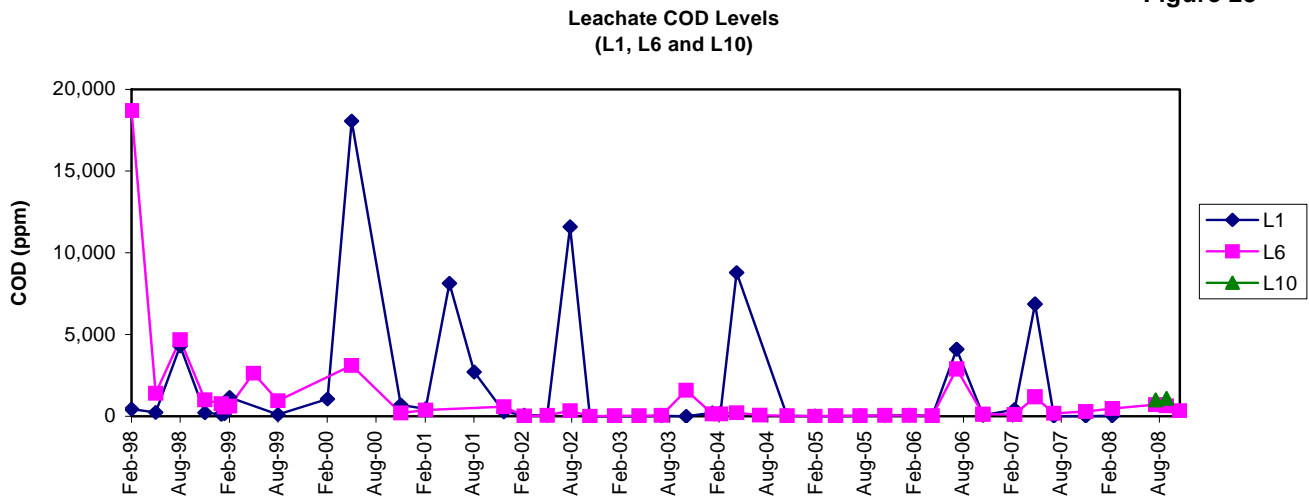
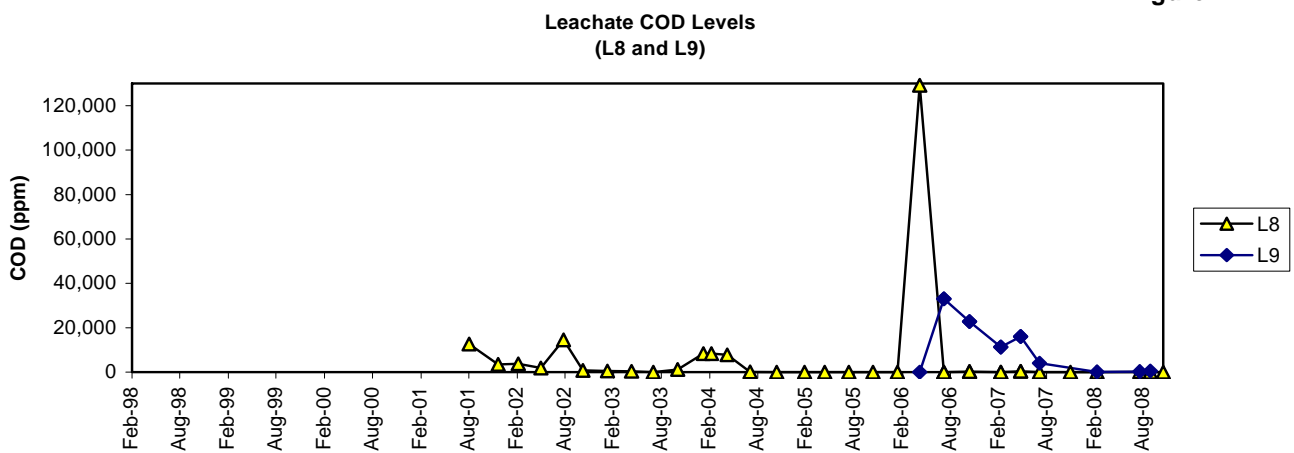
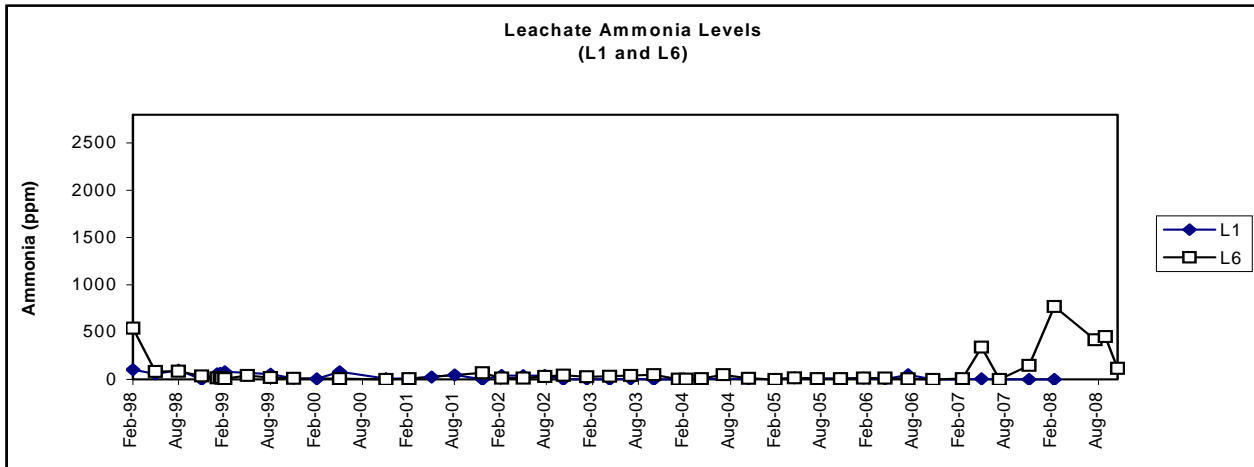
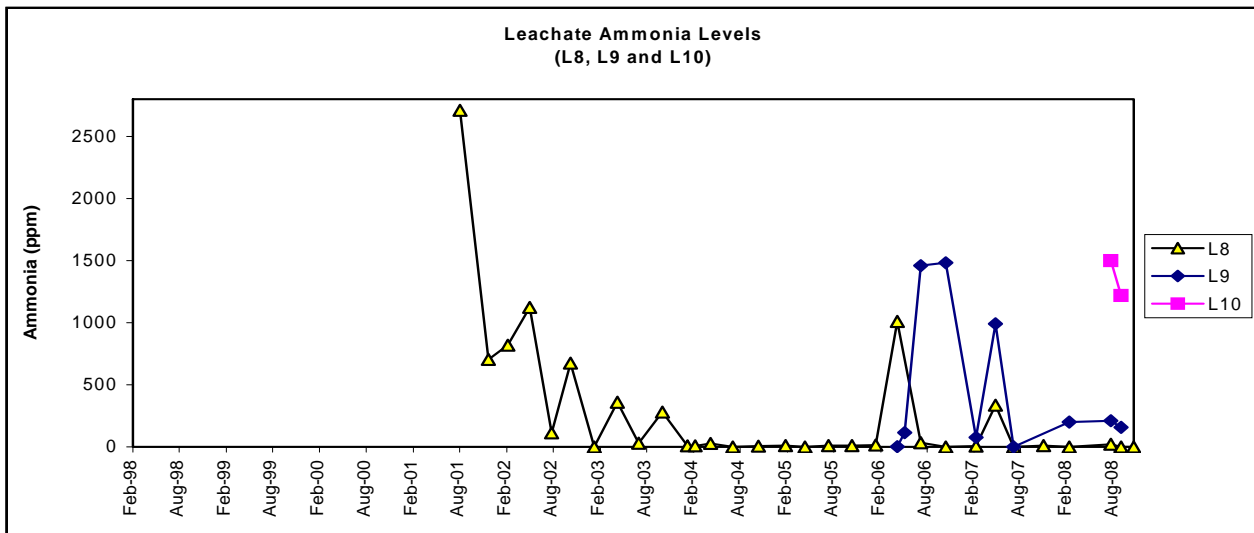
Figure 22

Ammonia, BOD and COD results for leachate wells are graphed in figures 22 to 26.

As would be expected given the locations of L8, L9 and L10 in Zone 3 (the area of most recent waste deposition) BOD, COD and ammonia levels were higher in these wells than in zone 1 (L1) and zone 2 (L6).

Abstraction of leachate from L6, L8, L9 and L10) was ongoing up to August/September 2008, with approximately 20m<sup>3</sup> of leachate removed each week for treatment at Sixmilebridge WWTP. No leachate was taken off site in October and November 2008 due to the power supply to the leachate pumps being interrupted. Leachate abstraction recommenced in December 2008 although only very small quantities have since been pumped. We are currently experiencing problems with the existing pumps. These will be repaired or replaced as required within the next four weeks.
