Connaught Regional Residual Landfill

EPA Waste Licence W0178-01

Annual Environmental Report

January 2008 - December 2008

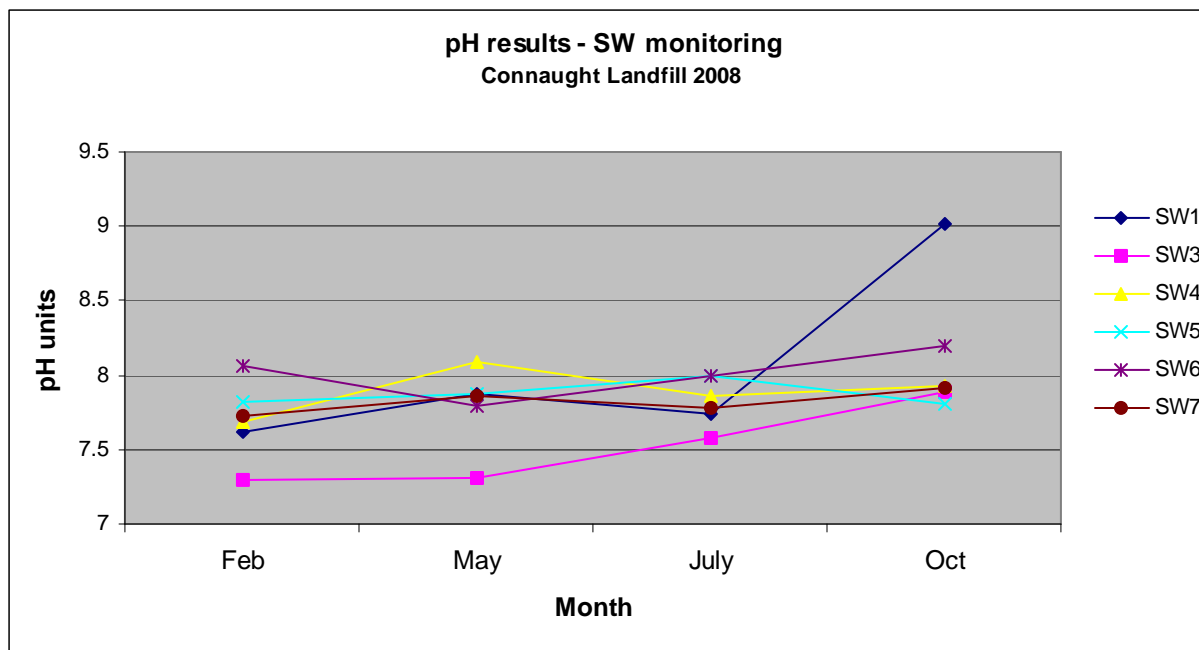
Figure 7-1 SW pH results Connaught Landfill 2008

pH Units	Feb	May	July	Oct
SW1	7.62	7.88	7.74	9.02
SW3	7.29	7.31	7.58	7.89
SW4	7.69	8.09	7.86	7.93
SW5	7.82	7.88	7.99	7.81
SW6	8.06	7.79	7.99	8.19
SW7	7.73	7.86	7.78	7.91

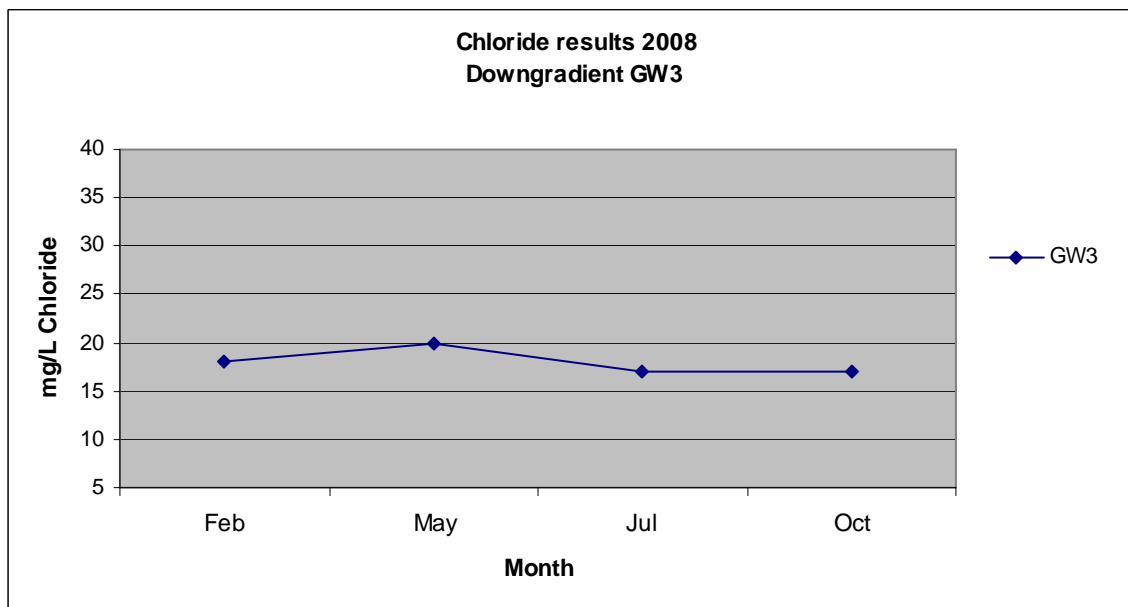
Figure 7-10 Groundwater Chloride results - CRRL 2008

Chloride mg/L	Feb	May	Jul	Oct
<i>GW1-A</i>	14	16	16	15
<i>GW2</i>	39	35	31	26
<i>GW3</i>	18	20	17	17
<i>GW4-A</i>	22	32	29	26
<i>GW5-A</i>	21	21	18	15
<i>GW6</i>	19	17	16	11
<i>GW7</i>	15	15	14	14
<i>GW8</i>	17	31	28	28

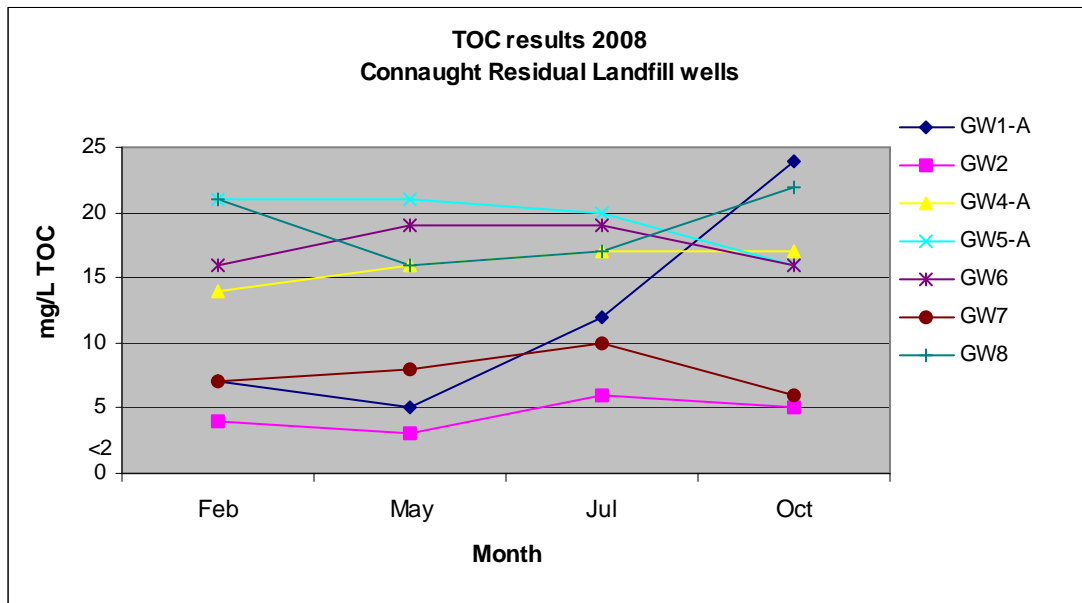
Figure 7-14 Groundwater TOC results - CRRL 2008

TOC mg/L	Feb	May	Jul	Oct
<i>GW1-A</i>	7	5	12	24
<i>GW2</i>	4	3	6	5
<i>GW3</i>	<2	2	5	9
<i>GW4-A</i>	14	16	17	17
<i>GW5-A</i>	21	21	20	16
<i>GW6</i>	16	19	19	16
<i>GW7</i>	7	8	10	6
<i>GW8</i>	21	16	17	22

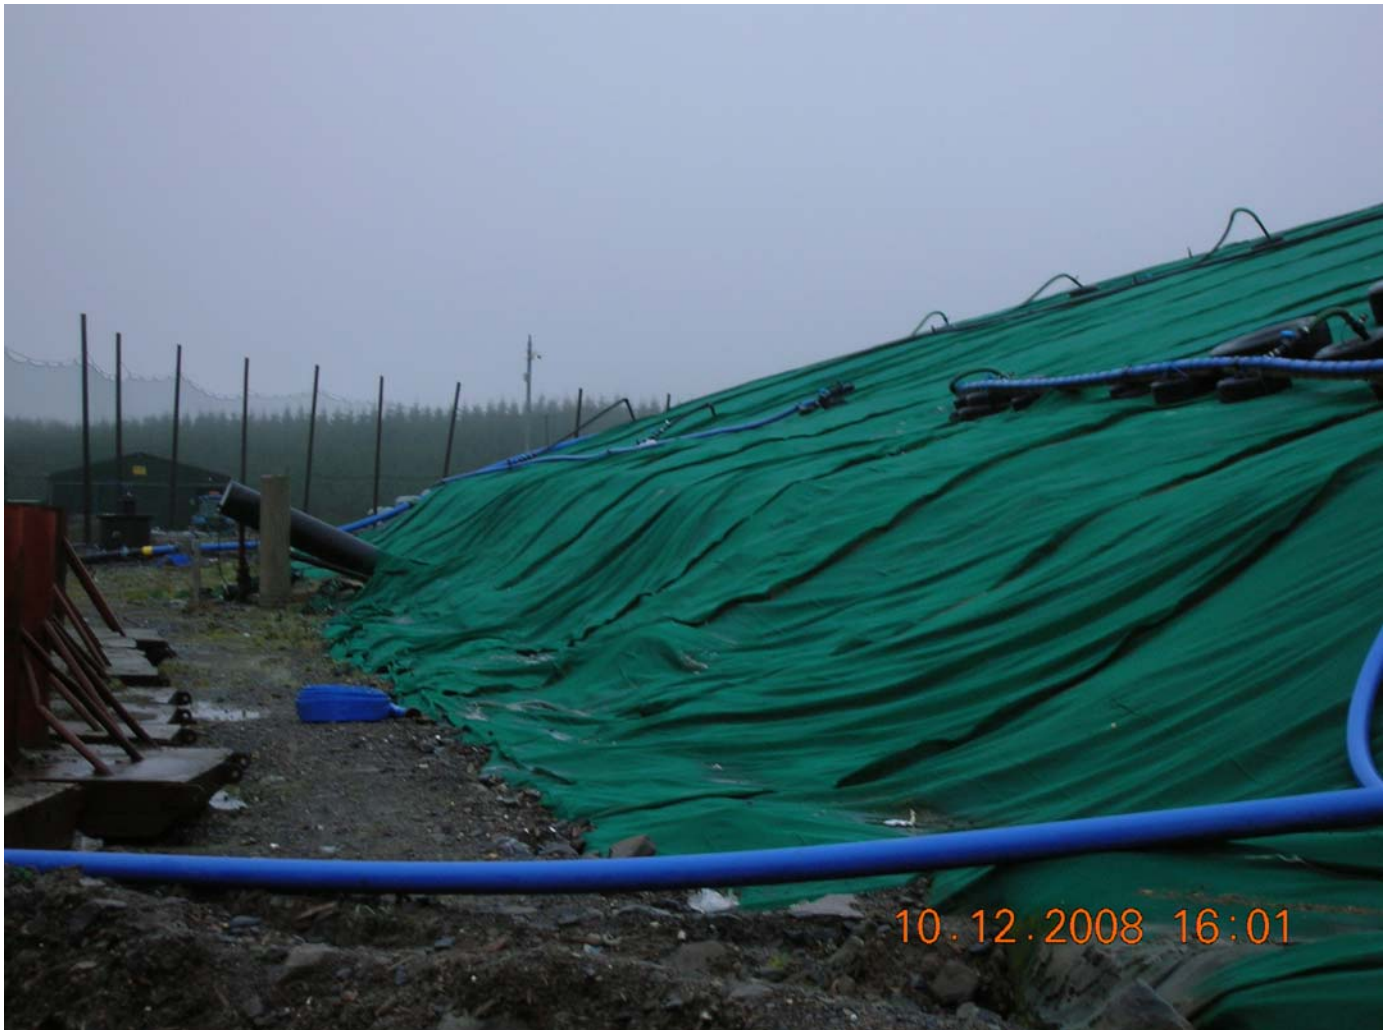
The side slope showed no signs of instability. The side slope was covered with an impermeable liner overlain by green fine mesh over a distance of approximately 150m and was partly capped with glacial till covered with thin grass over a distance of approximately 70m. The maximum side slope grade is 1:3(V:H) except for a short section of the lower 1.5m which is inclined at 1:1(V:H).

Photo 2: General view of Western Slope

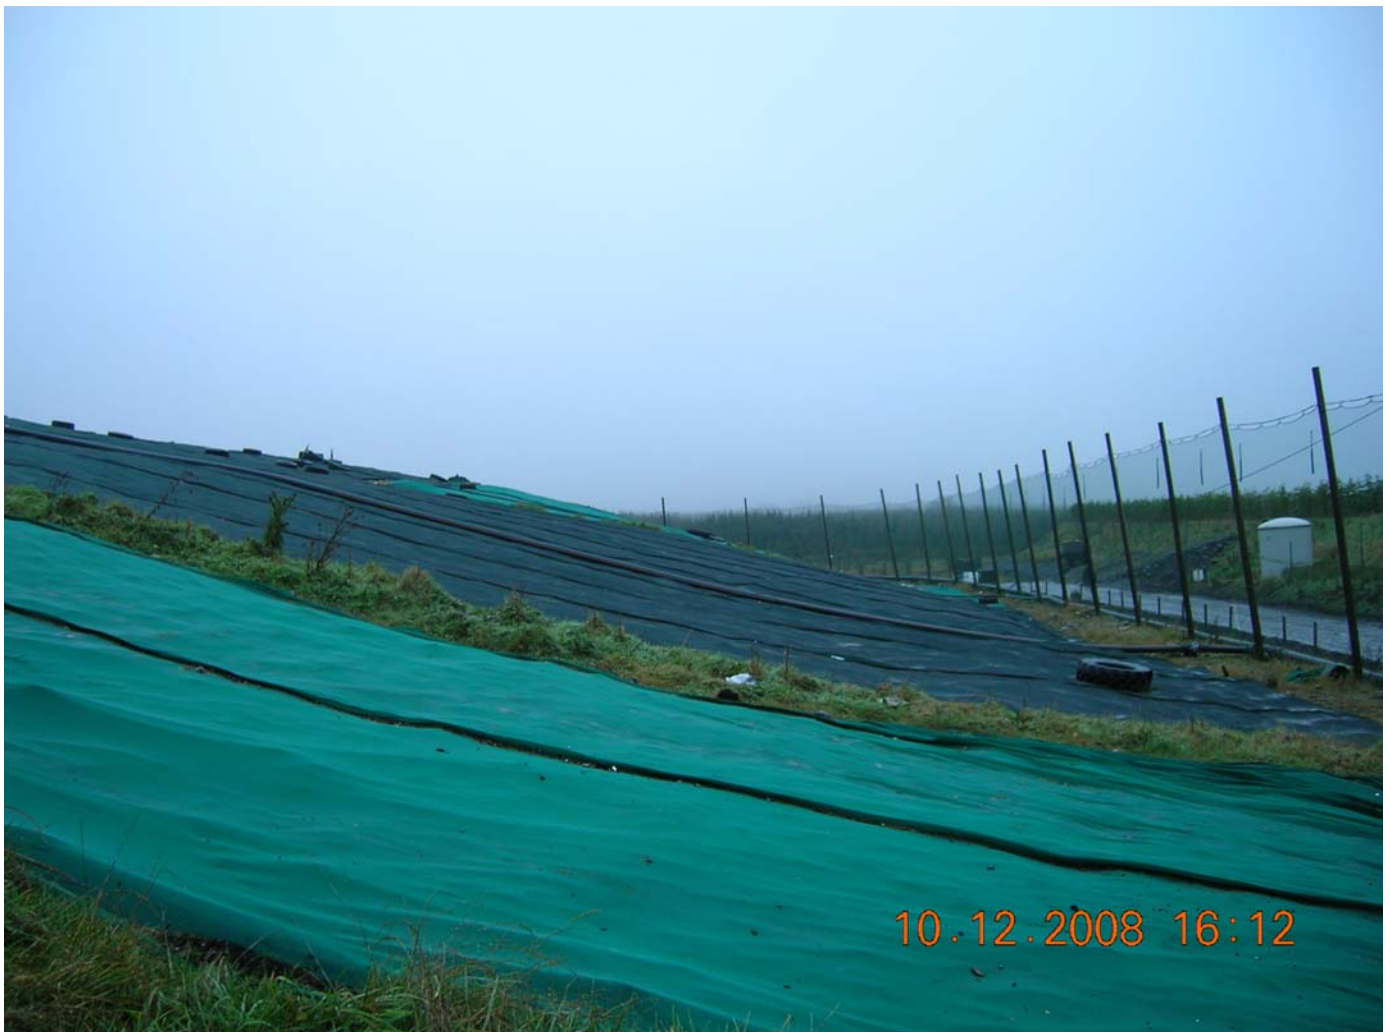
The side slope showed no signs of instability. The side slope was covered with an impermeable liner overlain by green fine mesh over a distance of approximately 120m and was partly capped with peaty topsoil covered by thin grass over a distance of approximately 60m. The maximum side slope grade is 1:3(V:H)

Photo 3: General view of Eastern Slope

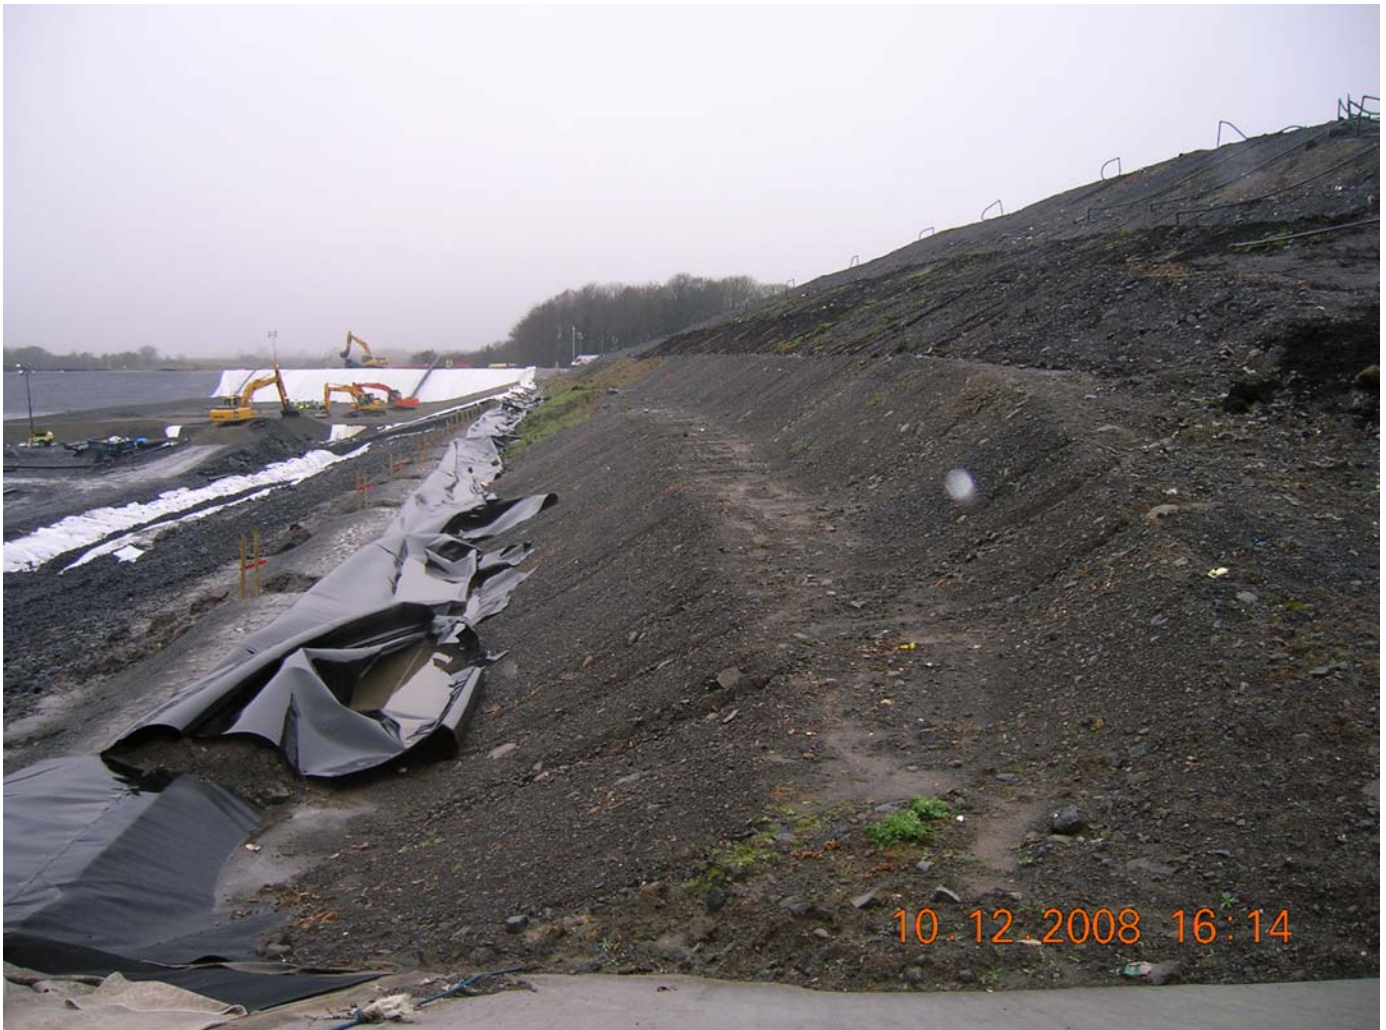
The side slope was in a stable condition during inspection, however minor soil erosion was found across the southern slope. The southern slope is temporary and waste will be deposited against it as Phase 2 is filled with waste therefore preventing further soil erosion. The slope is approximately 250m in length and the maximum side slope grade is 1:2 (V:H).

Photo 4: General view of Southern Slope for Cell 3

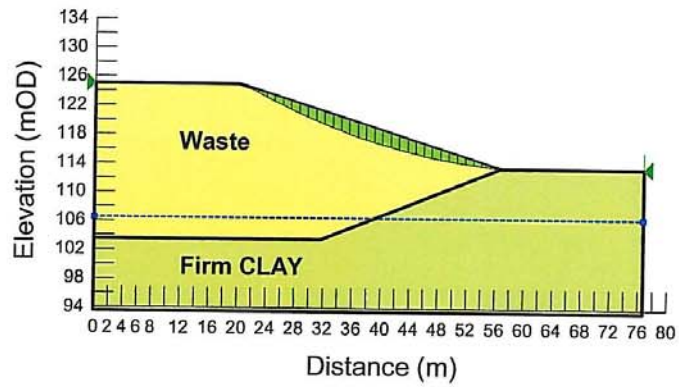
Section C-C: Western Slope Analysis
 Scale: 1:800

Name: Waste
 Model: Mohr-Coulomb
 Unit Weight: 14 kN/m³
 Cohesion: 0 kPa
 Phi: 28 °
 Piezometric Line: 1

Name: Firm CLAY (Longterm)
 Model: Mohr-Coulomb
 Unit Weight: 20 kN/m³
 Cohesion: 0 kPa
 Phi: 30 °
 Piezometric Line: 1
