ANNUAL ENVIRONMENTAL REPORT.

**LISDEEN RECYCLING CENTRE & TRANSFER STATION ,
CEMETRY ROAD, LISDEEN, KILKEE, CO. CLARE**

LICENCE REF. NO W0170-01

Date: 2009

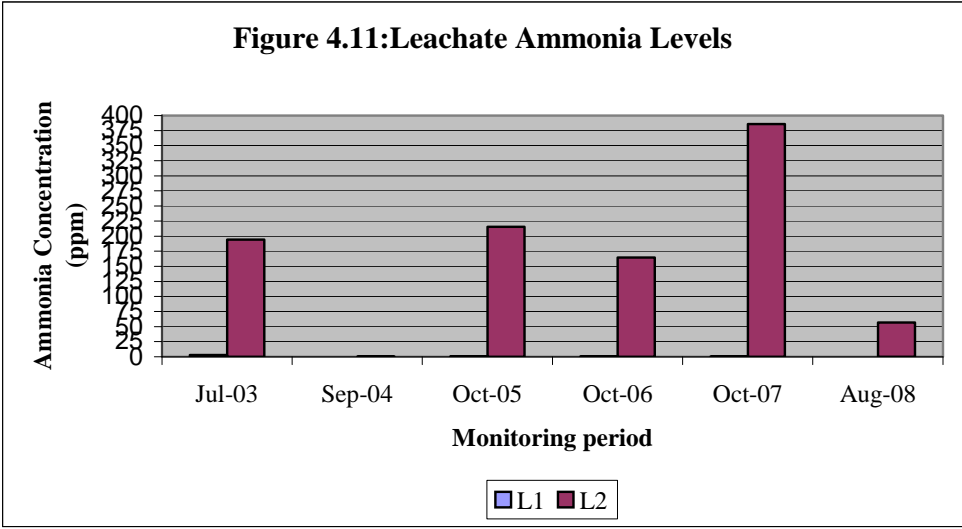
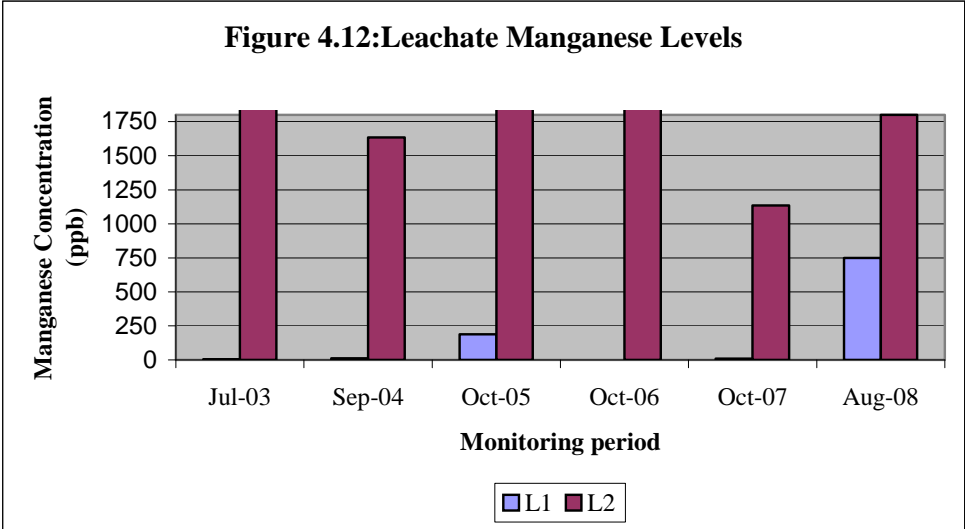
monitoring wells are shown in Appendix 1. Leachate composition results for the period are included in Appendix III of this report. Graphs of leachate parameters that are mentioned in this discussion are presented in Appendix VII (Figures 4.11-4.12). Results are summarised below.

The monitoring results obtained for 2008 for L1 were not similar to those obtained in 2007. This may have been due to the presence of lubrication oil contamination of this leachate well during 2007, which caused elevation in a number of parameters for the 2007-monitoring event or perhaps due unusually elevated volume of rainfall that occurred in August 2008, which may have contributed, to a dilution effect on the leachate. Therefore it is difficult to correlate the 2007 result with those obtained in 2008. However elevated results were obtained for a number of parameters in 2008, namely COD (285ppm), Iron (1100ppb) and Manganese (750ppb Figure 4.12). The remaining parameters were relatively low and similar to those obtained during previous monitoring events.

Because L2 is located in the body of the waste the concentrations of all parameters were significantly higher in L2 than L1. Monitoring results for L2 showed markable reduction in a number of parameters for 2008. This may be due to the extraordinarily high level of rainfall during August 2008 and therefore dilution effect of the leachate. There was a reduction in a majority of the parameters monitored. The only notable increases that were noted since 2007 were in Iron (173→8400ppb) and Manganese (1136→1800ppb), which are the 2 parameters that are present in natural background levels. All remaining parameters displayed a trend similar to that obtained for 2007.
