Greenclean Waste Management Ltd

Licence No. W0222-01

Annual Environmental Report

2008

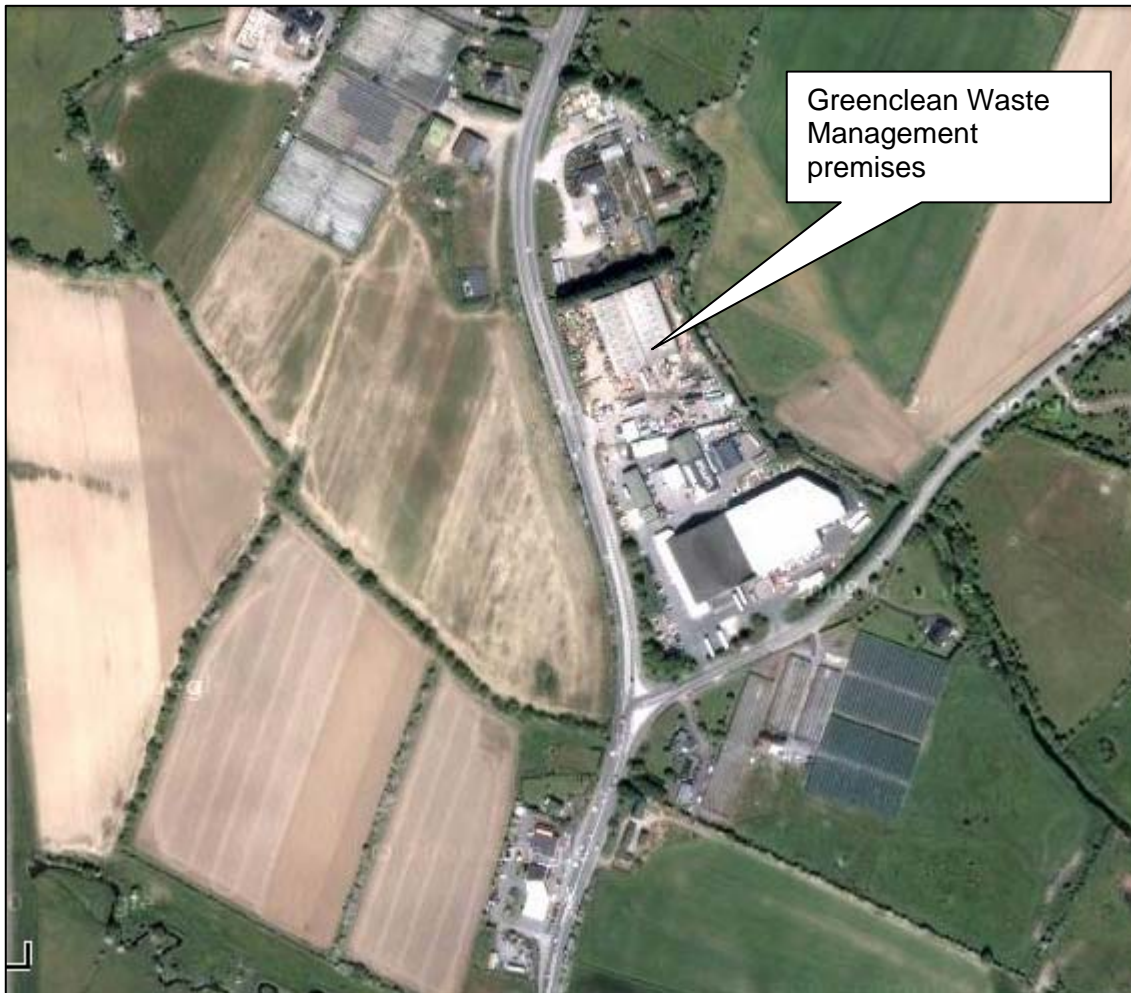
The 1.12ha site is located at Blake's Cross near Lusk directly on the N1 (R129) road and adjacent to the M1. The immediate surrounding landuse is a mix of agricultural land, light industrial developments and an Eastern Health Board residential unit. The Ballough stream, a tributary of the Ballyboghil stream forms the east boundary of the site.

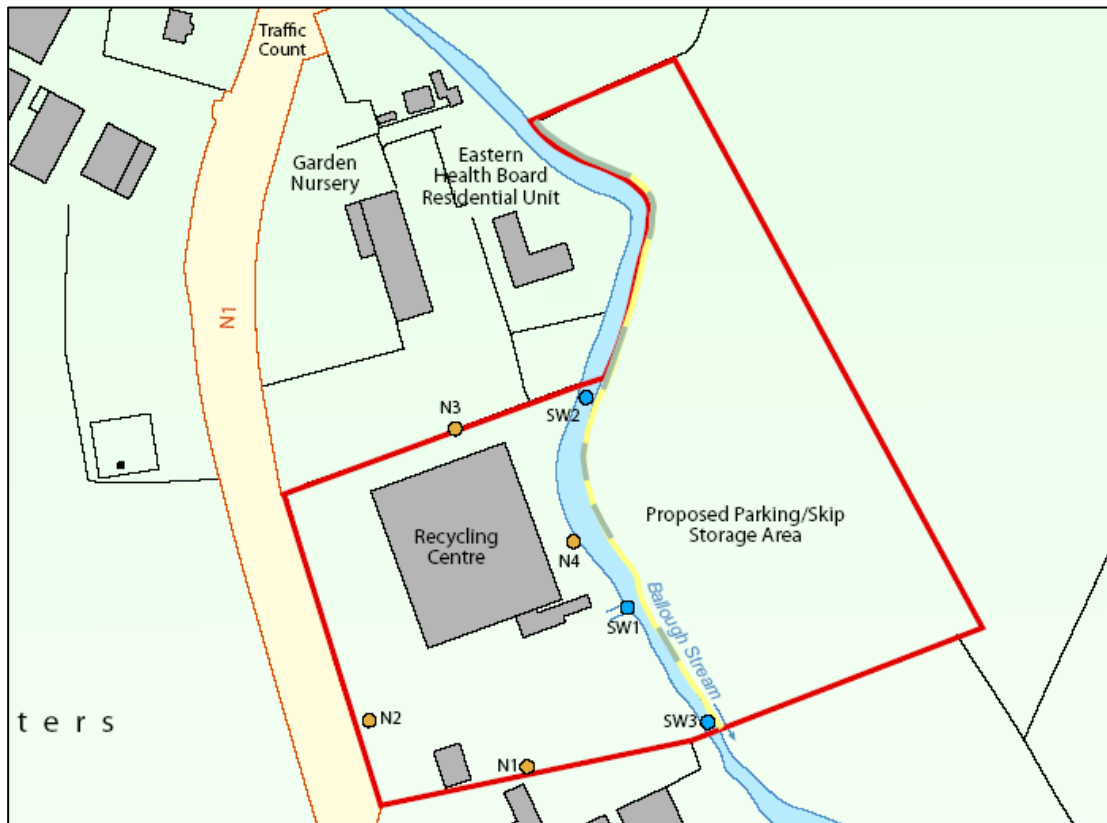
N1: Located on hard ground on the southern boundary of the site, besides the south-east corner of the reception building and 40-50 metres away from the recycling building.

N2: Located on hard ground on the western boundary of the site, besides the smoking area. This point was 6 metres away from main gate, 5 metres away from R129 road and 30 metres away from the recycling building.

N3: Located on hard ground on the northern boundary of the site, besides a line of trees and 5 metres away from the recycling building.

N4: Located on hard ground on the eastern boundary of the site, besides the Ballough Stream and 5 metres away from the recycling building.

Constant traffic movements on R129 road contributed to elevated noise levels at monitoring locations N1, N2 and partially at N3. Planes were recorded flying overhead during monitoring due to the close proximity to Dublin Airport.

Daytime noise levels at all monitoring locations exceeded the recommended day time noise limit of 55 dB(A) and therefore exceed the limits outlined in Schedule B.3 of Waste Licence W0222-1. The main sources of noise reported were traffic passing on the near by R129, HGVs entering and leaving the site and machinery in operation within the recycling building.

Tonal components were detected at a frequency of 16 Hz at two of the monitoring locations. This is in the low frequency range and could be attributable to the operation of diesel engines from plant at the facility.
