APPENDIX 8.1

Trial Pit Logs

TRIAL PIT LOG

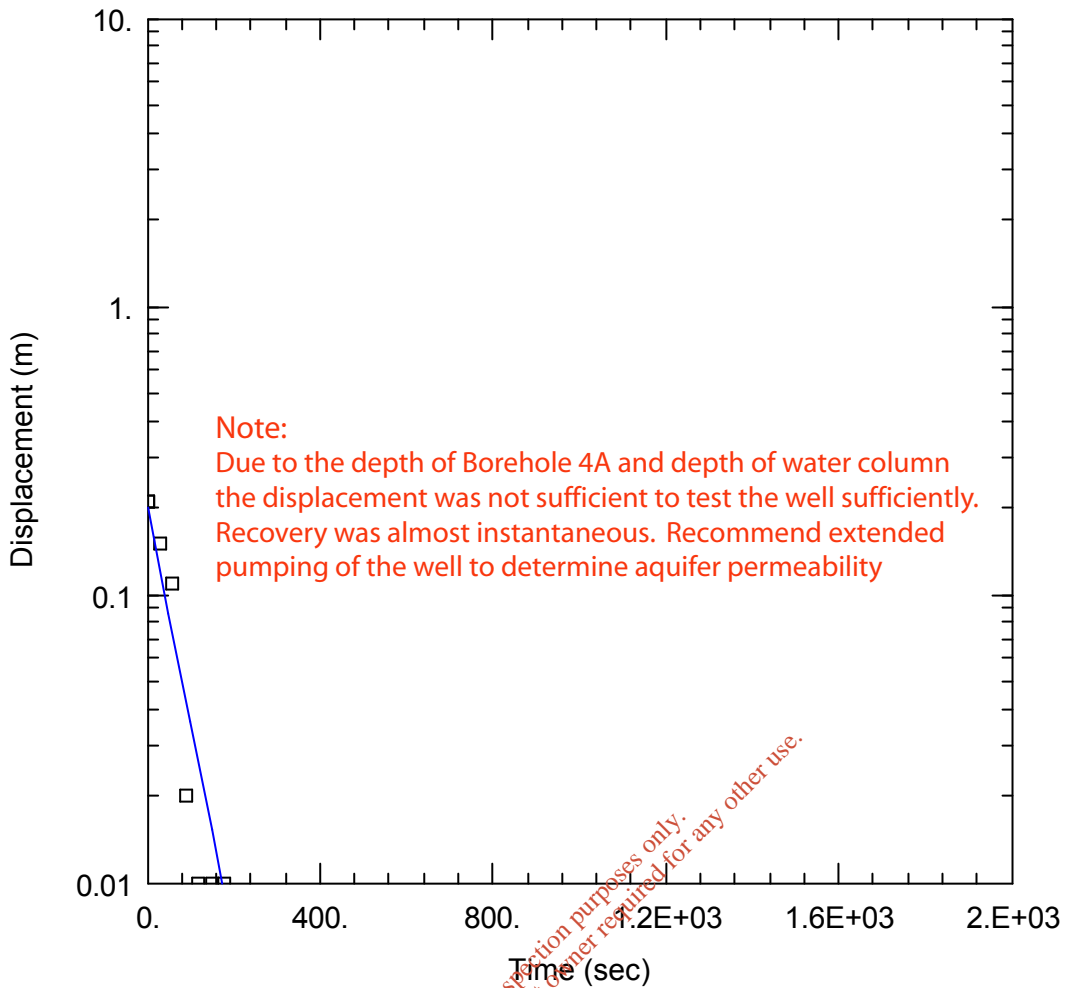
4A - SLUG

Aquifer Model: Unconfined Solution Method: Hvorslev
 K = 2.632E-06 m/sec y0 = 0.2015 m

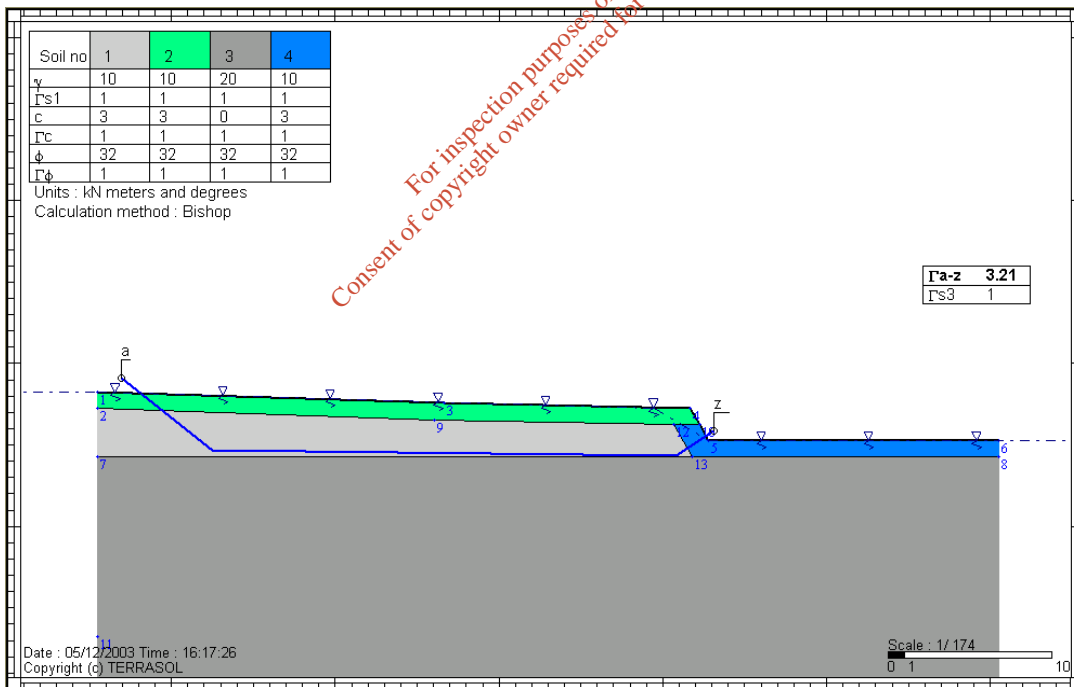
(b) Showing global stability of perimeter assuming translational slide for drained loading condition. Groundwater assumed at peat surface.

For Case (1) the FoS is high, as would be expected given the geometry of the area. The minimum FoS of 3.21 is prior to filling for global failure along perimeter of deposition (Figure 4a and b). This is greater than the required minimum of 1.3.

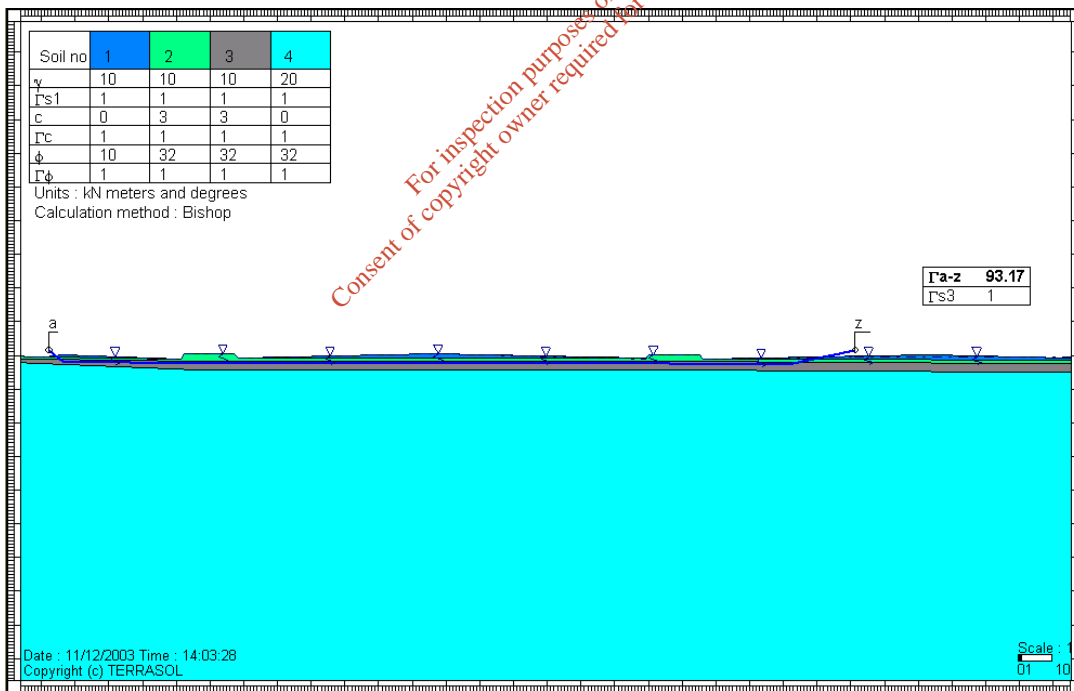
(f) Example of global stability under 2 highfields along Section 2-2 following peat placement assuming translational slide for drained loading condition. Groundwater assumed at peat surface.

Where peat is placed within Area 6, global stability analyses were carried out assuming potential translational failure below deposition area. Stability along Section 2-2 (Drawing No. 382_002) was examined together with stability along the lowfield to the south of Section 1-1 (Drawing No. 382_001). The calculated FoS is greater than 20 (Figure 4c to h). The high FoS indicates that such a failure mode is inapplicable.

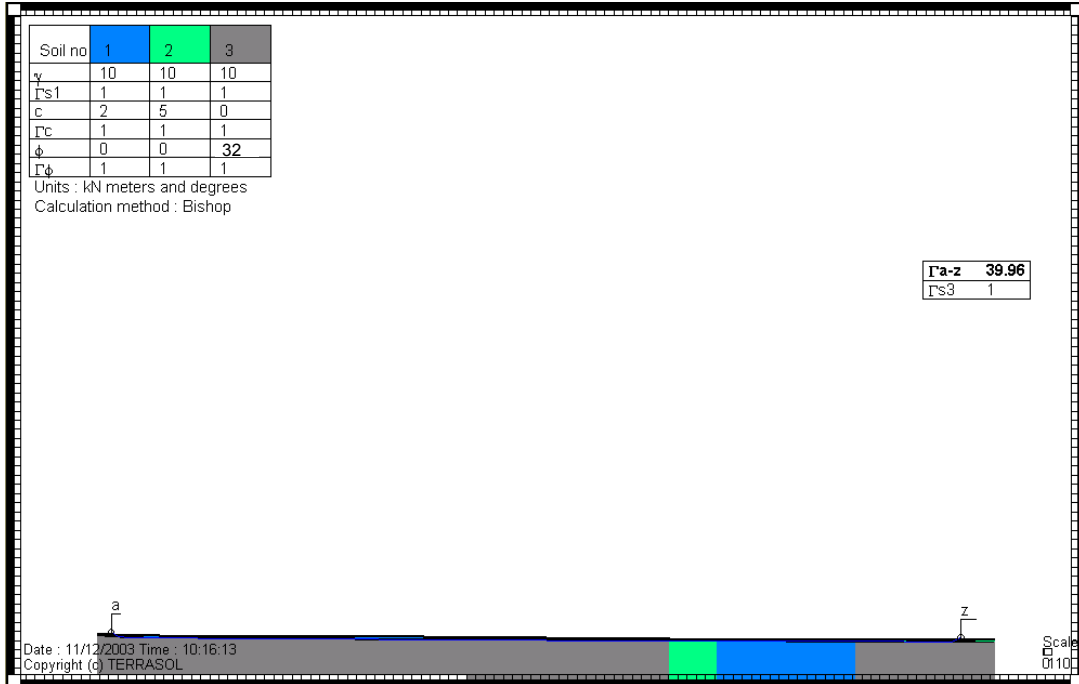
(i) Example of global stability under lowfield to south of Section 1-1 following peat placement assuming translational slide for total stress (undrained) analysis

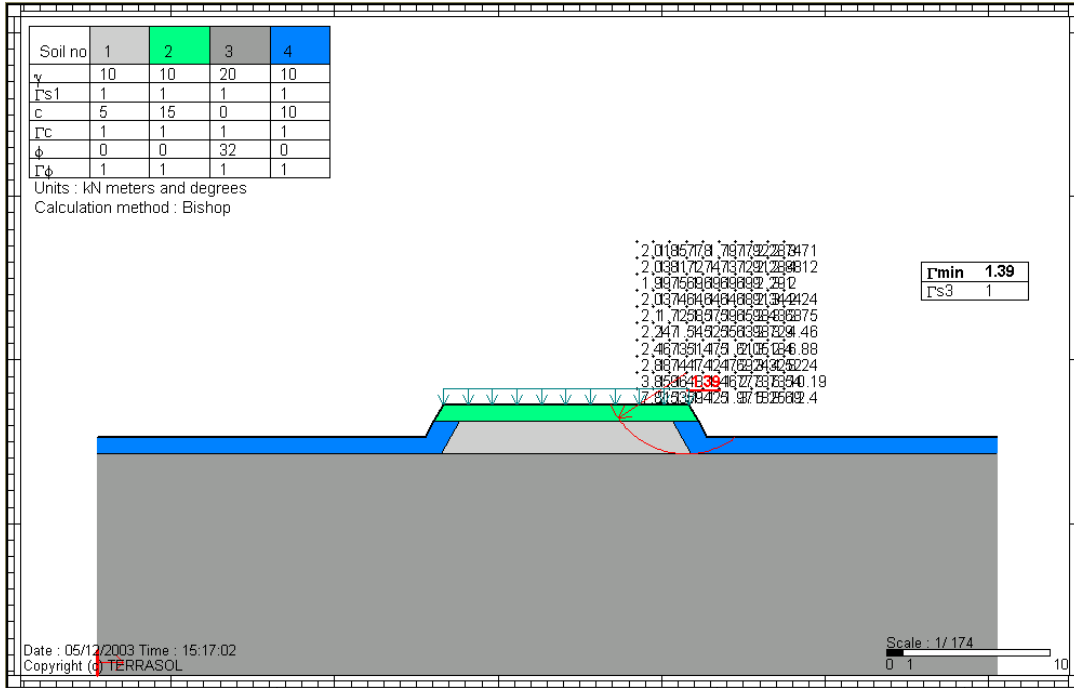
(a) Showing locally stability of highfield for total stress (undrained) analysis

Case (2) examined local stability within Area 6. The minimum FoS of 1.37 for local stability was found for potential side-slope failure of highfield (Figure 5a and b). Where a surcharge load is placed up to the edge of the highfield the FoS reduces to less than 1.3 within about 2m of the edge of the highfield. Siting of concentrated loads close to the edge of the highfield, may result in localised side slope failure of highfield, and is to be avoided.

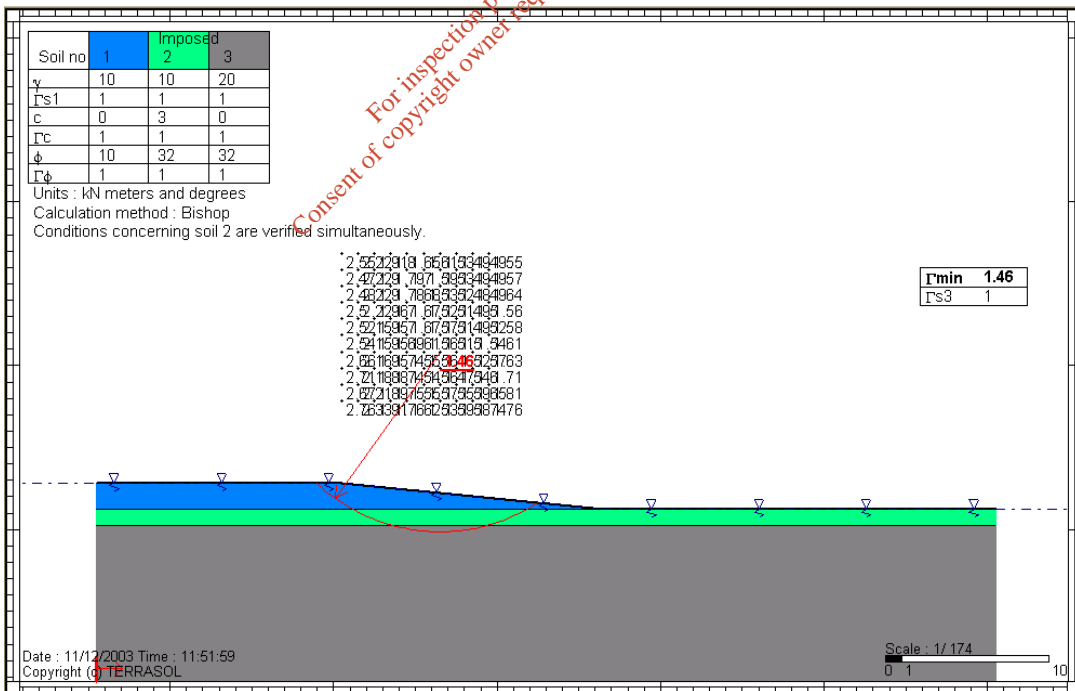
(d) Example of stability of placed peat at western end of lowfield assuming rotational slide for drained loading condition. Groundwater assumed at peat surface.

Local stability of placed peat in the western end of the lowfield was examined. This shows a minimum FoS of 1.46 (Figure 5d) and assumes failure surface passes through intact peat below placed peat. Some minor slippage of placed peat may occur from the face of the peat until such time as plant cover can be established on the placed peat surface.

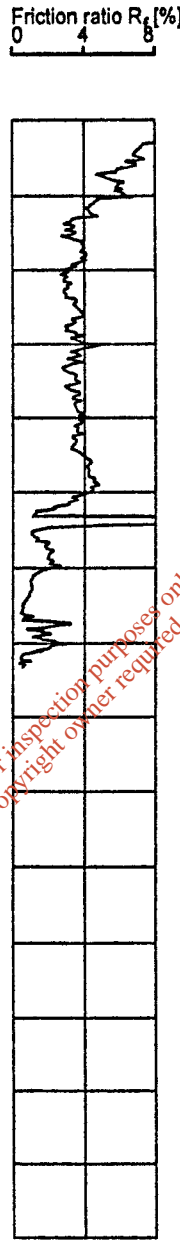
STATIC CONE PENETRATION TEST HF2 CP10
 EASINGTON LANFALL PIPELINE
 STATOIL

Location : HF2 CP4 Date of Test : 16-Jan-1990
 Coordinates : Date of Plot : 02-Dec-2003
 Ground Level [m] : File name : Hf2cp4.000
 Cone used : F7.5CKEW₂V 1515 Interpretation Checked by : ...

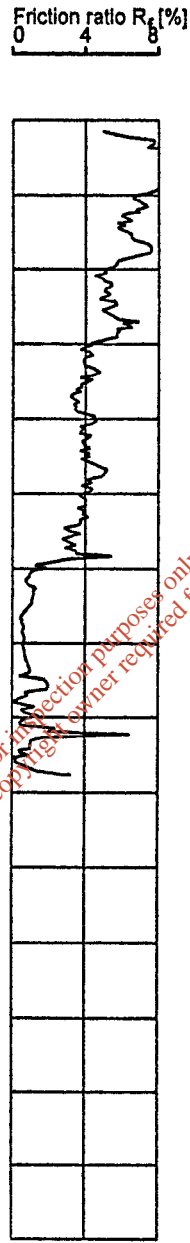
STATIC CONE PENETRATION TEST HF3 CP10
 EASINGTON LANFALL PIPELINE
 STATOIL
FUGRO ENGINEERING SERVICES LIMITED

Location : HF3 CP2 Date of Test : 16-Jan-1990
 Coordinates : Date of Plot : 02-Dec-2003
 Ground Level [m] : File name : HF3cp2.000
 Cone used : F7.5CKEW₂V 1515 Interpretation Checked by : ...

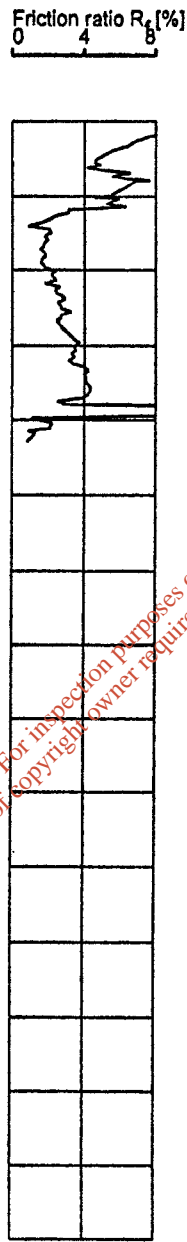
STATIC CONE PENETRATION TEST IF3 CP10
 EASINGTON LANFALL PIPELINE
 STATOIL
FUGRO ENGINEERING SERVICES LIMITED

Location : SCP01 Date of Test : 27-dec-2003
 Coordinates : Date of Plot : 02-Dec-2003
 Ground Level [m] : File name : Scp01.000
 Cone used : F7.5CKEW₂V 1515 Interpretation Checked by : ...
