ANNUAL ENVIRONMENTAL REPORT 2008

BALLYNAMUCK WASTE DISPOSAL SITE

Waste Licence Register No. W0032-2

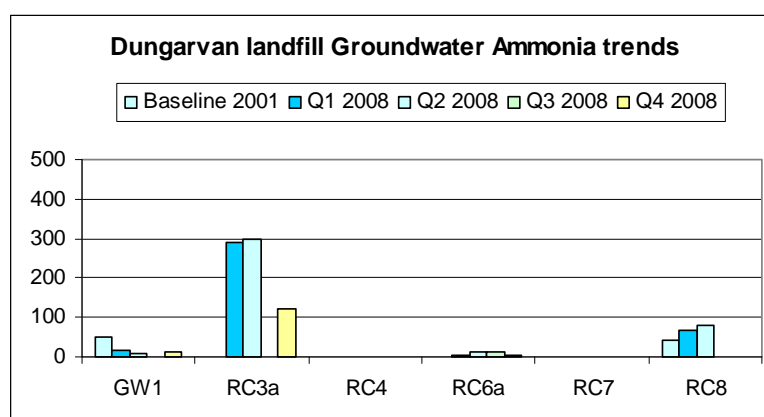
Results for 2008 were similar to baseline monitoring. The boreholes, RC4 and RC7, outside the landfilling area, consistently had relatively low ammonia.

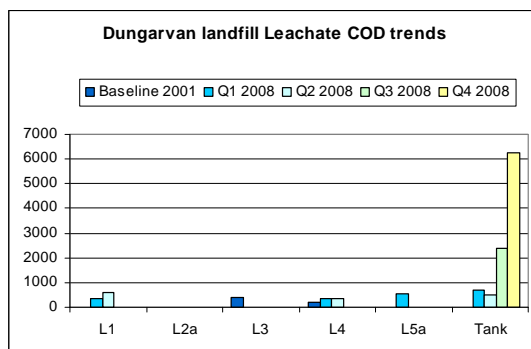
Figure 5.3.1 Leachate COD trends

COD levels were typical of landfill leachate, and similar to baseline levels. An increase in COD occurred in the leachate manhole sample in the 3rd and 4th quarters of 2008, possibly as a result of increased run-off to this tank during wet weather, due to leachate management infrastructure, or a general concentration of leachate due to drying of landfill infiltration due to capping. The contents of this tank are removed and treated off-site, as required. Continued monitoring will indicate any trends.
