Ballyogan Landfill Facility and Recycling Park Waste Licence W0015-01

Annual Environmental Report 2008

Client	Dun Laoghaire Rathdown County Council					
Project Title	Ballyogan Landfill Facility and Recycling Park					
Document Title	Annual Environmental Report 2008					
Document No.	088510001Rp074					
This Document Comprises	DCS	TOC	Text	List of Tables	List of Figures	No. of Appendices
	1	2	46	1	1	4

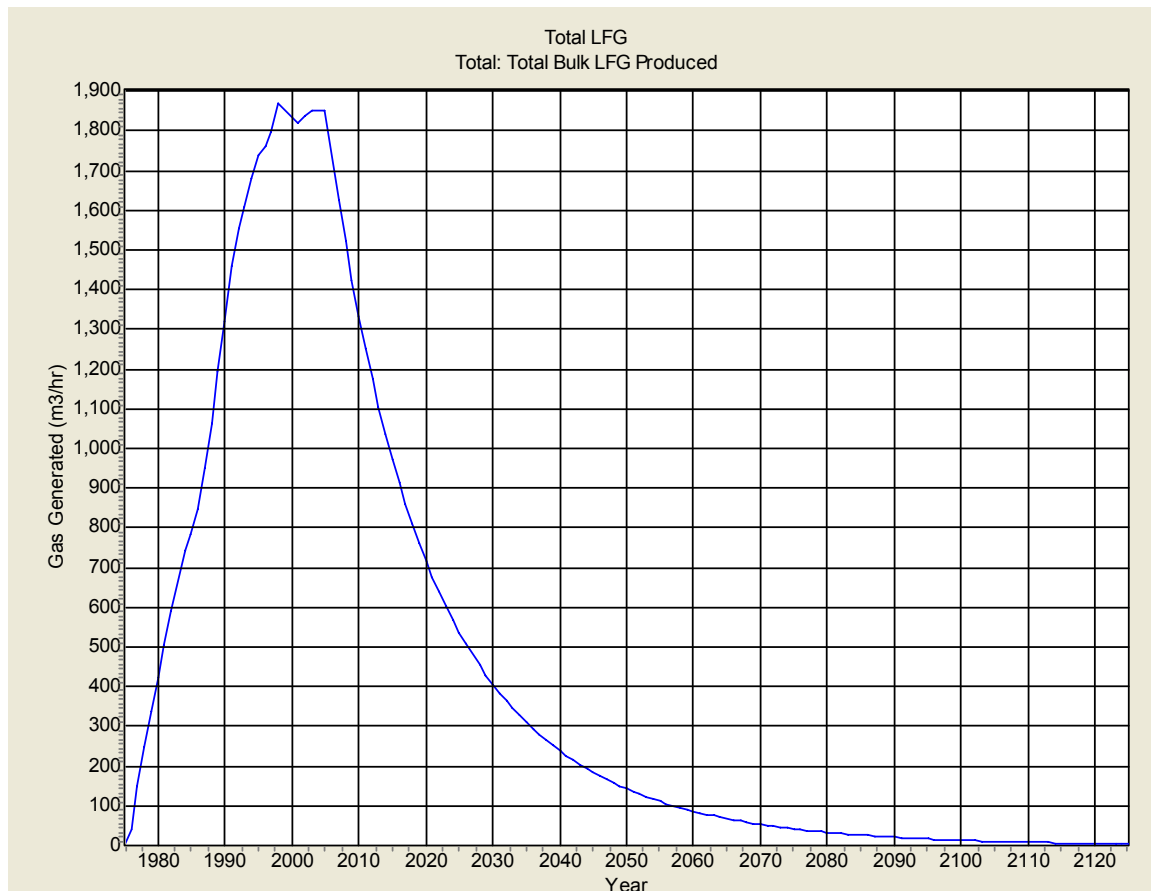
Figure 6.1: Estimated Hourly LFG Generation at Ballyogan Landfill

From the GasSim 2.0 model run for the site for 2008, the estimated quantity of methane generated at the site is 3,921,888Kg. The estimated quantity of methane emitted from the site, post combustion i.e taking into account the quantity of gas that is consumed by combustion, is 727,000Kg for 2008.

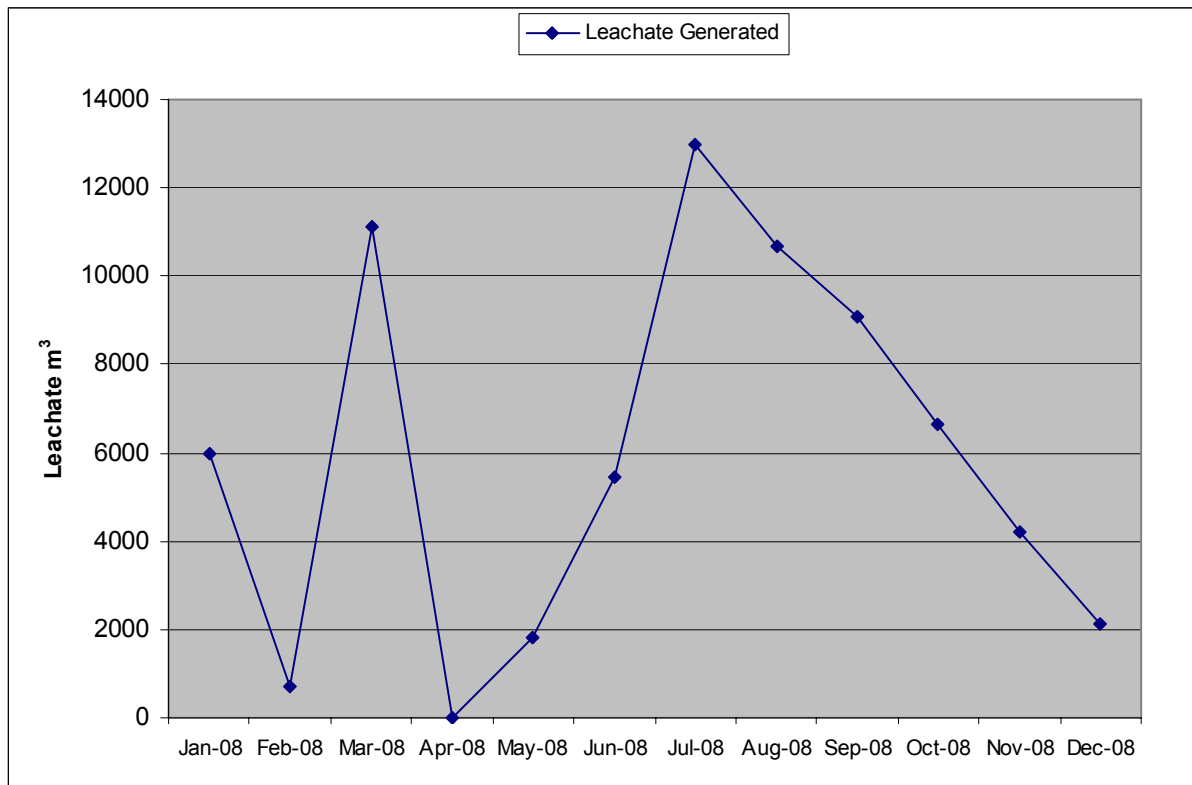
Figure 6.2: Monthly Leachate Generation at Ballyogan Landfill 2008

It is estimated that a total volume of leachate of 73,788.45m³ (73,788,450 litres) was generated during the reporting period (this does not take into account the effects of storage).

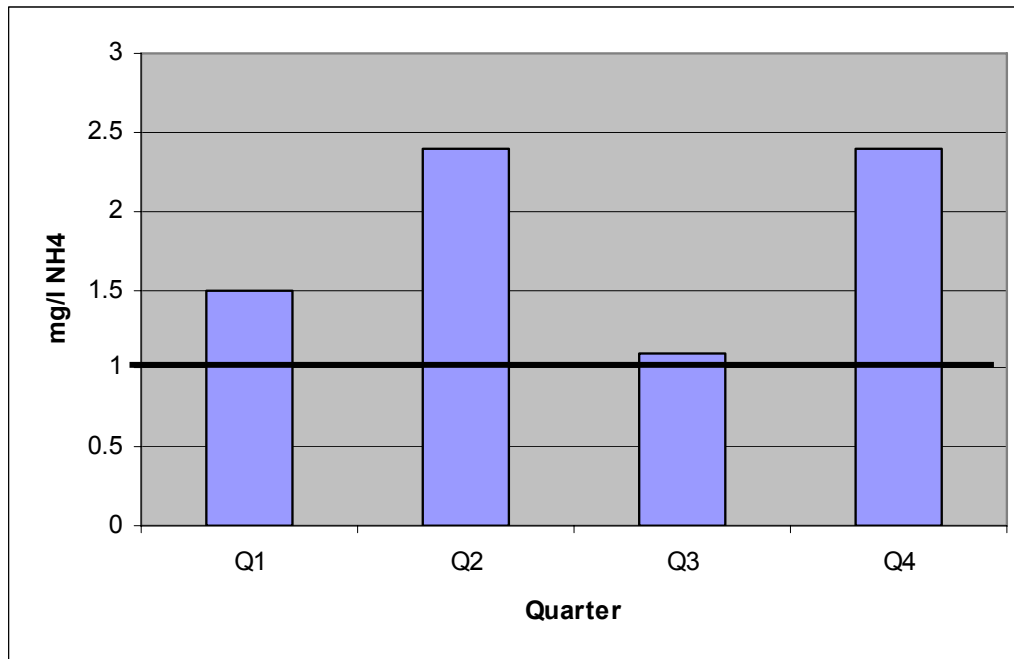
Figure 7.2: Ammoniacal Nitrogen in Surface Water at SW8 during 2008

Ammoniacal nitrogen concentrations at SW8 were elevated throughout the year, as illustrated in Figure 7.2 below. This was the only location where high levels of ammoniacal nitrogen were recorded, which is a marked improvement on 2006.

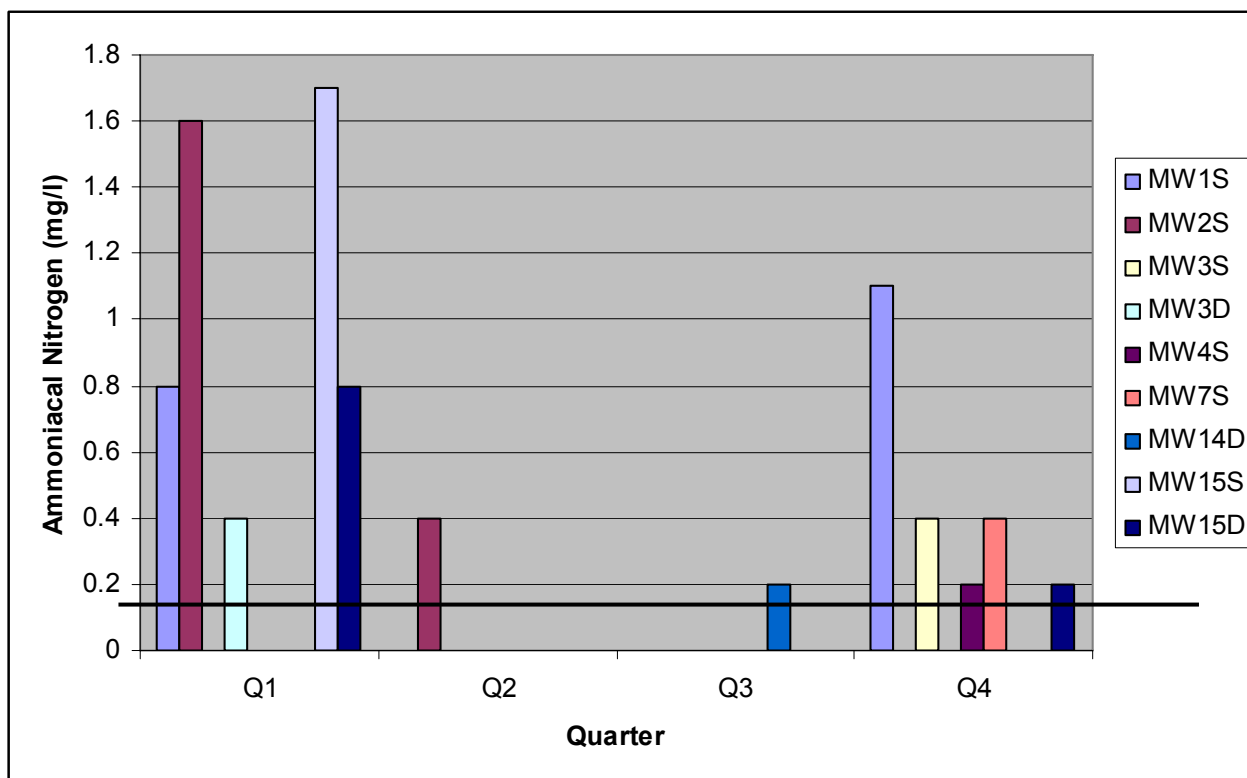
Figure 7.3: Wells where Ammoniacal Nitrogen was elevated in Groundwater during Quarterly Monitoring in 2008

The ongoing capping of the landfill will significantly reduce the generation of leachate and consequently will reduce the risk posed to groundwater quality in the area.

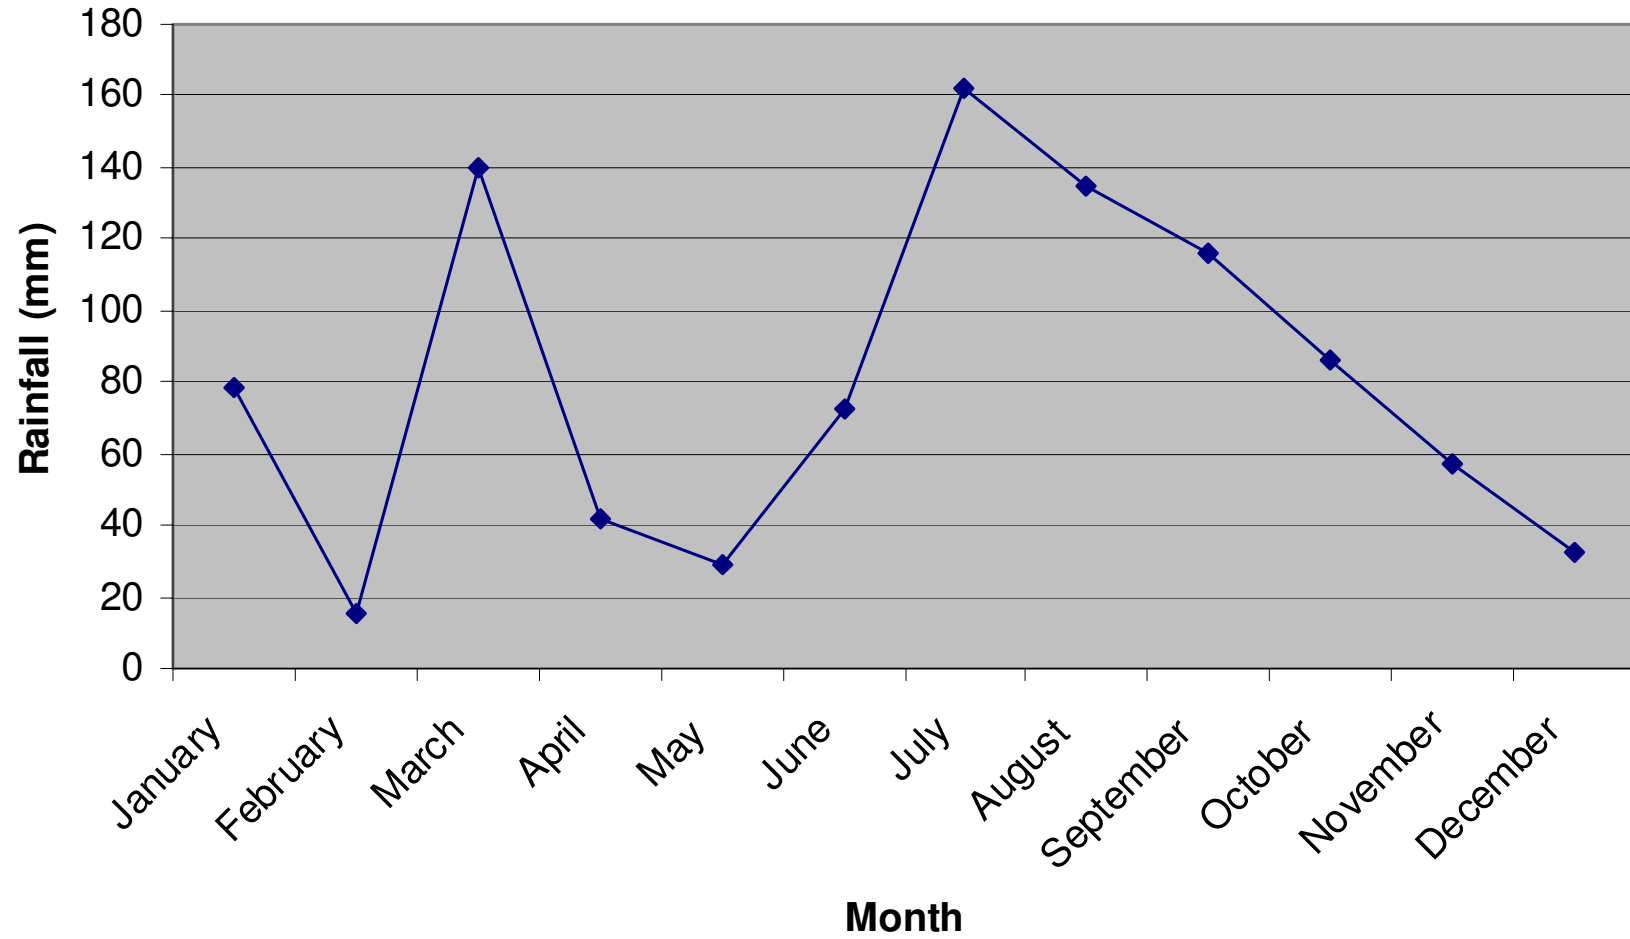
Monthly Rainfall 2008, BRP Weather Station

A meteorological station in the BRP records the local meteorological conditions on a daily basis. Rainfall for the twelve month period from January to December 2008 was recorded at 965.7mm. It should be noted that 15 days of data is absent from the records due to technical difficulties encountered at the meteorological station in the BRP.
