Apex Geophysical Survey Report

**REPORT
ON THE
GEOPHYSICAL SURVEY
AT
FOYNES,
COUNTY LIMERICK
FOR
MICHAEL PUNCH & PARTNERS**

March 31 2009

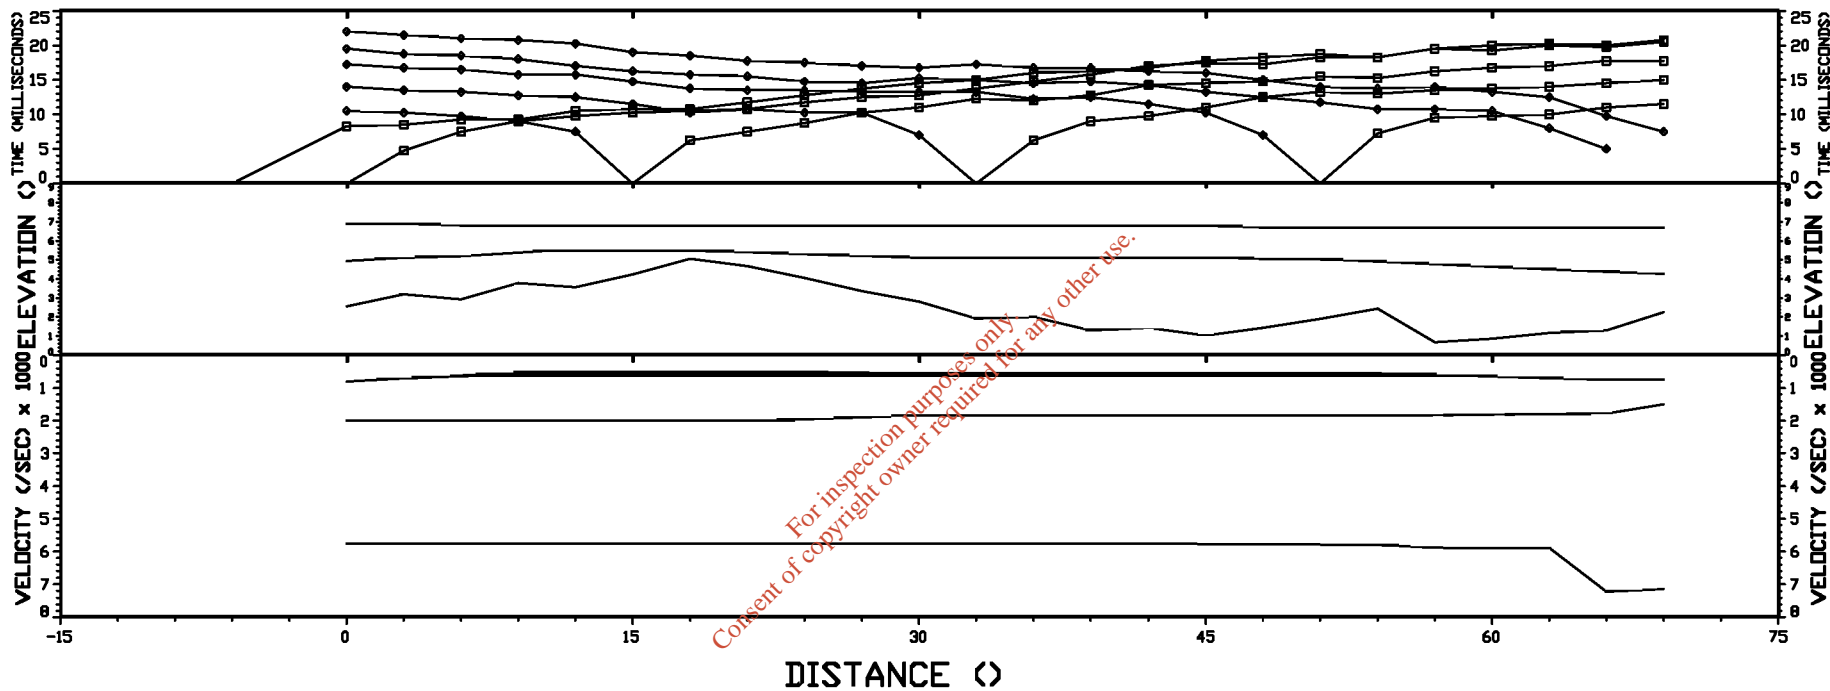
Plate: 10a

for: Michael Punch & Partners		9005
by: APEX Geoservices Ltd.		
Data Set: S2	Date: 02-04-2009	Foynes Limerick
Equipment: Seistronix RAS	Spread: S2	Azimuth:

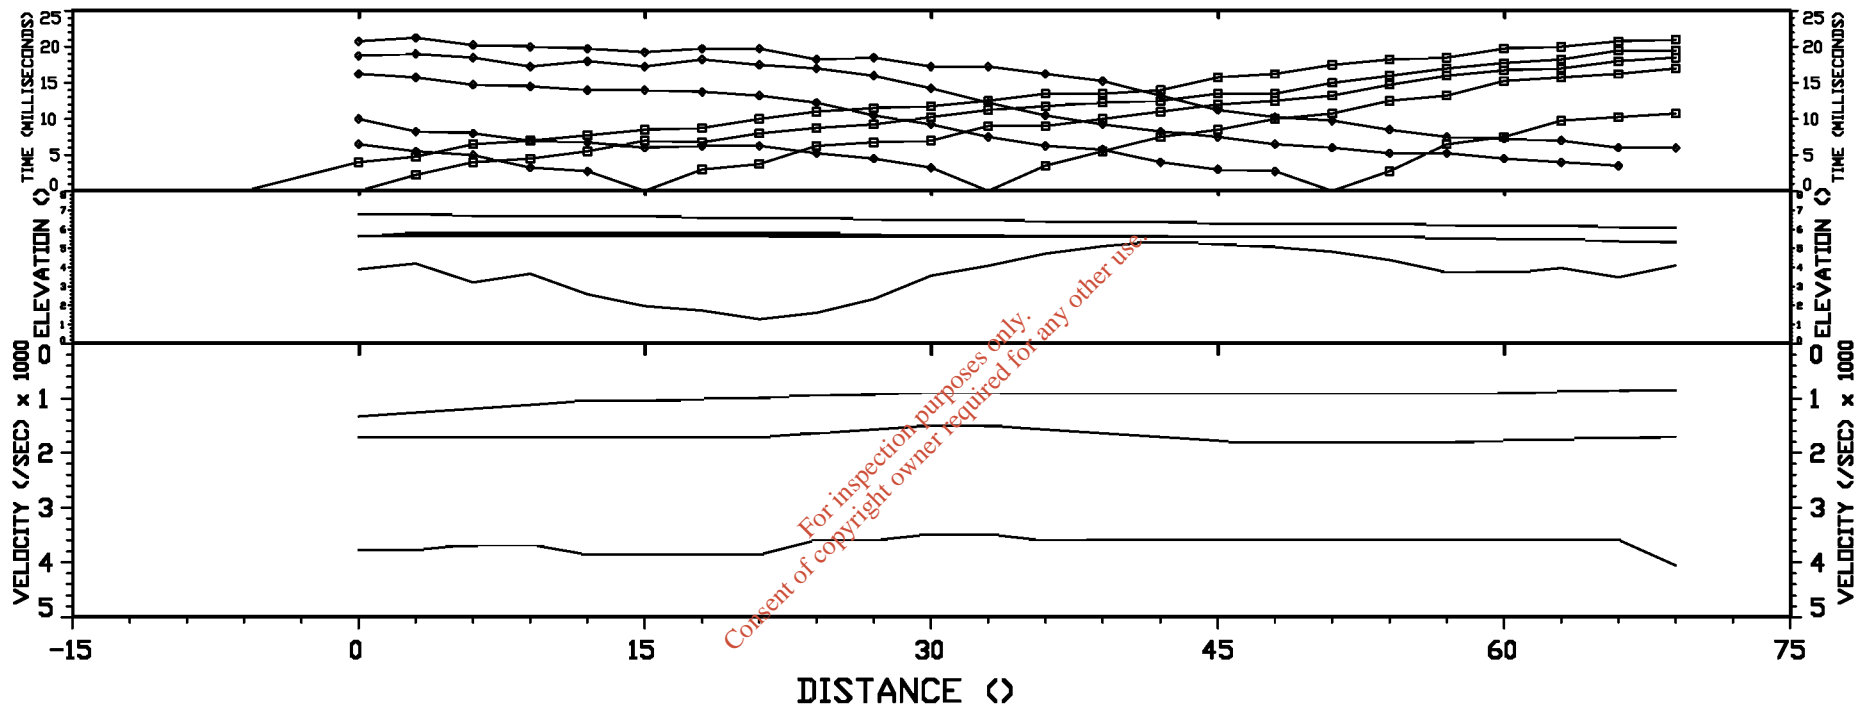
Plate: 10a

for: Michael Punch & Partners		9005
by: APEX Geoservices Ltd.		
Data Set: S3	Date: 02-04-2009	Foynes Limerick
Equipment: Seistronix RAS	Spread: S3	
		Azimuth:

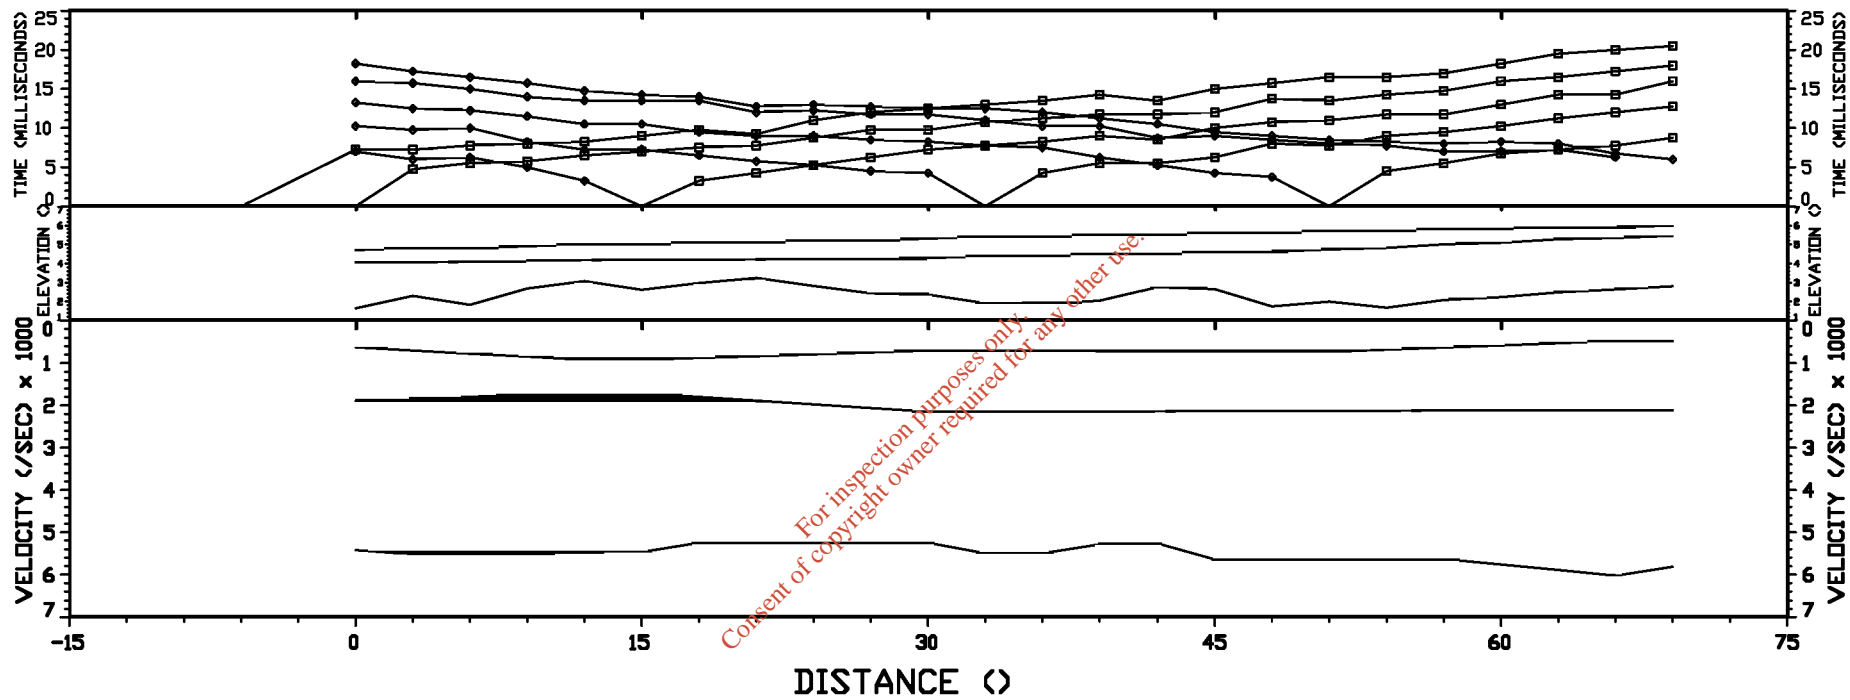
Plate: 10a

for: Michael Punch & Partners		9005
by: APEX Geoservices Ltd.		
Data Set: S6	Date: 02-04-2009	Foynes Limerick
Equipment: Seistronix RAS	Spread: S6	
		Azimuth:

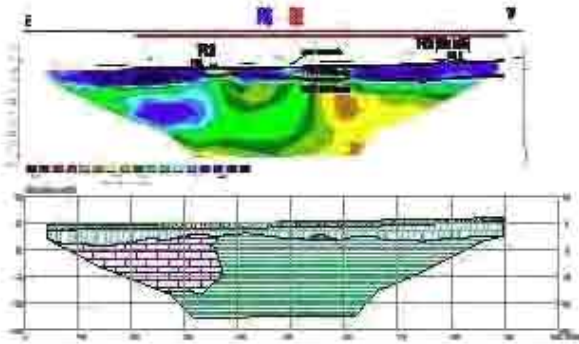
FIGURE 7: RESISTIVITY PROFILE R6 & SEISMIC SPREAD S6

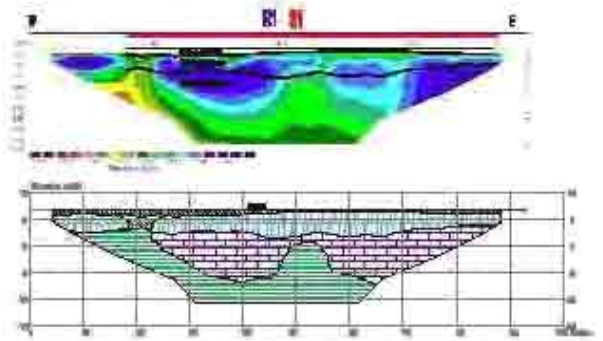
FIGURE 2: RESISTIVITY PROFILE R1 & SEISMIC SPREAD S1

This weathered/fractured rock layer has been interpreted on all profiles except R7 and the eastern parts of R3 and R5. It is thickest on R1 and R3 (up to c.4.8m thick). Weathered/fractured limestone with shale can be expected to be somewhat poorer quality and to be more easily excavated.

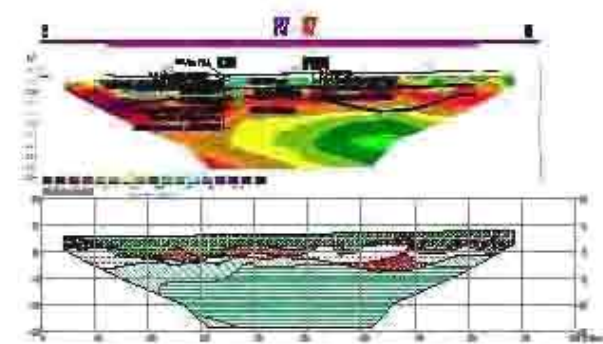
FIGURE 8: RESISTIVITY PROFILE R7 SEISMIC SPREAD S7
