**Re: D0160-01 – Dunmanway Waste Water Discharge Licence Application –
Reply to notice in accordance with Regulation 18(3)(b) of the Waste Water
Discharge (Authorisation) Regulation 2007**

Dunmanway Sewerage Scheme Upgrade

Appropriate Assessment

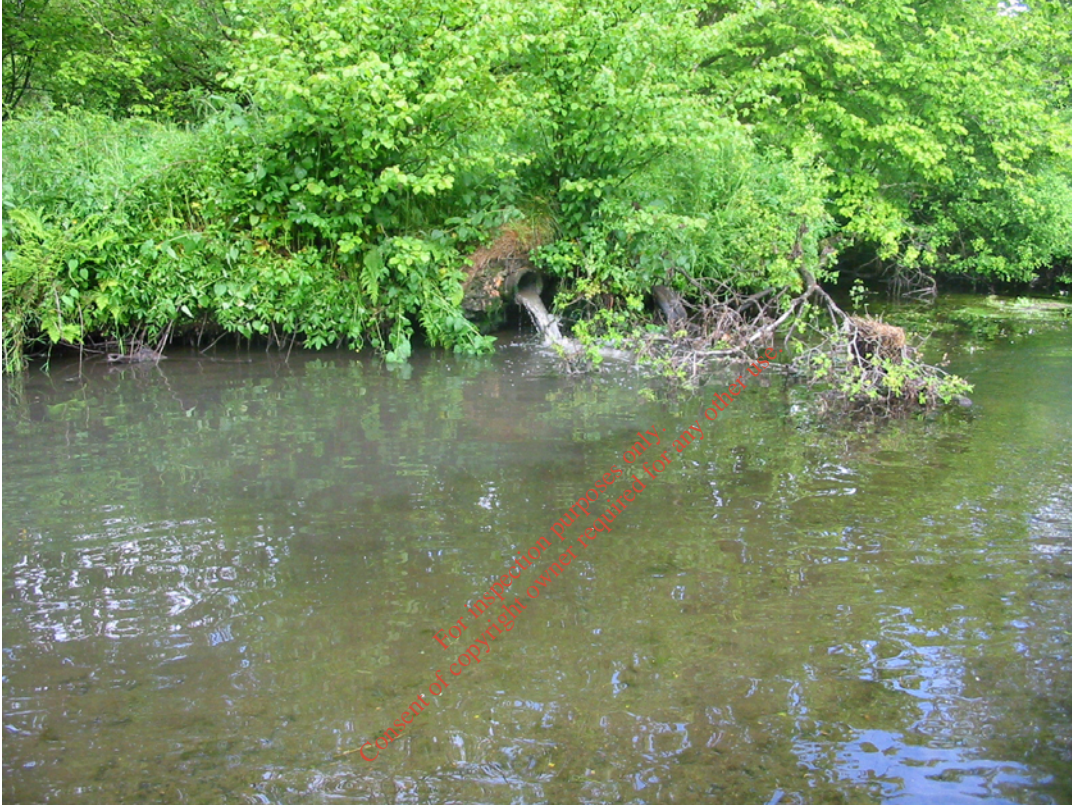
The river was visited during moderate flow conditions and during low flow conditions. The effect of the discharge can be determined by the silt deposition pattern. Based on this pattern it was determined that the discharge is diverted through the larger of the two channels (denoted channel "A" for the purposes of this report). Deep silt has built up along the bank for approximately 4m between the discharge point and the mouth of channel A. In places this layer of silt is up to 0.5m in depth. This pattern of silt deposition continues down channel A which runs for 308m before rejoining the main channel. In the upper reaches of this channel there are obvious indications of the effect of the discharge with strong growth of sewage fungus on woody material in the stream. Sanitary products were also noted.

The structure of the channel and silt plume at the discharge point is shown in Photography (I) & (II) and Map 4.

Photography (I) showing silt plume

Based on the information outlined above it is recommended that, provided certain mitigation measures are put in place, the preferred option is the provision of a new discharge pipe discharging to channel A downstream of the existing discharge point. The exact route of the pipe should be designed to as to provide minimum disturbance to riparian habitats and to prevent any instability in the riverbank. The use of the existing discharge point is considered a secondary option and the use of a new discharge on the Bandon River should be considered as a last resort.

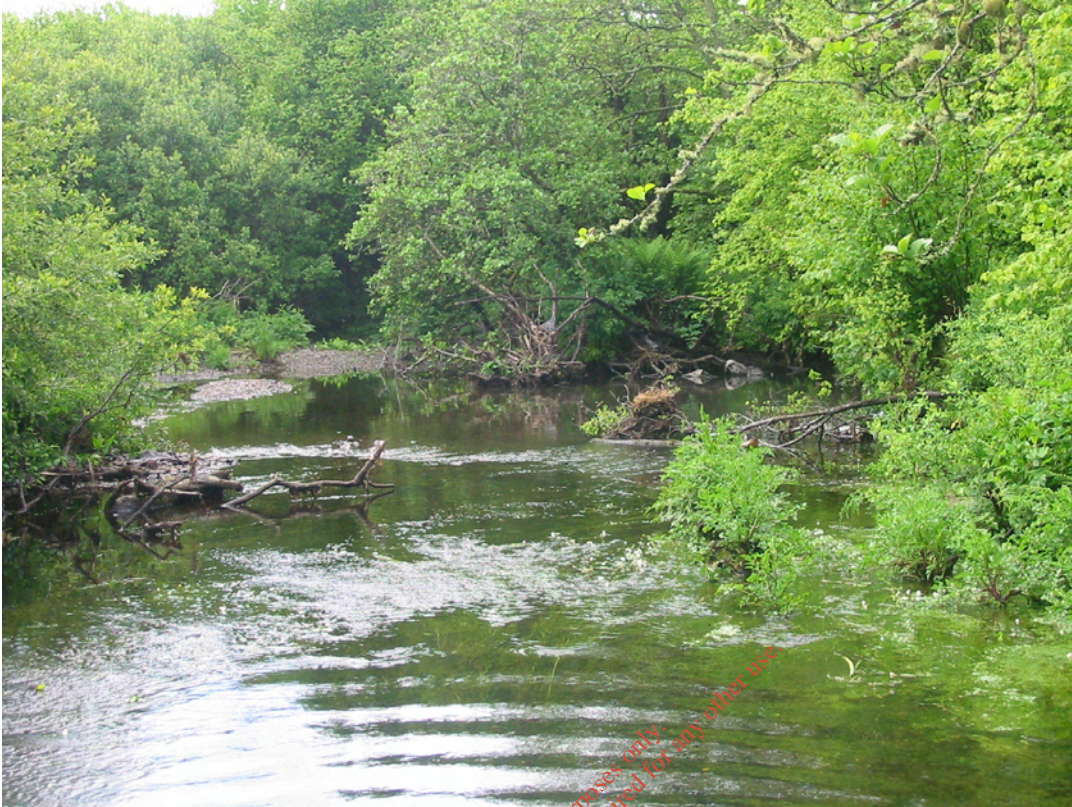
Photography (II) showing structure of the channel at the discharge point.
