Inert Waste Recovery Facilities Milverton Quarry, Co. Dublin.

Factual Report on Trial Pit Excavations and Soil Chemical Testing

January 2009

SLR Consulting Ltd.,
Unit 7, Dundrum Business Park,
Windy Arbour,
Dublin 14

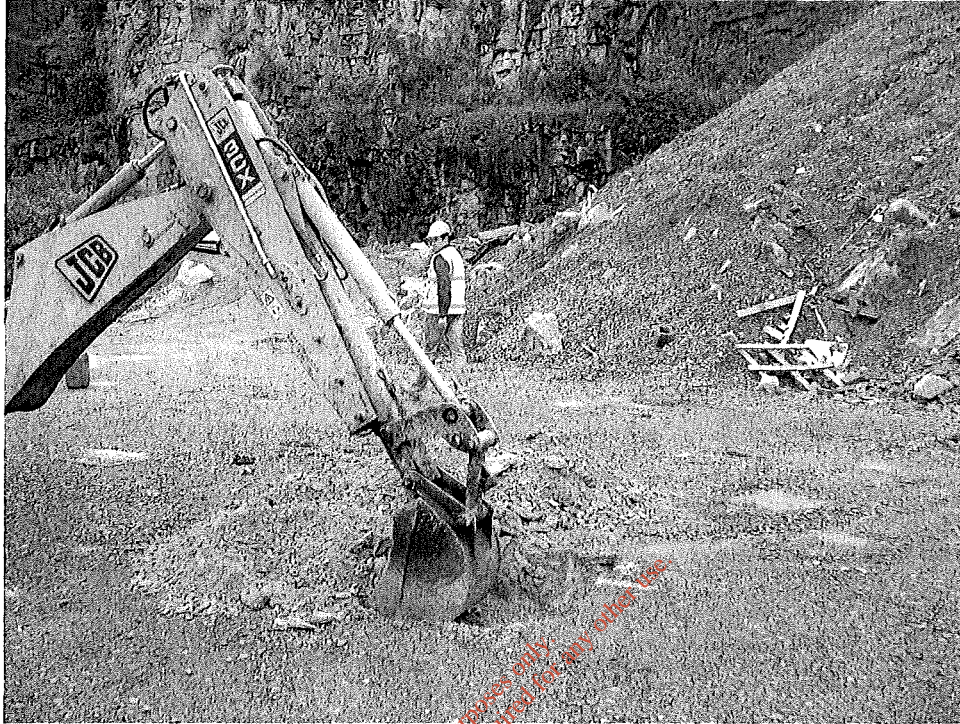
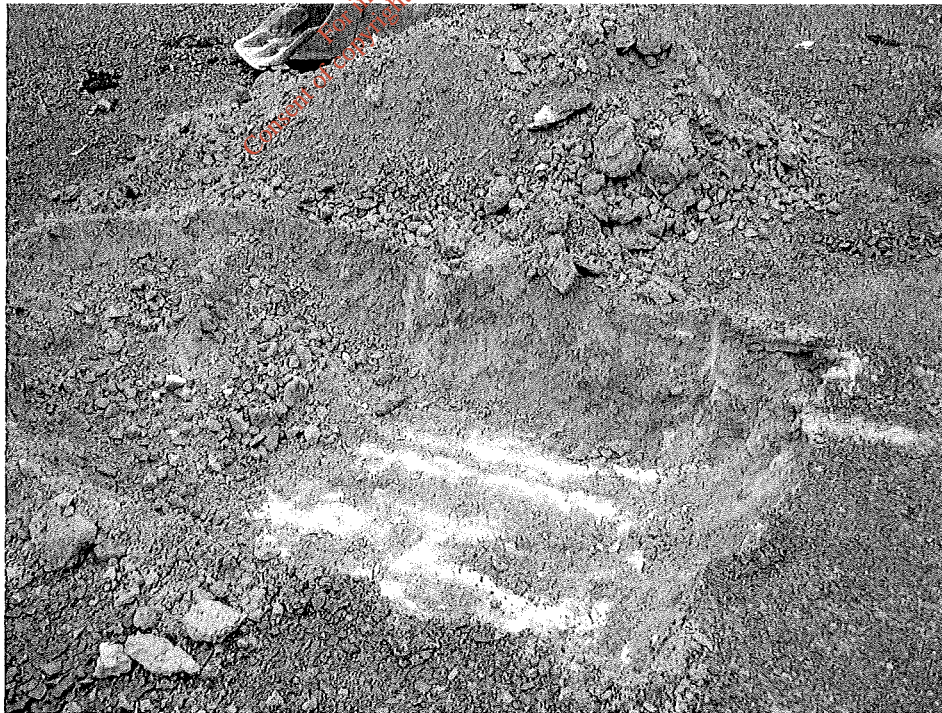
Trial Pit No.
MTP2

Samples & In Situ Testing				Depth (m)	Level (m AOD)	Legend	Stratum Description
Depth (m)	Type	Waterstrike	Results				
				0.40			Grey crushed aggregate compacted by site traffic. Rock breaker required to advance through top 300mm. (MADE GROUND)
				0.50			LIMESTONE (BEDROCK)
							Trialpit Complete at 0.50 m
1							
2							
3							
4

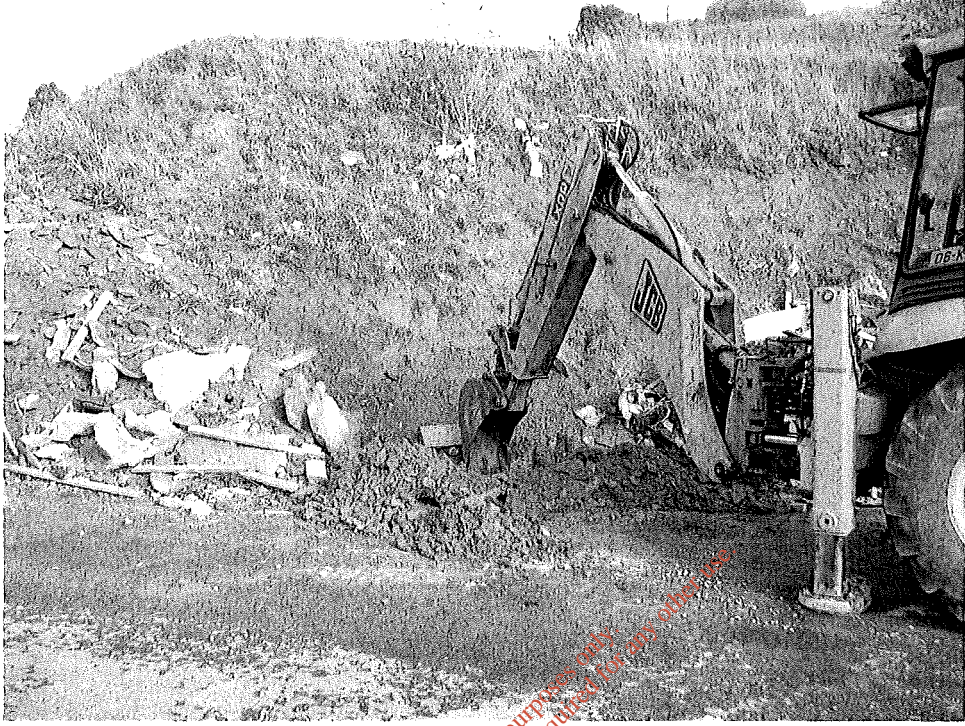
<p>Project Name: Milverton Ground Investigation. Location: Milverton Date: December 2008</p>	<p>Trial Pit No. MTP3</p>

Samples & In Situ Testing				Depth (m)	Level (m AOD)	Legend	Stratum Description
Depth (m)	Type	Waterstrike	Results				
				0.70			Crushed aggregate fill (MADE GROUND)
				2.40			Crushed Rock Fines (CRF) (MADE GROUND)
				2.50			Brown gravelly CLAY (placed material on ramp to quarry floor). (MADE GROUND)
							Trialpit Complete at 2.50 m

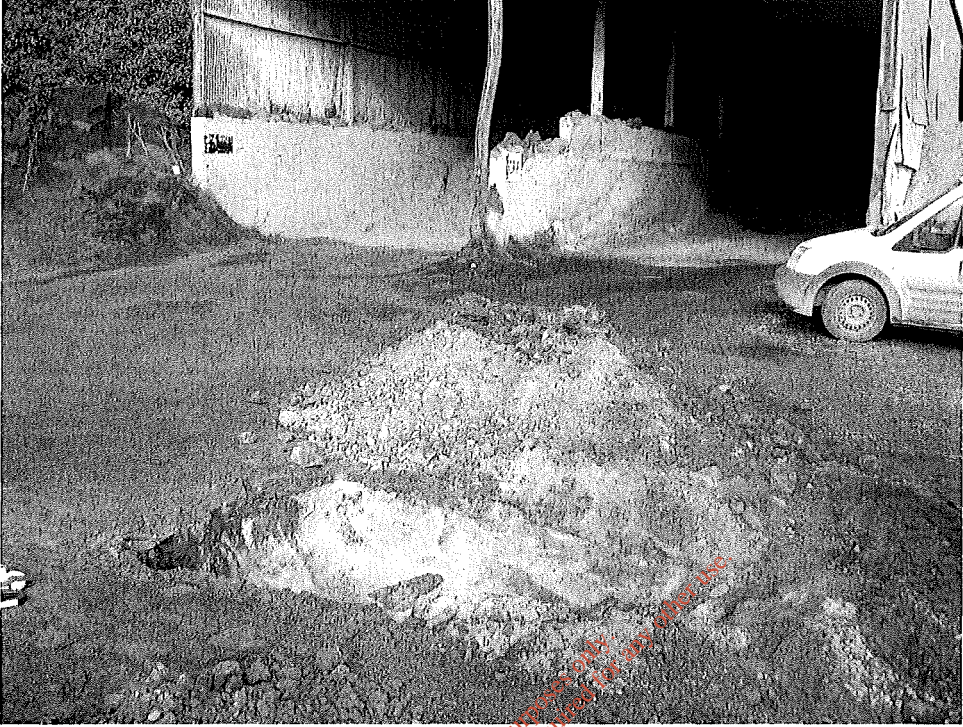
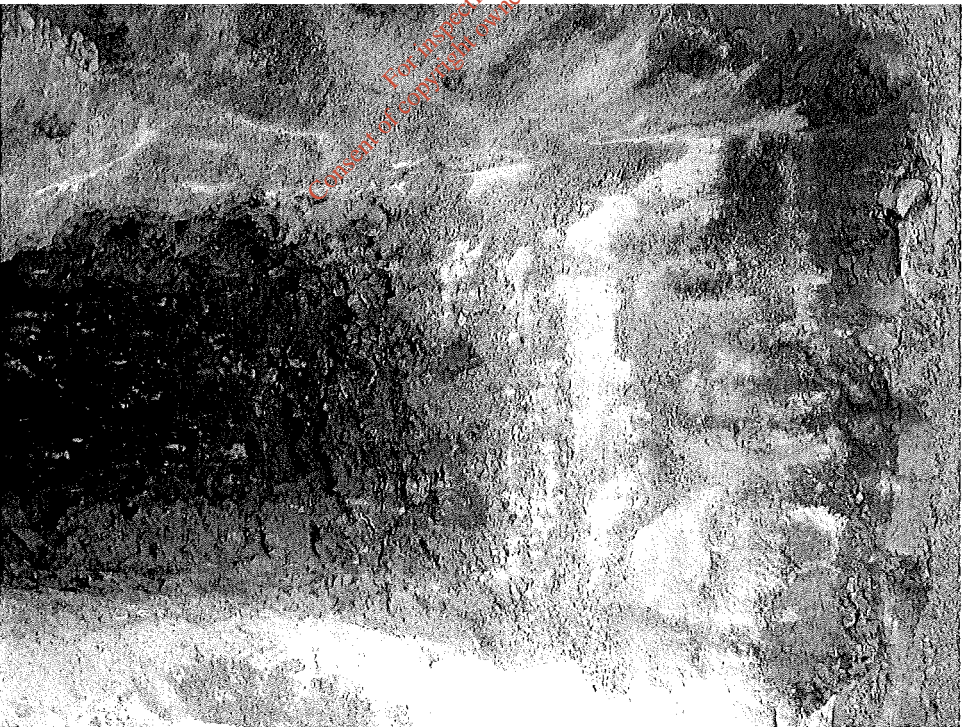
<p>Project Name: Milverton Ground Investigation. Location: Milverton Date: December 2008</p>	<p>Trial Pit No. MTP4</p>

Samples & In Situ Testing				Depth (m)	Level (m AOD)	Legend	Stratum Description
Depth (m)	Type	Waterstrike	Results				
				0.70			Crushed Rock Fines (CRF) (MADE GROUND)
				1.20			Crushed Aggregate fill material (MADE GROUND)
				2.20			Brown gravelly CLAY (MADE GROUND)
							Trialpit Complete at 2.20 m

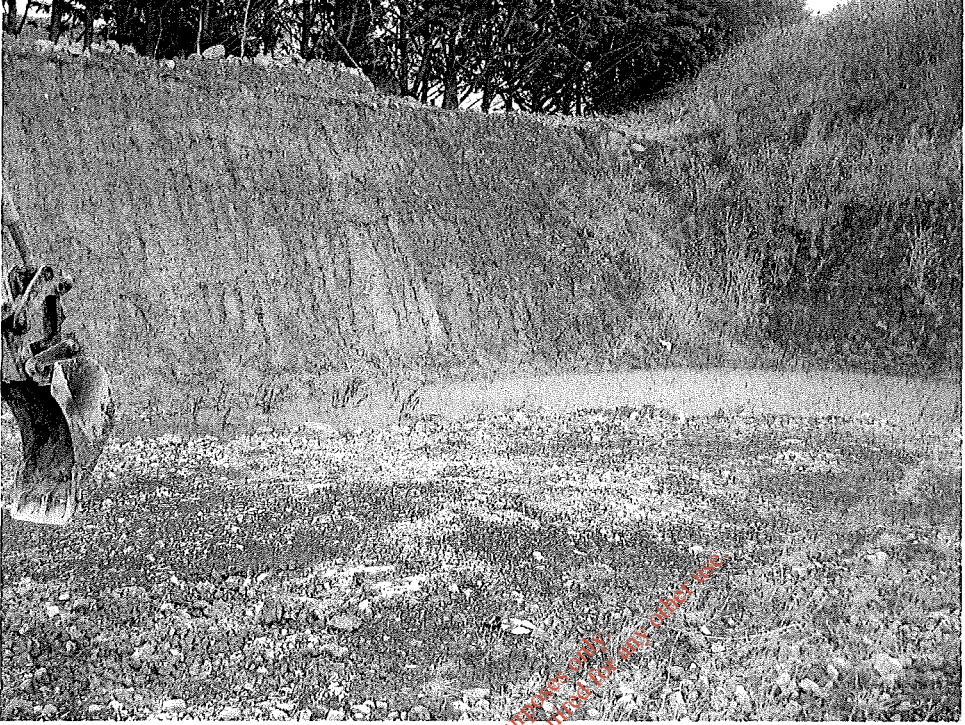
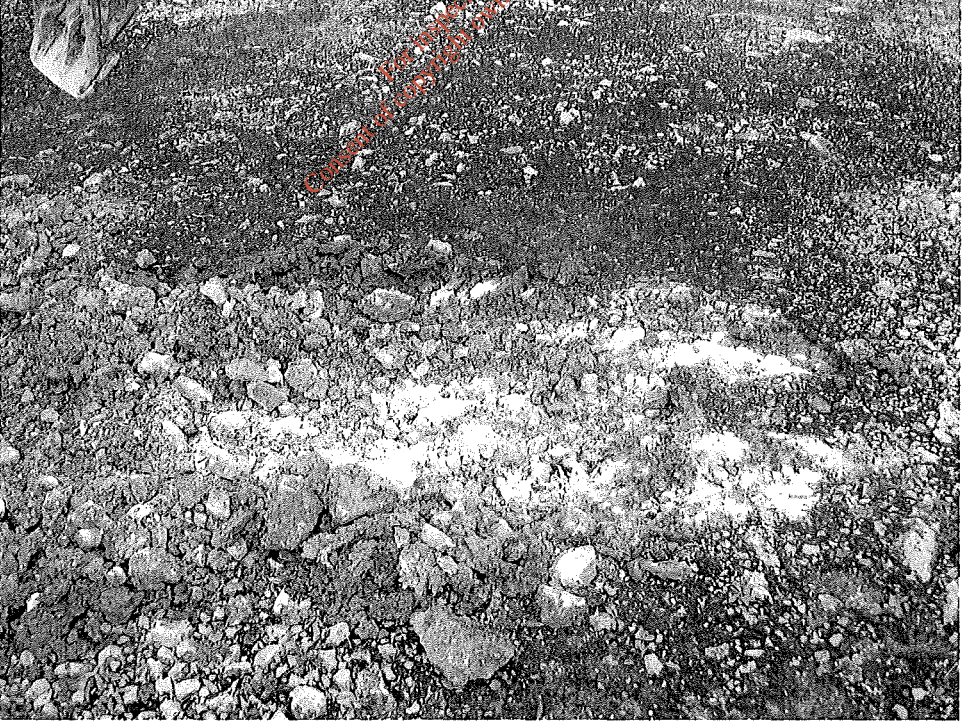
<p>Project Name: Milverton Ground Investigation. Location: Milverton Date: December 2008</p>	<p>Trial Pit No. MTP6</p>

Samples & In Situ Testing				Depth (m)	Level (m AOD)	Legend	Stratum Description
Depth (m)	Type	Waterstrike	Results				
0.10				0.10			LIMESTONE (LIMESTONE BEDROCK) Trialpit Complete at 0.10 m
1				1			
2				2			
3				3			
4				4
