**SILLIOT HILL INTEGRATED WASTE MANAGEMENT  
FACILITY, KILCULLEN, COUNTY KILDARE**

**WASTE LICENCE REF. W0014-01**

**ANNUAL ENVIRONMENTAL REPORT – 2008**

Abstract: This report presents the monitoring results for Silliot Hill Integrated Waste Management Facility to the Environmental Protection Agency. The report covers the annual reporting period of 2008.

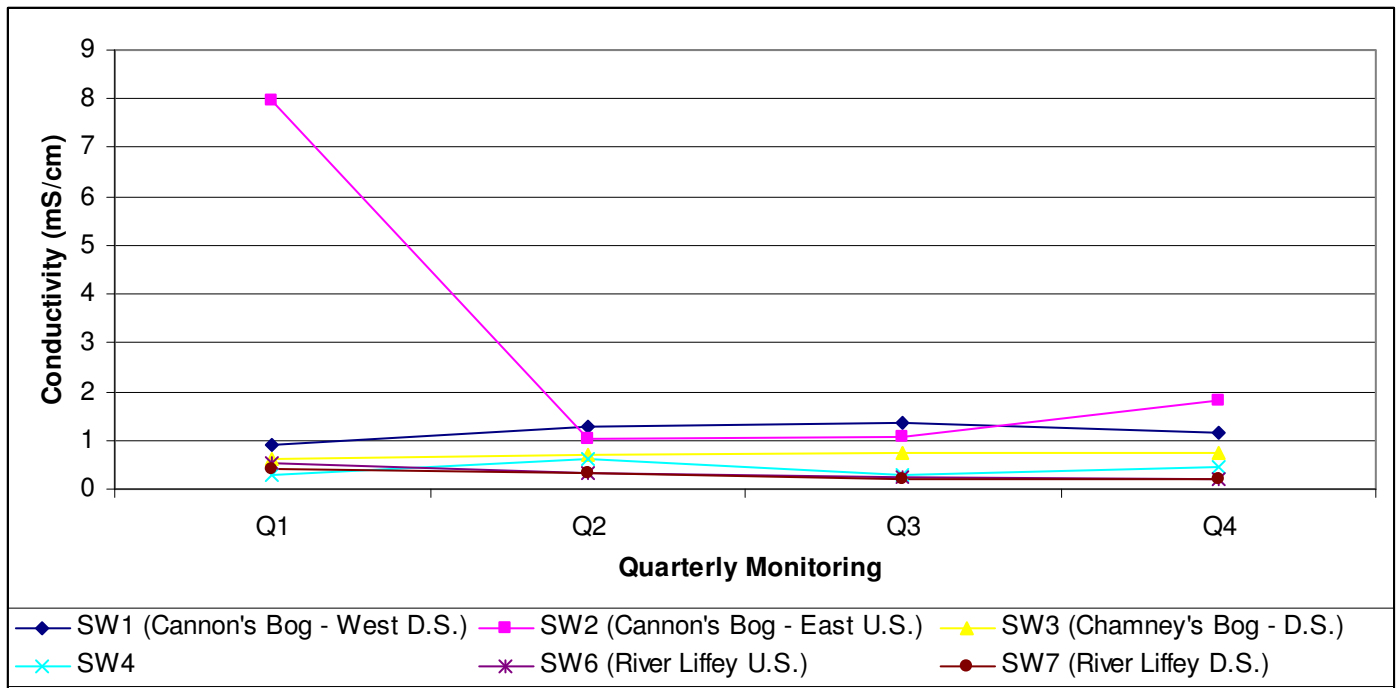
**Figure 5.3: Conductivity at Surface Water Monitoring Points (2008)**

The above figure indicates a possible impact from the landfill for SW1 and SW2. However, these surface water channels are known to receive inputs from an industrial estate outside Kilcullen which is upstream of the landfill and thus may have contributed to the quality downstream. There is no discernable deterioration of the River Liffey at the downstream monitoring point SW7.

SW1 and SW2 have higher indicator values than those of SW3, SW4, SW6 and SW7. Two of these parameters, conductivity and chloride are plotted for quarterly data in Figures 5.3 and 5.4 respectively. These parameters were chosen because they are indicators of leachate impact, but they also may demonstrate impact by other sources, such as sewage or industrial effluent.

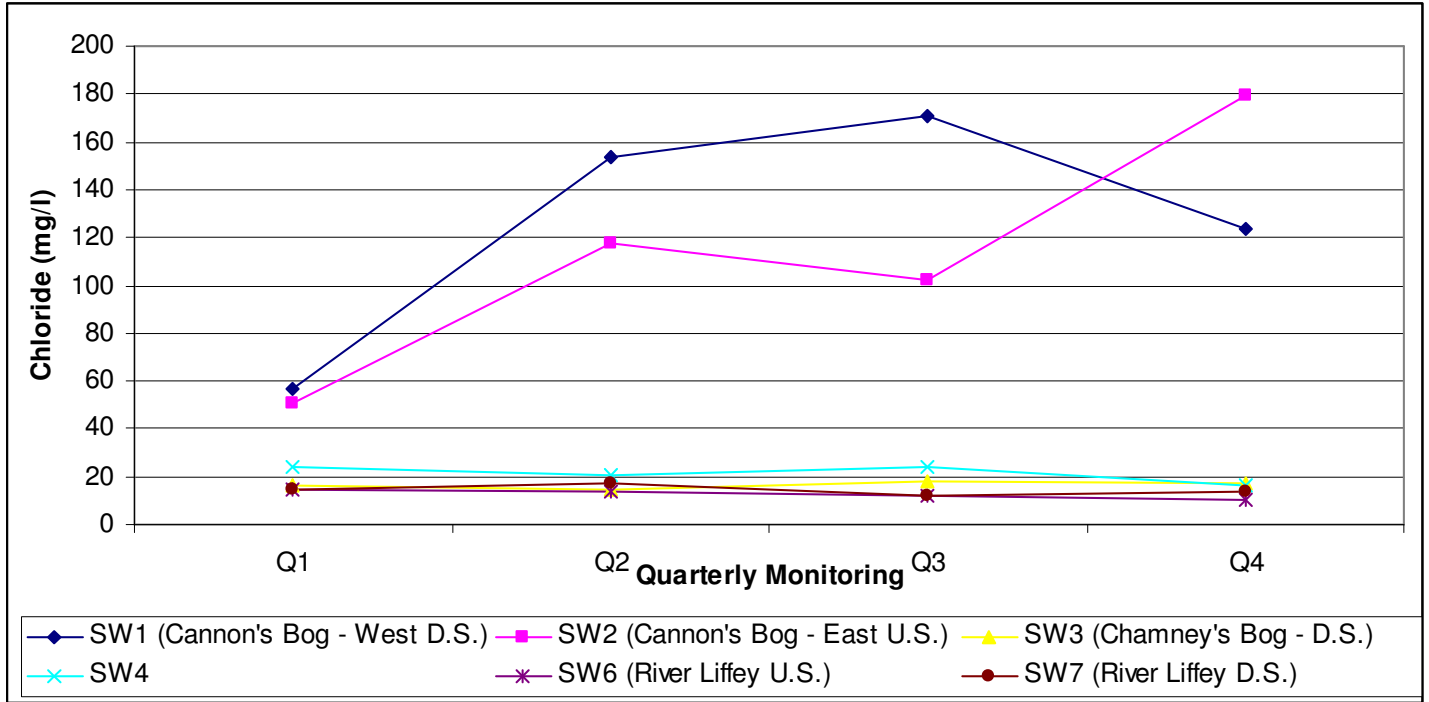
**Figure 5.4: Chloride at Surface Water Monitoring Points (2008)**

The elevated levels of Chloride are caused by the same pollution sources as those that raise the conductivity.

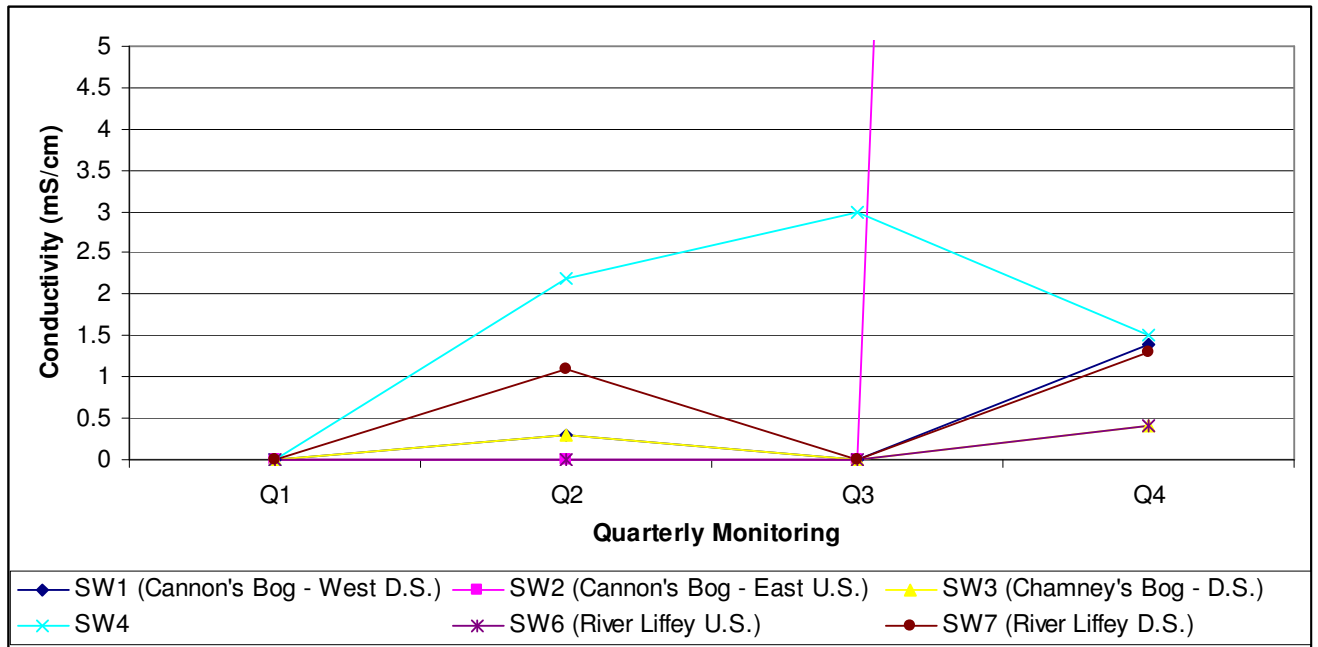
**Figure 5.5: Ammoniacal Nitrogen at Surface Water Monitoring Points (2008)**

Levels of ammoniacal nitrogen as an indicator of pollution were also examined over the year. In contrast to 2007 surface water has shown levels of ammoniacal nitrogen above the MAC of 0.23 mg/l. The raised levels at location SW4 is likely to be owing to the high organic content of the water at this site. The raised level at SW7 is from an unknown source.

There was an excursion at SW2 in Q4. No cause has been attributed to this and it is being monitored in 2009, it is however upstream of the

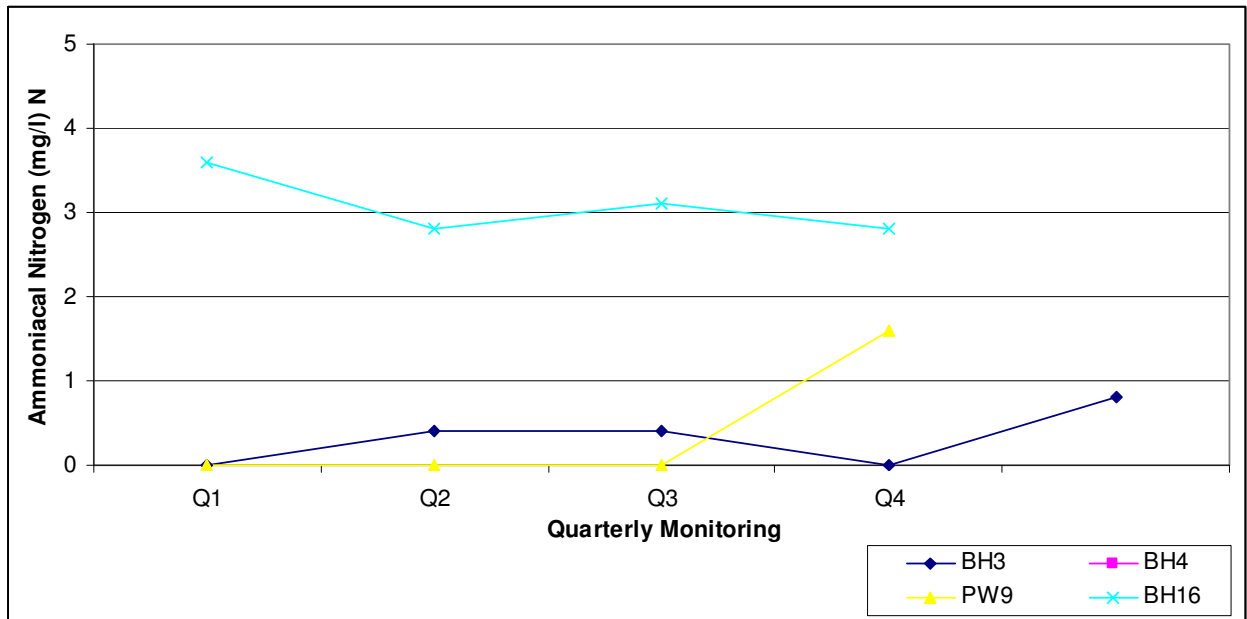
Figure 5.7: Ammoniacal Nitrogen Levels at Downgradient Groundwater Monitoring Points (2008)

The contamination resulting from the unlined portion of the landfill does not extend a significant distance from the landfill, as shown by the results from Quarter 1 recorded in the well BH11D which is located greater than 100m south of the landfill.

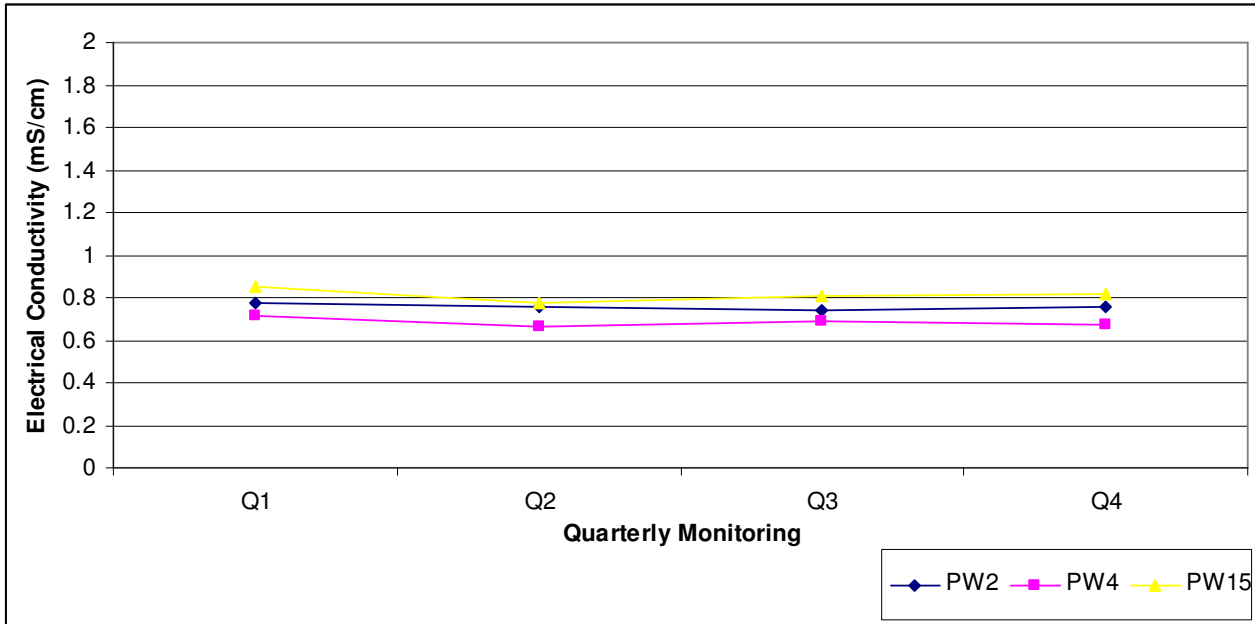
**Figure 5.8: Conductivity Levels at Upgradient Groundwater Monitoring Points (2008)**

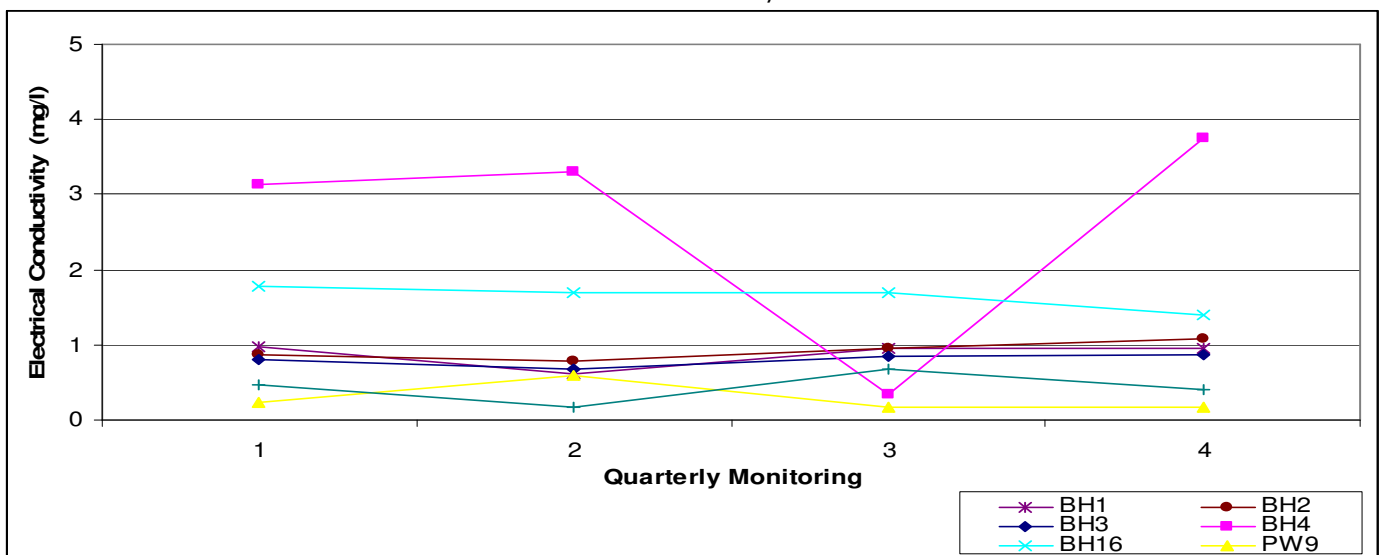
**Figure 5.9: Conductivity Levels at Downgradient Groundwater Monitoring Points (2008)**

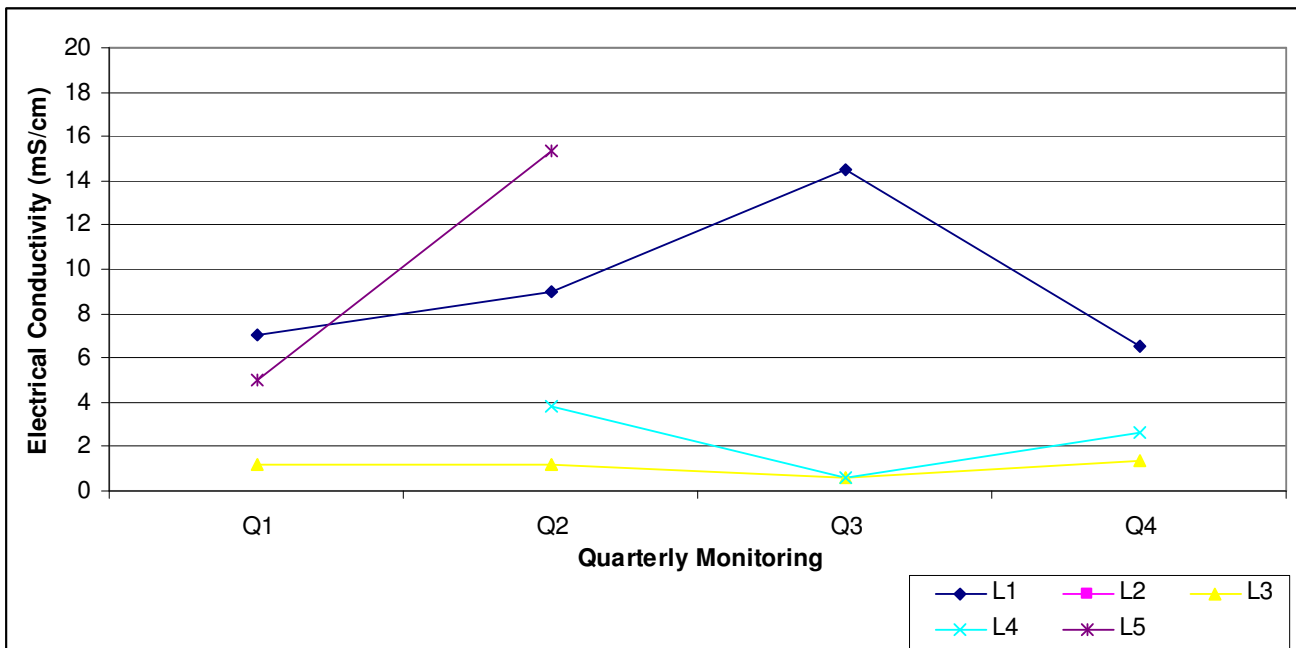
**Figure 5.10: Conductivity Levels at Leachate Monitoring Points (2008)**

The results for L3 & L4 indicate a more attenuated leachate than that found at the other leachate monitoring points. L3 also has a high total coliform count.

Figure 5.9 shows the levels of conductivity measured at leachate wells throughout the year and these are typical concentrations for leachate. Construction works on the landfill cap interfered with the performance of L2, L5 and L6. This work has prevented a complete set of samples being taken.

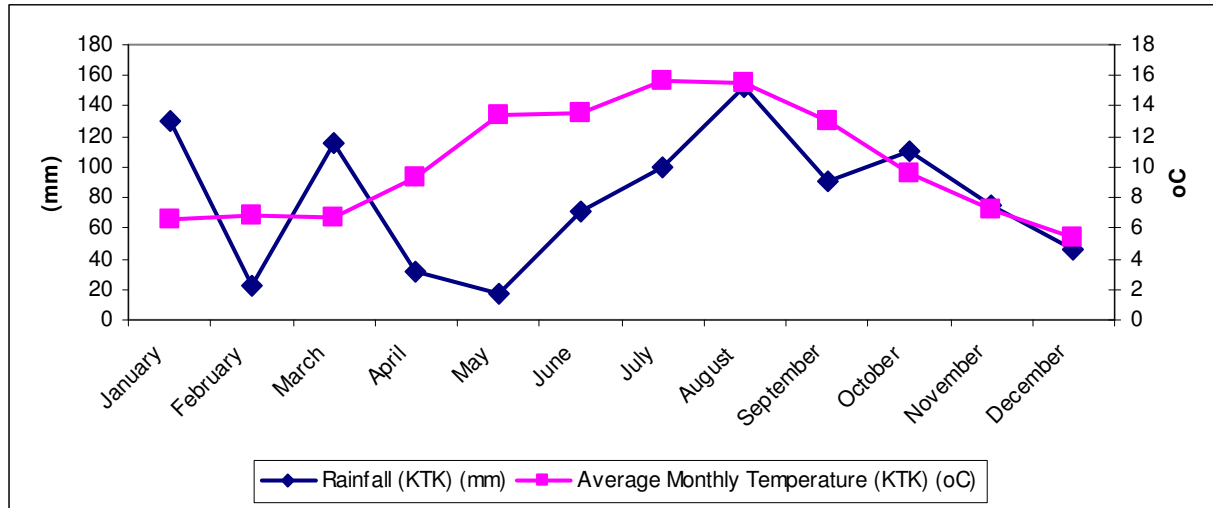
Figure 5.18: 2008 Rainfall and Temperature
