# **Environmental Impact Statement for Ballymurtagh Landfill**

Volume 2  
Main EIS Document

November 2009

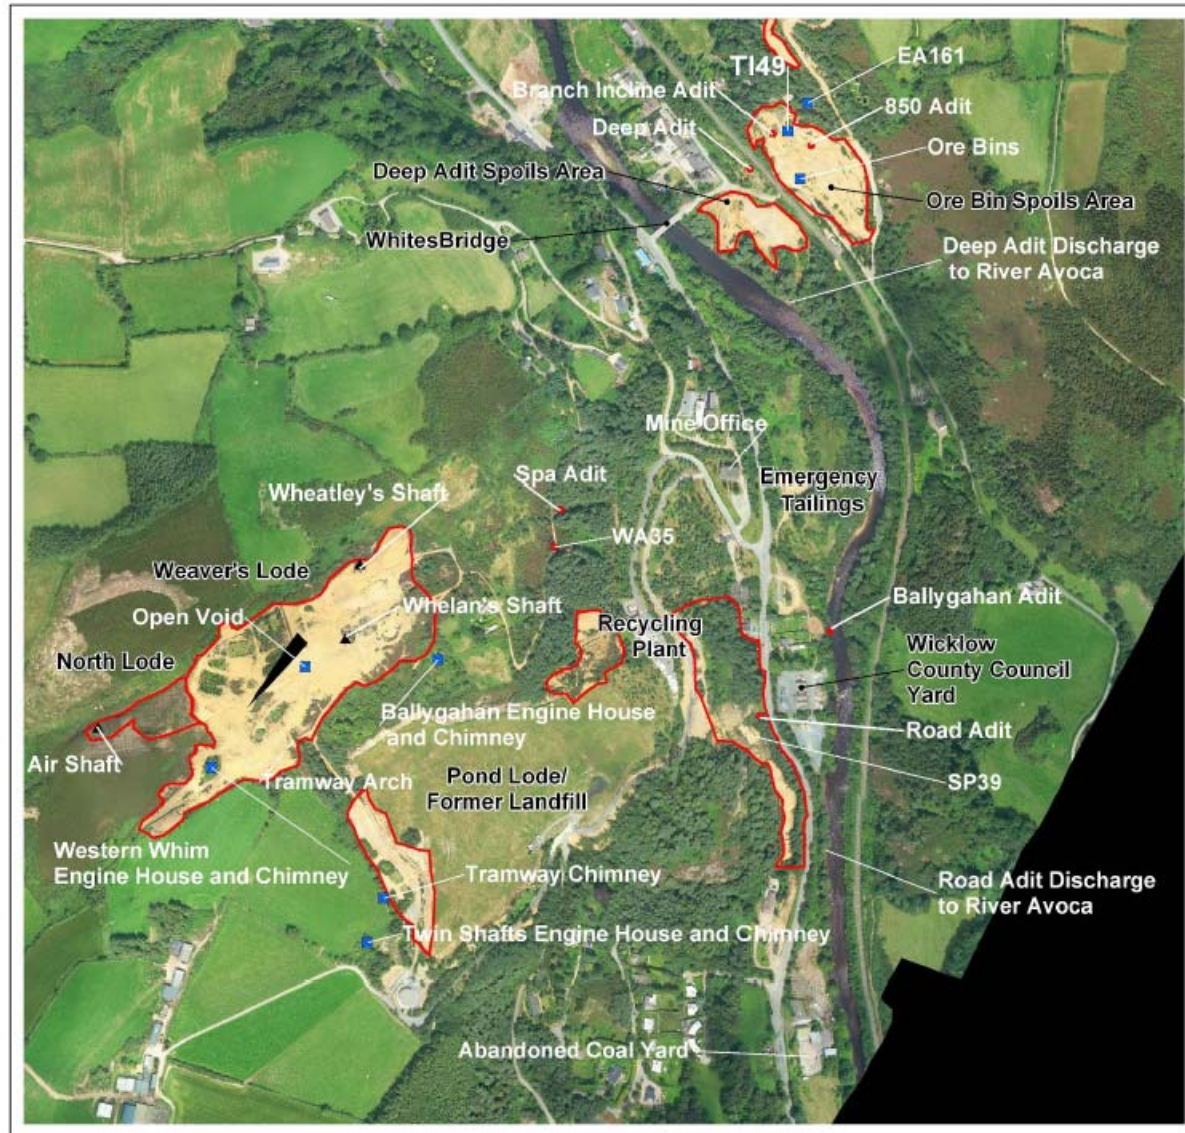
Figure 5-2: Location of spoil heaps in West Avoca (From CDM, 2008)

Mine spoils and tailings are a prominent feature of the Avoca Mining Area. In West Avoca, spoils and tailings cover a total area of about 10 hectares. Spoils are present immediately downgradient of the landfill, as fill material, between the Civic Waste Facility and the Avoca-Rathdrum road. The present locations of spoil heaps (and other mining-related features) in West Avoca are shown in **Figure 5-2**, while the volumes and areas of different spoils heaps are presented in **Table 5-3** (CDM, 2008).

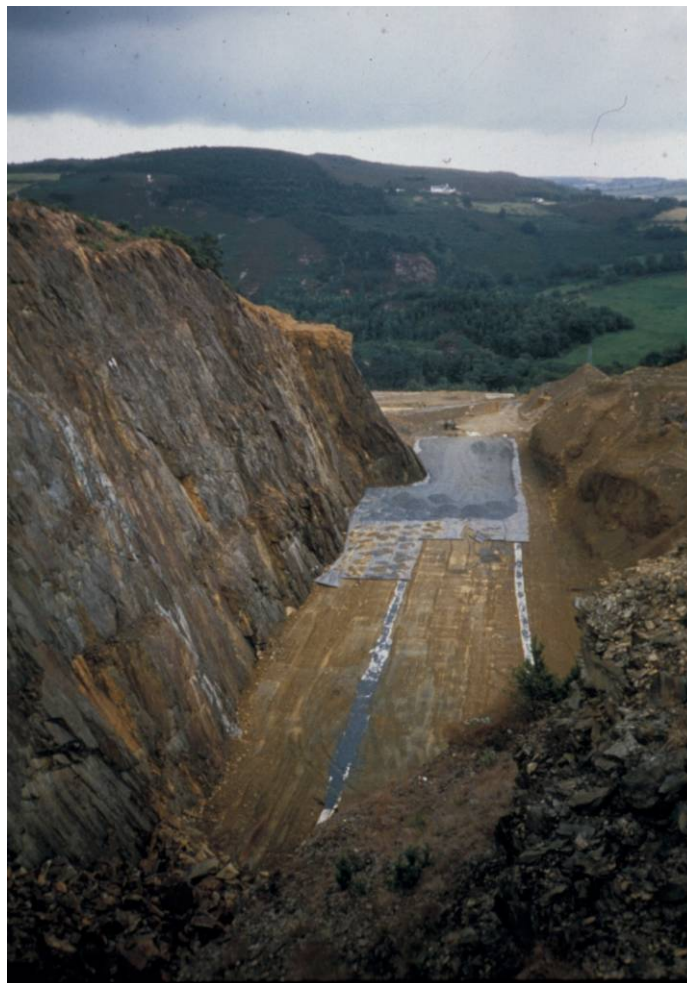
Based on available information (RPS, 1998; Kevin T Cullen, 1987), the entire base of the landfill is covered with mining tailings. As well, there is evidence that at least the lower part of the landfill was lined with a butyl rubber 'mat'. The low-permeability, silt-grade mine tailings were deposited and spread over the rubber as suggested by the photograph included in **Figure 7-2**. Whether or not the rubber liner covers the entire floor of the open pit has not yet been possibly to verify.

Figure 7-2: Rubber liner and mine tailings in Pond Lode Pit

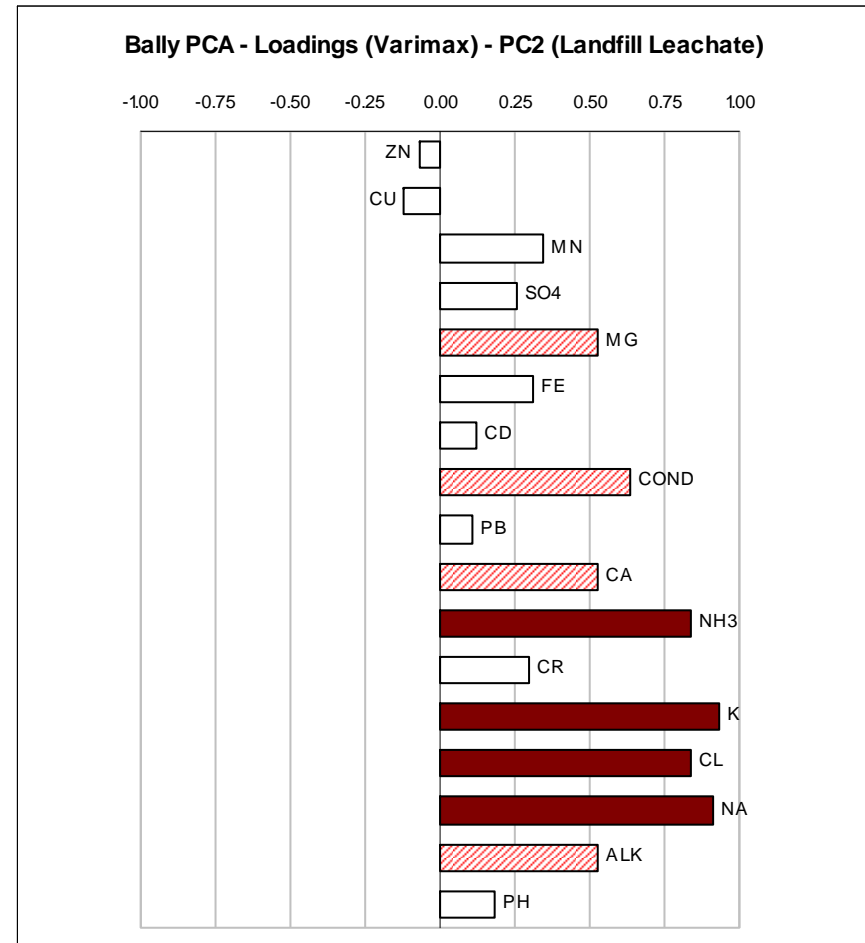
Figure 7-7: PCA – Loadings (Varimax) – PC2 (Landfill Leachate). Solid bars > 0.75, hachured bars > 0.50 to 0.75, and open bars < 0.50

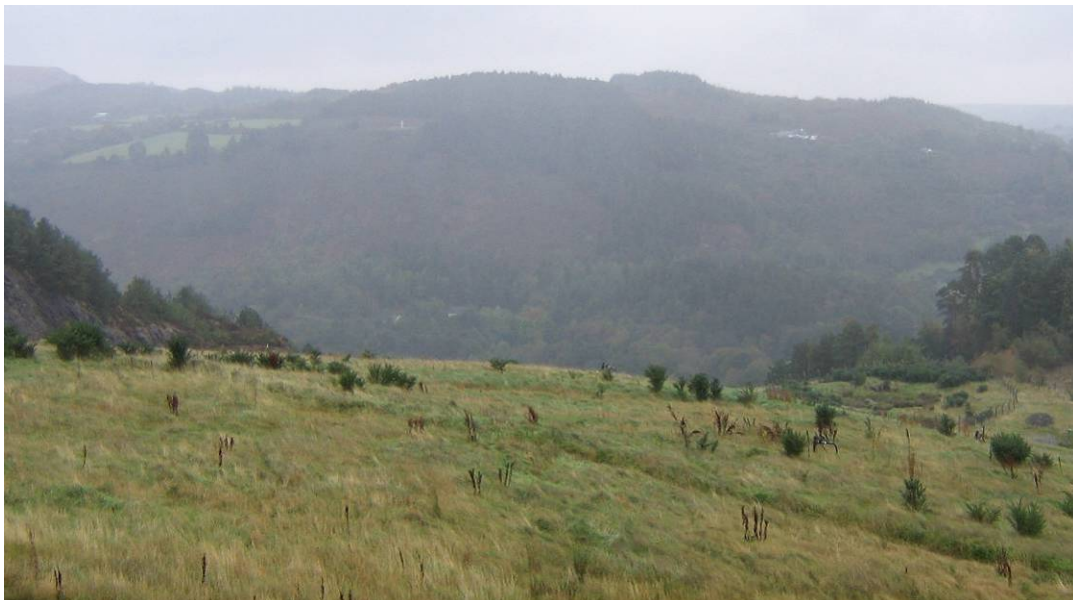
Following closure of the Ballymurtagh landfill in 2002, a restoration and aftercare plan was prepared to address closure, aftercare and long term management of the facility (RPS, 2002). In 2006 the restoration of the landfill was carried out, planting the final configuration with ecologically appropriate species, tolerant to the site conditions as woodland, heathland and wild grasses. The restored landfill is mainly a grassland habitat, as shown in **Figure 8-1**.

*Figure 8-1: Photograph of Restored Landfill Showing Established Grassland Habitat (Oct, 2009)*

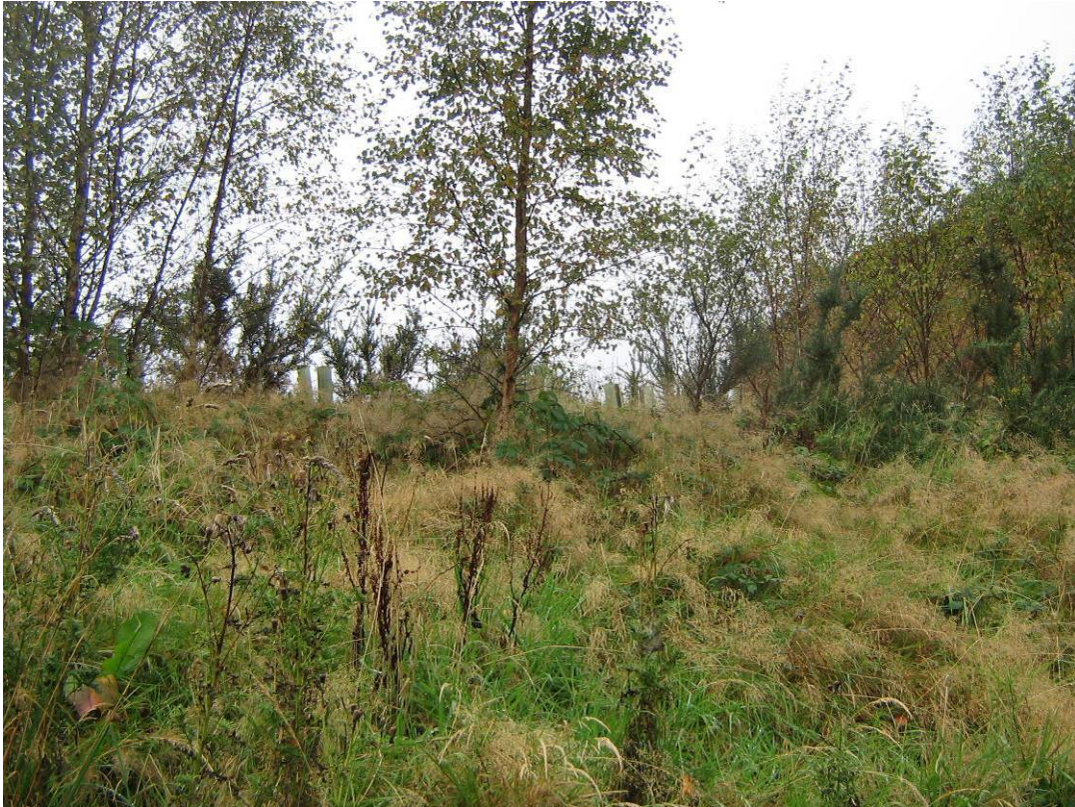
The front slope of the landfill has nutritionally richer soil and recent tree planting has occurred as shown in **Figure 8-3**. The upper trees are planted along a new bank and the water drains and accumulates towards the south. This allows floating sweet grass (*Glyceria fluitans*), jointed rush (*Juncus articulatus*) and a single plant of pendulous sedge (*Carex pendula*) into the vegetation.

Figure 8-3: Photograph Showing Established Vegetation on the Lower Slope and Recent tree Planting (Oct, 2009)

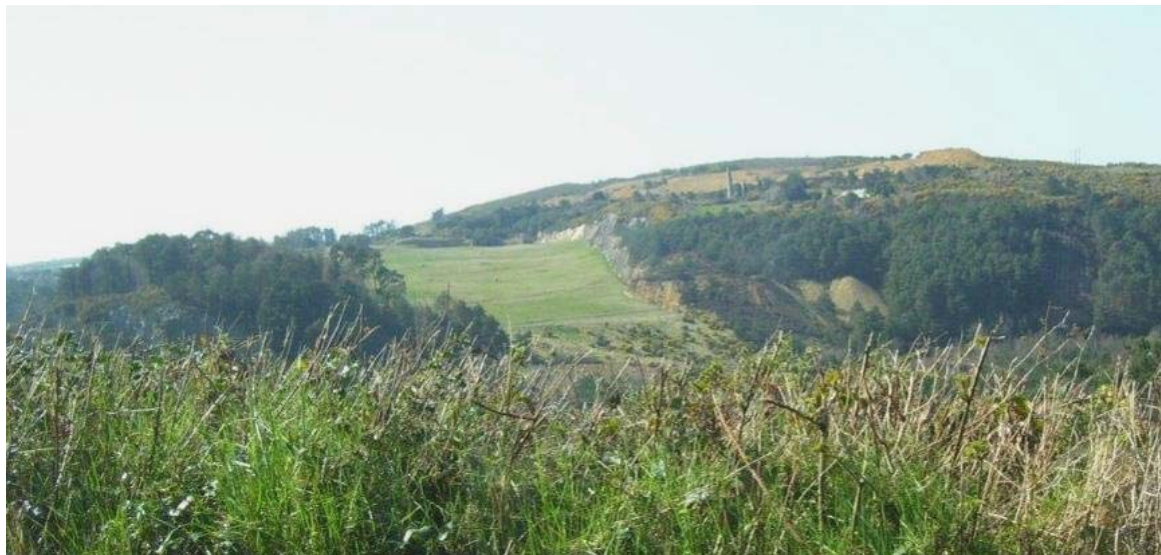
*Figure 10-1: Views into the Ballymurtagh Landfill Site, from the West Facing Slopes of Avoca Valley*

There are short distance views into the site from the Avoca to Rathdrum road. The site however is well screened by trees and blends quite naturally into the surrounding landscape. There are long distance views into the site from the west-facing slopes of the hills located further to the east, as shown in **Figure 10-1**.
