Meath Waste Management Facility

**Factual Ground Investigation Report
(Project No. 14039)**

**Meath Waste Management Facility
Carranstown, Duleek, Co. Meath**

**Factual Geotechnical Investigation Report
(Report No. 14039)**

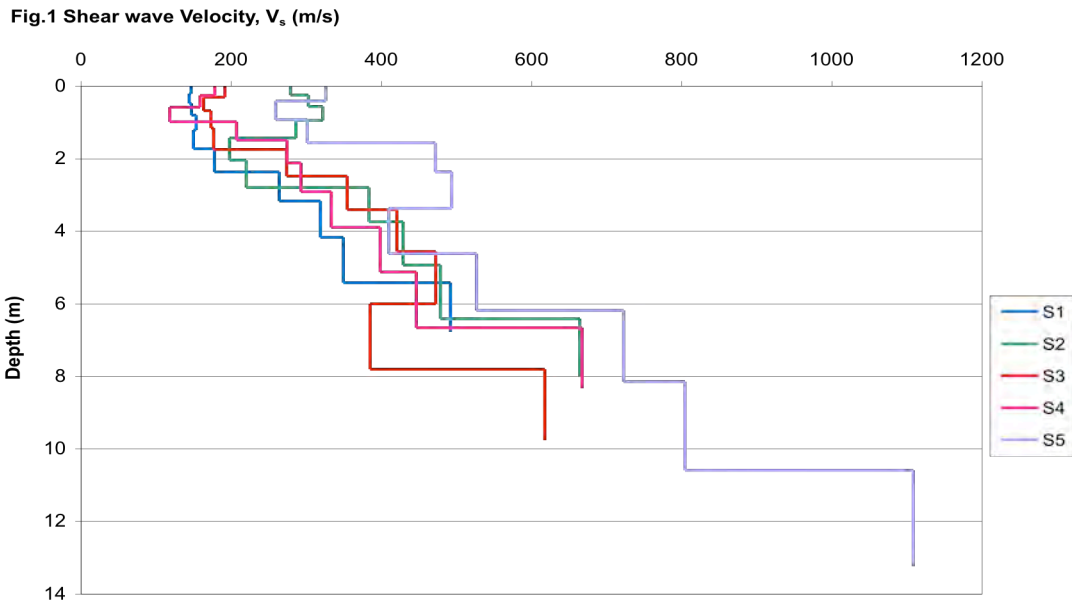
Figure 2 – Shear Wave Velocities v Depth

Surface wave velocities (Rayleigh waves) were measured by Apex Geoservices at five spread locations using an array of geophones at designated spacings. The shear wave velocity data (V_s) was used to derive small strain shear modulus or stiffness values (G_{max}) with depth. The shear wave velocity and small strain stiffness plots have been combined and are presented in Figures 2 and 3 respectively. The shear wave velocities increase with depth and this data can be used to derive Bulk Modulus, Youngs Modulus, Poisson's Ratio and G_{max} . Values of dynamic moduli (G_{max}) are typically an order of magnitude *greater* than static values, established by routine in-situ testing. Ground strains are generally accepted to be $< 0.1\%$ and therefore small strain stiffness values can be used to make reasonable predictions of deformations (Jardine et al. 1986). The Apex geophysical report presents values of V_s , V_p , Density, Poissons Ratio, Youngs Modulus (dynamic & static) and Bulk Modulus.

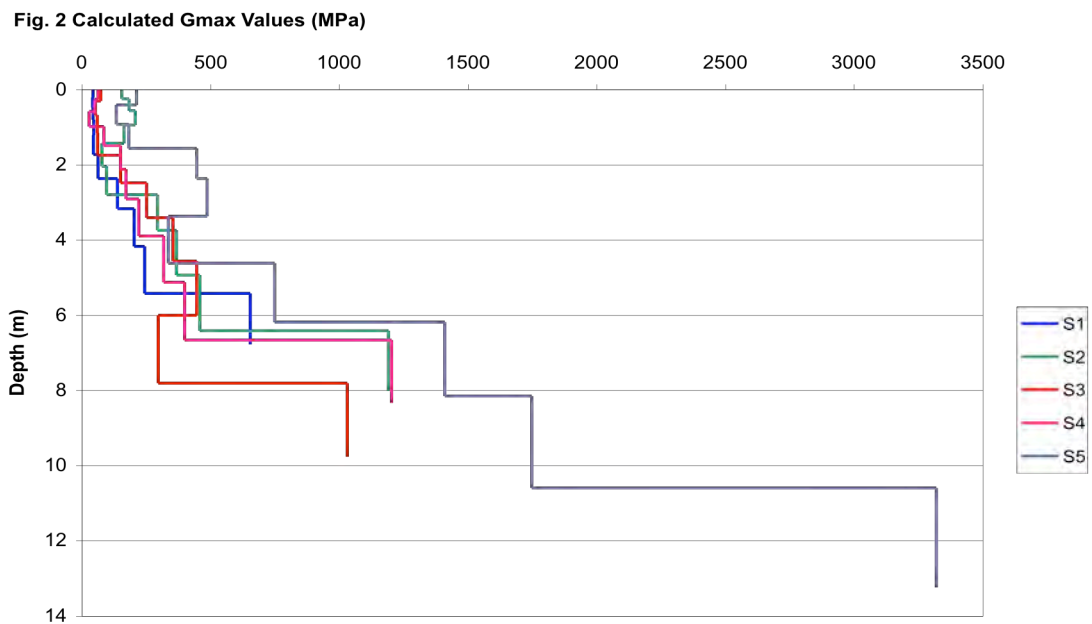
Figure 3 – Small Strain Stiffness (G_{max}) v Depth

The data shows of G_{Max} values in the upper glacial soils typically ranging from around 50 MPa to 150 MPa (firm / stiff boulder clay), increasing to 500 MPa in the very stiff till /upper variably weathered bedrock. The variations in the small strain stiffness values correlate well with the variations in soil composition as indicated by the Geobor core recovery. There is a noticeable 'kick' at a depth of approximately 5 to 6m, this correlates with the core drillhole data (GC 1 to 5) where rockhead was confirmed at depths of 5.30 to 8.00m.
