**Monitoring of Daytime  
Noise Levels at the  
Milltown Compost Site Milltown  
Mor, Fethard  
Co. Tipperary.  
October 2008**

***ANNUAL BIOAEROSOL MONITORING***  
***AT THE***  
***MILLTOWN COMPOST SITE,***  
***MILLTOWN MOR, FETHARD,***  
***Co. TIPPERARY.***  
***OCTOBER 2008***

**Archaeological Damage Assessment  
For Application for Retention of  
Planning Permission at MilltownMore,  
Rosegreen, Cashel, Co. Tipperary.**

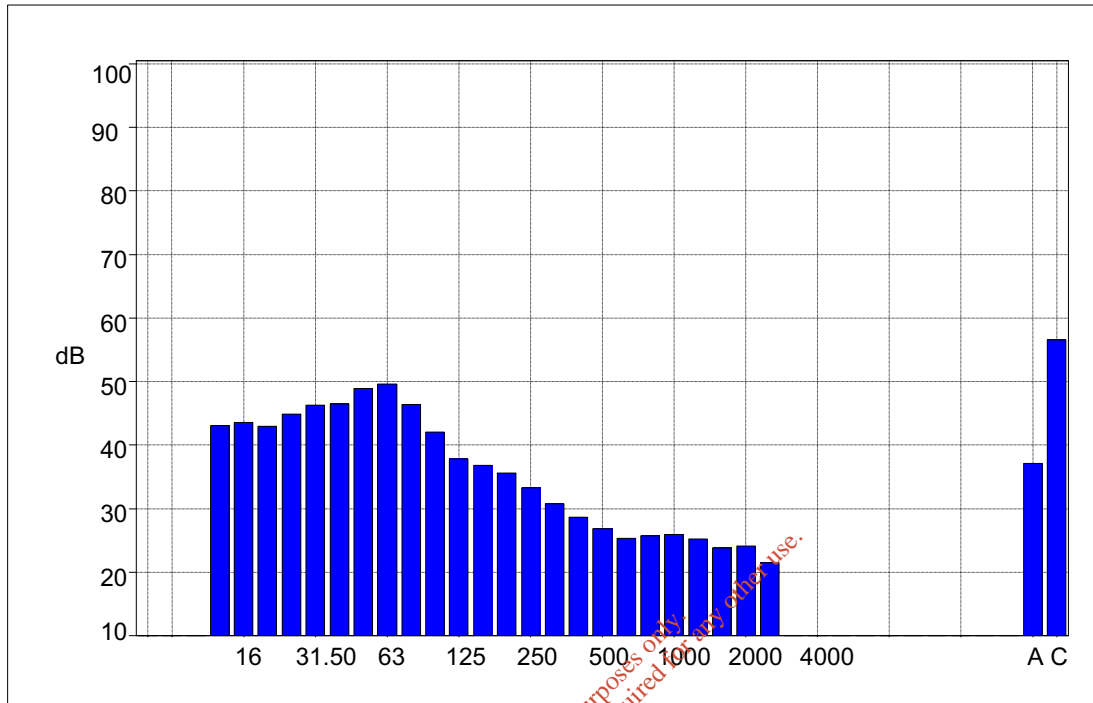
**Sensitive Receptor N1 - Tonal Graph**

Throughout the monitoring period the composting operations were in progress. The  $L_{Aeq}$  result of 40dB is not considered significant and is well below the recognised daytime limit of 55 dB (A) for industrial units. The NSL is located a further 200 – 300 meters from this location and it can therefore be assumed that the noise from the facility will not impact on the NSL. No tonal noise observed (See Appendix 1 for tonal graph)

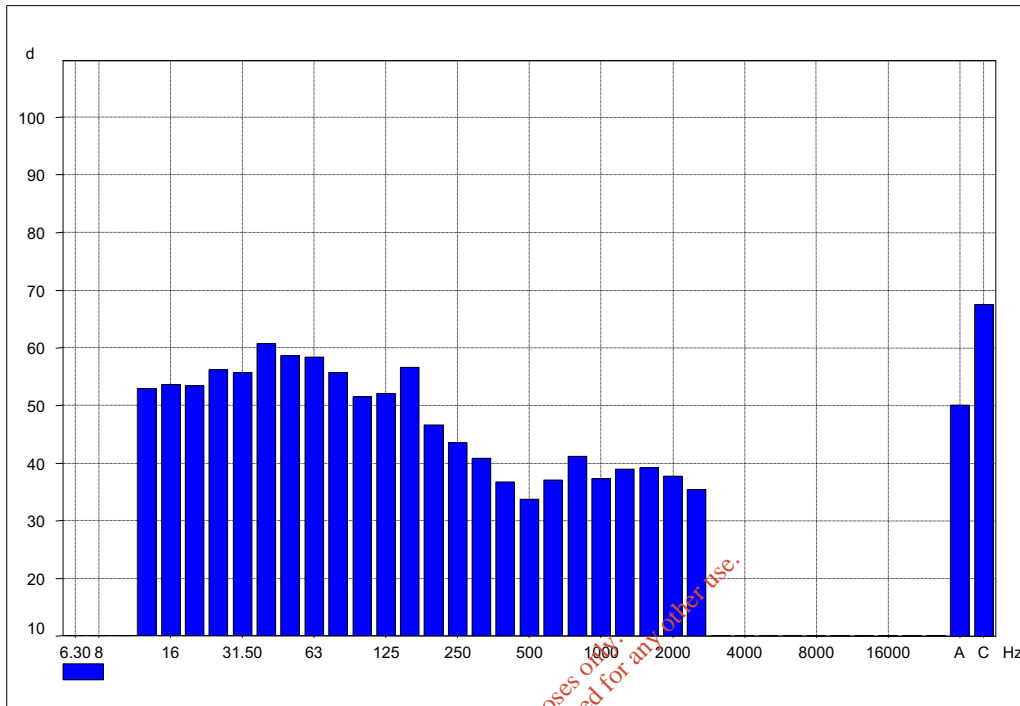
**N2 - Tonal Graph**

Throughout the monitoring period the composting operations were in progress. The  $L_{Aeq}$  result of 50dB is not considered significant and is well below the recognised daytime limit of 55 dB (A) for industrial units. The NSL is located a further 500 – 600 meters from this location and it can therefore be assumed that the noise from the facility will not impact on the NSL. No tonal noise observed (See Appendix 1 for tonal graph)

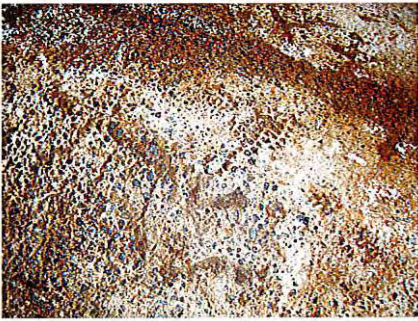
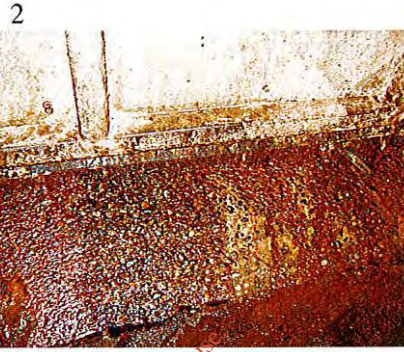
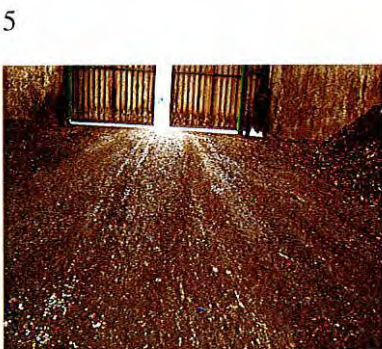
Appendix 1  
1

Based upon the above assessment and descriptions the structures are considered sound for the purpose of containment of leachate or sewage.

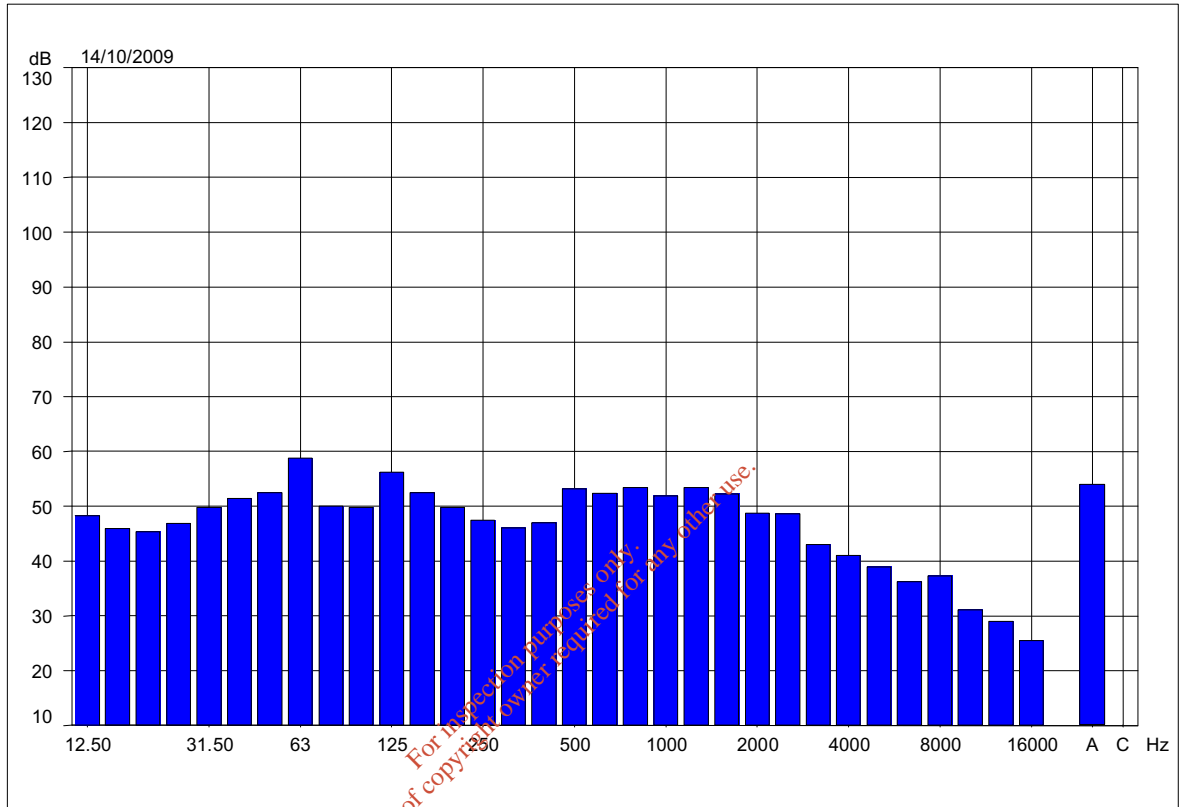
Sensitive Receptor N1 - Tonal Graph

The  $L_{Aeq}$  recorded at this location of 52 dB (A) is within the day time limit of 55 dB (A) as stipulated in the waste permit. Tonal noise was observed at 63 Hz on the 1/3 Octave band analysis graph (See Appendix 1 for tonal graph). The source of this tonal noise was a tractor spreading slurry in an adjacent field. The  $L_{AFMax}$  was as a result of a tractor passing by the monitoring location. No compost site operations were audible during the monitoring period.

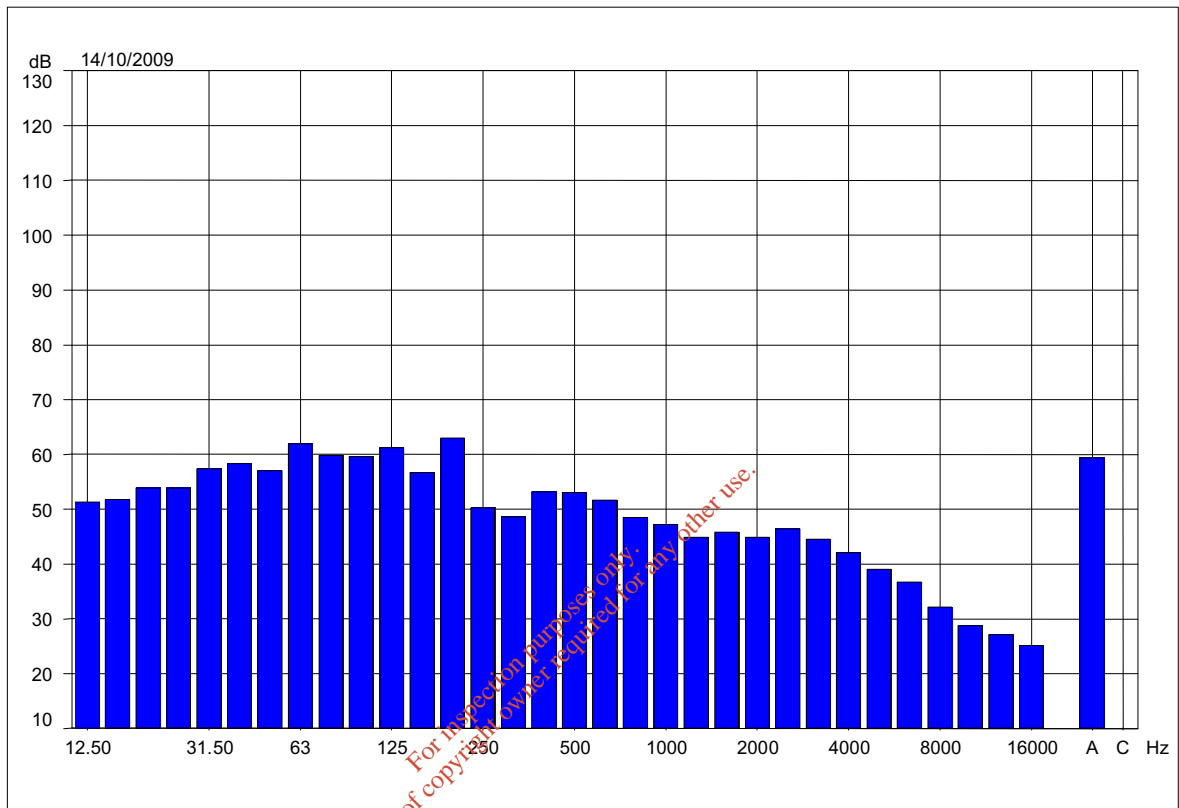
### N2 - Tonal Graph

Throughout the monitoring period the composting operations were in progress. The  $L_{Aeq}$  result of 60dB is influenced by the fans located around the base of the processing buildings, the results for the  $L_{10}$  and  $L_{90}$  of 60 and 59 dB (A) indicate that the fans are the main noise contributors at this location. Tonal noise was observed at 200Hz on the 1/3 octave band analysis graph (See Appendix 1 for tonal graph)
