RE: 2008 Annual Environmental Report - Greenstar Ltd. - Knockharley Landfill (Reg. No. W0146-01)

ANNUAL ENVIRONMENTAL REPORT
FOR
GREENSTAR LTD.
KNOCKHARLEY LANDFILL
LICENCE NO. W0146-01
JANUARY – DECEMBER 2008

Greenstar Ltd.,
Knockharley Landfill,
Knockharley,
Co. Meath.

O' Callaghan Moran & Associates,
Granary House,
Rutland Street,
Cork.

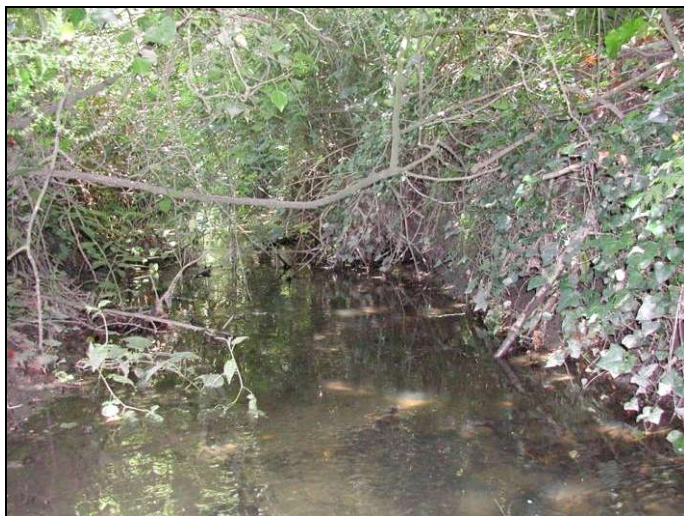
Plate 1 Knockharley Stream downstream receptor site (Site 1).

A total of 14 different macroinvertebrate families were recorded from this site, a significant increase from the previous survey when 9 families were recorded. Cased trichopteran/caddisfly larvae were well represented with fair numbers of the northern caddisfly *Limnephilus lunatus* while both the black caperer *Sericostoma personatum* and *Goera pilosa* were scarce. Caseless larvae of the trumpet-net caddisfly *Plectrocnemia conspersa* were present. True fly larvae of the midge and the green chironomid were found in small numbers and present, respectively. Freshwater shrimp *Gammarus deubeni* was numerous while another crustacean, the hog louse *Asellus aquaticus* was less abundant being common. The only snail recorded was the pea mussel of which there were small numbers. Worms in the groups Oligochaeta, Nematoda (roundworms) and Platyhelminthes (flatworms) were all present. The leeches *Glossiphonia complanata* and *Erpobdella octoculata* were scarce and present, in that order. An aquatic weevil was the only member of the beetle family found and this was present.

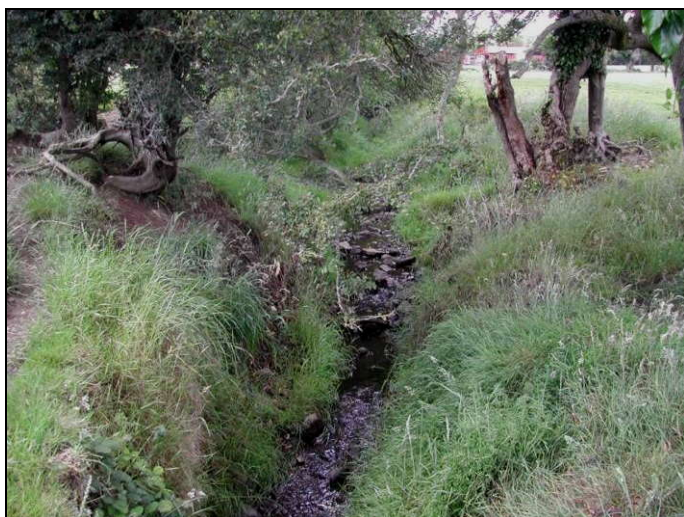
Plate 2 Knockharley Stream upstream control site (Site 2).

Along with three-spined stickleback *Gasterosteus aculeatus*, macroinvertebrates in 15 different families were recorded at this site. However, no group 'A' or group 'B' pollution indicators were recorded. True flies were the most diverse group with 5 taxa at larval stage recorded; midge (common), green chironomid (present), crane fly/Tipulid (common), *Dicranota* sp. (present) and moth fly/Psychodidae (present). The hog louse and freshwater shrimp were numerous and scarce, correspondingly. Fair numbers of pea mussels were recorded. Small numbers of the river limpet *Ancylus fluviatilis* were recorded and the wandering snail *Lymnaea peregra* was scarce. Flatworms and water mites were found in small numbers while oligochaete worms were present. The leeches *Glossiphonia complanata* and *Erpobdella octoculata* were both scarce with *Haemopsis sanguisuga* being present. Also present was a diving beetle in sub family Colymbetinae (*Agabus* sp.) and a water scavenger beetle in subfamily Helophorinae (*Helophorus* sp.).

The water quality of the control site on the Knockharley Stream has gradually deteriorated since 2005. It was rated as 'Moderately Polluted (Q3) in 2005, 'Seriously Polluted' (Q2-3) in 2007 and currently 'Seriously Polluted (Q2)'. This decline in water quality has also been reflected in the SSRS (small streams risk score) over the two most recent surveys when it fell from 2.4 in 2007 to 0 this year. There was an overall increase in macroinvertebrate diversity at the control site this year but this increase was brought about by an increase of 'very pollution tolerant' organisms. Also, the pollution tolerant hog louse has overtaken the freshwater shrimp in relative abundances since the 2007 survey. Identification of the cause of this pollution is outside the scope of this study but is thought to include agricultural inputs. This site is located upstream of the landfill site and would not be affected by emissions from this facility.

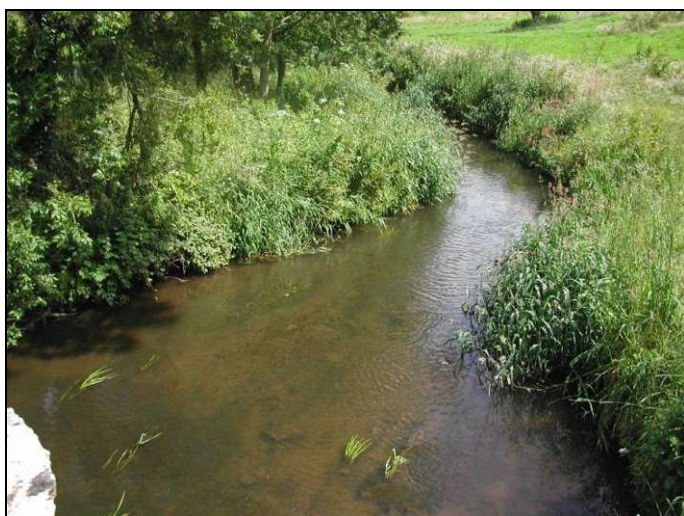
Plate 3 River Nanny downstream receptor site (Site 3).

Three-spined stickleback was the only fish species recorded at this site when sweep netting through the vegetation at the bankside. This site had a diverse macro-invertebrate community with 19 different families recorded. Two species of mayfly were recorded; larvae of the blue-winged olive *Ephemerella ignita* were common while larvae of the large dark olive *Baetis rhodani* were scarce. Larvae of the northern caddisfly *Potamophylax latipennis* was found in fair numbers with *Goera pilosa* in small numbers and the black caperer present (all cased species). Bloodworms or midge larvae were present as were gnat larvae (Culicidae) and caseless caddisfly larvae of the sandfly *Rhyacophila dorsalis*. Freshwater shrimp were numerous and hog louse were found in fair numbers. Small numbers of flatworms were found on the undersides of stones while the leech *Glossiphonia complanata* and the water mite were both scarce. Each of the following organisms were present: water crickets, common whirligig beetle *Gyrinus substriatus*, riffle beetle larvae of *Helmis maugeri*, Oligochaete worms, pea mussels and the leech *Haemopsis sanguisuga*.

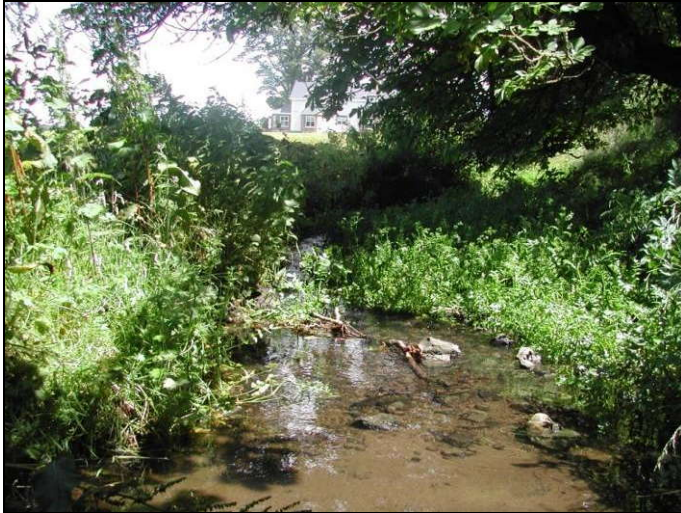
Plate 4 River Nanny upstream control site (Site 4).

In addition to three-spined stickleback, 16 macroinvertebrate families were recorded at this site. Two varieties of Ephemeropteran/mayfly larvae were found; those of the large dark olive in fair numbers with a presence of blue-winged olive larvae. The most diverse group were the caddisflies (Trichoptera) with four cased species and three caseless species recorded. Fair numbers of larvae of the little black caddisfly *Agapetus fuscipes* and the northern caddisfly were recorded with small numbers of the black caper. Northern caddisfly larvae of *Halesus digitatus* were present. The caseless caddisfly larvae composition was sandfly (scarce), trumpet-net caddisfly (present) and grey flag caddisfly (present). Numerous freshwater shrimp were recorded at this site. True fly larvae recorded were green chironomids which were scarce and crane fly larvae of *Dicranota sp.*, the latter being present. River limpets, flatworms and roundworms were generally scarce. The crawling water beetle *Brychius elevatus* and water crickets were both present.

Despite the levels of silt in pools of this reach of the River Nanny, the pollution tolerant group 'E' *Chironomus sp.* and group 'D' hog louse and leeches were not found during the current survey. Though no Class 'A' pollution indicators were recorded at this site, all other factors (macroinvertebrate composition, D.O. at 88.1%, absence of algal growths) indicate that biological water quality is deemed to be at least as good as in the previous survey. Therefore it is rated as being 'Slightly Polluted, Class B (Q3-4)'. The SSRS for this site is 6.4 meaning that this part of the river is in the 'at risk category'. However, this is borderline with the 'probably at risk' category as it is near the threshold of 6.5.

At the control site on the River Nanny, the previously recorded pollution tolerant group 'E' *Chironomus sp.* and group 'D' hog louse and leeches were not found during the current survey. Furthermore, there was an increase in the diversity and relative abundance of group 'B' cased caddisfly larvae (N=4 in 2007 to N=7 in 2008). From the current study, it was found that the water quality of the control site has not changed between 2007 and 2008 and remains 'Moderately Polluted (Q3-4)'. However, there appears to be a slight improvement in water quality but this was not enough to increase the Q-value. The SSRS for this site changed from 5.2 in 2007 to 6.4 in 2008. Should this trend continue, this part of the River Nanny will no longer be in the 'at risk category'. However, this part of the river has some siltation problems and the previously recorded group 'A' heptagenid mayfly larvae *Ecdyonurus sp.* was not recorded in the current survey. This site is upstream from the landfill facility and would not be affected by emissions from this site.

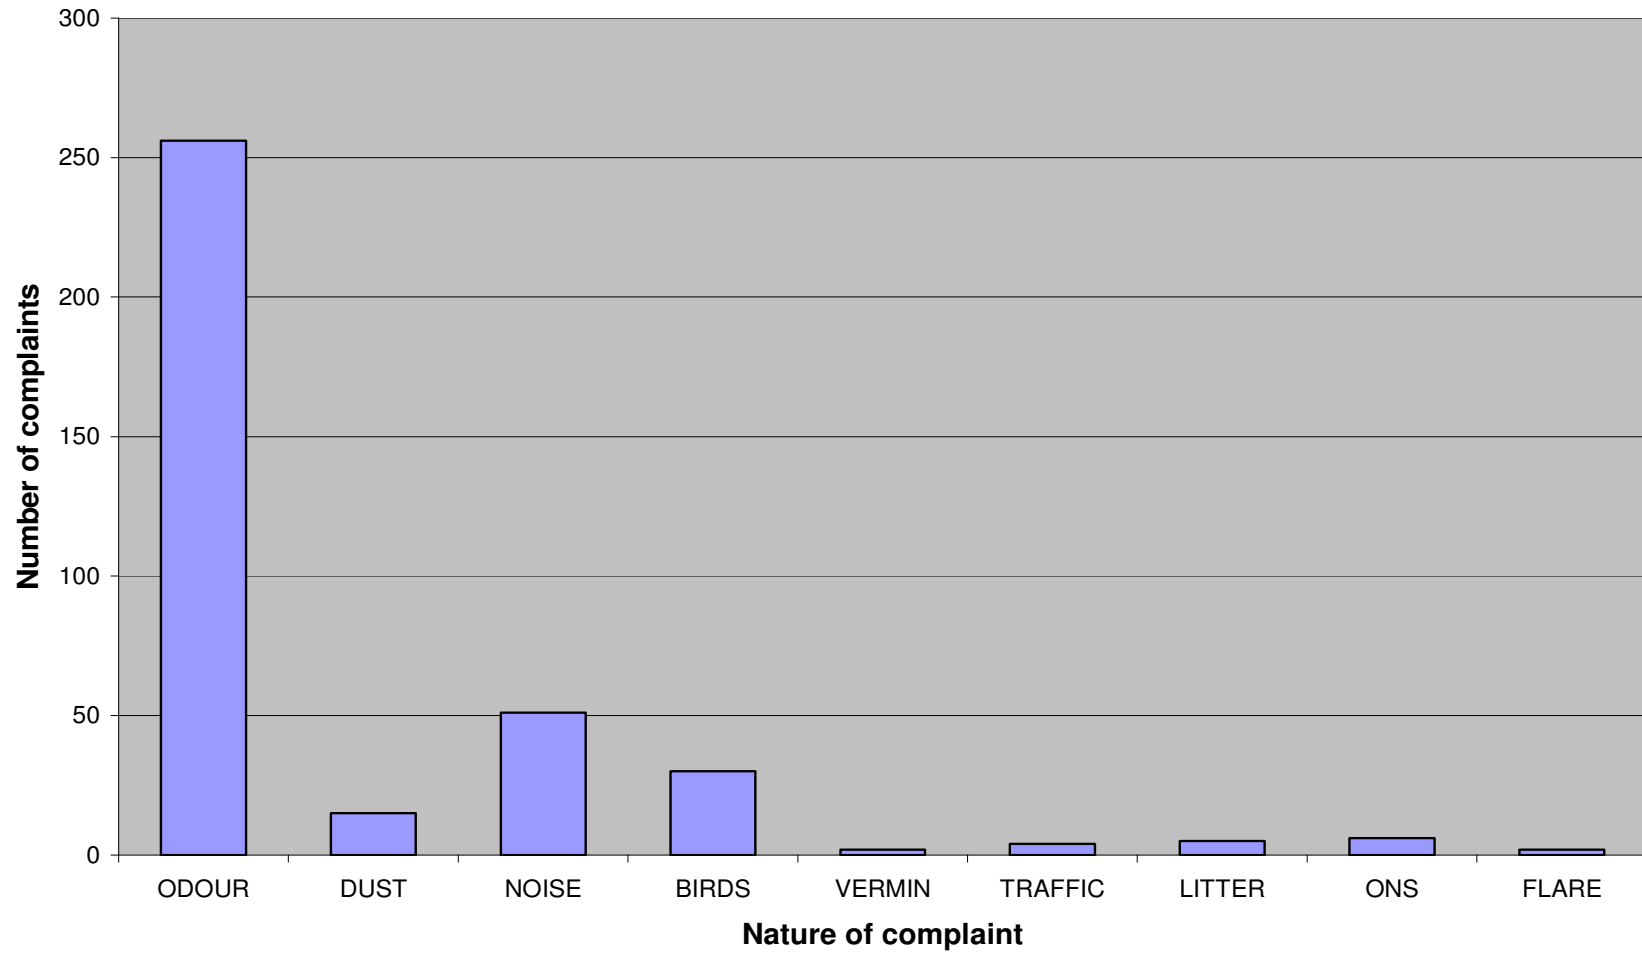
Complaints Summary 2008

Greenstar maintains a register of complaints in compliance with Condition 10.14. Details of all complaints received during the reporting period and the action taken by Greenstar are available at the facility. A graph showing the composition of the 338 complaints is included in Appendix 7.
