ANNUAL ENVIRONMENTAL REPORT – 2009
CAPPINCUR WASTE TRANSFER STATION
TULLAMORE, COUNTY OFFALY
WASTE LICENCE REG. NO. W0104-02
ORIGINAL
MARCH 2010

Keywords: Cappincur Waste Transfer Station, Annual Environmental Report (AER), waste recovery & disposal, environmental monitoring

Abstract: This report presents the Annual Environmental Report for Cappincur Waste Transfer Station, Tullamore, Co. Offaly to the Environmental Protection Agency. The report covers the annual reporting period of 2009.

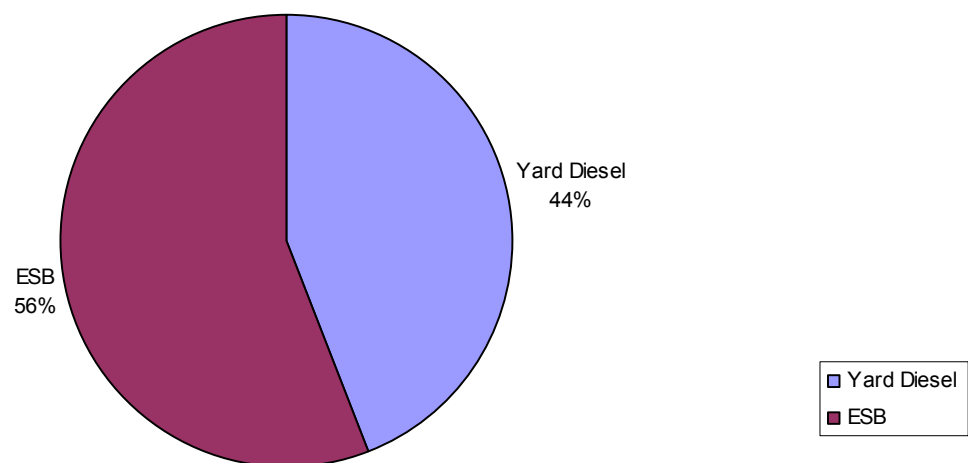
The most significant energy inputs into the existing facility are electricity supplied by ESB, and diesel supplied by Sutton Oil Ltd. Table 4.1 below outlines these inputs.

Figure 4.1 Percentage Distribution of Energy Costs for the AES facility at Cappincur during Audit Period June '08 to June '09

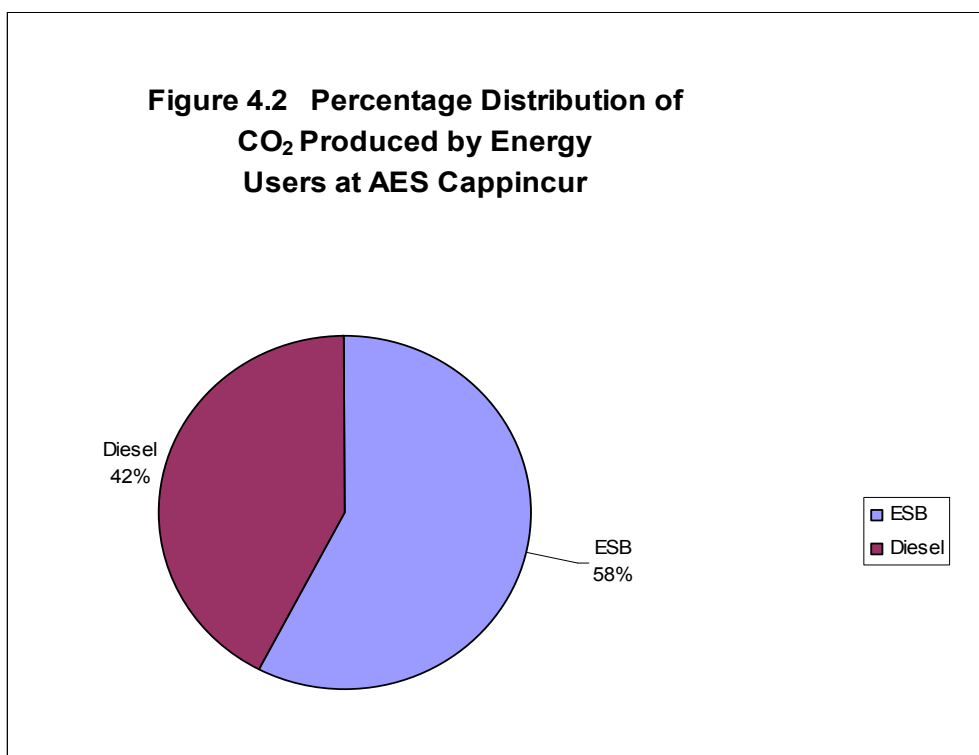
Figure 4.2 Percentage Distribution of CO₂ Produced by Energy Users at AES Cappincur

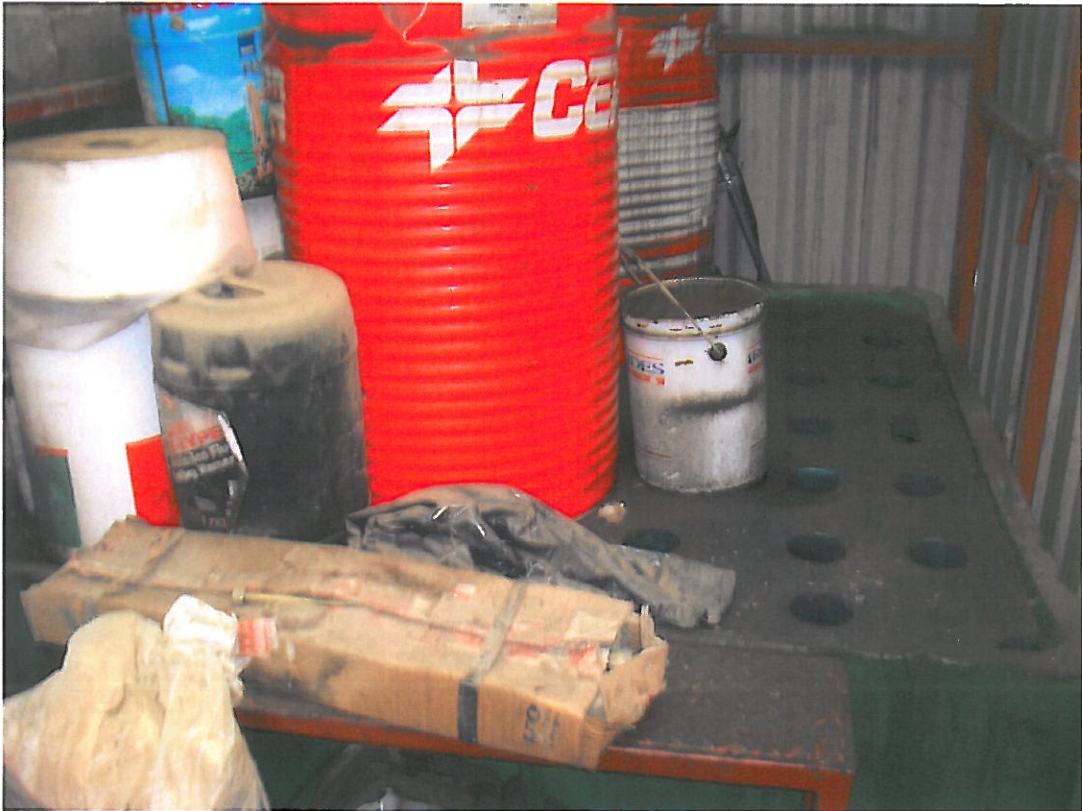
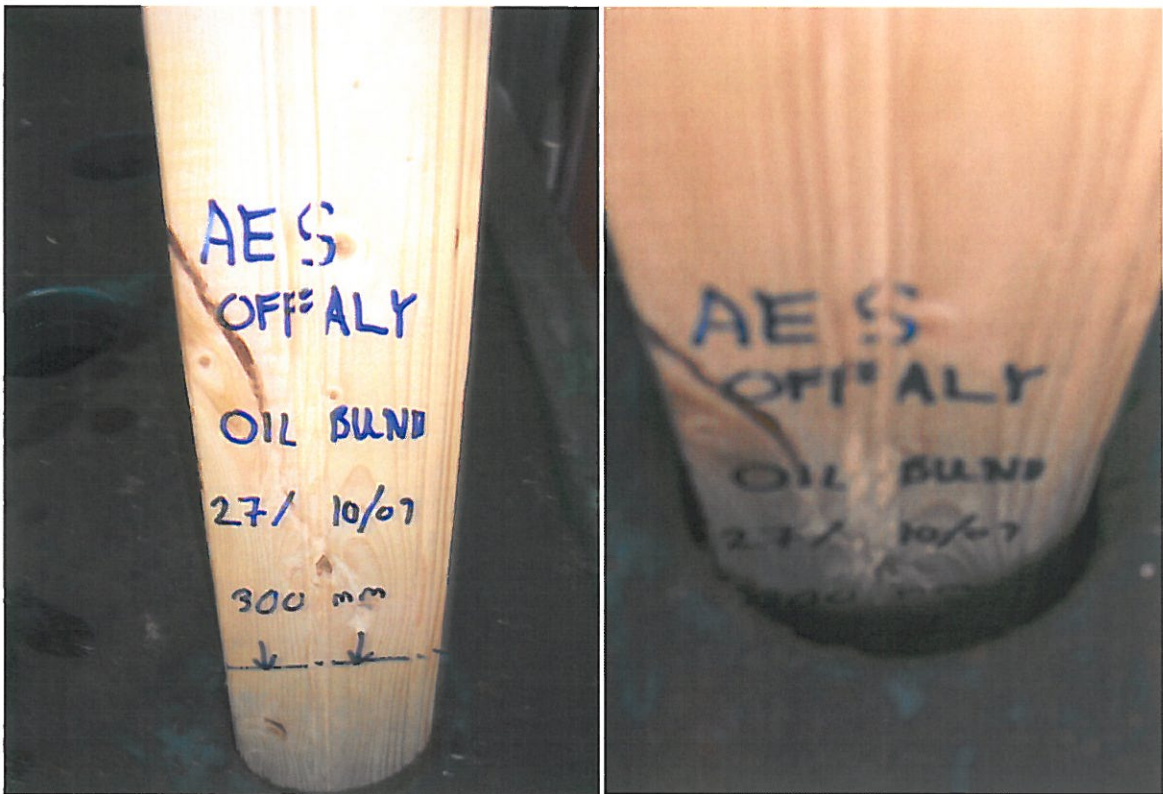
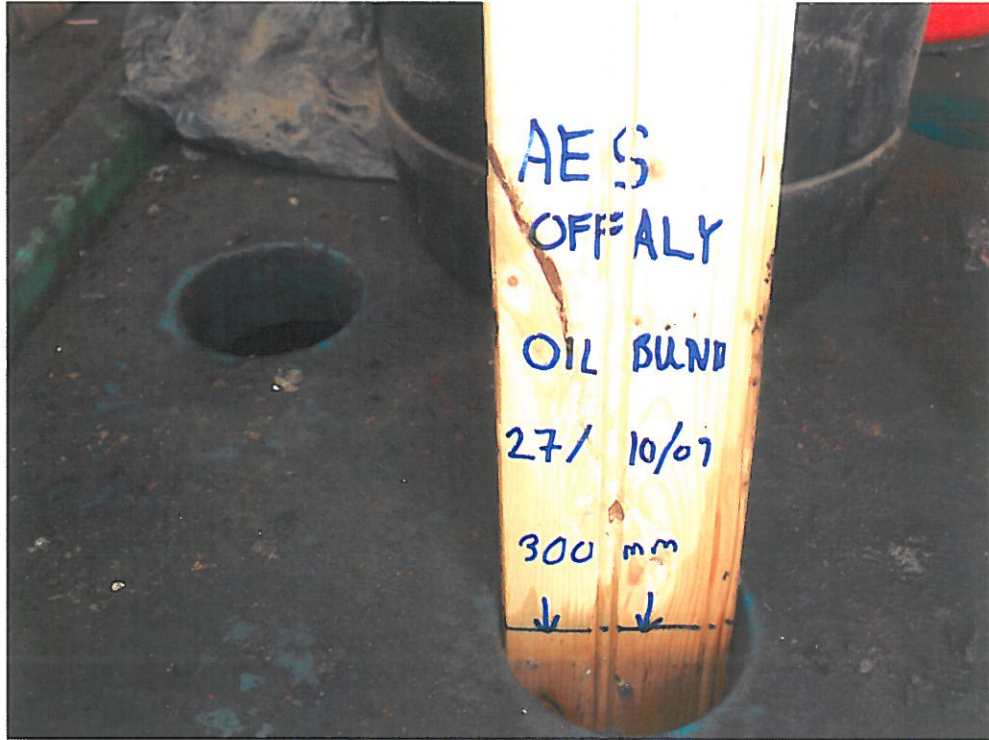
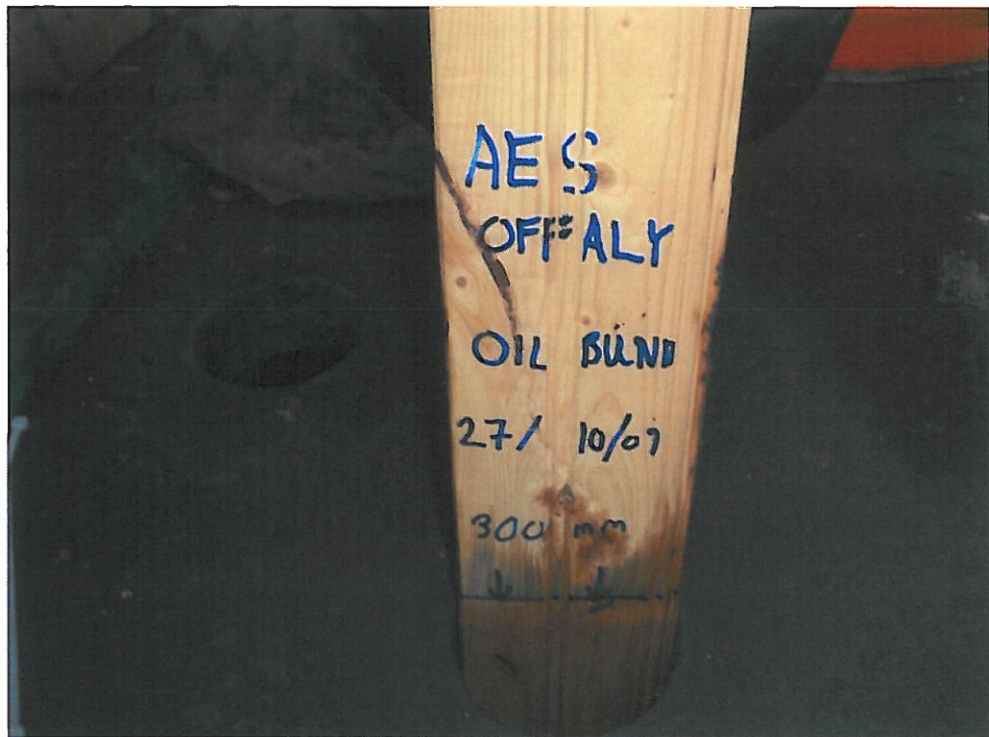
The oil bund 1 was found to be in compliance with the bund assessment.

Photo ID: Oil Bund 1 - Day 1 – prior to filling (27/10/09)

Photo ID: Oil Bund 1 - Day 1 (27/10/09)

Photo ID: Oil Bund 1 - Day 2 (28/10/2009)

Photo ID: Oil Bund 1 - Day 7 (3/11/2009)

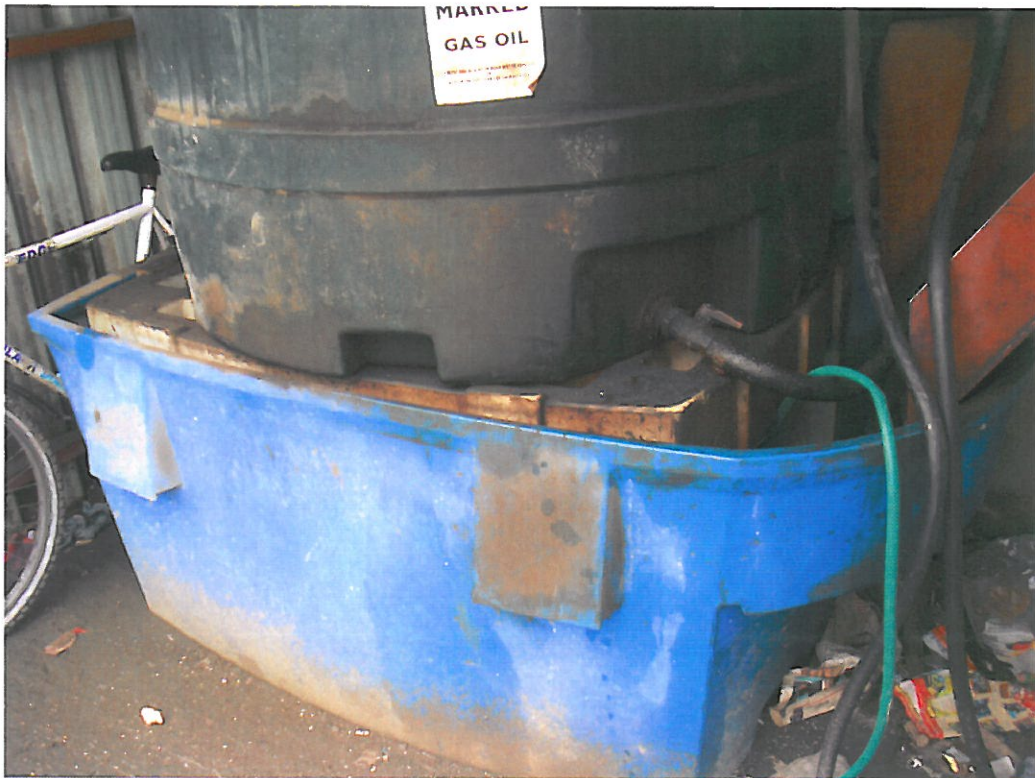
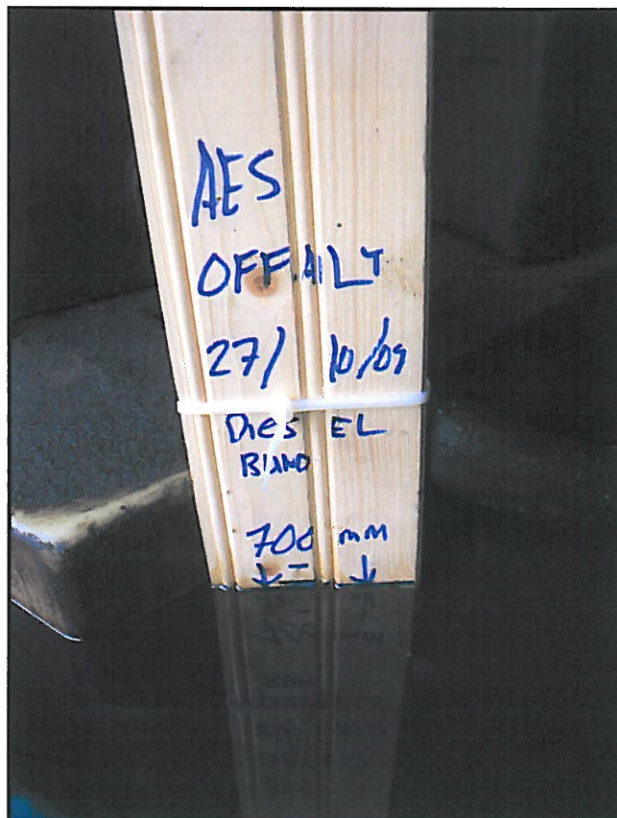
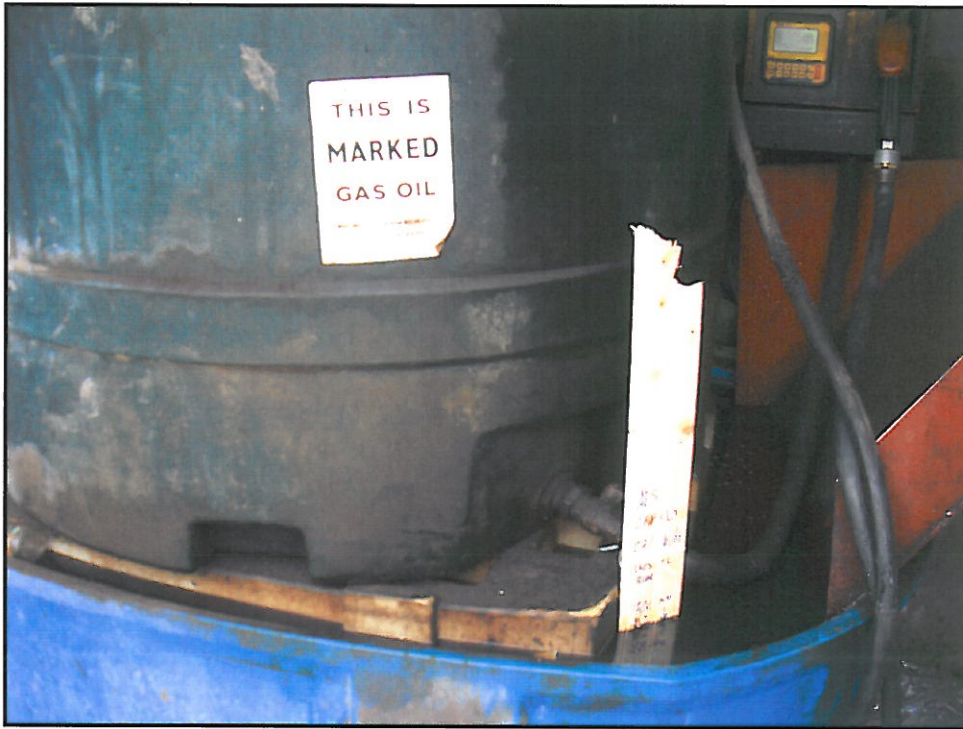
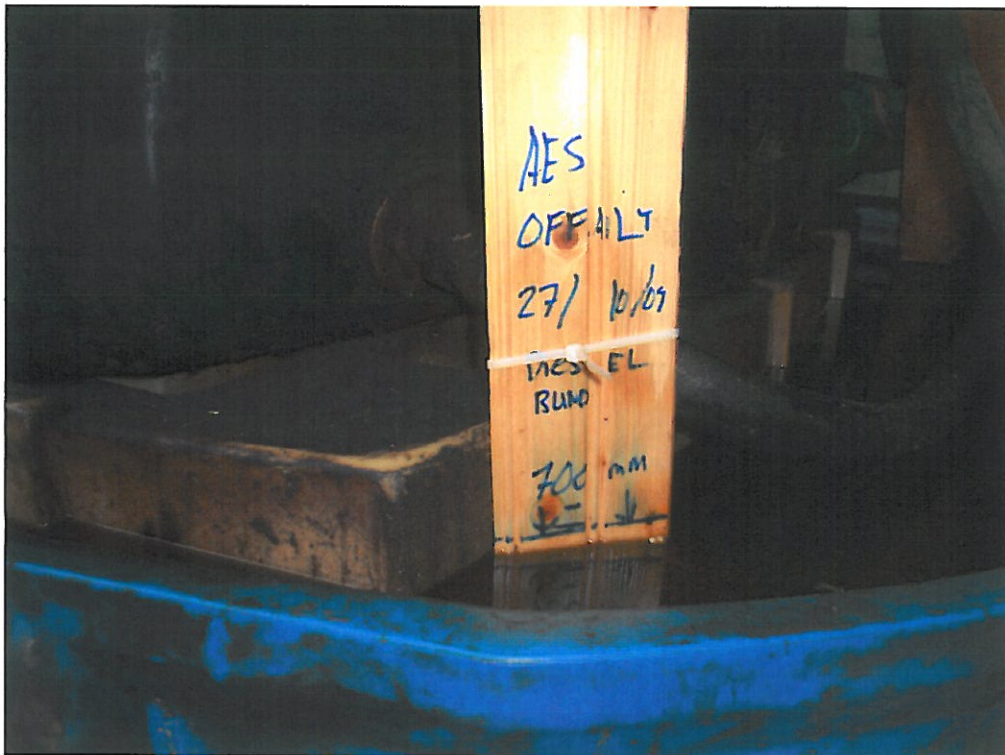
The diesel bund 2 was not found to be in compliance with the bund assessment for the following reasons;

1. The diesel bund does not have the capacity to hold 110% of the diesel tank capacity.
2. The diesel bund was also found to be the exact width of the tank. For this reason any potential spills from rupturing of the diesel tank would not be completely captured by the bund area.

The bund does not have the capacity to hold 110% of the diesel tank capacity. The bund was also found to be the exact width of the tank. For this reason any potential spills from rupturing of the diesel tank would not be completely captured by the bund area.

The water tightness of the diesel bund was found to be in compliance. However the capacity of the bund is found to be non-compliant.

Conformance to B.S. 8007: 1987 Section 9 (24 Hr Stabilising Period)**Non-Compliant**

Photo ID: Diesel Bund 2 - Day 1 – prior to filling (27/10/09)

Photo ID: Diesel Bund 2 - Day 1 – (27/10/09)

Photo ID: Diesel Bund 2 - Day 2 (03/11/2009)

Photo ID: Diesel Bund 2 - Day 7 (03/11/2009)

It is recommended that the bund be replaced with a bund of larger capacity.
