**Annual Environmental Report, 2009 for  
Marrakesh Ltd., Kilmurry South Landfill,  
Waste Licence W0048-01**

**Marrakesh Ltd.**

Kilmurry,  
Kilmacanogue,  
Co. Wicklow.

MA0105/AER09

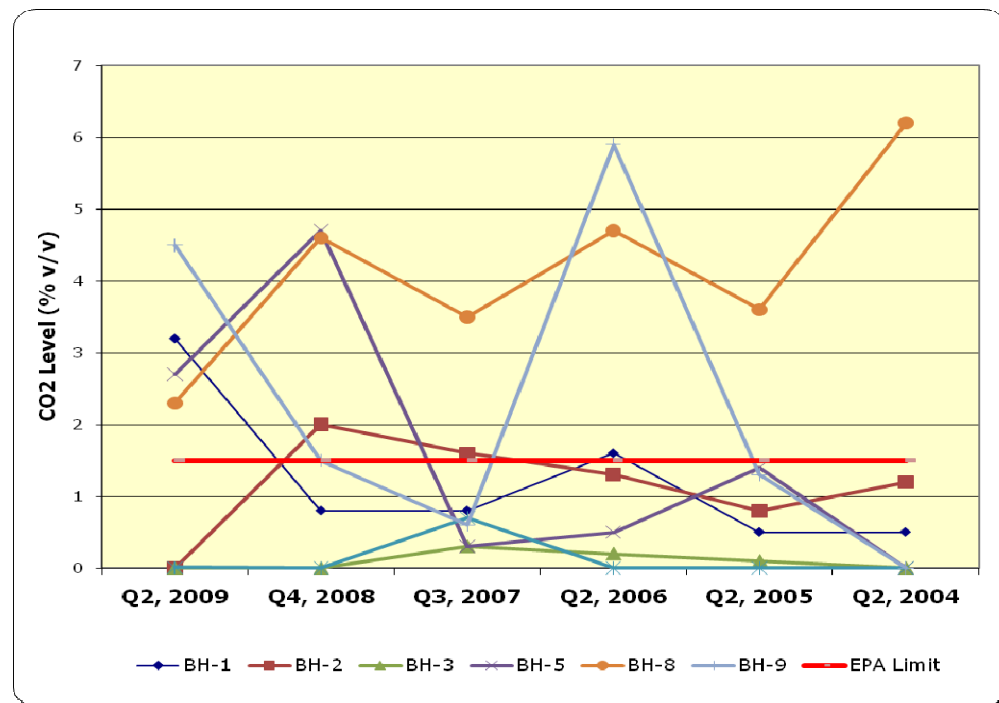
Figure 3.1: Carbon Dioxide Levels Measured in Site Boreholes, 2004-2009

The levels of CO<sub>2</sub> measured in site boreholes at Kilmurry Landfill are presented in **Table 3.3**, and are graphically represented in **Figure 3.1** for the period 2004 to 2009. Carbon dioxide levels exceeded the licence limits during gas monitoring carried out in June 2009 at BH-1, BH-5, BH-8 and BH-9. This is in line with previous monitoring results for CO<sub>2</sub> as shown in Table 3.3.

The CO<sub>2</sub> measurements in excess of the limits were found in the absence of CH<sub>4</sub> and are therefore thought to be attributable to aerobic microbial activity in the boreholes, which produce CO<sub>2</sub> as a by-product of respiration.

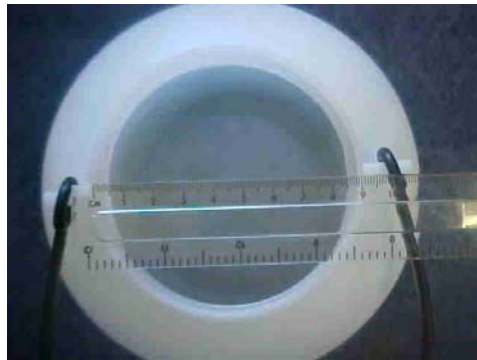
**Plate 3.1: Dust Bottle**

The dust bottle used as part of the Bergerhoff Dust Deposition Gauge; note the neck of the dust bottle has a diameter of 90 mm.

The apparatus consists of a collection vessel with an open mouth of 90mm diameter with a collection sample bottle of 1.5 litres volume (**Plate 3.1**). It was set up in the areas outlined in Schedule D of the waste licence. The gauges were left for a period of 30 days. When the sample period had elapsed the sample bottles were checked for the presence of any unusual deposits such as leaves or insects and these were removed before analysis of the samples took place.

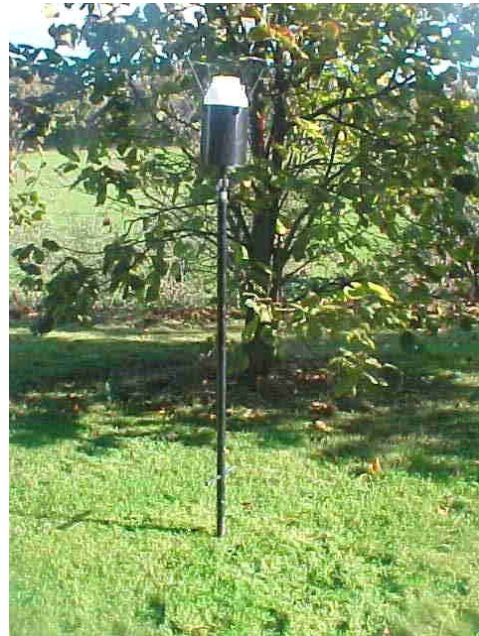
**Plate 3.2: Bergerhoff Dust Gauge**

The Bergerhoff Dust Gauge apparatus as used to measure the level of dust deposition.

Dust was measured using a Bergerhoff dust gauge, which was exposed over a 30-day period to collect bulk dust deposition. The method employed is based on the German Standard Method VDI 2119 and collects total particulate matter. The gauge consists of a gauge bottle supported on a stand of approximately 1.5 metres high (Plate 3.2). The gauges were located at two positions as outlined in **Table 3.16**.

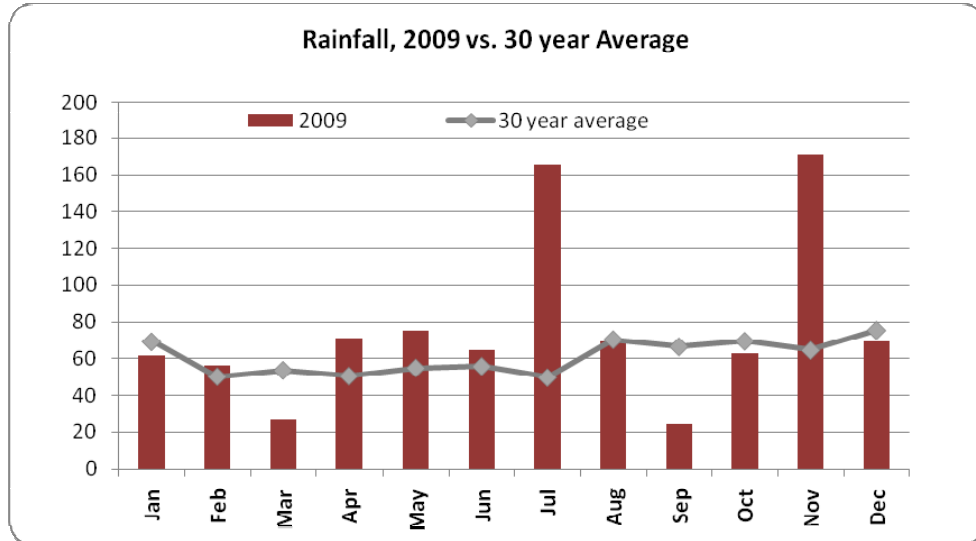
Figure 3.2: Rainfall, 2009

Meteorological data was obtained from the meteorological station situated at Dublin Airport, the parameters obtained were: precipitation, temperature (average), wind speed and direction, relative humidity and atmospheric pressure (as per Schedule D.5). **Figures 3.2 to 3.5** represent temperature, precipitation and atmospheric pressure throughout the reporting period.
