**Cavan County Council**

**Annual Environmental Report 2009**

**Bailieborough Landfill WL 91-1**

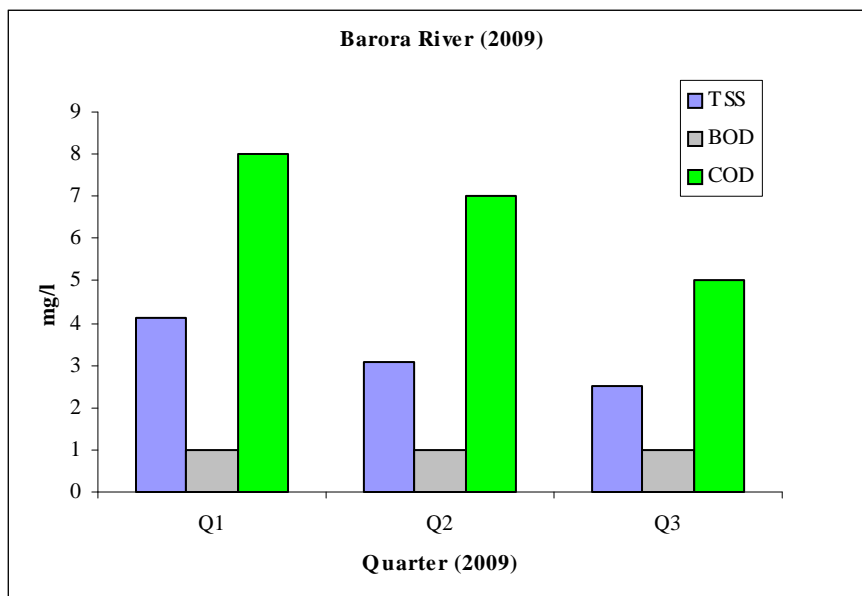
SW1 is classed as a category A1 in Quarter 3. Only a visual assessment was required in Quarter 4 and no change was noted. SW2 (River Barora) was found to be free of odour and no unusual visual anomaly was noted.

The surface water taken from the Barora River is classed as a category A1 in Quarter 3. Only a visual assessment was required in Quarter 4 and no change was noted. Graph 4.1 below shows the trend results for Total Suspended Solids (TSS), BOD & COD.

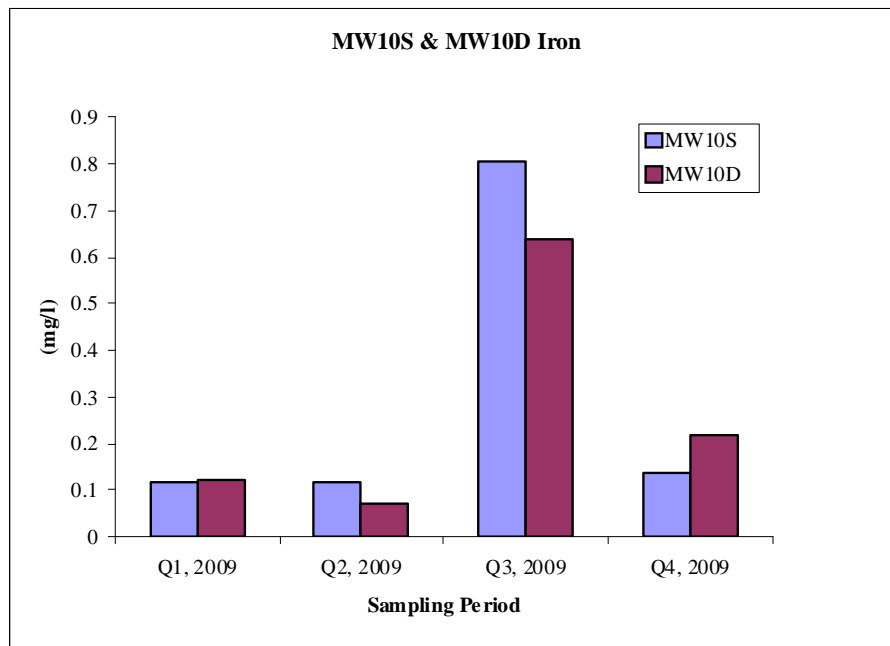
Overall groundwater quality is good with the exception of elevated Iron levels in some samples. This is commonly associated with samples taken from landfills or in the vicinity of landfills. Overall the quality of the groundwater varied across the site and signs of contamination existed in all sampled groundwater wells in the vicinity of the landfill.

MW10D for Quarter 4 exceeded the interim guideline values for the protection of groundwater in Ireland for iron (0.22mg/l and total and faecal coliforms (146 and 1 cfu/100mls respectively). The exceedences are minor and are quite treatable should the water be considered for drinking purposes. See Graph 4.2 below.

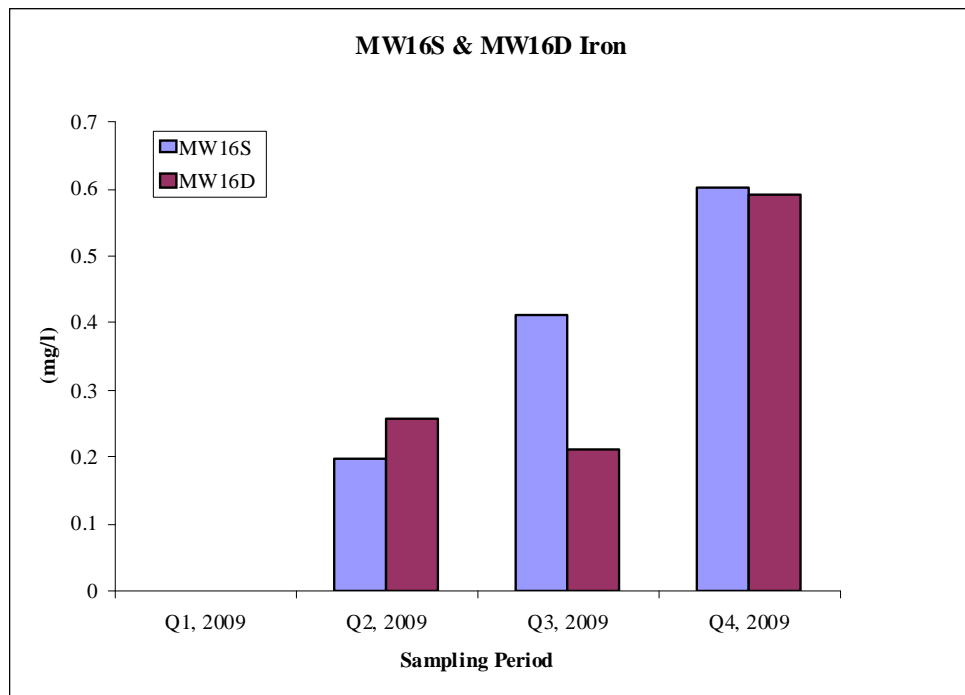
MW16D for Quarter 4 exceeded the interim guideline values for the protection of groundwater in Ireland for chloride, iron, potassium, phenols and total coliforms. When compared to S.I No.278 of 2007, the drinking water standard, the results for potassium, phenols and the result for total coliforms are in exceedence. The parameters iron, potassium, phenols and total coliforms are now in exceedence for this and the previous 2 quarters. The major concern in drinking water is the avoidance of bad taste that may develop especially for a groundwater that is disinfected by chlorination if intended for use as a drinking water. The phenol reading is trending

downwards along with the readings observed for total coliform bacteria. See Graph 4.3 below for these details.

MW16S for Quarter 4 exceeded the interim guideline values for the protection of groundwater in Ireland for chloride, iron, potassium and total coliforms. When compared to S.I No.278 of 2007, the drinking water standard, the results for potassium, iron and the result for total coliforms are in exceedence. The parameters Chloride, potassium and total coliforms are now in exceedence for this and the previous 2 quarters. The total coliform bacteria results are trending downwards along while all others are stable.

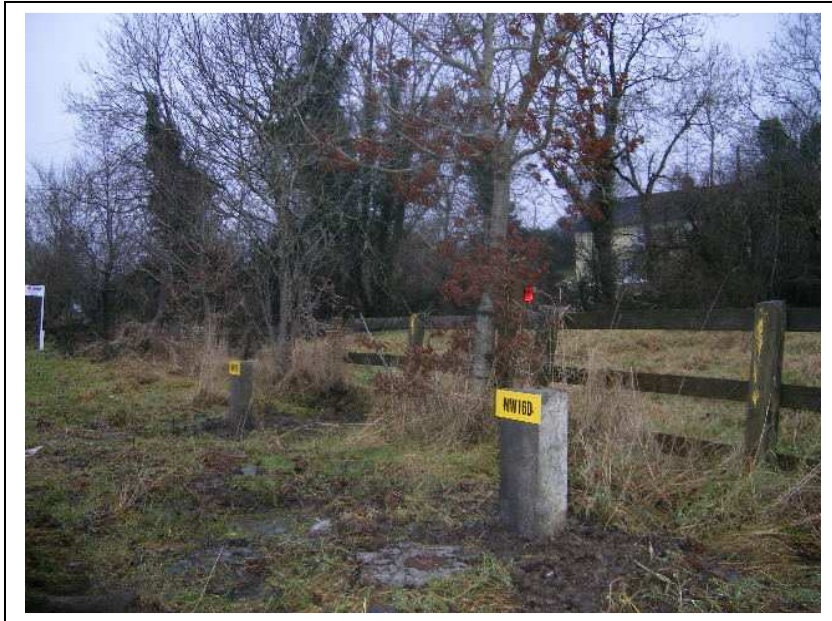
Photo 7.1

- Newly drilled roadside boreholes were named, surveyed and elevations recorded, given additional protection and permanent signage erected – see photo below 7.1.

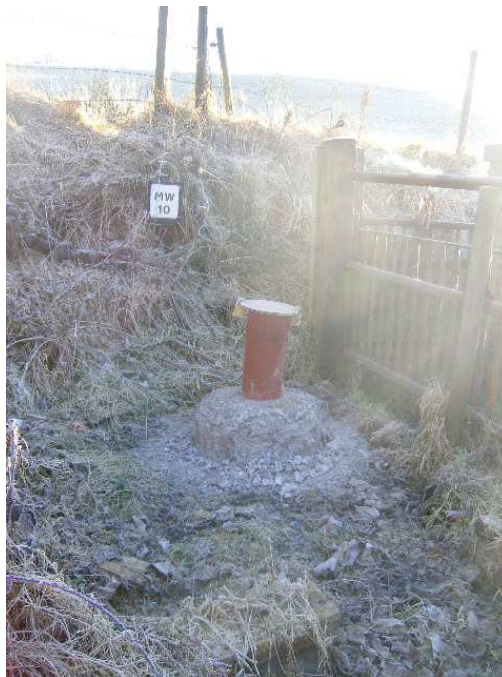
- Borehole Logs for the newly drilled wells were submitted to the Agency.
- Groundwater Borehole MW10 was protected from any potential pollution/contamination associated with nearby animal pen. -See Photo 7.2
