Cavan County Council

Annual Environmental Report 2009

Ballyjamesduff Landfill WL 93-1

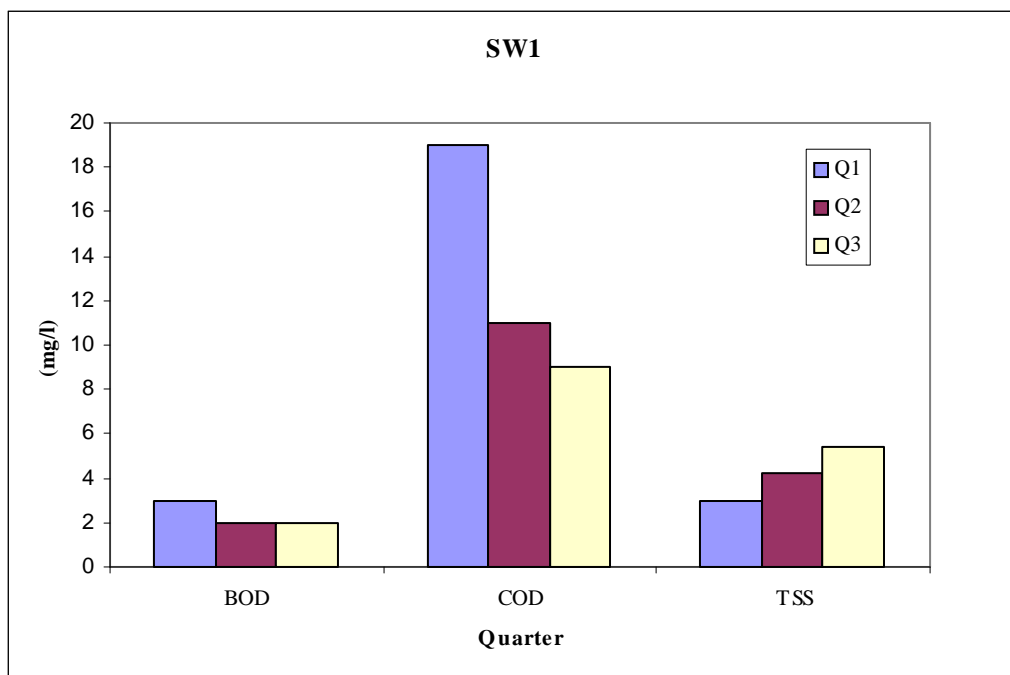
Graph 4.1 SW1 Results

Location SW1 is classed as a category A1 and no change was noted. Location SW2 is classed as a category A1 and no change was noted. No surface water sample was taken from the discharge from the final cap but this has since been added into the monitoring schedule.

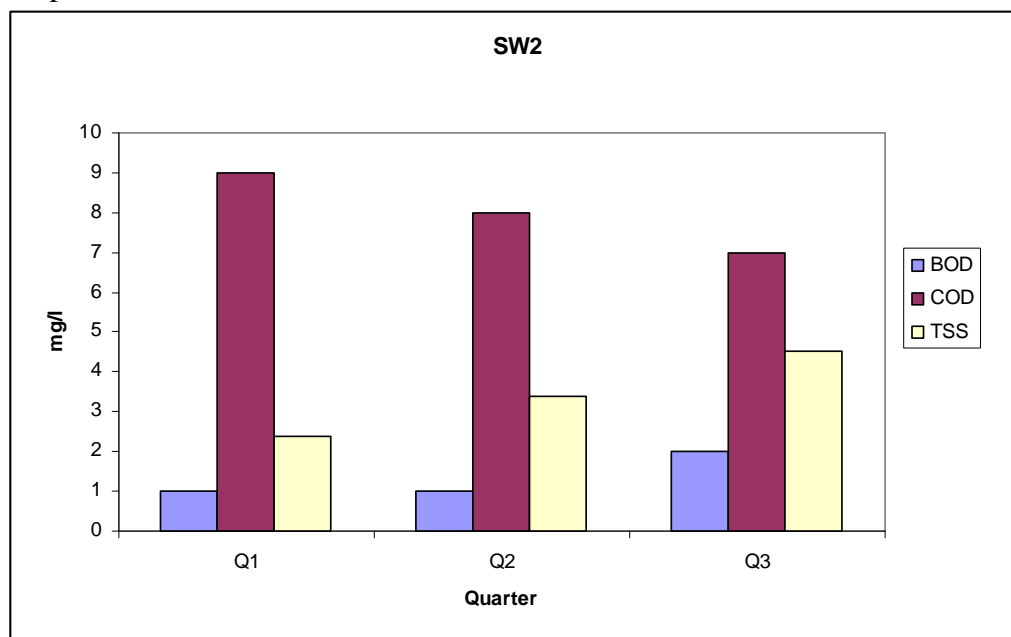
Graph 4.2 SW2 Results

Results from location SW2 downstream of the landfill are represented in Graph 4.2 below. COD results appear to be elevated with a downward trend.

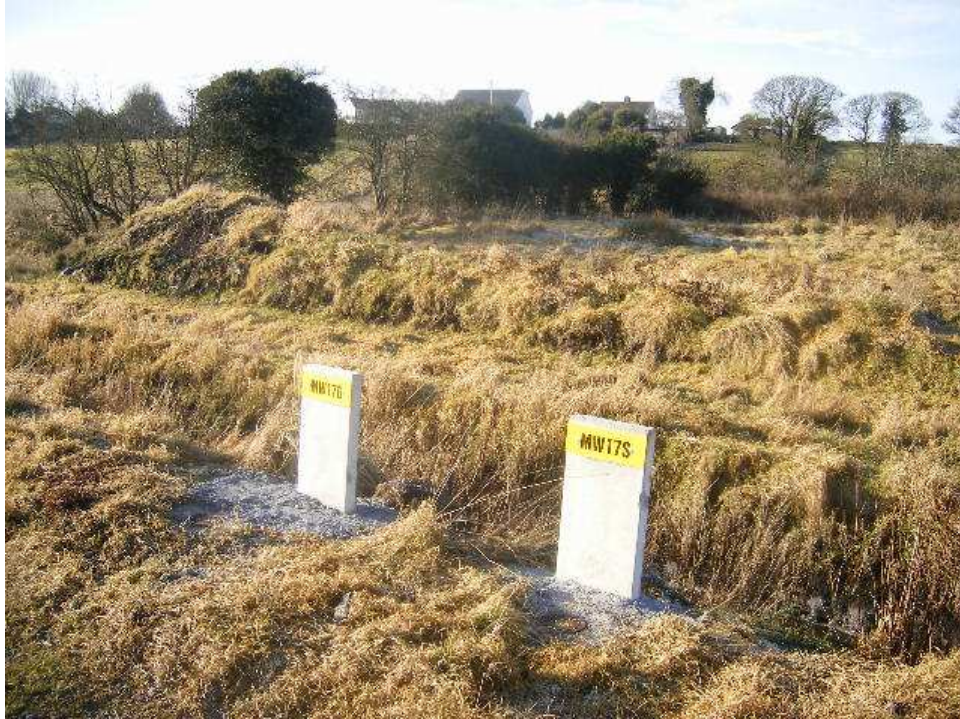
Photo 7.1

- Newly drilled roadside boreholes were named, surveyed and elevations recorded, given additional protection and permanent signage erected – see photo below 7.1
